Assessment of the Takla Landing Contour Trench Wastewater Disposal System

A Report to:
Canada Mortgage and Housing Corporation
Environment Canada
Health & Welfare Canada
Indian & Northern Affairs Canada
Takla Lake Band

May, 1989

NovaTec Consultants Inc.
Environmental Engineers & Scientists

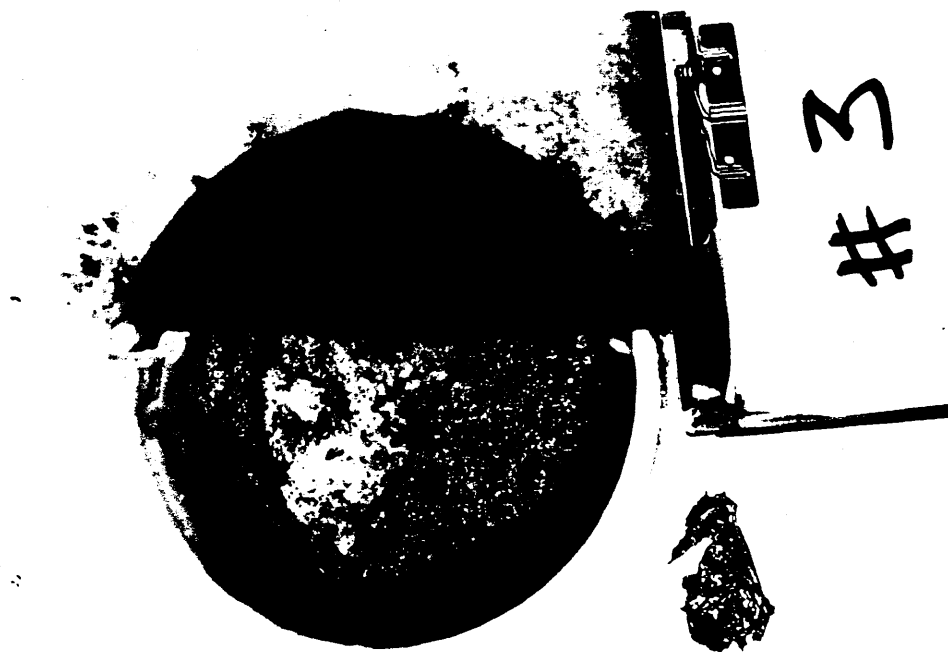
Photo 3: Underside of geotextile fabric in Biomat Sampler No. 3 - March 1988.

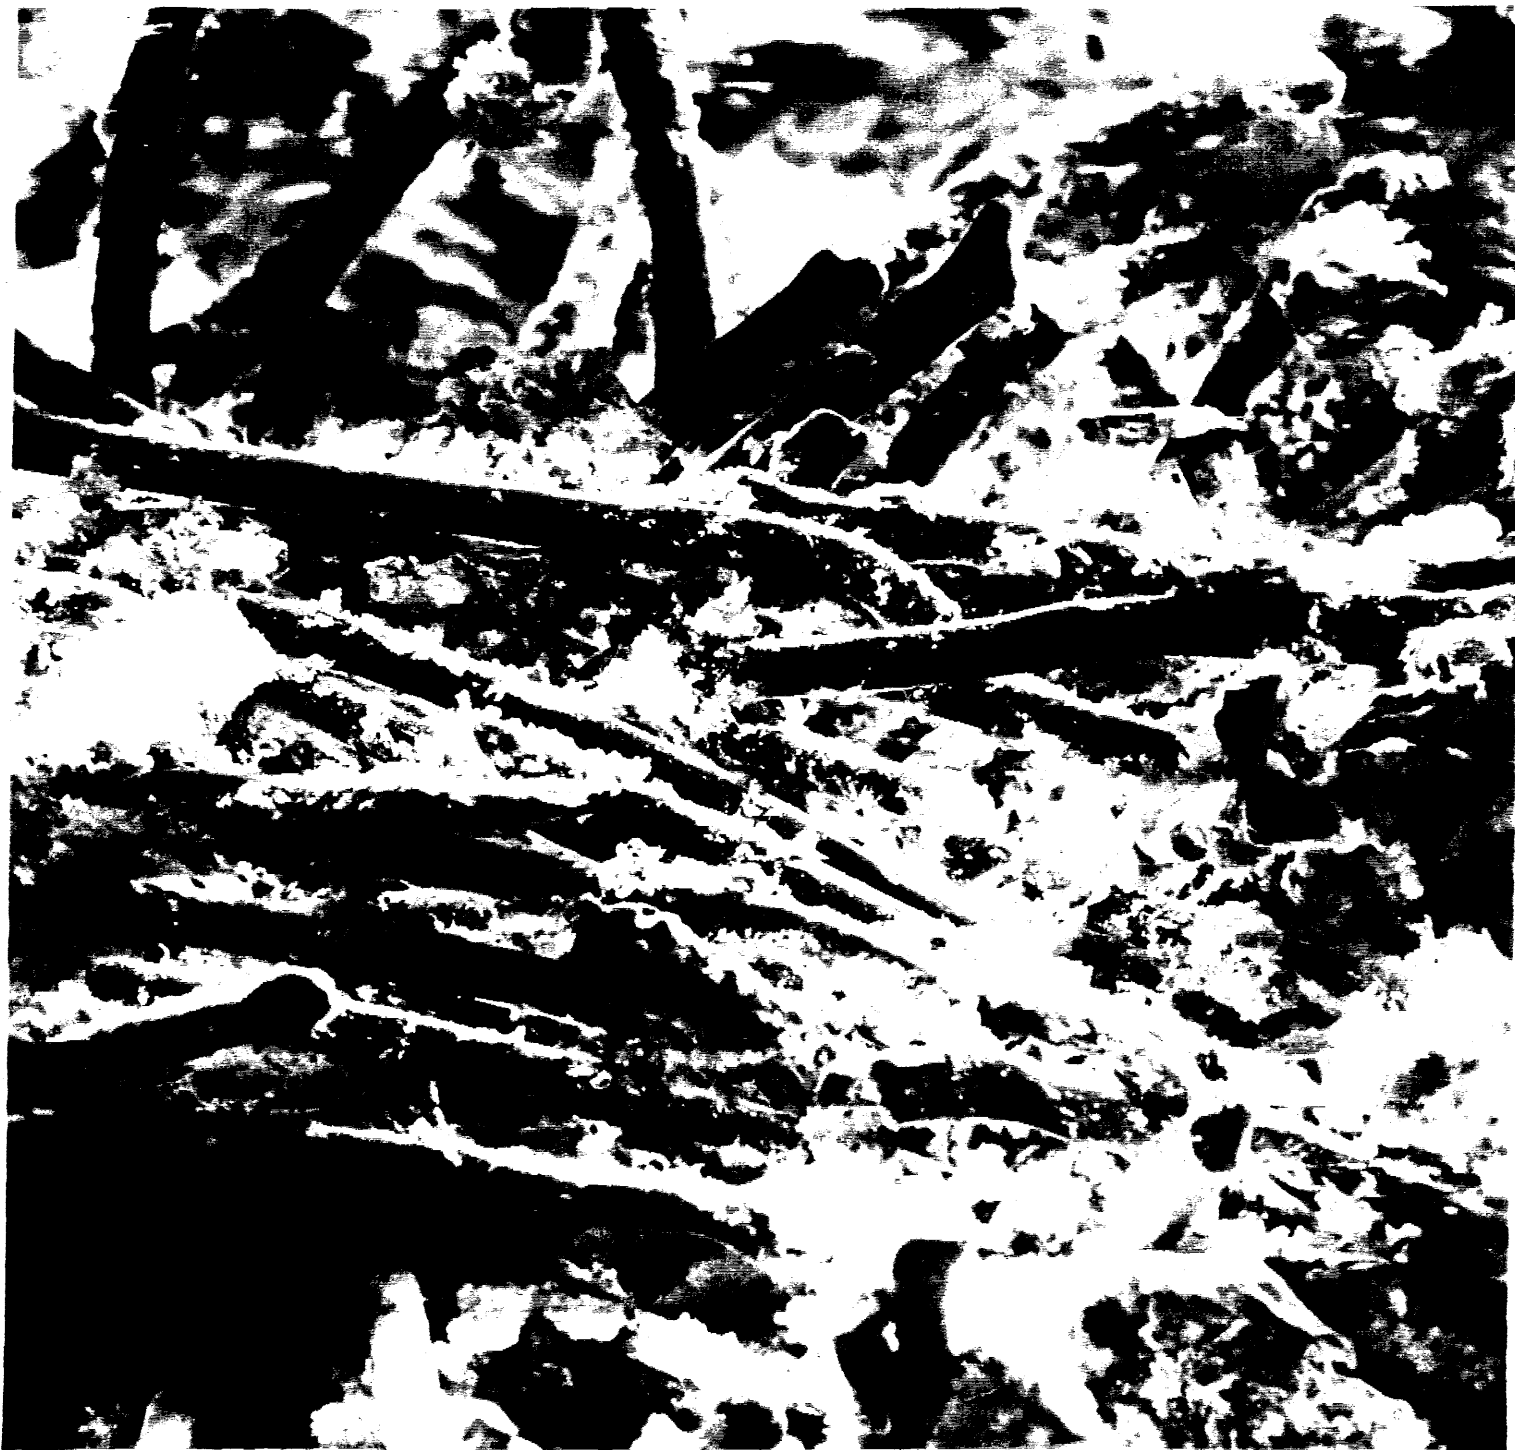
SEM Photo 4: Geotextile cloth close to biomat-organic layer interface. Note that the cloth is blocking up with organics. (Magnification = 6,300).

In the early stages of the project the geotextile liner (Samplers 1, 2 and 3) showed good biomat development characteristics. However, in the microscopic examination conducted in September 1988 it was reported that the fabric appeared to be clogged with organic material to the point that hydraulic conductivity may be seriously impaired (See Section 4.2, below). The effects of biomat submergence and/or temperature cannot be determined from the limited data available in this study. However, long term equilibrium conditions could be evaluated at some future date.
