**MEASUREMENTS OF THE CONFIGURATION
OF A BREAKUP JAM**

S. Beltaos¹ and W.J. Moody²

National Water Research Institute

March 1986

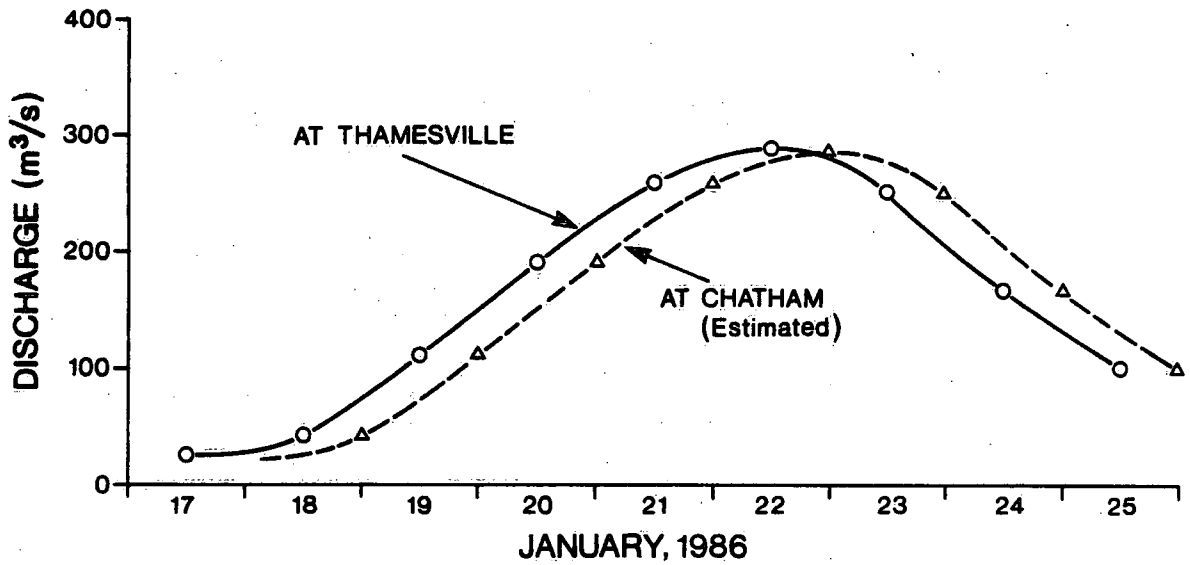
Fig. 3. Discharge hydrographs during January breakup.
 (Water Survey of Canada, Guelph, Provisional Data)

Measurements of discharge are not available for the period of the January '86 breakup. The Thamesville hydrograph of Fig. 3 is based on such related data as water levels, weather conditions, rainfall, flows at upstream gauges and the like. For the Thamesville gauge, flow estimates of this kind are usually reliable owing mainly to the presence of upstream gauges where ice effects are often minimal during breakup periods at and below Thamesville. The Chatham hydrograph in Figure 3 is a mere translation in time of the Thamesville hydrograph and assumes a travel interval of about 12 hours while neglecting any tributary inflows or flow attenuation effects.

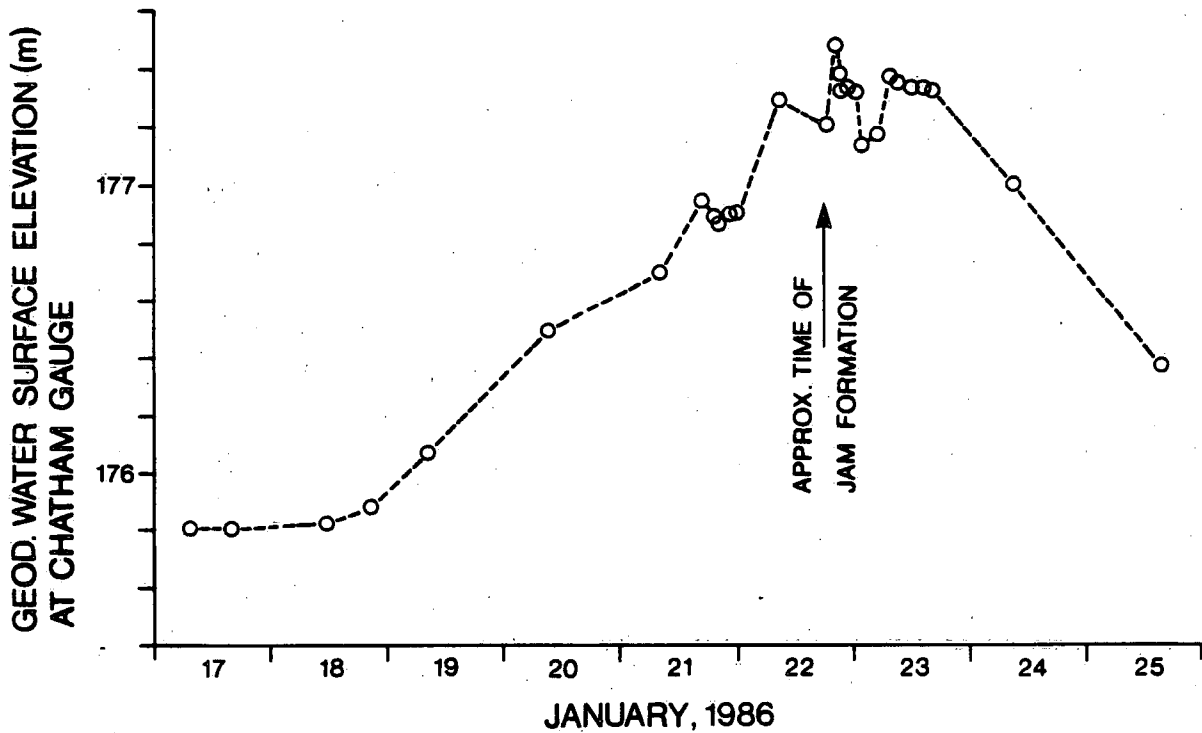
Fig. 4. Stage hydrograph during January breakup at Chatham gauge.

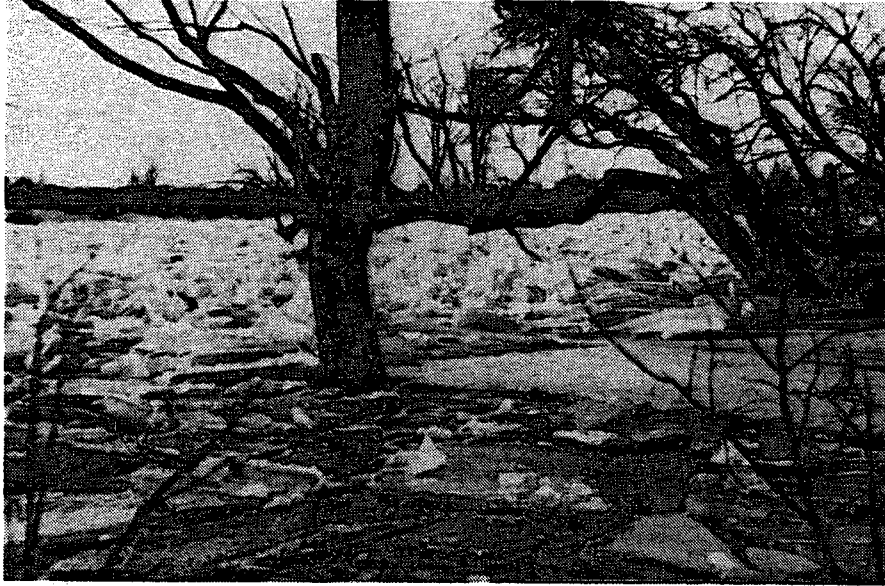
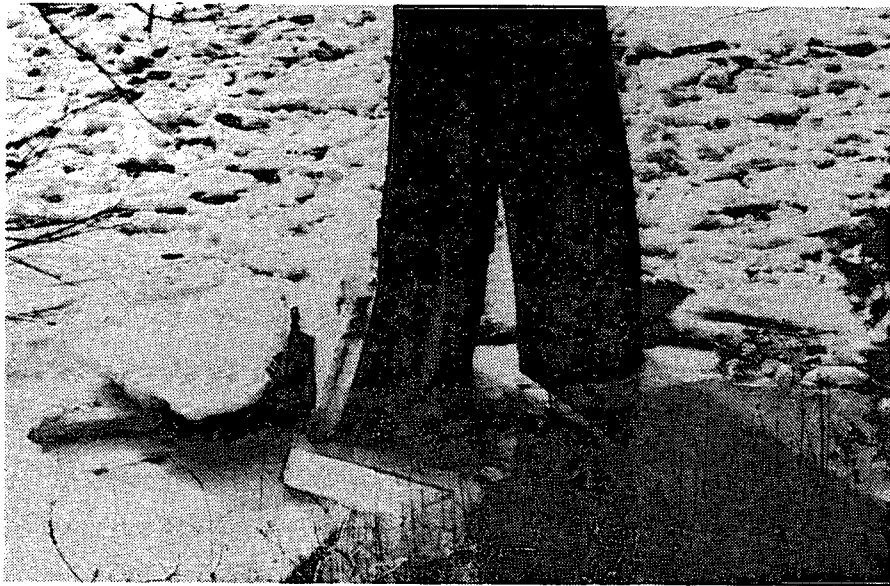
Photos 4 & 5. Examples of photos used to survey ice jam water levels. Upper photo: →LB at mouth of Arnold Creek; lower photo: →LB, 300 m d/s Sherman Brown Bridge.

To obtain water surface elevations along ice jams, conventional topographic surveys are, as a rule, too slow because the jam may release or change configuration before the survey is completed. The method adopted to circumvent this difficulty is to photograph the water stage against identifiable objects near the river banks (e.g., see photos 4 and 5). These photographs are then used to locate and survey the jam levels when the river is clear of ice. The obvious lack of accuracy is partially compensated for by the possibility of taking numerous spot water levels over long river distances.

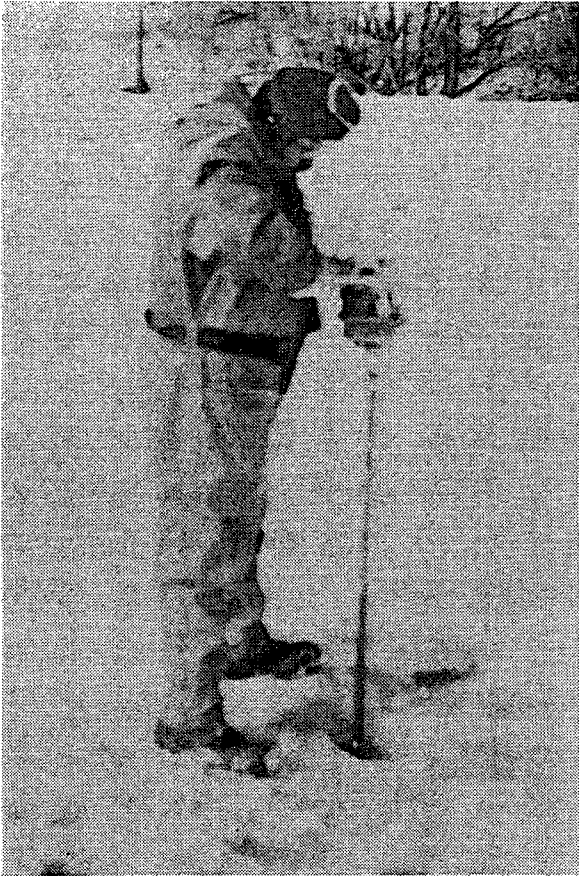
Photo 6. Drilling access hole for thickness measurement, February 1986.

While the location of measuring points was being established and recorded, the third member started drilling access holes through the ice at those sites (see Photo 6). Drilling equipment consisted of 3 HP gasoline powered ice drills with 18 cm diameter, 1 m long augers. Two 1 m long extension bars were made up to bolt onto the auger to give a 3 m drilling depth capacity. The operation of this extra length equipment required a strong team effort to complete the drilling procedures.

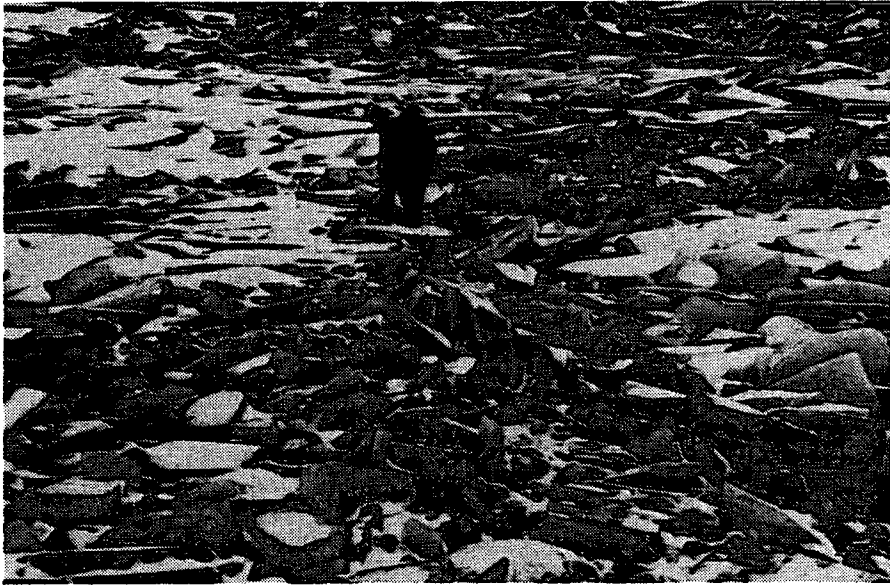
Photo 8. Preparing to drill near
CP Railway Crossing.
February 1986,

The second major problem was in drilling access holes and retrieving the equipment. Hazardous footing on the surface plus the jumbled configuration of ice throughout the jam thickness made it extremely hard to keep the holes vertical (see Photo 8). To compound the problem, loose and floating ice within and under the ice jam frequently trapped the auger. Retrieval sometimes required the efforts of all three crew members. Access to the work area, although generally good, did involve carrying all equipment up to a kilometer for some locations.

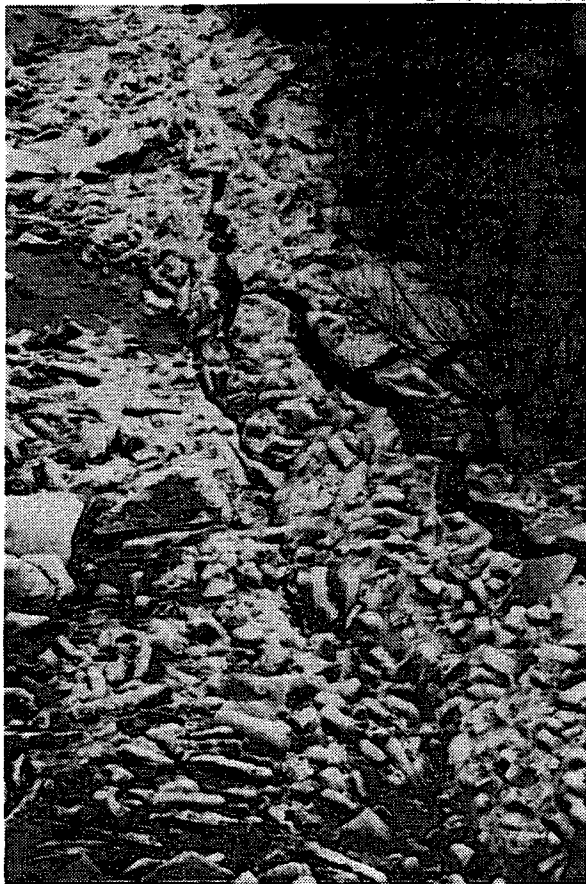
Photo 9. Ice pile on right bank,
formed by decrease in water
level. February 1986.

Another possible error was the specification of water surface width. The actual water's edge was hidden by inaccessible piled ice (see Photo 9). This necessitated estimation of these points for inclusion in profile data.
