Diefenbaker Lake

Effects of bank erosion on storage capacity

R. O. VAN EVERDINGEN

TECHNICAL BULLETIN No. 10

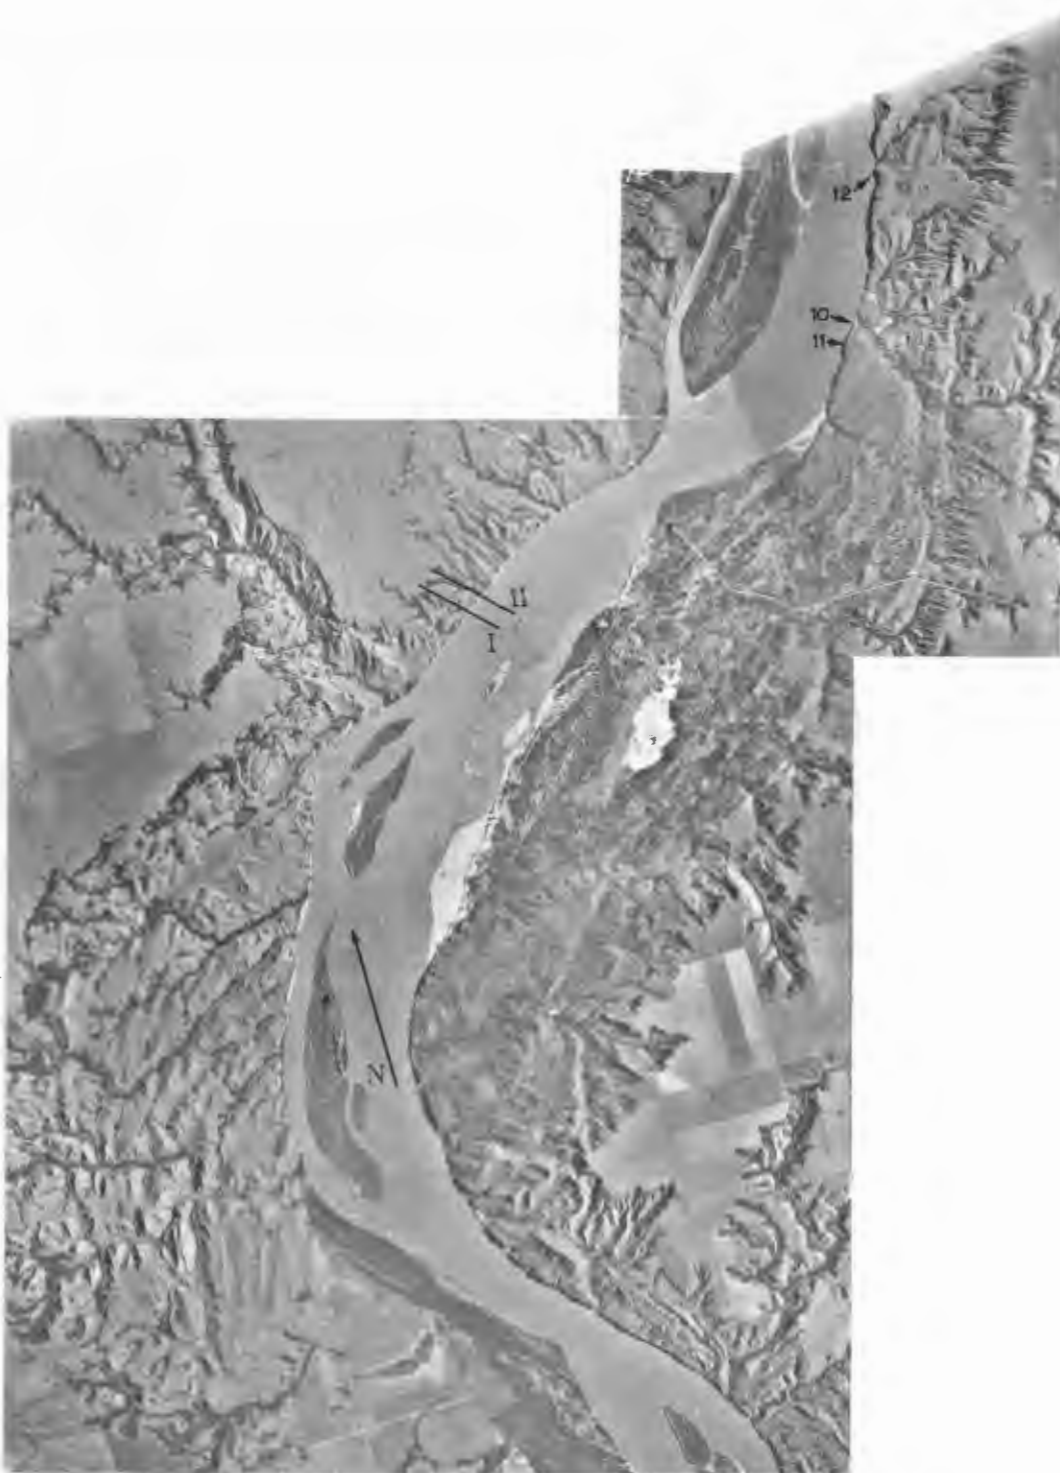
Figure 2. Valley of South Saskatchewan River near Riverhurst Ferry, Saskatchewan. Note evidence of earlier landslides mainly on west bank; and sandy area on east bank inside main bend. Numbers refer to location of photographs Figures 10 to 12; arrows indicate direction of view; Roman numerals indicate sections of Figure 17. (RCAF - A15963-121/123)

Between April 1965 and July 1967 the water level in Diefenbaker Lake (South Saskatchewan Reservoir, see Figure 1) rose from 1690 feet to 1805 feet above sea level at Riverhurst Ferry, Saskatchewan. During the above-noted period, erosion of the reservoir banks was observed near the ferry crossing during a groundwater study in the area. Photographs taken at various times since spring 1964 show some of the erosion phenomena in till and shale and indicate the magnitude of the effects. Locations of the photographs are marked on the aerial photographs, Figures 2 and 3.

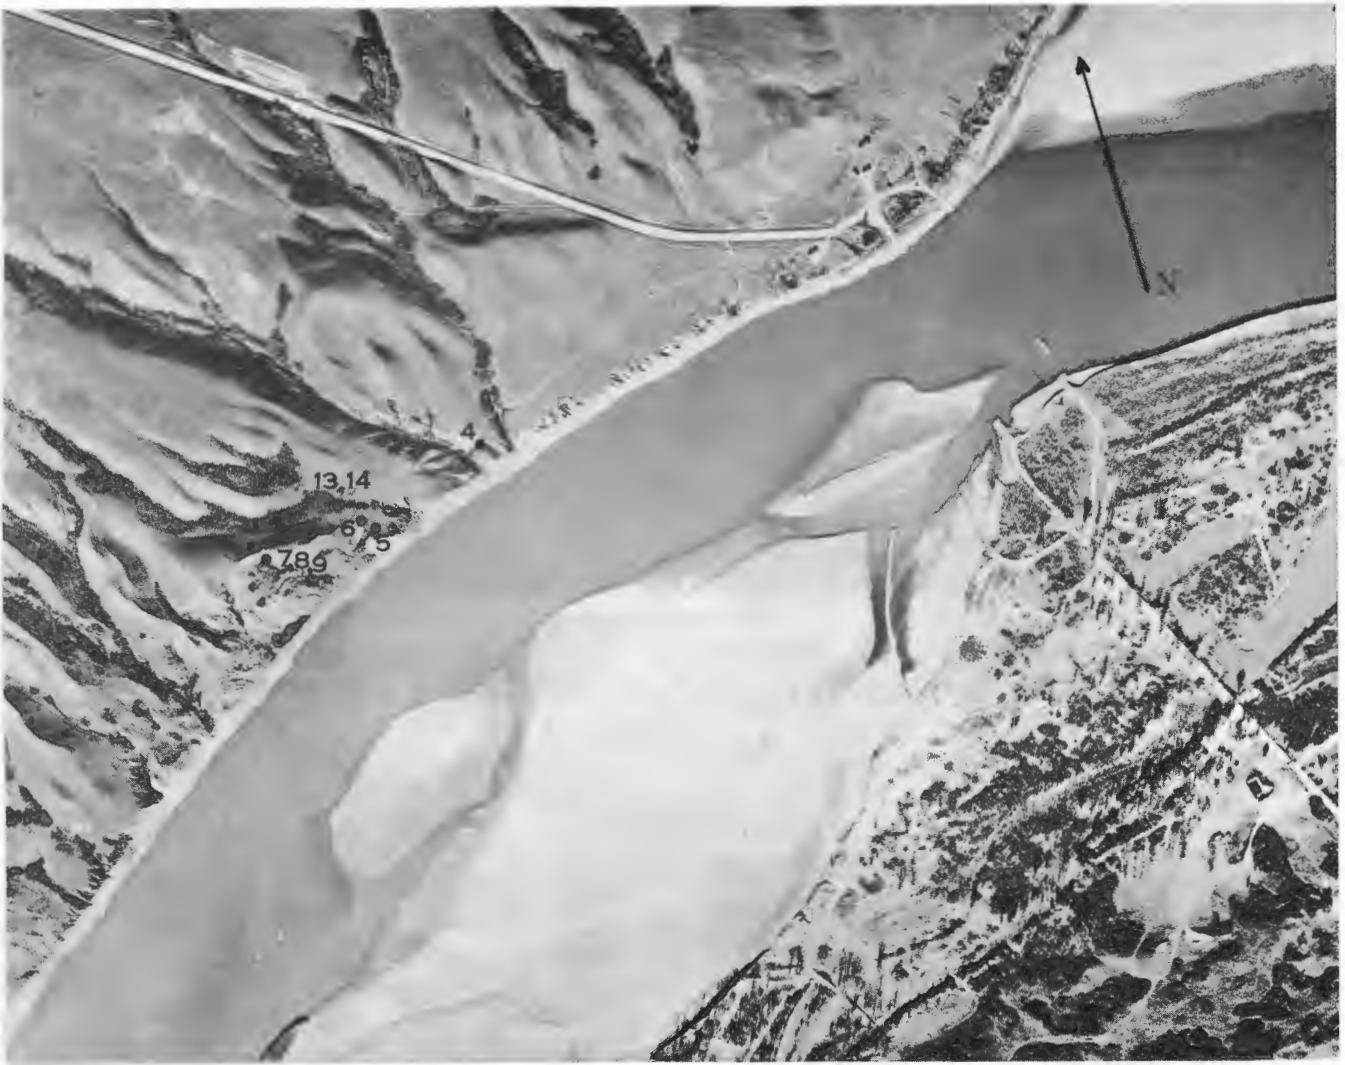
Figure 3. South Saskatchewan River at Riverhurst Ferry, Saskatchewan. Pre-reservoir 'beach' and cliffs are shown at low-flow stage.

Numbers refer to location of photographs figures 4-9 and 13-14; arrows indicate direction of view.
(RCAF - A16379-108)

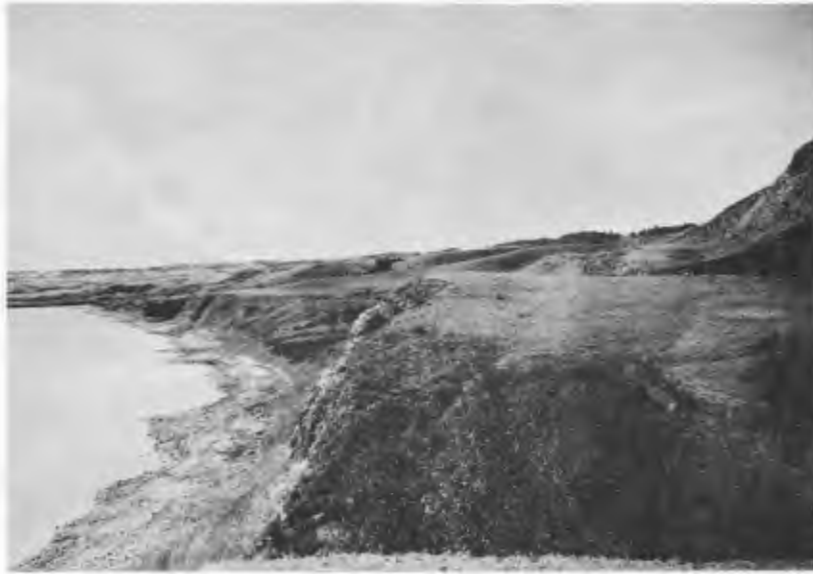
Figure 4. Gravel beach and steep banks in till and shale. West bank of South Saskatchewan River, looking upstream near Riverhurst Ferry. August 1964--Water level at 1689 feet above sea level.

The first photograph, Figure 4, shows the west bank of the South Saskatchewan River, looking upstream (southwest) from a point about one-half mile from the ferry. The flat beach or shelf and the relatively steep cliffs developed in glacial till and Upper-Cretaceous Bearpaw shale are characteristic of this reach of the valley in its original state.

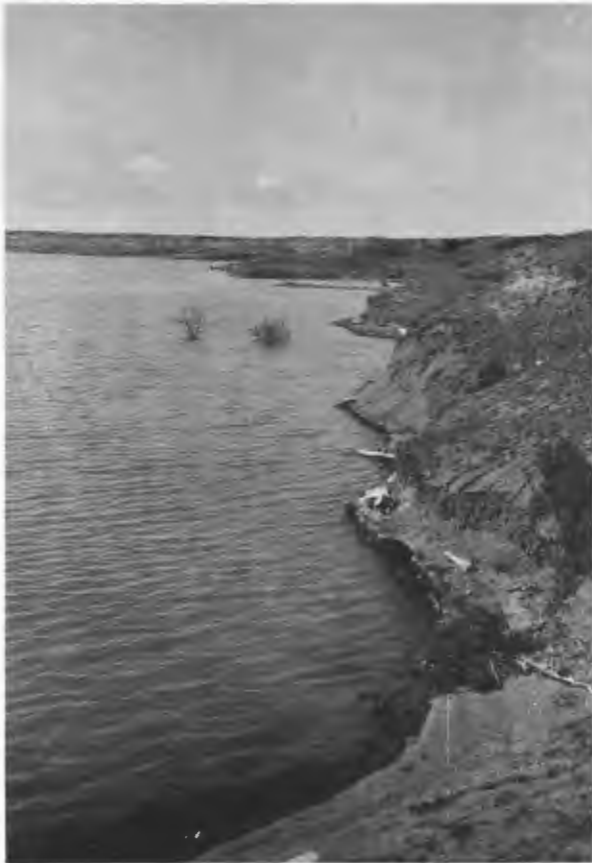
Figure 5. Accelerated erosion of steep banks. West bank of Diefenbaker Lake, looking upstream near Riverhurst Ferry. August 1965--Water level at 1720 feet above sea level.

The water level stood at 1720 feet above sea level, or 30 feet above the original river level when Figure 5 was photographed in August 1965. The cliffs show signs of accelerated erosion. Figure 6, photographed from the top of one of the cliffs in September 1966, shows development of steep fractures a few feet inward from the edge of the cliff.

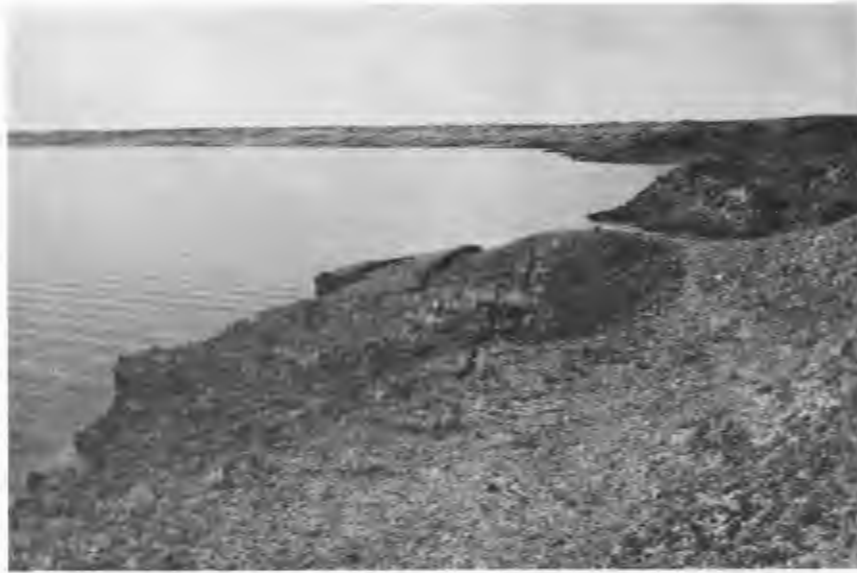
Figure 6. Development of steep-angled cracks above newly eroded cliffs. West bank of Diefenbaker Lake, looking upstream near Riverhurst Ferry. September 6, 1966--Water level at 1739.7 feet above sea level.

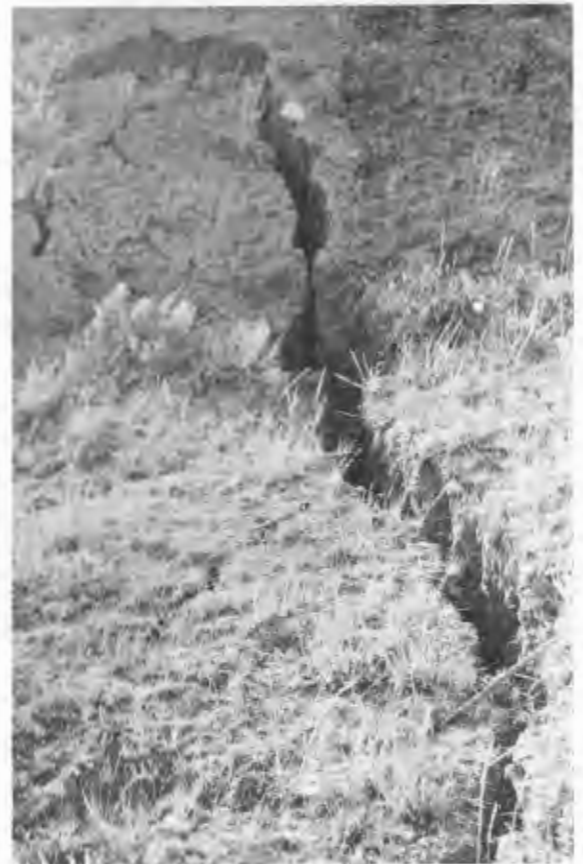
Figure 7. Development of large fracture in the face of the steep hill shown on Figure 4. Close up view; September 6, 1966.

The high hill of Figure 4 developed a number of fractures during the summer of 1966. Figure 7 gives a close-up view of the main fracture on September 6, 1966; Figure 8 is a view of the hill side. At that time the width of the fracture opening was $4\frac{1}{2}$ inches and apparent vertical displacement 6 inches. The water level stood at roughly 1740 feet above sea level. It rose to 1754 feet by January 13, 1967, dropped to about 1738 feet by March 16 and rose again to 1754 feet by May 3, 1967, the date Figure 9 was photographed. Reports from local

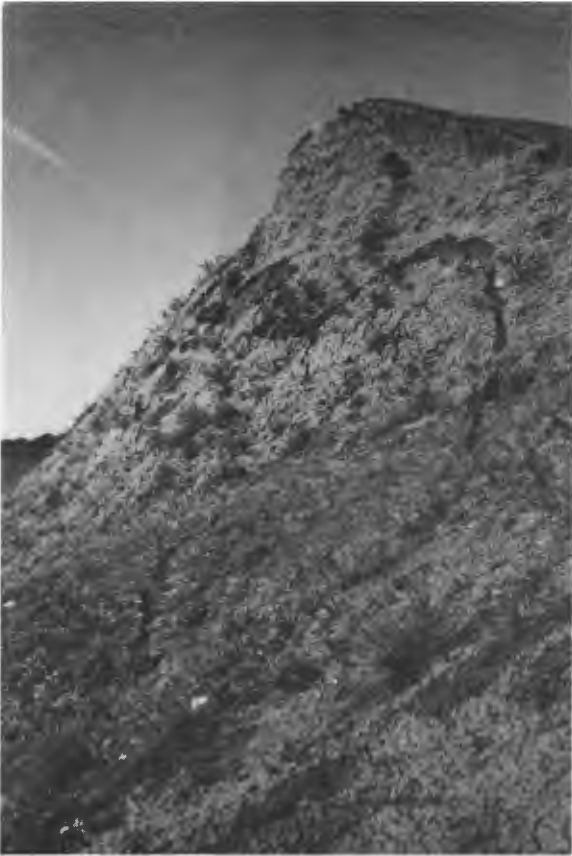
Figure 8. Landslide developing in the east face of the steep hill of Figure 4; September 6, 1966.

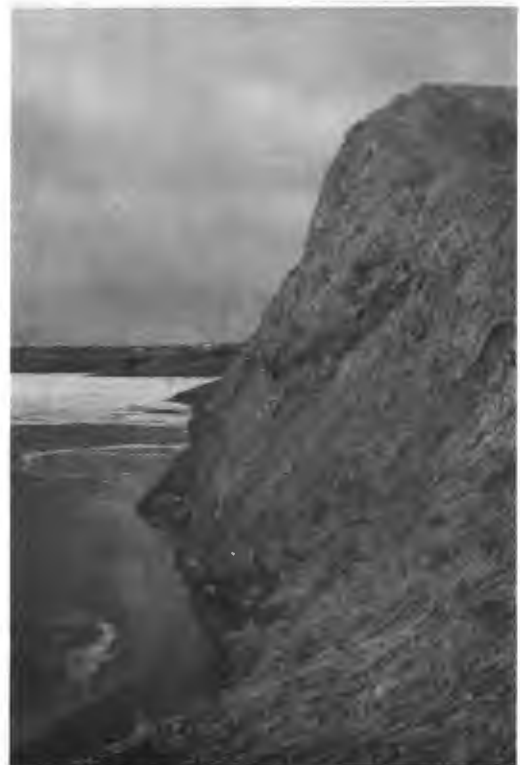
Figure 9. The hill of Figure 4 on May 3, 1967, some time after the slide had taken place. Reports place the time of the slide sometime in February 1967. Level of ice is 1754 feet. Water dropped from 1755.5 feet on January 13 to 1737.8 feet on March 16 after which it rose steadily to the level shown.

people place the occurrence of the slide sometime in early February, during the lowering of the lake level. Figure 9 shows the slide scar; the outer and lower parts of the hill have vanished below the water.

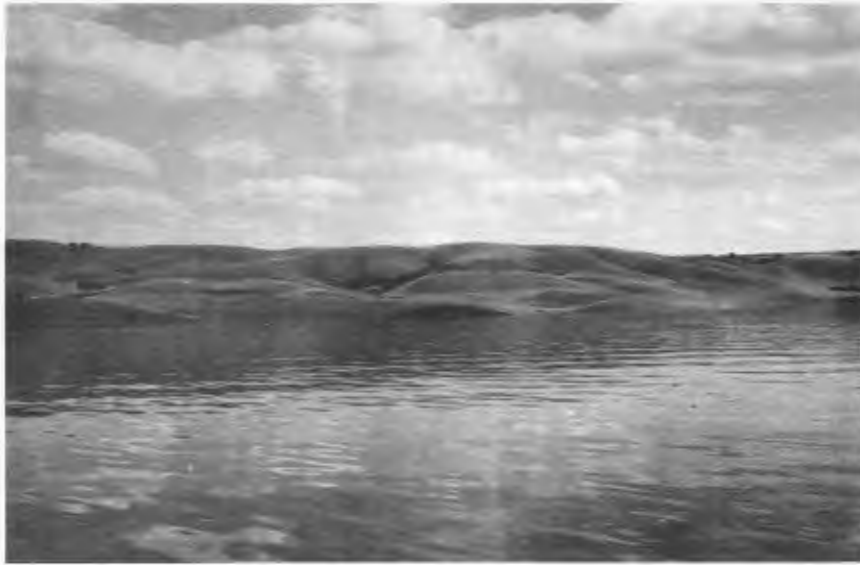
Figure 10. Incipient cliff formation. East bank of Diefenbaker Lake north of Riverhurst Ferry. August 16, 1966--Water level at 1733 feet above sea level.

Figures 10 to 12 illustrate the progress of erosion above the top of the original cliffs on the east bank, north of the ferry crossing, in late August 1966. Figure 10 shows the earliest stage in the development of a new cliff face at the base of a grassy slope of approximately 15 degrees. In Figure 11 a similar cliff is shown in a more advanced state of development. "Columnar jointing", due to desiccation, is clearly visible in the glacial till that forms this cliff. In Figure 12 a slide had taken place from the cliff in the foreground approximately two weeks before photographing. The fracture to the right of the slide scar indicates the plane of failure for the next slide.

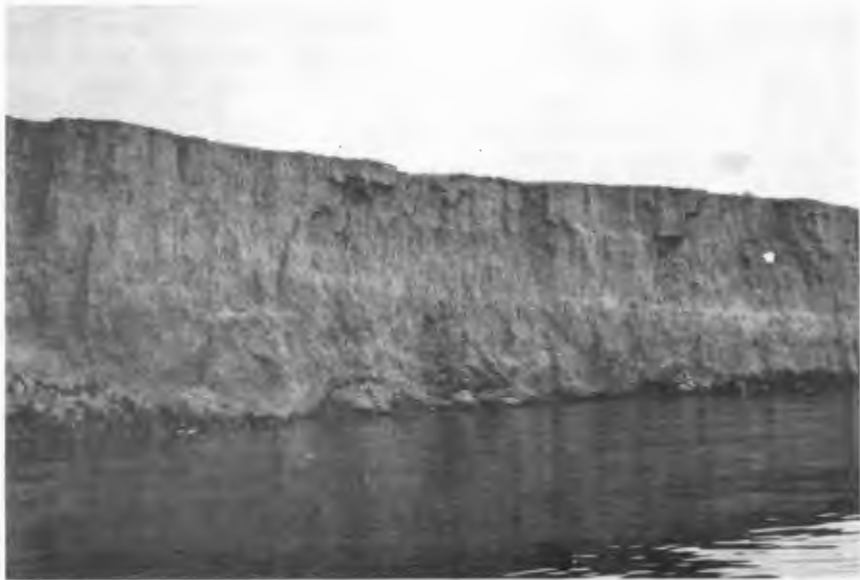
Figure 11. More advanced cliff formation. Note columnar jointing in till, resulting from desiccation; wet zone at base of cliff not fully drained. Height of cliff is approximately 11 feet. East bank of Diefenbaker Lake north of Riverhurst Ferry. August 16, 1966.

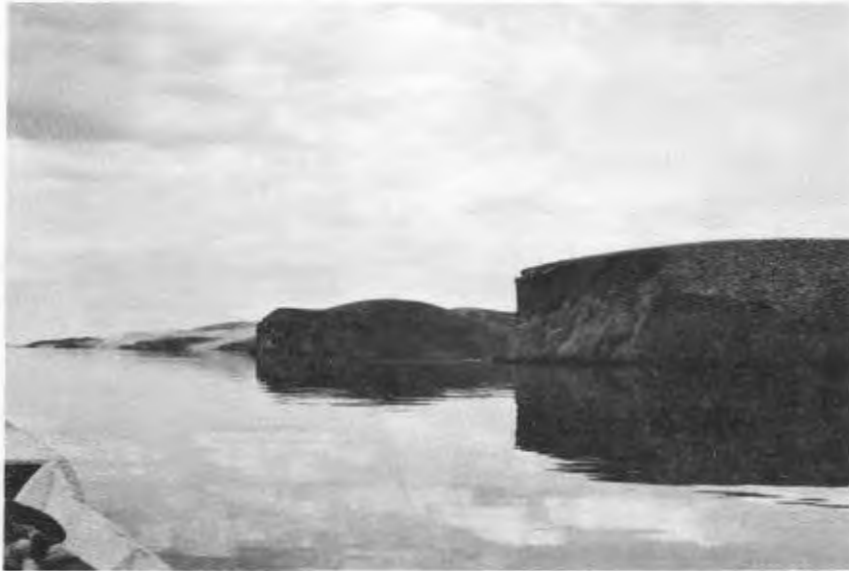
Figure 12. East bank of Diefenbaker Lake, north of Riverhurst Ferry. The high cliff on the right has already produced at least one slide; a steep fracture is clearly visible indicating the next part to go. August 16, 1966.

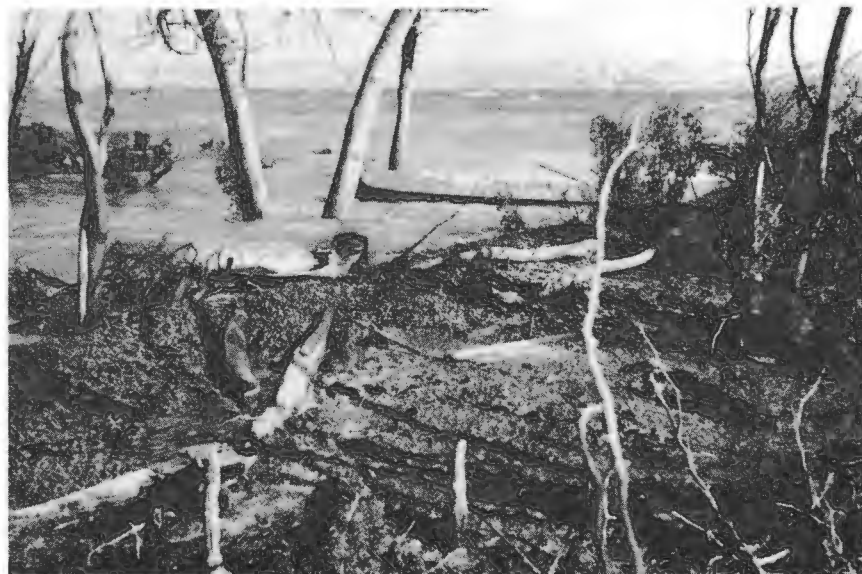
Figure 14. View across Diefenbaker Lake from small coulee at the base of the hill of Figure 8, during storm of September 12, 1966. Accumulation of shale pebbles and driftwood in foreground; note white-capped waves, amplitude about four feet. Water level at 1741.5 feet above sea level.

Erosion of the bedrock shales and the glacial drift of the valley slopes produces boulders, gravel, sand, silt and clay. In addition to these, shale "pebbles" may constitute a more or less important fraction of the erosion products, as indicated by Figures 13 and 14. Figure 13 shows the "beach" at the base of the hill of Figure 4 on September 12, 1966, during the height of a storm from the east. The material in the foreground consists of shale pebbles. A view across the reservoir from the same location (Figure 14) shows accumulation of driftwood giving some protection from wave action. It also gives an idea of the size of the waves that can be expected.

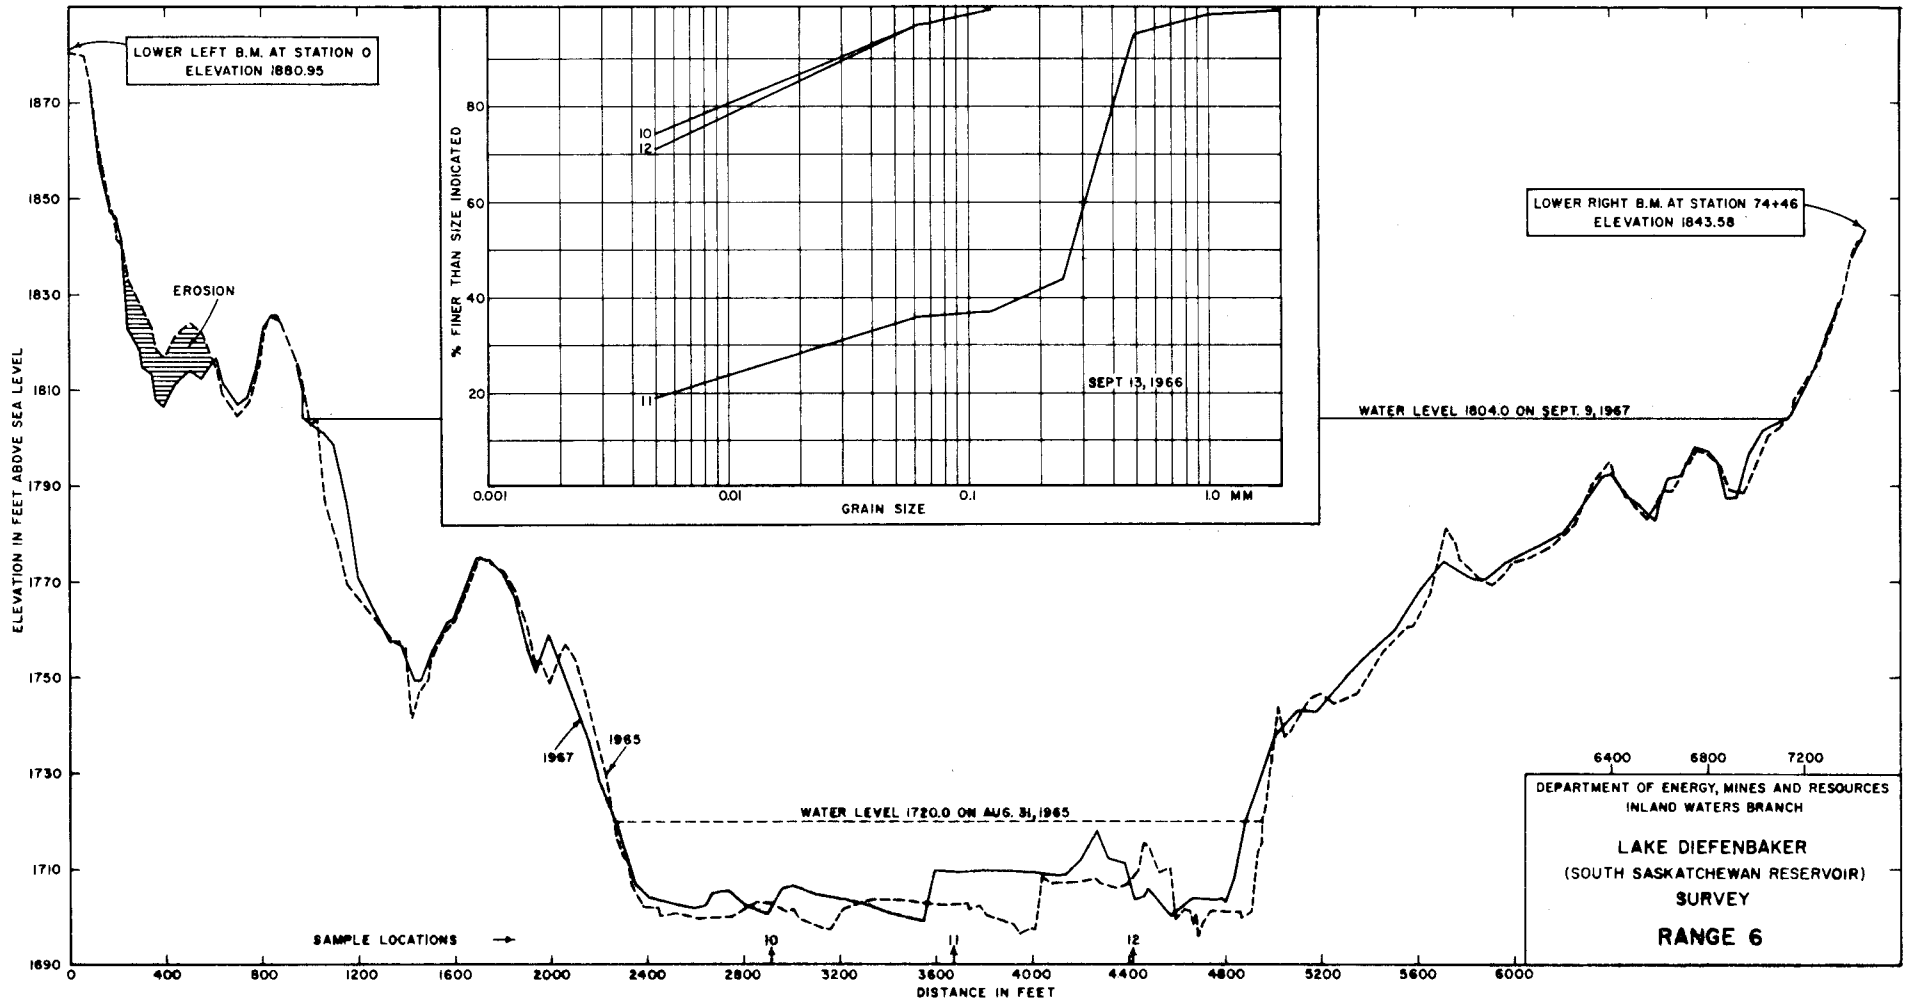
Figure 16-c. Cross-section of Diefenbaker Lake, range 6, on August 31, 1965 and September 9, 1967. Grain-size distributions for samples taken at locations and on dates indicated.

Both figures 16-a and 16-c show a number of features in the central part of the valley off-set towards the left bank in 1967 as compared to their position in 1965. The elevated areas in the bottom of the valley in all three ranges represent sand bars or islands in the original river bed. It is unlikely that those in range 4 would have shifted their position after the original survey in August, 1965, because the reservoir level did not drop below elevation 1720 (water depth of 30 feet or more) at any time since. It is also unlikely that during such a shift the outline of these features and their elevation would have been preserved to the extent shown in Figure 16. Therefore, it is assumed that the difference in sounding equipment, and variations in the speed of the survey vessel during the echo-sounding runs are responsible for the apparent changes in the central part of the cross-sections.

The only instance where the possibility of inaccuracy in the survey line can be ruled out is the downward displacement of the surface on the left bank in range 6 (Figure 16-c). Only a land-based survey was involved because this part of the section is located above the water level of the reservoir. Erosion at the sides of a gully near this cross-section must account for this change in the reservoir cross-section.
