**A History of Rocky Mountain House,  
by Hugh A. Dempsey**

**The Excavation and Historical Identification of Rocky Mountain House,  
by William C. Noble**

Canadian Historic Sites:  
Occasional Papers in Archaeology  
and History — No. 6

National Historic Sites Service  
National and Historic Parks Branch  
Department of Indian Affairs and  
Northern Development  
Ottawa, 1973

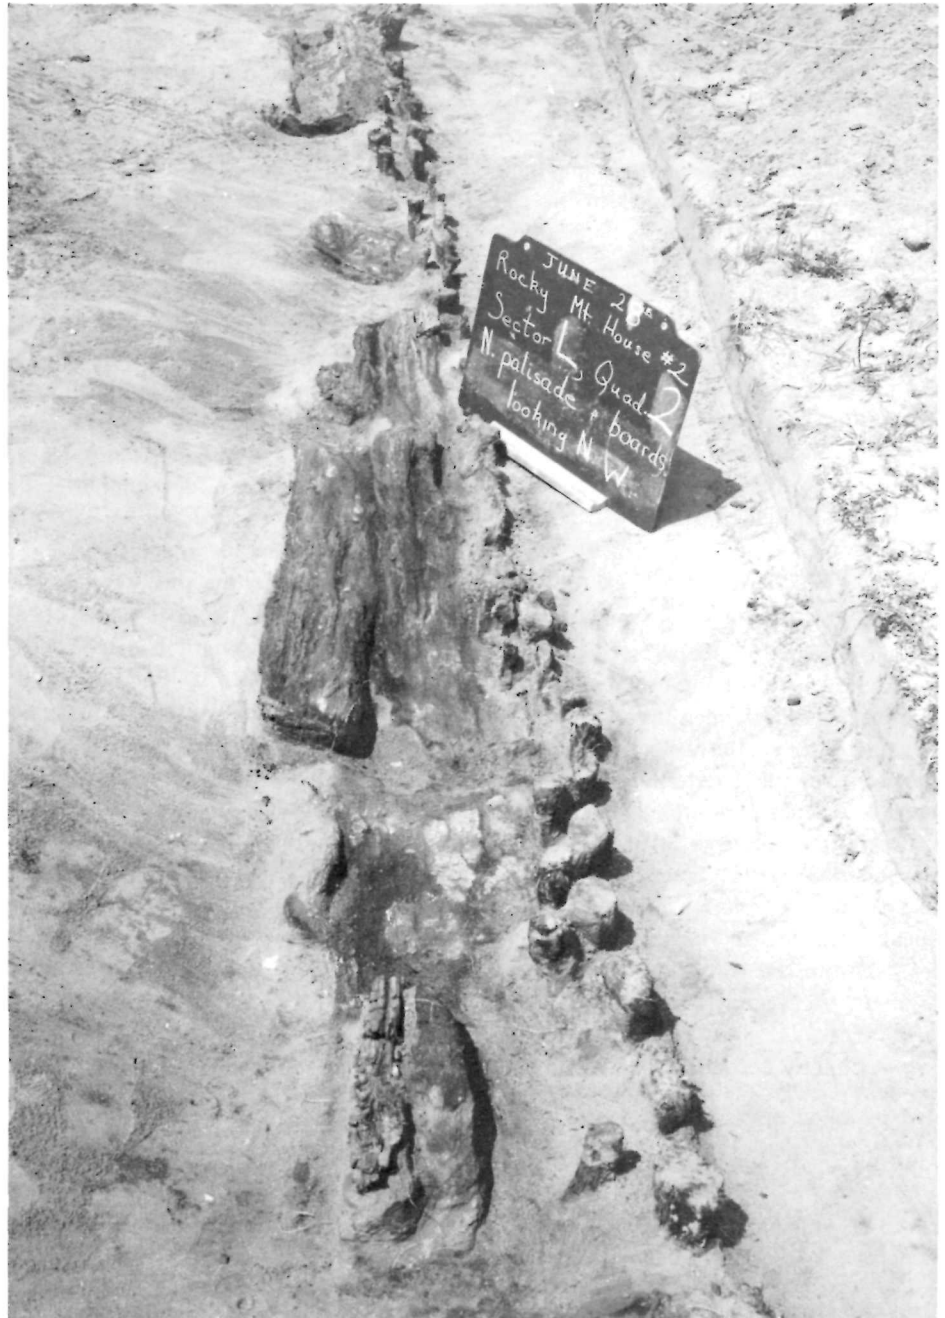
4 Fallen boards along the interior of the north wall of the exterior palisade.

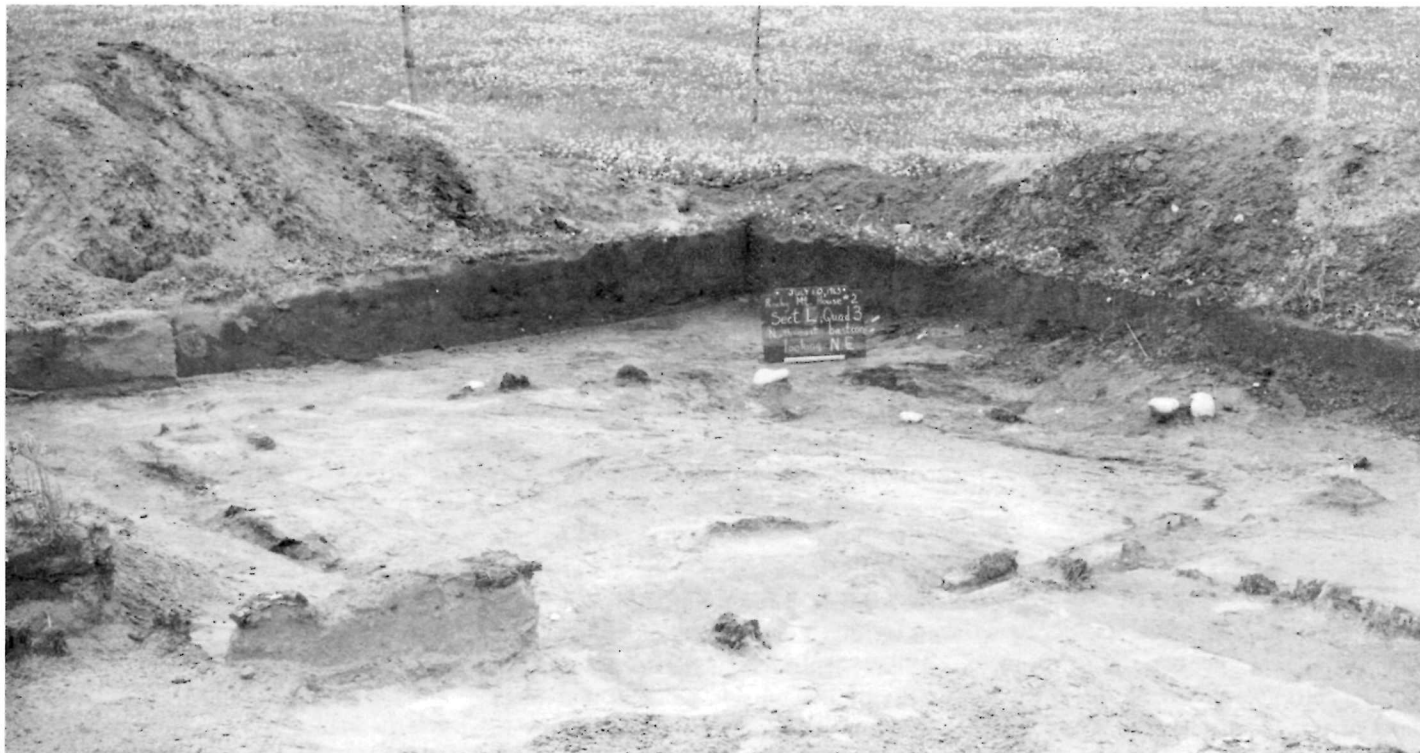
7 Outline of the north corner bastion looking northeast.

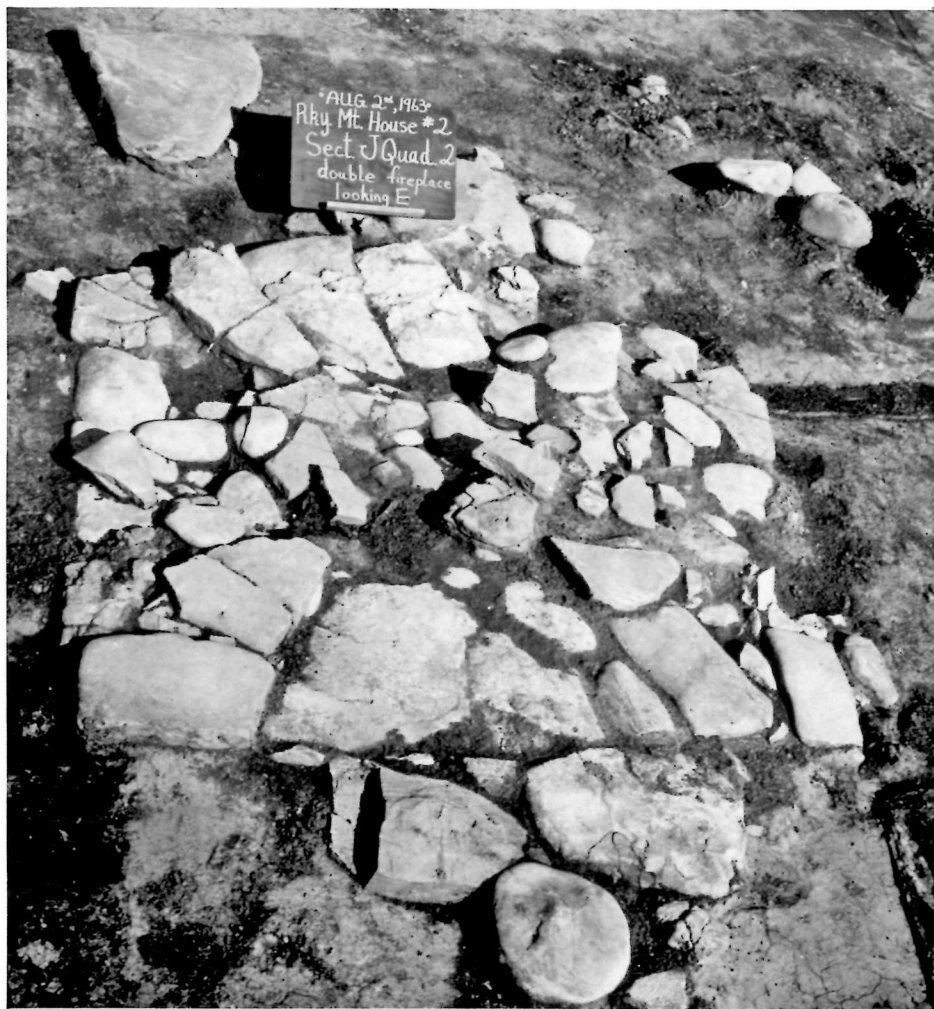
12 Close-up view of base for double-hearth fireplace in building II

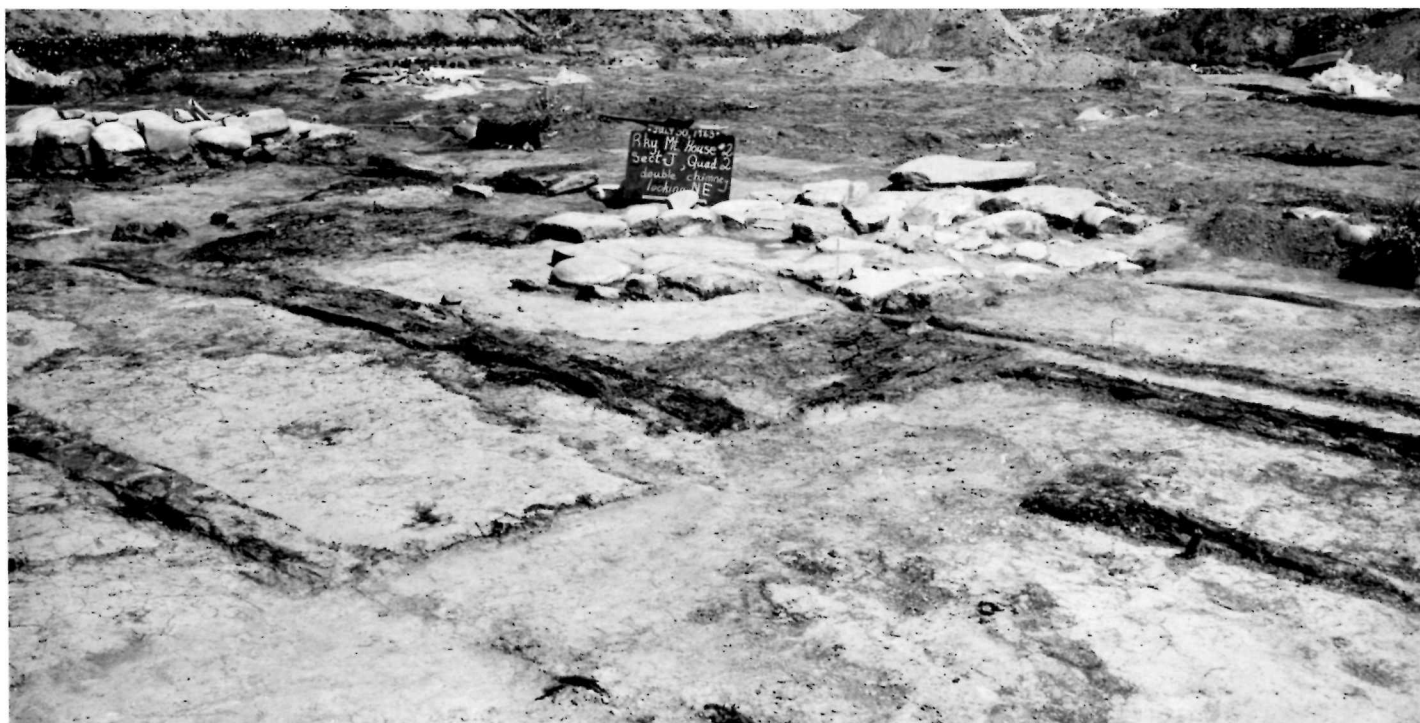
13 Northeast view of charred joists and base for double-hearth fireplace in building II.

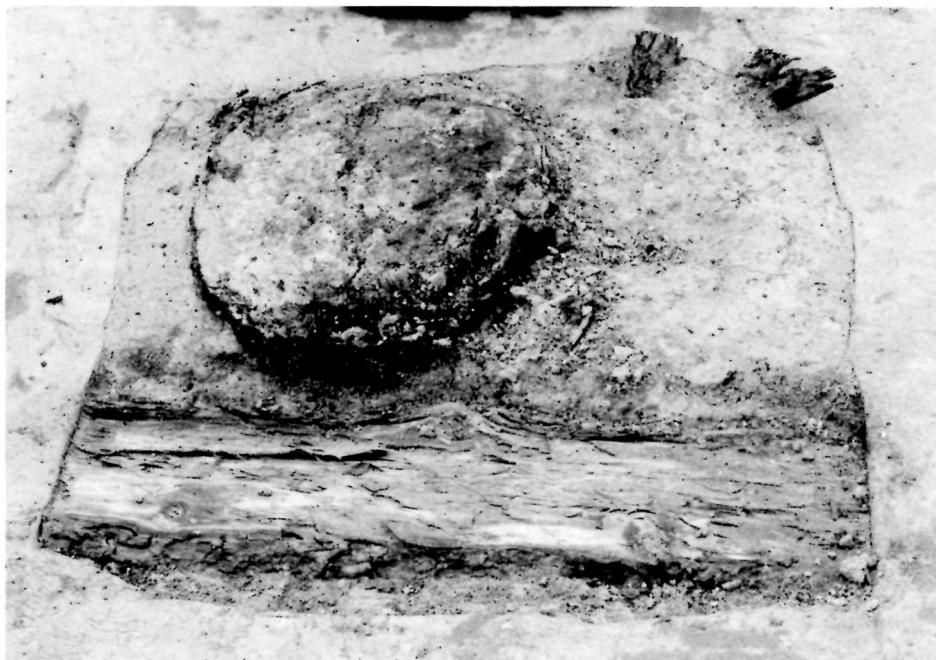
14 Post 4 looking west showing the rectangular pit outline and dead-man log.

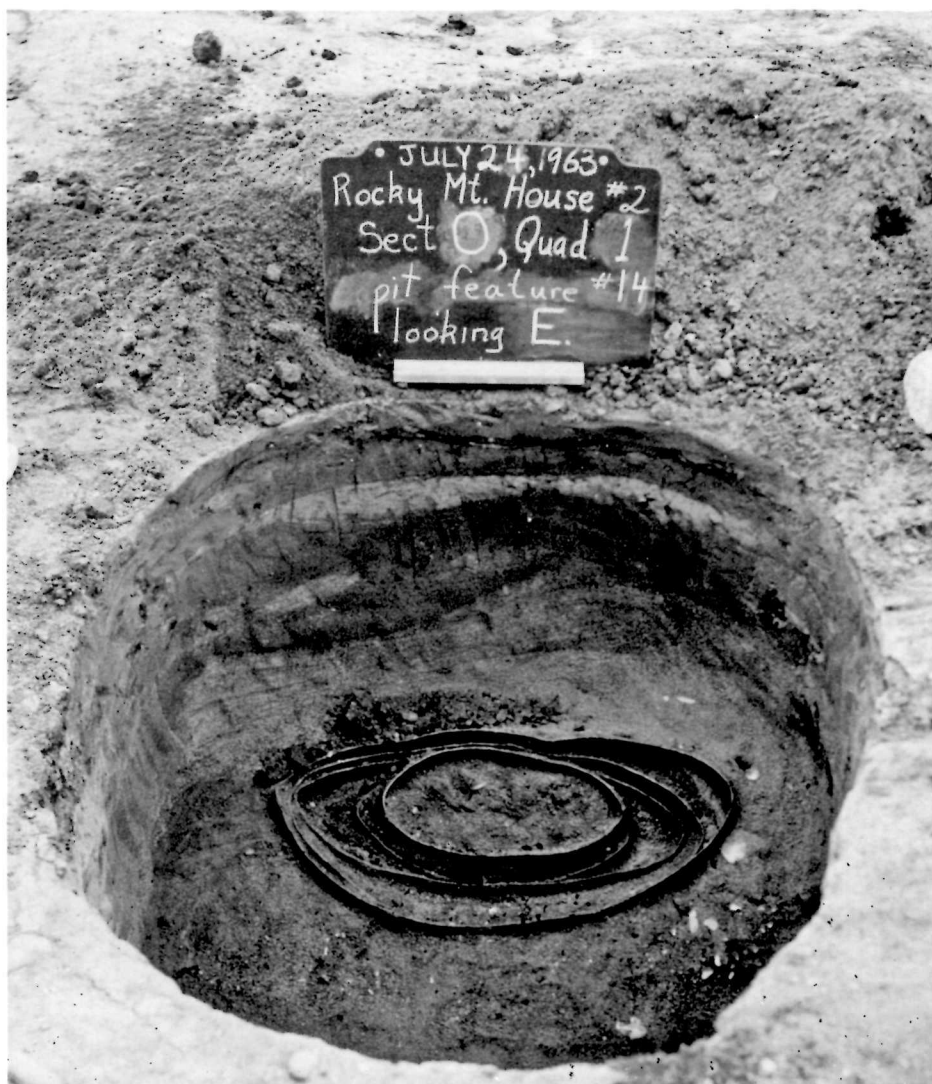
- 34 Pit 14 with buried group of six nested iron hoops. This pit lies within building V and probably represents an iron cache.

in. deep layer of brown sand containing charcoal flecks. Six iron hoops nested inside one another lay horizontally in this layer at a depth of 28 in. below ground surface. Above the iron hoops was a thick 4 in. layer of wooden boards which in turn was covered by a thin layer of black

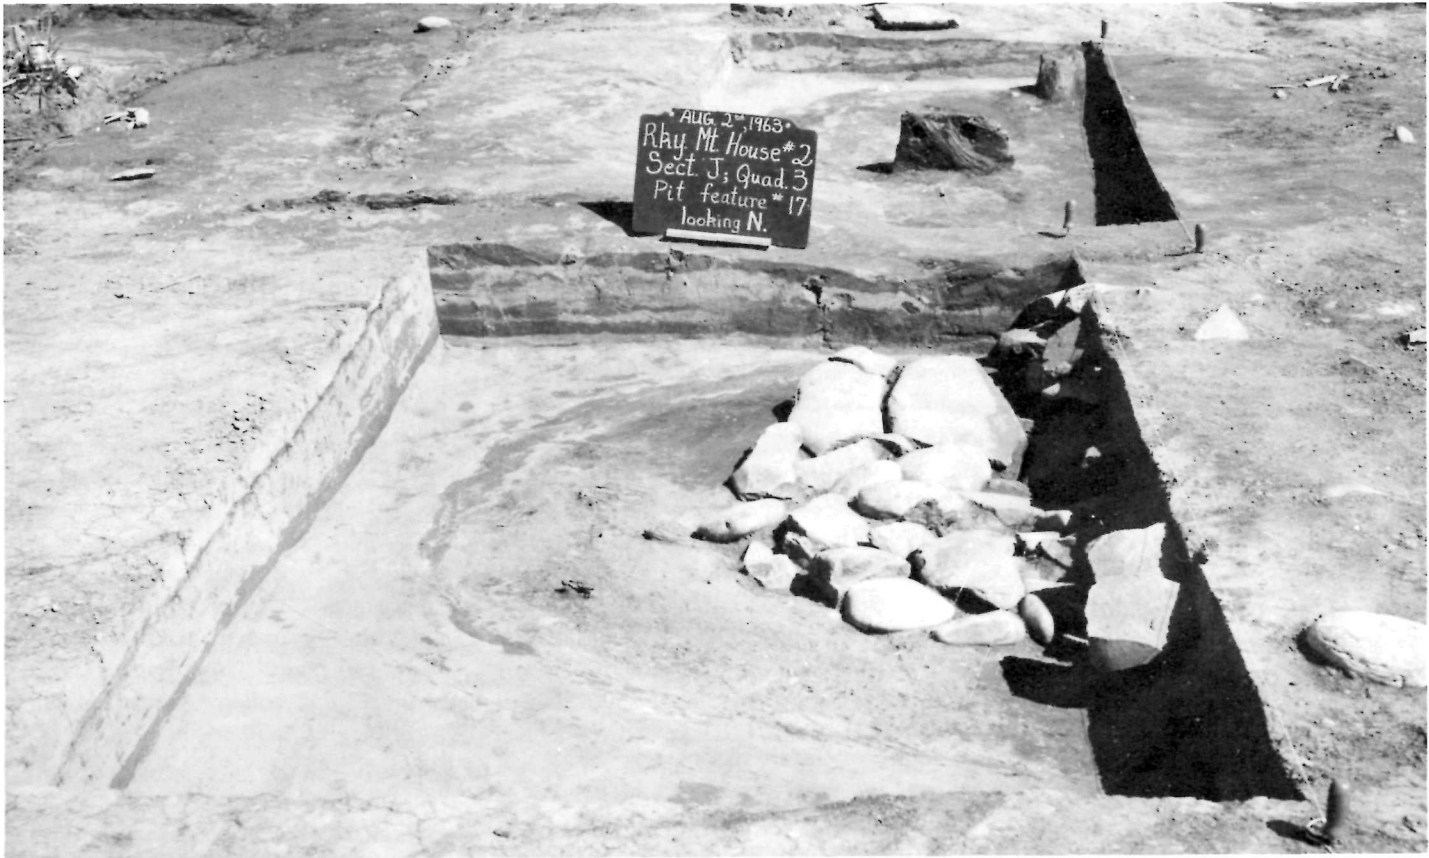
37 Pit 17 in partial cross-section. Pit 18 can be seen in the immediate background to the north.
