CASTONE - Composite Panel Cladding

Project Title: CASTONE - Composite Panel Cladding

Author's Name: Peter J. Goodings, B.Sc.(Eng)

Report Completed: March 15, 1994

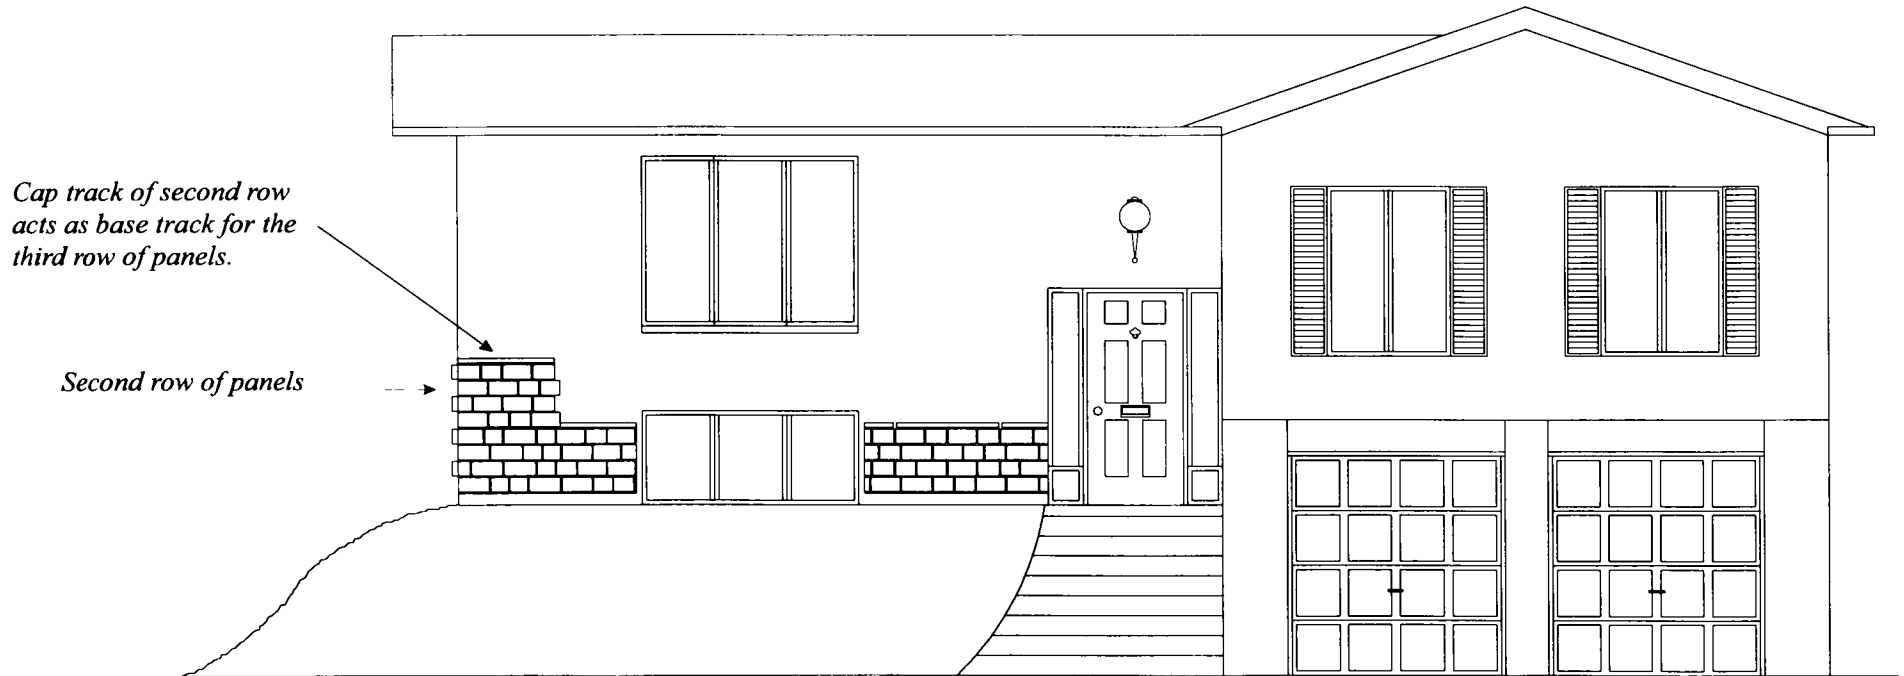
Installation of Second Row

After the first row of panels has been installed, the cap tracks from this first row act as the base tracks for the second. Because the placement of all rows is determined by the first row, the importance of levelling the base track cannot be overemphasized. The mechanics of the installation is similar to that of the first row.

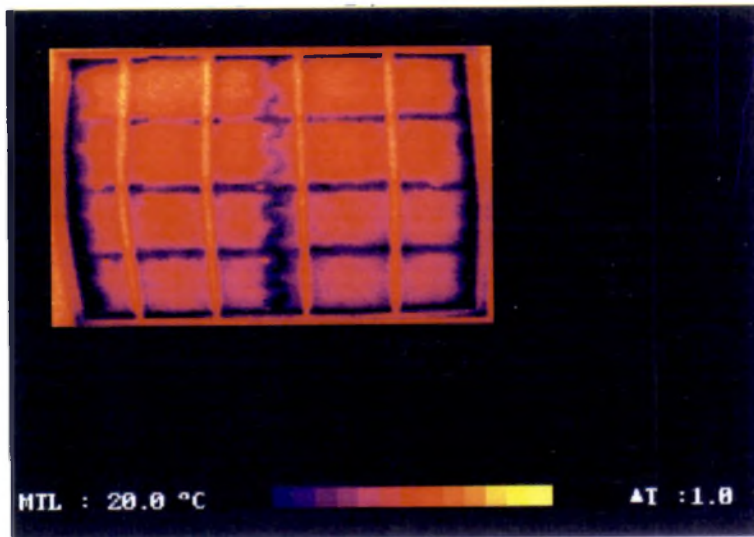
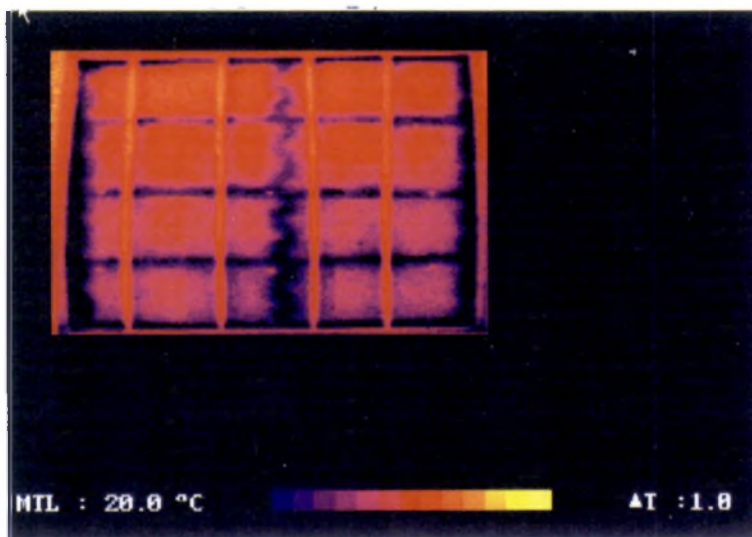
Figures 1a, 1b, 1c, and 1d are thermographic images taken of the test wall from the interior conditions side of the Environmental Chamber at a mid-scale temperature of 20°C for the shown colour display.

The uniformity of heat transfer in each image, and of the images over time, indicates that the wall system has consistent thermal properties. No separation of the product from the plywood wall or degradation of the insulating quality of the materials occurred.

Thermocouples positioned in the middle section of the wall indicated that the joint areas were colder than the panels which was in agreement with thermographic images. Typical convective heat loss characteristics, cooler at the bottom and warmer at the top, were displayed by the test wall in both the thermocouple bar chart and the thermographic images. Physical deterioration of the test wall due to thermal cycling does not appear to be a concern. No delamination of materials was apparent in the test wall. The thermal performance of the Castone wall system would improve if an insulating material was incorporated into the design of the joints during manufacturing, or if an appropriate insulating material was applied during its installation.

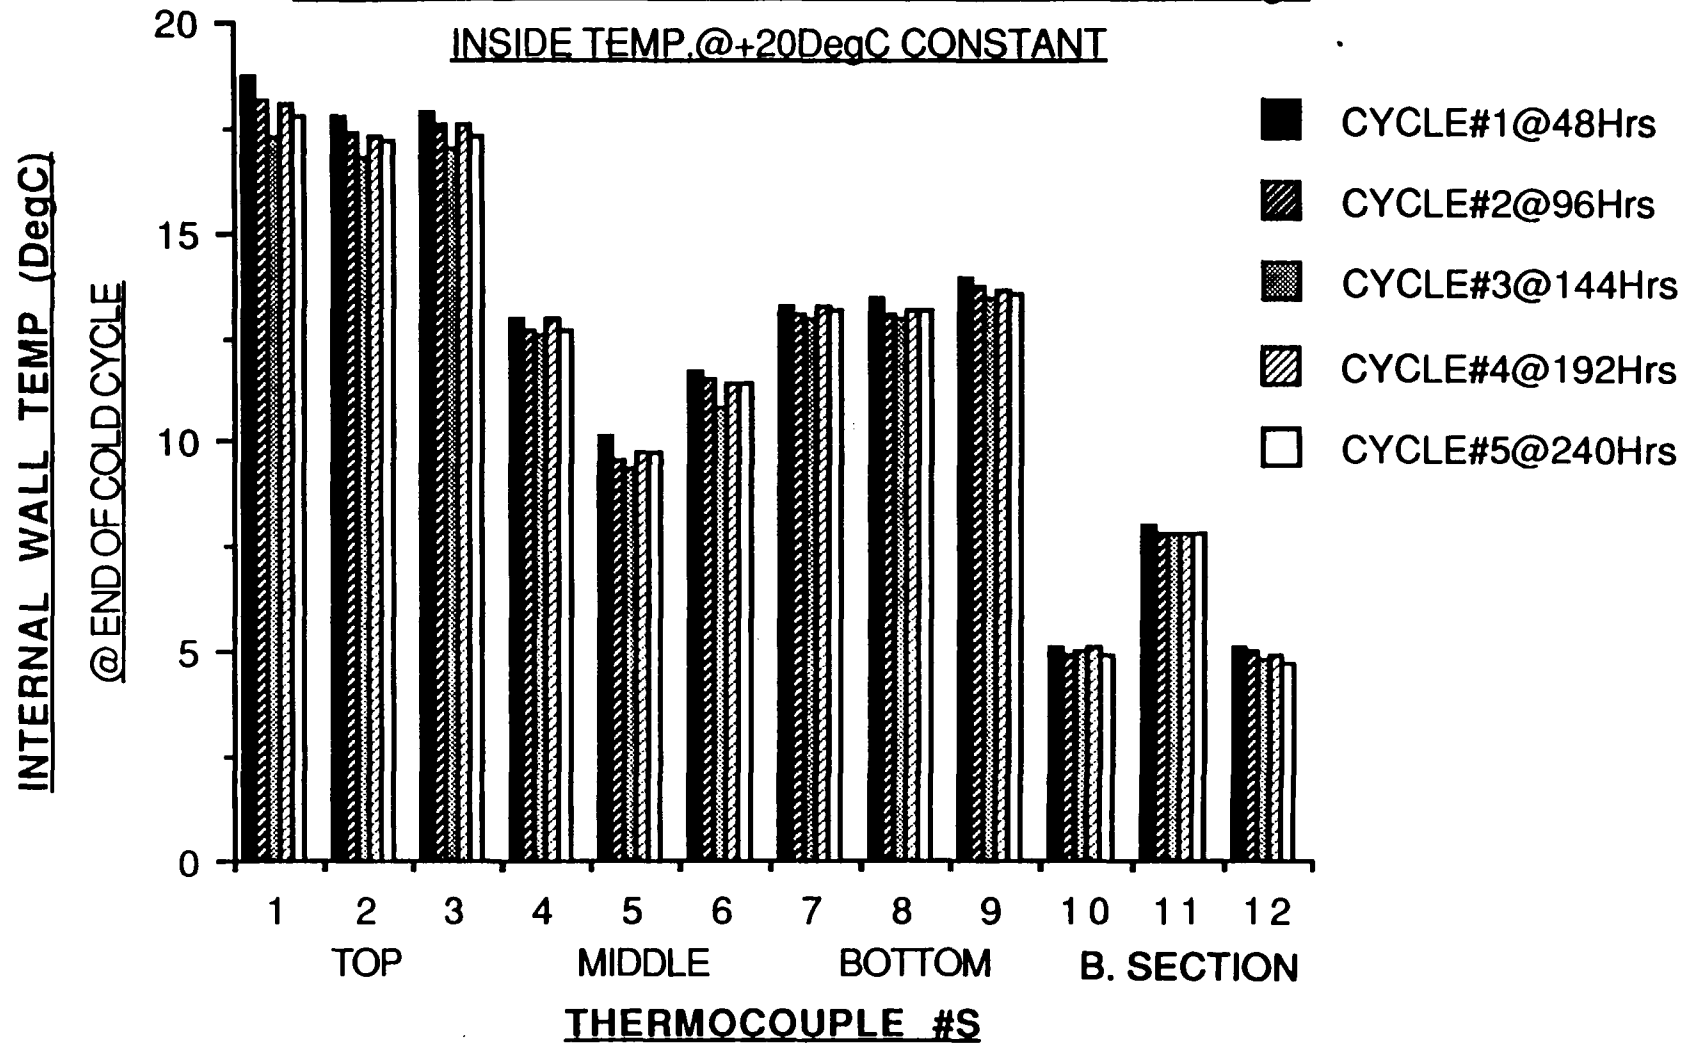
OUTSIDE TEMP. CYCLE 24Hrs.@+20 ; 24Hrs.@-30DegC

INSIDE TEMP.@+20DegC CONSTANT

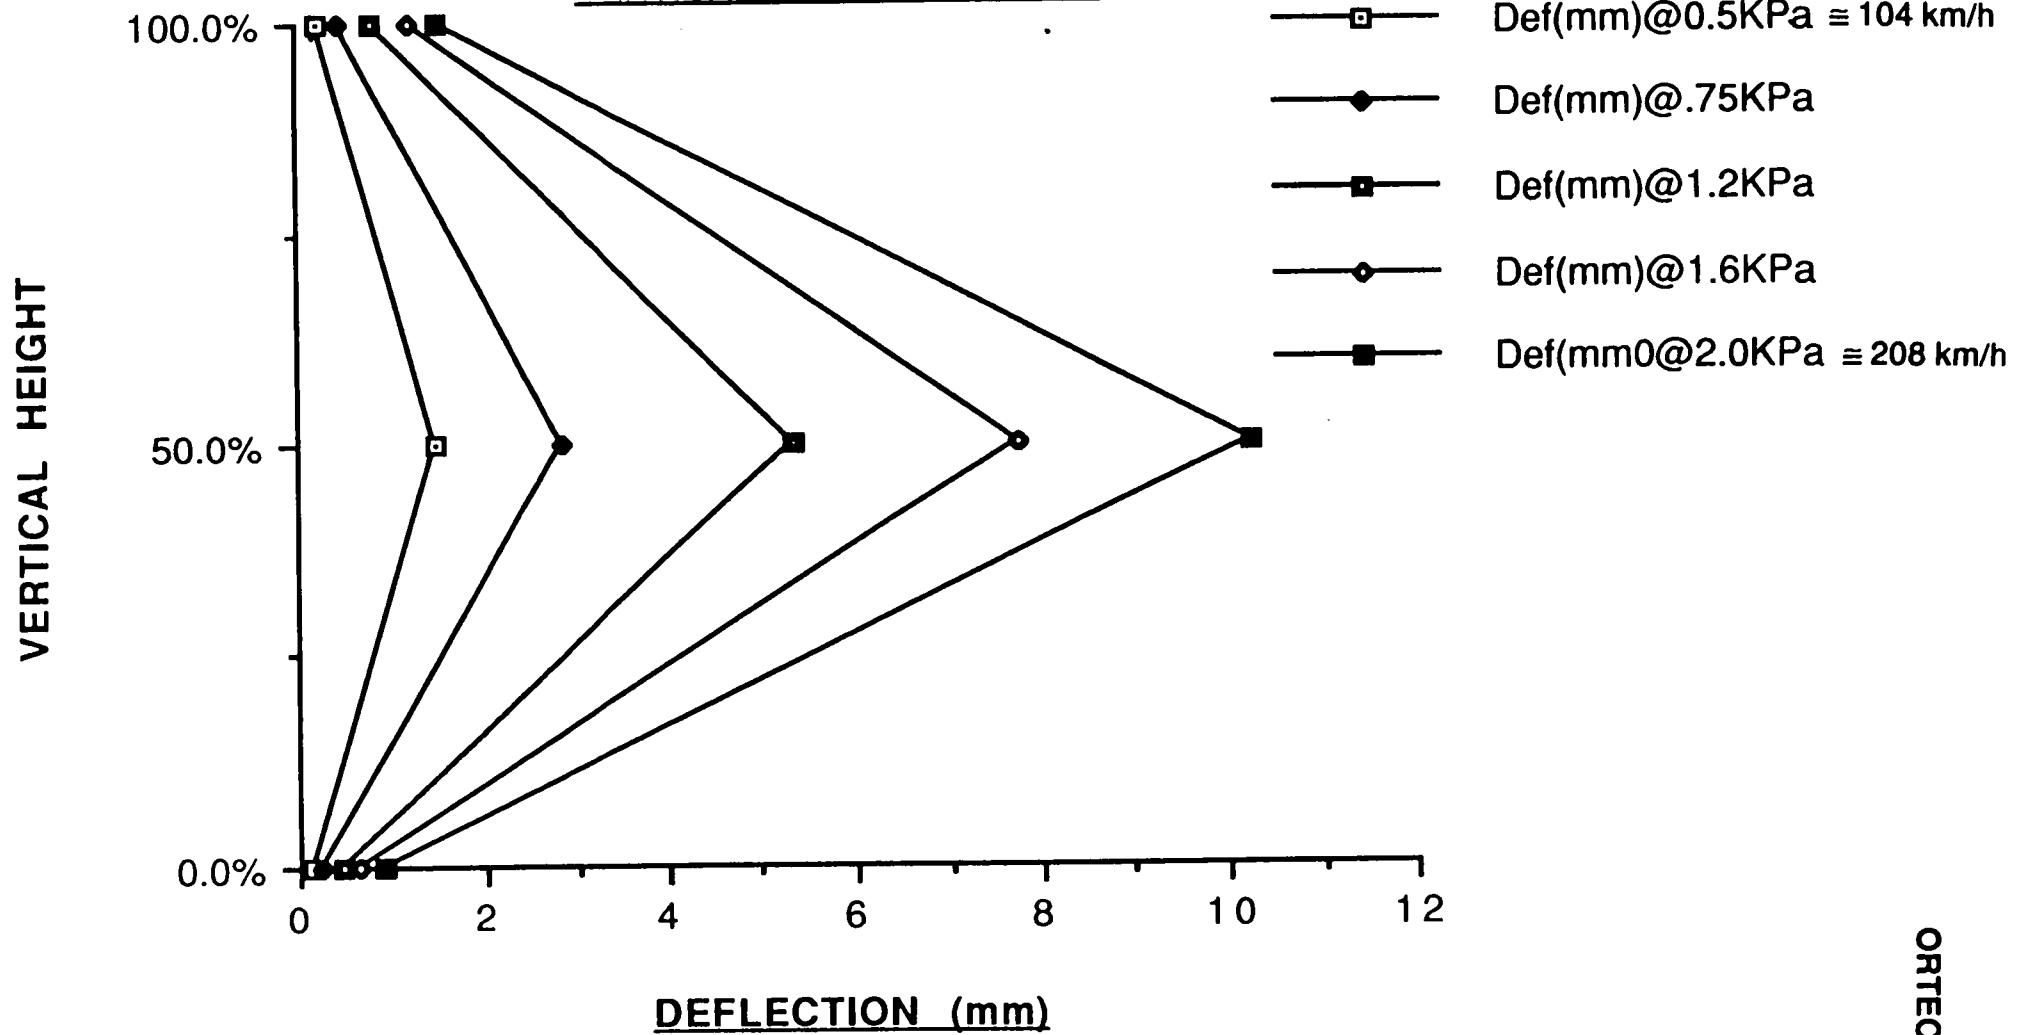
VERTICAL DEFLECTION TEST

CASTONE WALL SYSTEM
