**PART 1 OF THE McMASTER UNIVERSITY LABORATORY TEST
PROGRAM ON BRICK VENEER/STEEL STUD WALL SYSTEMS**

**STRENGTH AND STIFFNESS CHARACTERISTICS
OF STEEL STUD BACKUP WALLS DESIGNED
TO SUPPORT BRICK VENEER**

**PROJECT IMPLEMENTATION DIVISION
CANADA MORTGAGE AND HOUSING CORPORATION**

December 1991

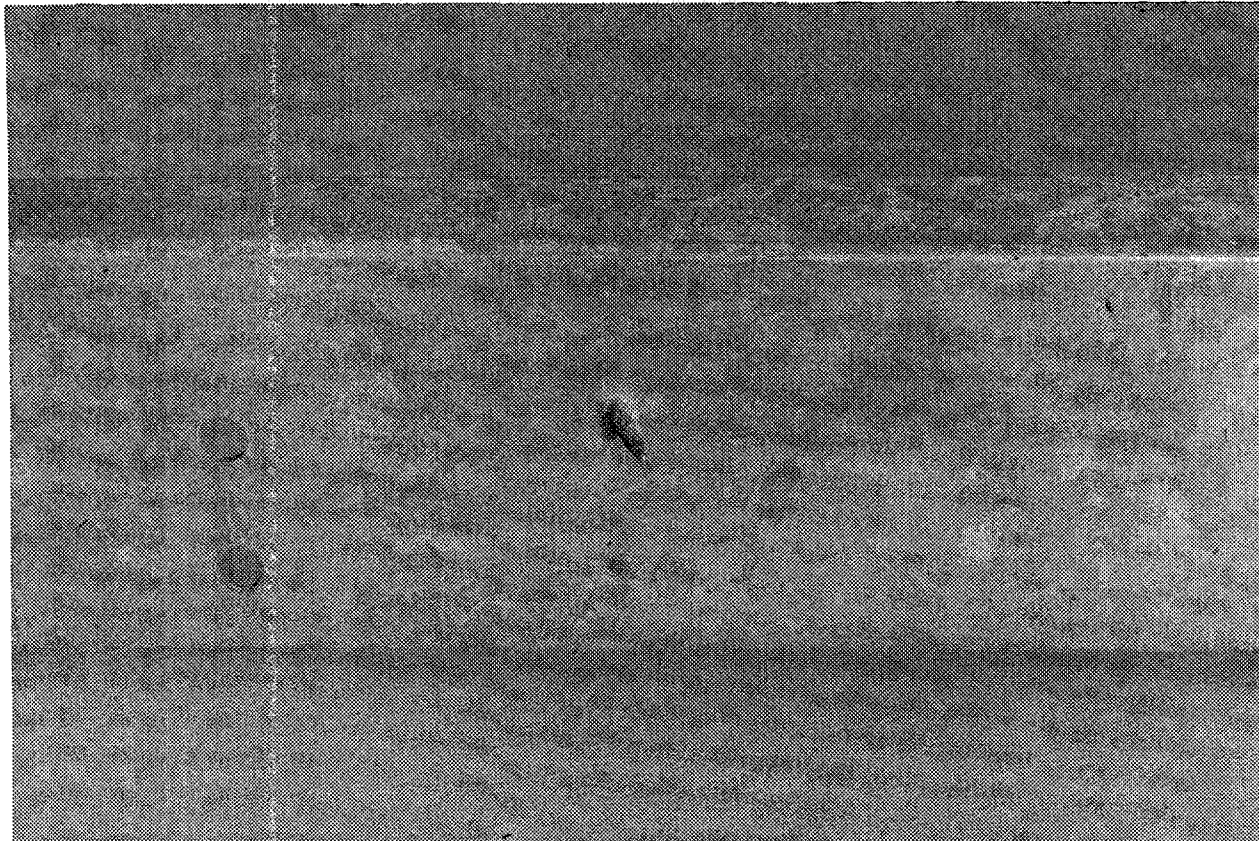
Figure 2.25 Photograph of Typical Nail Anchor After Failure
