Regulatory Oversight Report for Uranium Mines, Mills, Historic and Decommissioned Sites in Canada: 2015

Regulatory Oversight Report for Uranium Mines, Mills, Historic and Decommissioned Sites in Canada 2015

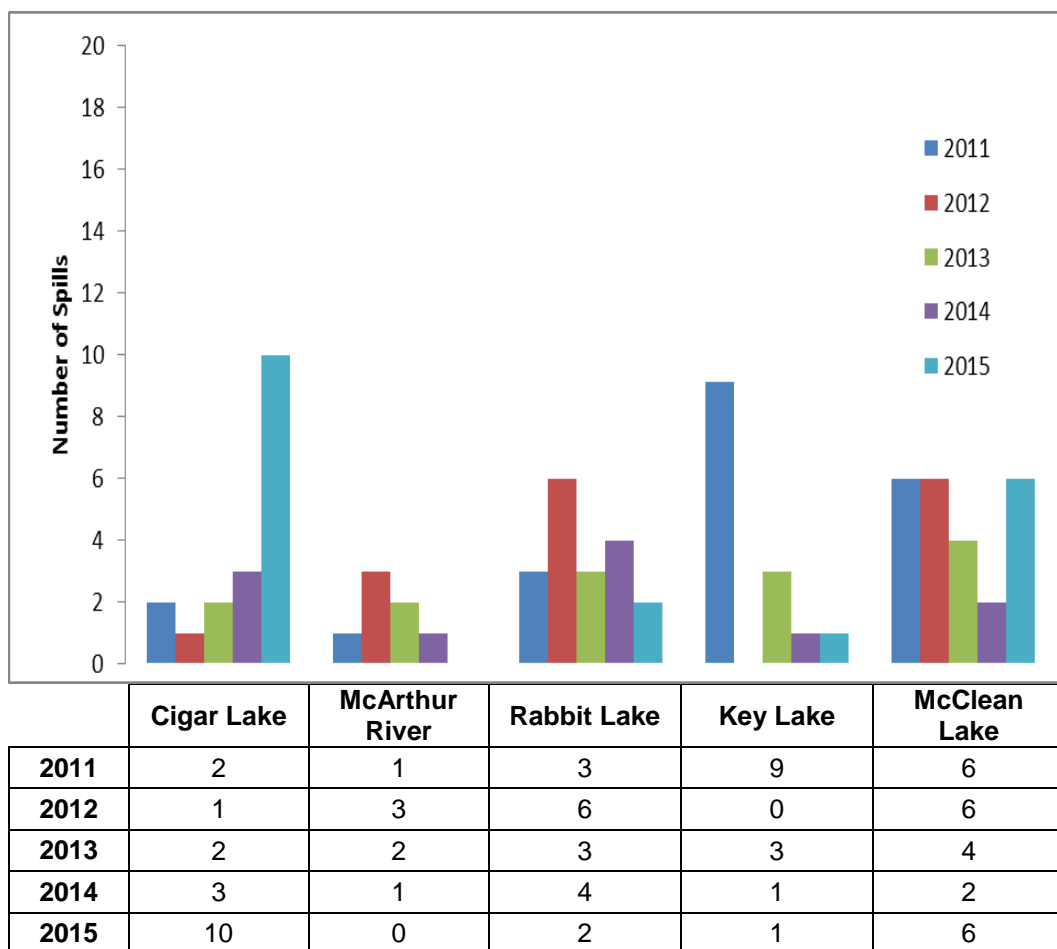
Figure 2.4: Uranium mines and mills environmental reportable spills, 2011–15

The site-specific sections and appendix G further describe each reportable spill and any corrective actions taken by the licensee in response to the spill. The CNSC spill rating definitions are also found in appendix G.

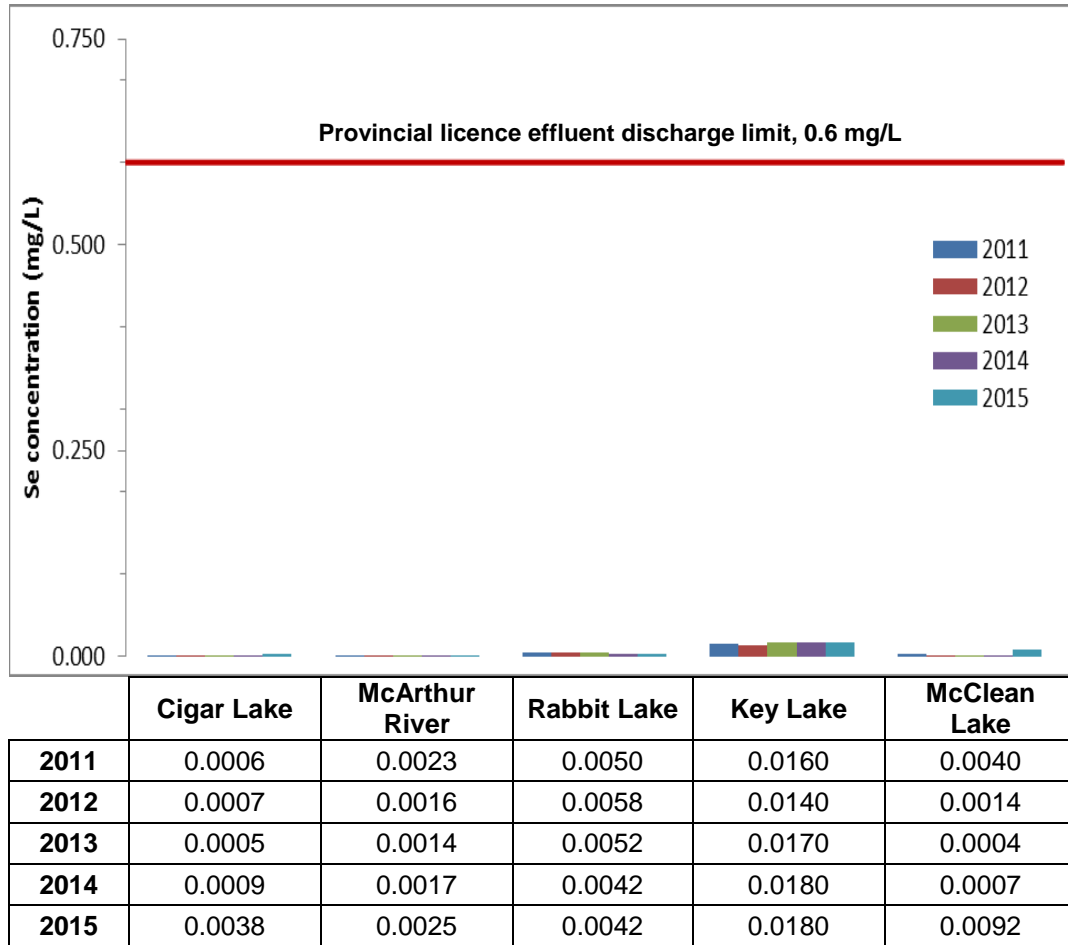
Figure 2.6: Annual average concentration of selenium (Se) in effluent released to the environment, 2011–15 (mg/L)

No federal limits are currently established for selenium and uranium in effluent discharge. The Province of Saskatchewan’s licensed effluent discharge limits for selenium and uranium are 0.6 mg/L and 2.5 mg/L, respectively. The CNSC expects performance well below these limits and requires licensees to continually minimize effluent contaminant concentrations to be ALARA. Figures 2.6 and 2.7 demonstrate that both selenium and uranium concentrations in treated effluent that was released to the environment in 2011 to 2015 from operating mine and mill facilities remained below the provincial licence effluent discharge limit.

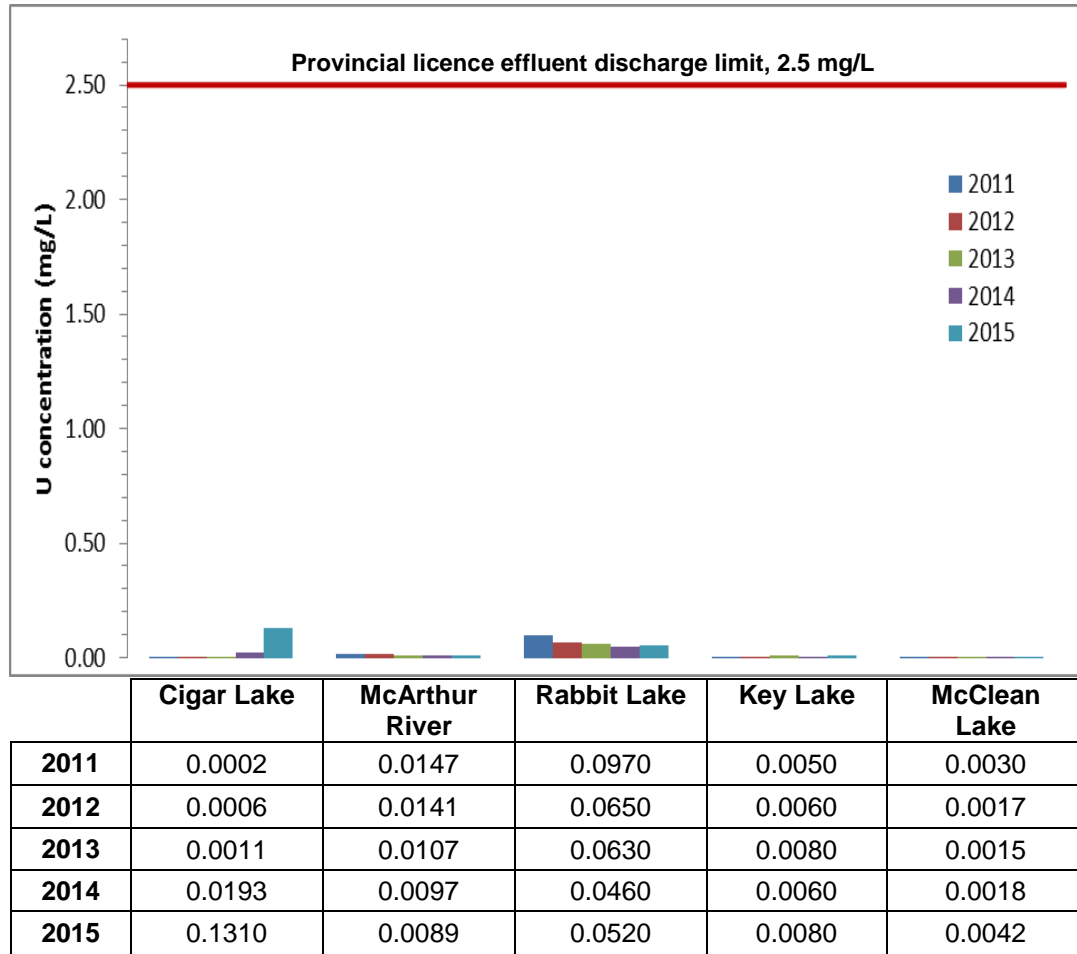
Figure 2.7: Annual average concentration of uranium (U) in effluent released to the environment, 2011–15 (mg/L)

In 2006, a review titled Uranium Effluent Treatment Process identified a concentration of uranium in effluent of 0.1 mg/L as a potential treatment design objective that could be achieved and is protective of the environment. The CNSC uses this value as an interim objective for uranium mine and mill facilities.

At the Cigar Lake operation, increases in uranium concentrations were observed in early 2015 that reflect optimization of operations. Results returned to well below the CNSC’s objective level during the second half of 2015. This is further discussed in section 3.3

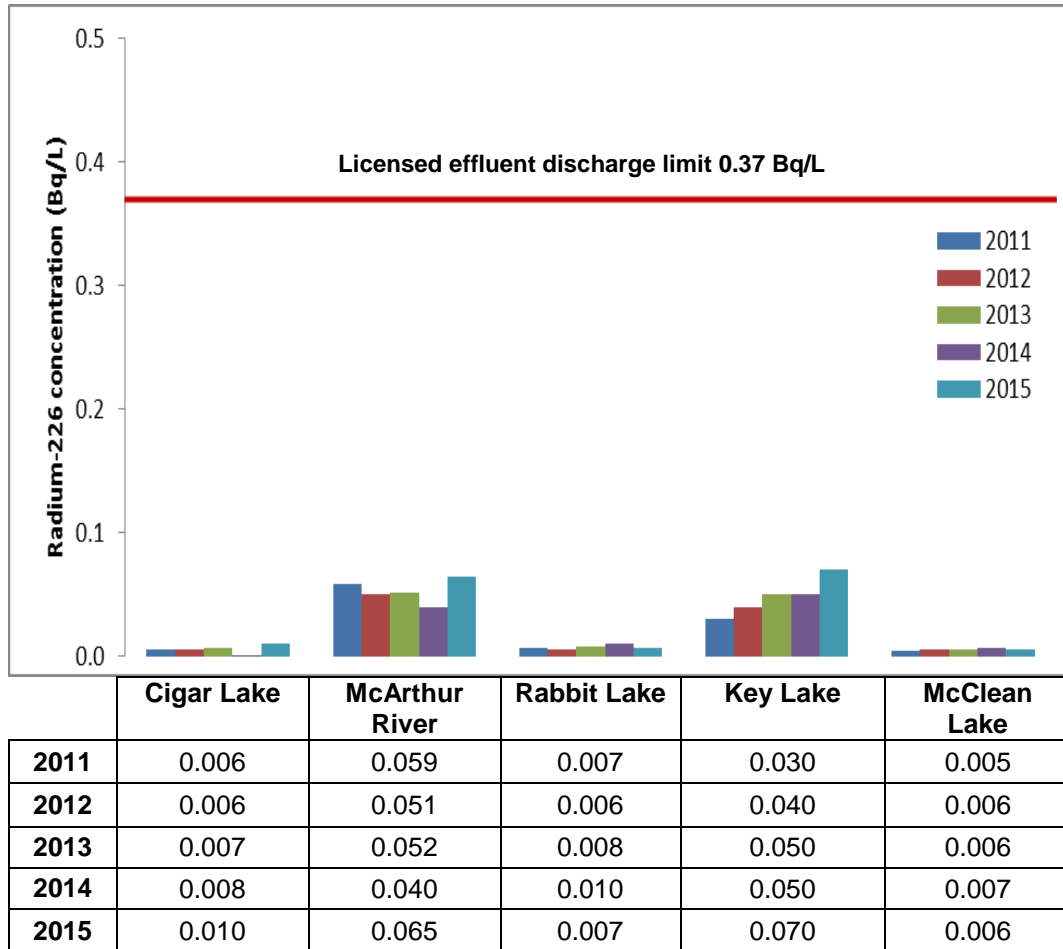
Figure 2.8: Annual average concentration of radium-226 in effluent released to the environment, 2011–15 (Bq/L)

In addition to the above constituents of potential concern, a graph showing concentrations of radium-226 is provided in figure 2.8. The 2011 to 2015 radium-226 annual average effluent concentrations for the five facilities was well below the CNSC’s licence-authorized effluent discharge limit of 0.37 Bq/L.

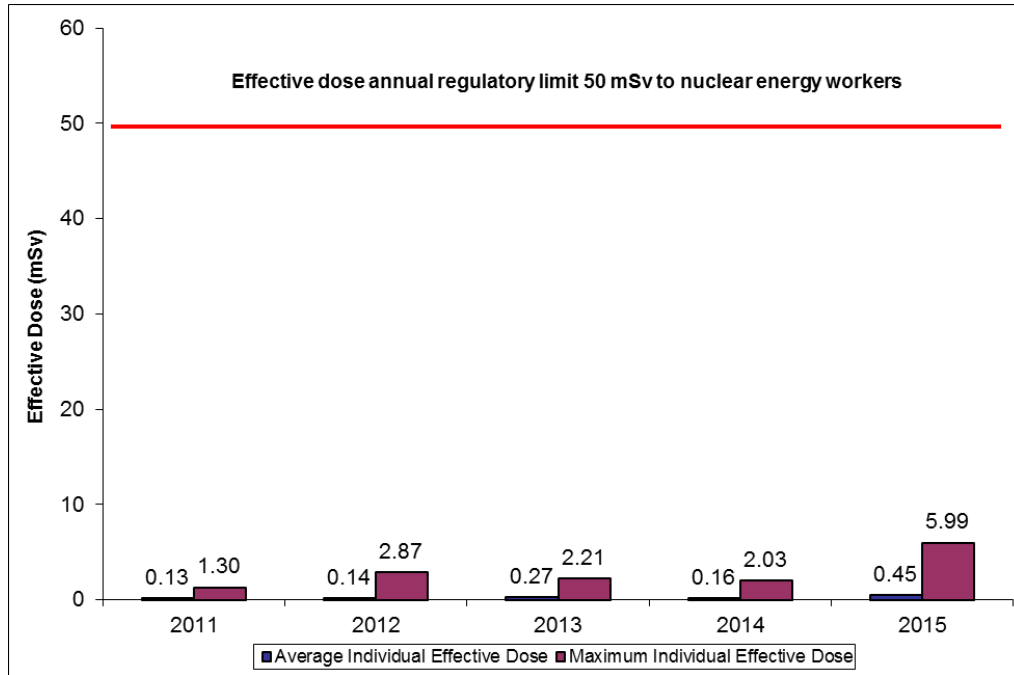
Figure 3.2: Cigar Lake individual effective dose to NEWs, 2011–15

* The effective dose annual limit illustrated applies to the maximum individual effective dose.

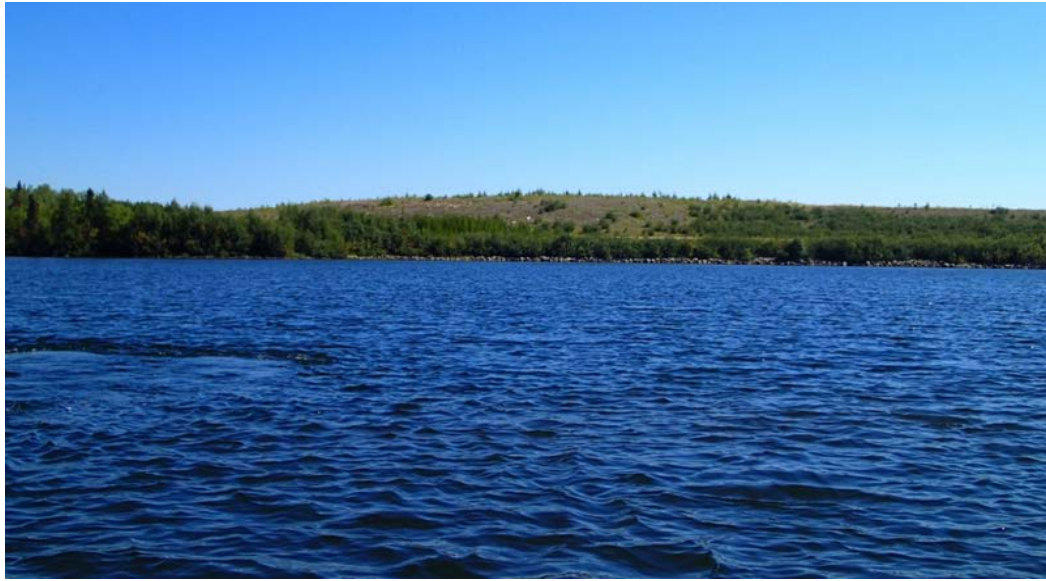
Figure 5.2: Rabbit Lake – reclaimed flooded D Zone pit and waste rock pile

- In 2005 and 2010 respectively, the dykes that separated the A Zone and D Zone pits from Wollaston Lake were purposely breached. In 2015, the water quality in the pits continued to be consistent with Wollaston Lake background values. The vegetation in the remediated areas surrounding the pits is well established (see figure 5.2).

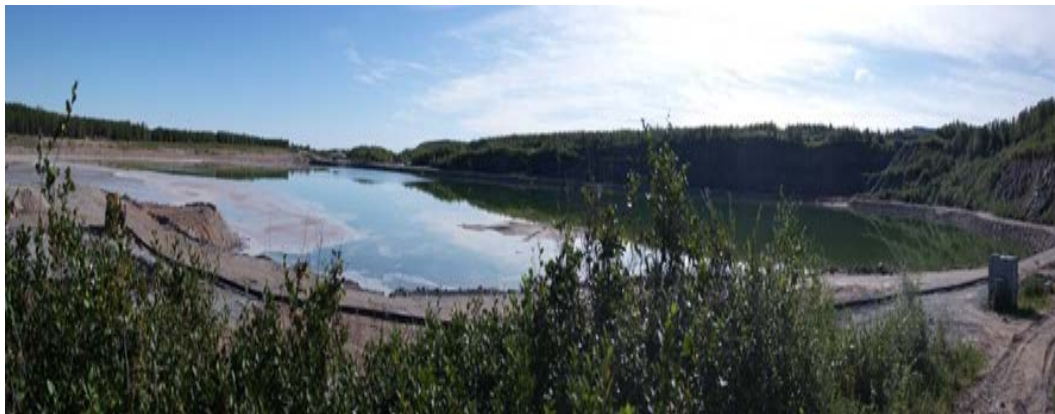
Figure 5.3: Rabbit Lake – in-pit tailings management facility

The Rabbit Lake in-pit tailings management facility (RLITMF), shown in figure 5.3, is nearly at the end of its operational life. Active thawing of ice incorporated in the facility is required before decommissioning of the facility can begin. During the care and maintenance period beginning in 2016, the RLITMF will continue its function as part of the water management and treatment program at the Rabbit Lake facility.

In 2015, tailings were deposited into the RLITMF under a water cover. This method of tailings placement prevents the inclusion of ice in newly deposited tailings and reduces the release of radon and dust.

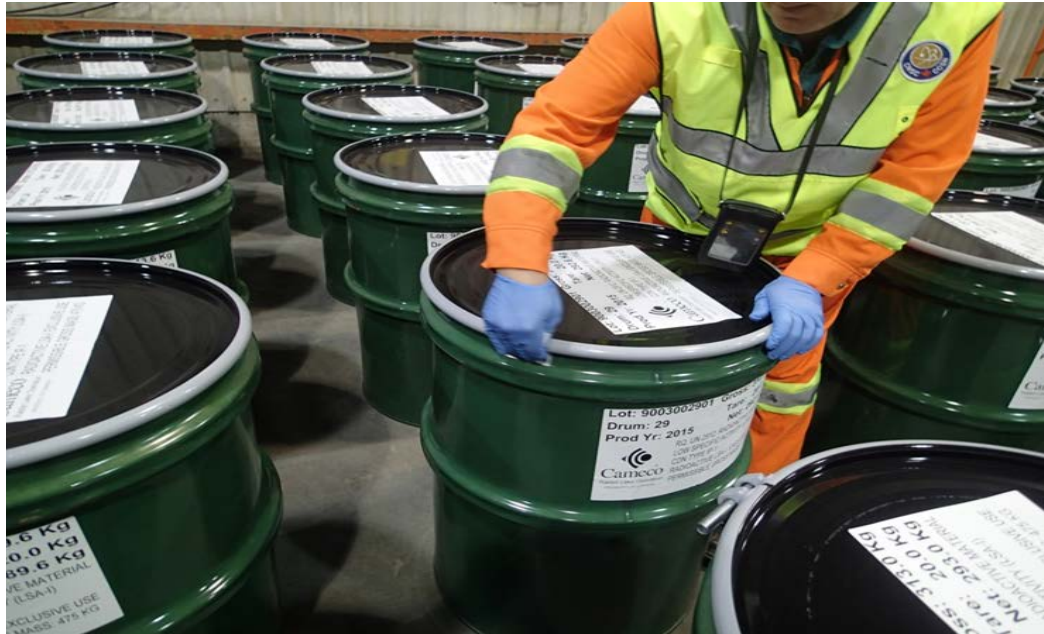
Figure 5.4: CNSC staff conducting a swipe test

Figure 5.4 shows CNSC staff conducting a swipe test to verify uranium concentrate drums are free of external contamination.

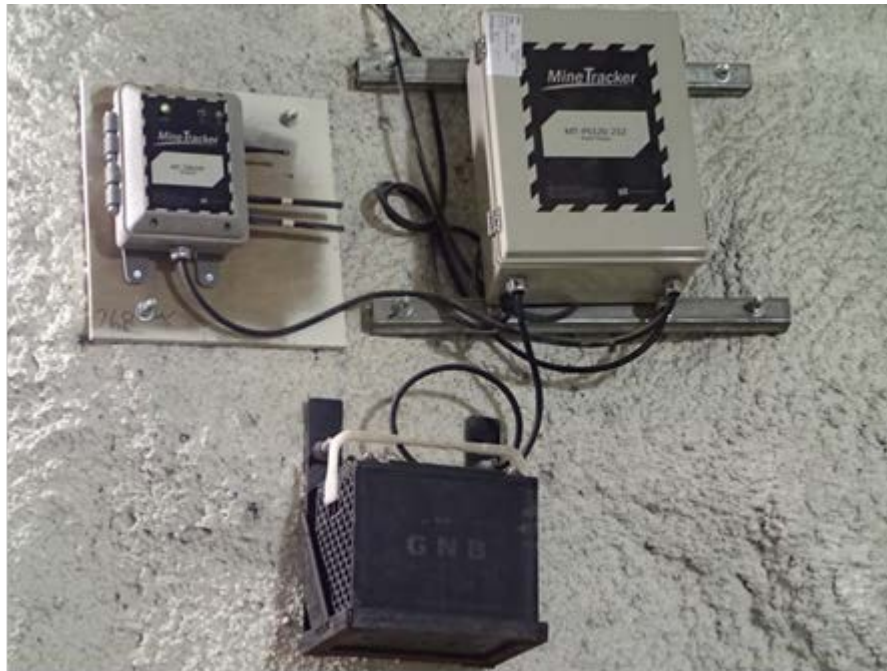
Figure 5.10: Rabbit Lake – electronic tracking of miners’ locations in Eagle Point underground mine

Cameco’s Rabbit Lake operation has implemented a safety and health management program to identify and mitigate risks. The program includes internal inspections, a safety permit system, occupational health committees, training and incident investigations. By way of example, Rabbit Lake operation implemented a continuous method of monitoring miners onsite (see figure 5.10). CNSC staff monitor this program to ensure the protection of workers through compliance activities.

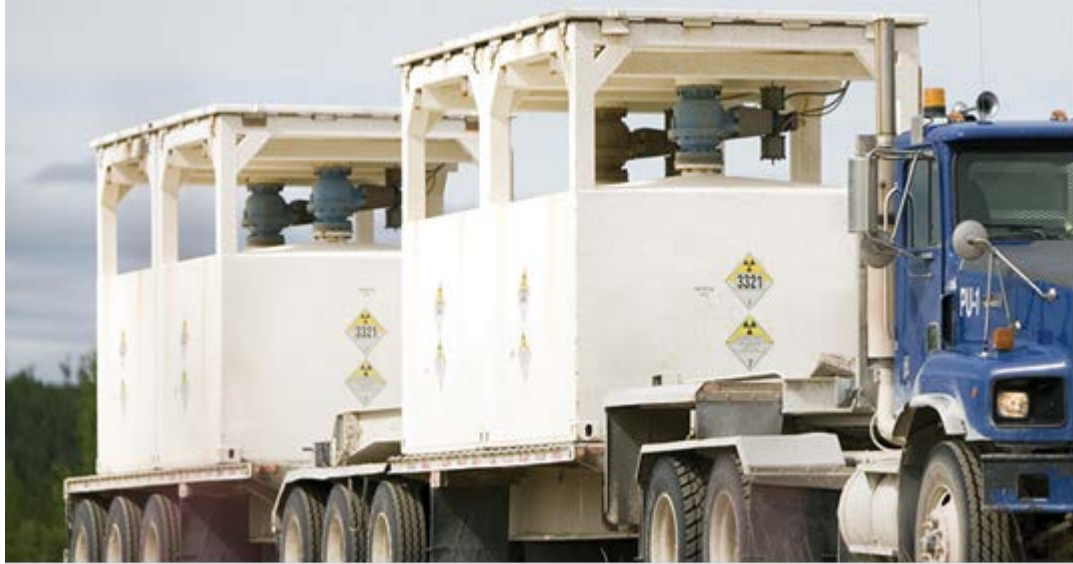
Figure 6.2: Ore slurry being transported from McArthur River to the Key Lake mill

Milling of the Deilmann ore continued until 1999, when the McArthur River operation began supplying ore slurry to the Key Lake mill (see figure 6.2). The Key Lake operation continues today as a mill operation processing McArthur River ore slurry.

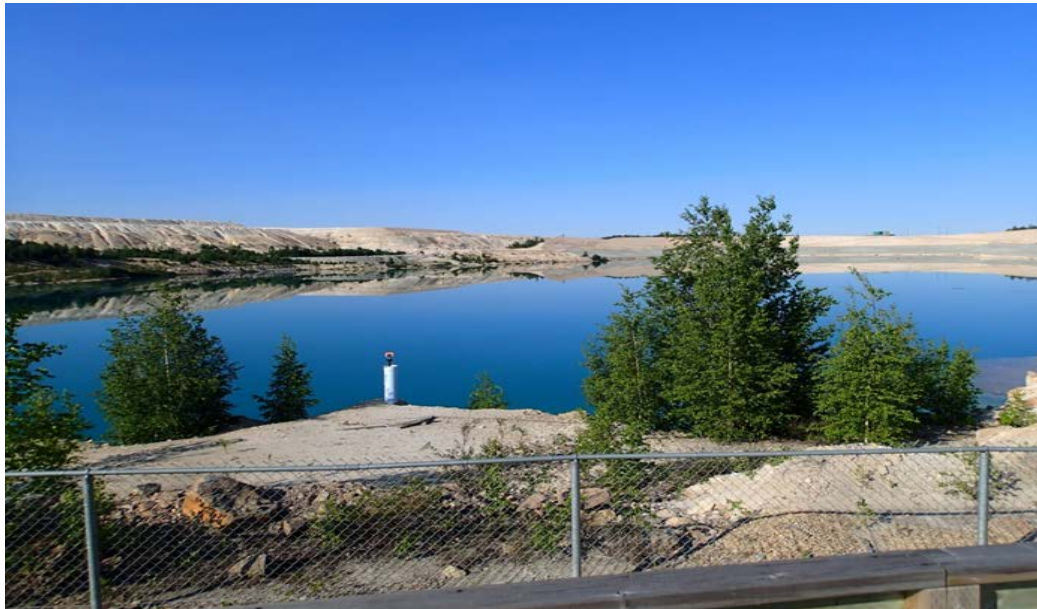
Figure 6.4: Key Lake – Deilmann tailings management facility

After open-pit mining in the eastern pit of the Deilmann orebody was completed in 1995, the pit was converted into the engineered Deilmann tailings management facility. Mill tailings continue to be deposited into this facility today.

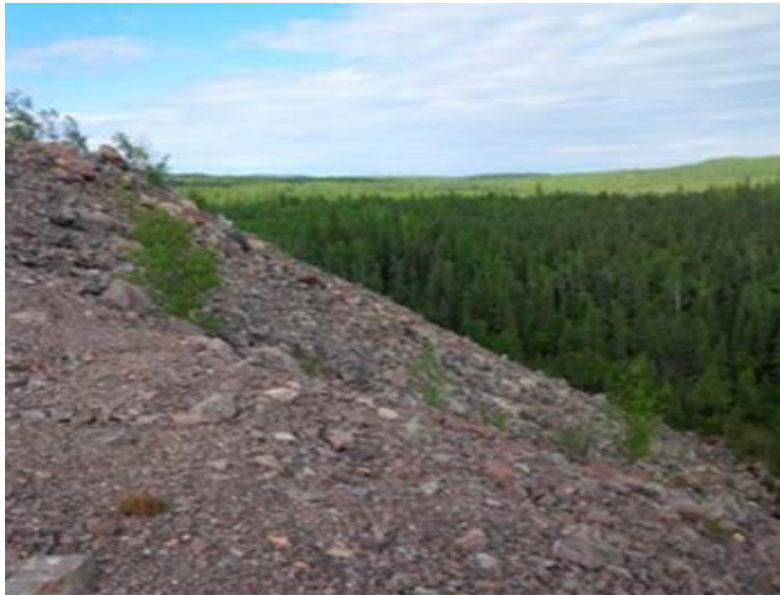
Figure 9.2: Surface of waste rock pile at Gunnar site

The remediation project consists of the clean-up of mine tailings, waste rock piles (see figure 9.2), an open pit, a mine shaft and demolition debris. The remediation work is being carried out in three phases. Phase 1, which is now complete, involved characterizing and monitoring the onsite waste and developing remediation plans. Phase 2 consists of implementing the remediation plans. Phase 3 will be the long-term monitoring and maintenance to ensure the site remains stable and safe.

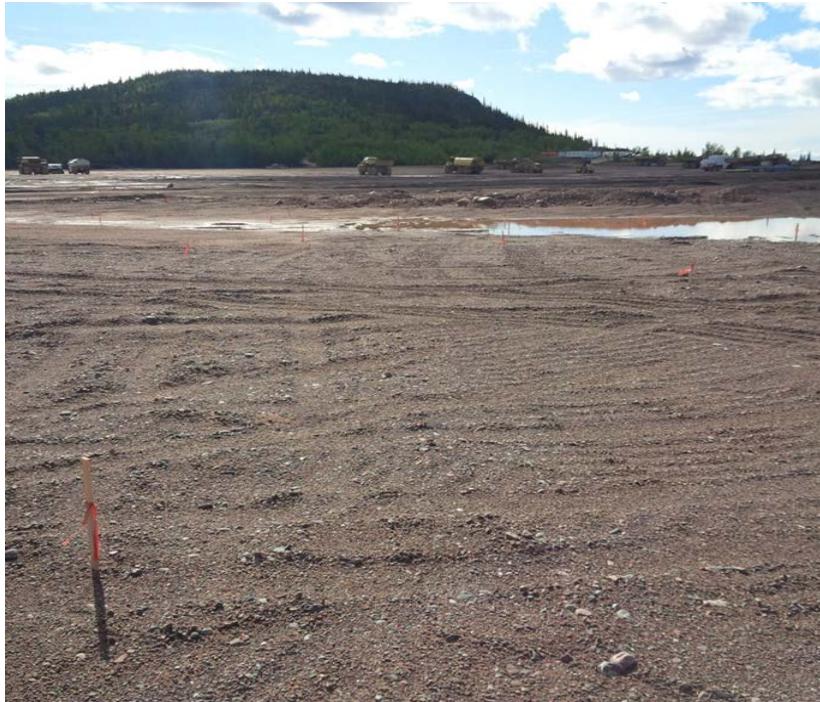
Figure 10.1: Lorado – soil cover on tailings area before final grading, 2015

At the end of 2015, SRC completed remediation of the Lorado site. The remediation work consisted of:

- covering the mine tailings with an engineered cover
- treating the water of Nero Lake to neutralize acidity and reduce contaminant concentrations
- monitoring the environment

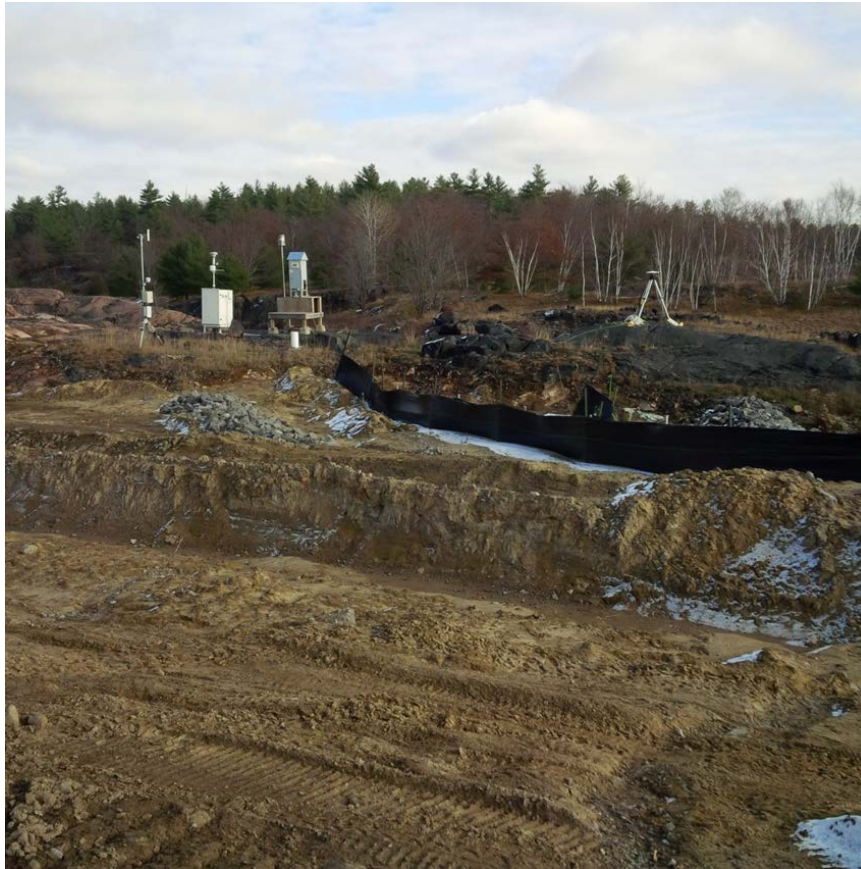
Figure 11.1: Deloro mine site, 2015

The Deloro mine site is located approximately 65 kilometres east of Peterborough, Ontario. This site was an abandoned gold mine where metallurgical and refining processes related to the production of cobalt oxides and metal, and the extraction of silver, nickel and arsenic took place (see figure 11.1).

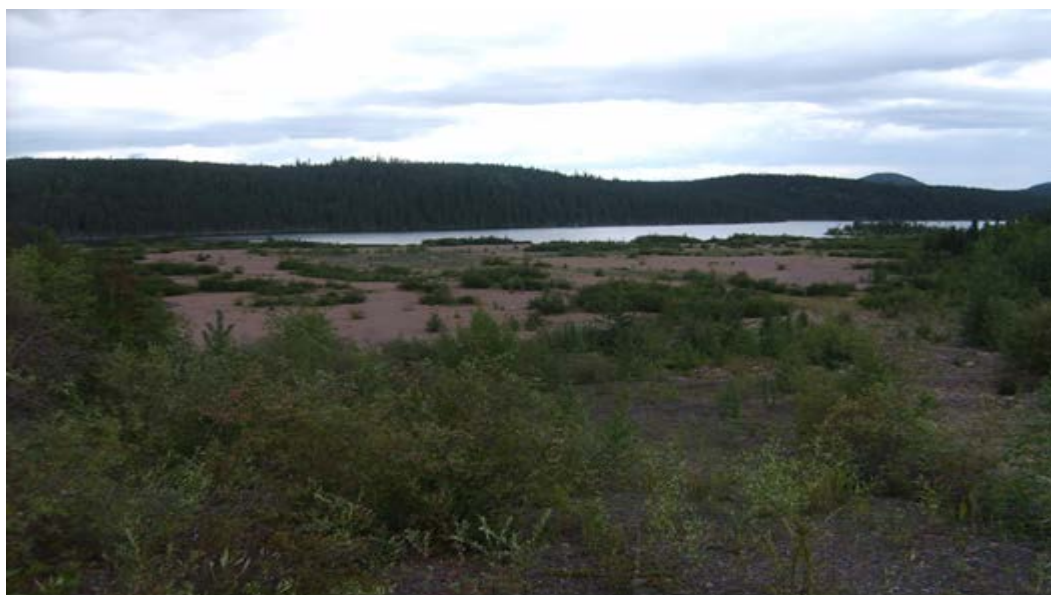
Figure 12.2: Beaverlodge tailings cover, 2015

Mining and milling activities began at the Beaverlodge site in 1950. The mine closed in 1982. The Beaverlodge site consisted of a central mill, underground mine and an above ground tailings management area. The tailings management area is located on Fulton Creek watershed (shown in dark blue in figure 12.1 and shown again in figure 12.2). There are also several smaller satellite mines that provided ore during the three decades of operation. Decommissioning commenced shortly after operations ended and was completed to the standards in place at the time of decommissioning (i.e., in 1985). Beaverlodge was the first uranium site in Canada to be decommissioned under an Atomic Energy Control Board licence. On behalf of the federal government, Cameco Corporation manages the site conducting routine environmental monitoring, environmental investigations and maintenance work, to ensure the site remains safe and secure.

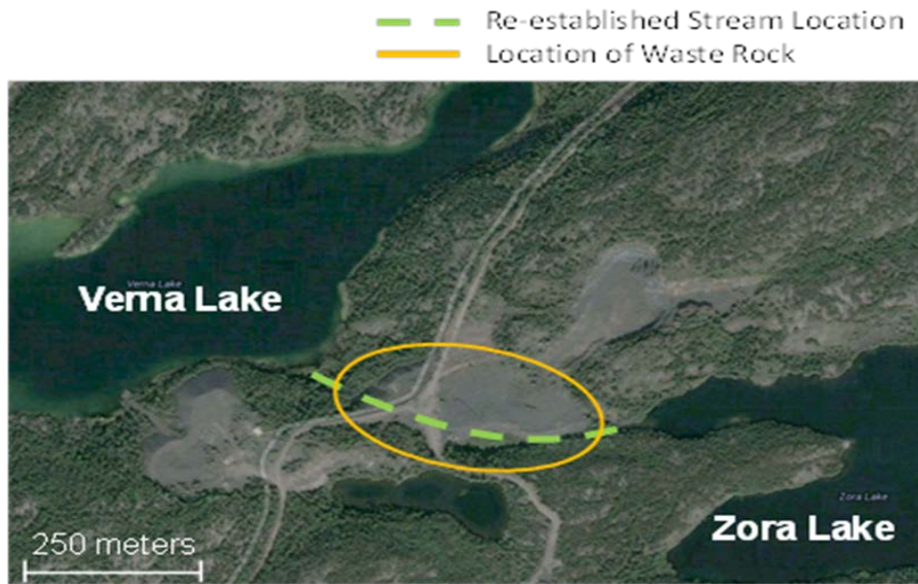
Figure 12.3: Beaverlodge – Bolger/Verna Stream diversion

In addition to continued monitoring and maintenance activities in 2015, Cameco completed the stream diversion at the Bolger/Verna area (see figure 12.3). The purpose of the stream diversion was to relocate a stream around a waste rock pile, and thereby reducing a source of contamination to the downstream watershed. The stream diversion site was inspected by CNSC staff in June 2015. They verified that stream diversion activities were implemented in accordance with the licence. No issues were identified during the inspection and CNSC staff concluded that Cameco's Beaverlodge site is meeting regulatory requirements. CNSC staff will continue to conduct inspections on the Beaverlodge site to verify regulatory compliance.

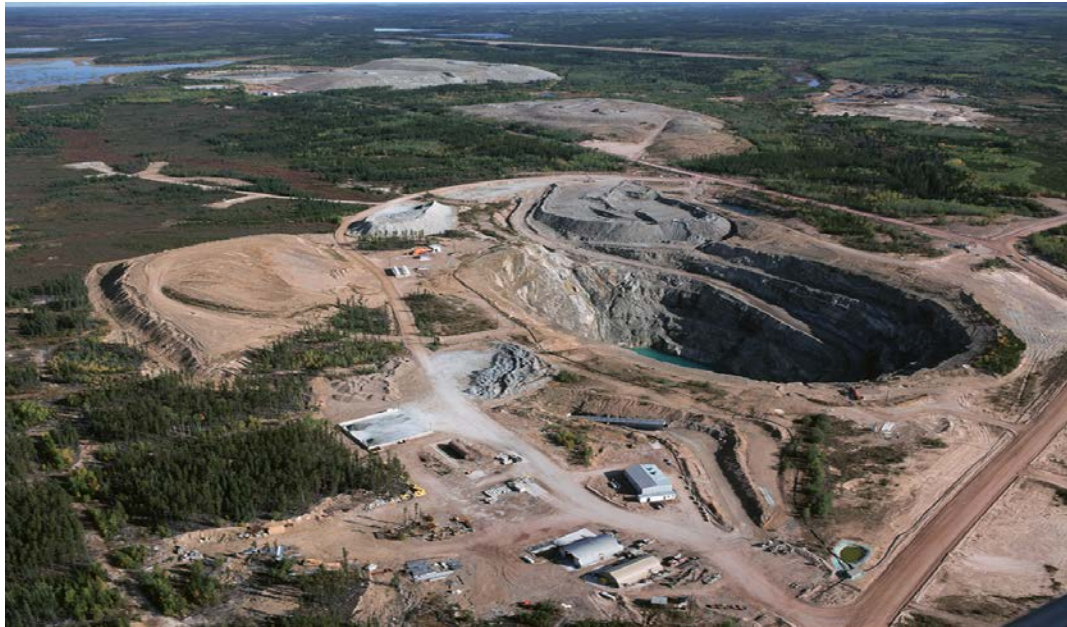
Figure 13.2: Cluff Lake – pre-decommissioning view, 2009

The former Cluff Lake operation consisted of a central mill and above ground tailings management area (TMA), three open-pit and two underground mines, associated waste rock piles, and site infrastructure including an airstrip and camp (see figure 13.2).

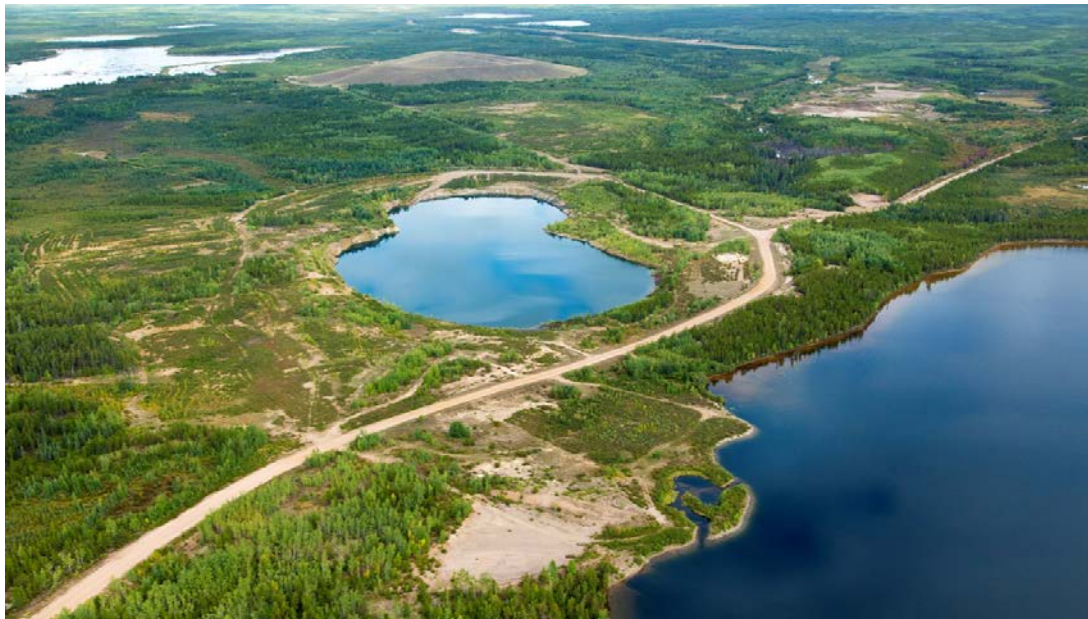
Figure 13.3: Cluff Lake – DJ and DJX pits and Claude waste rock pile, 2014

As part of decommissioning activities, the Claude pit was completely filled in. The DJ/DJX and D pits were flooded and remain isolated from adjacent natural water bodies. Potentially problematic portions of the surface waste rock piles were placed into the pits, while the remainder of the surface waste rock was contoured, covered and revegetated. The portals and vents to the underground mines were closed. The TMA was contoured, covered and revegetated. All structures were dismantled and disposed of. Figure 13.3 shows the DJ and DJX pits with the Claude waste rock pile in the background.

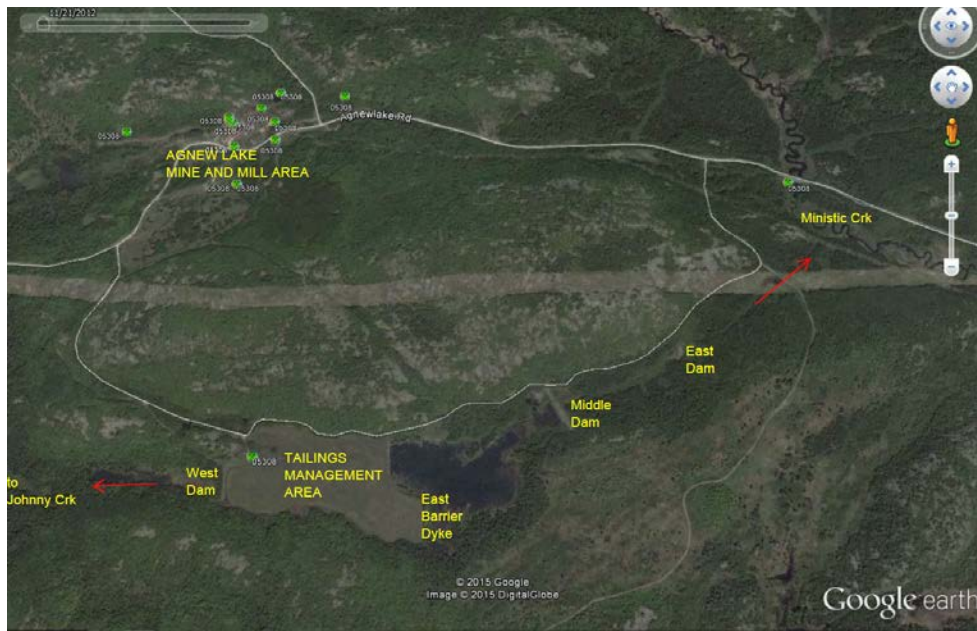
Figure 16.1: Agnew Lake remediation spillway

The Agnew Lake mine is located about 25 kilometres northwest of Nairn Centre, Ontario (see figure 16.1). The uranium mine site was decommissioned and monitored by Kerr Addison Mines from 1983 until 1988. The site was then turned over to the Province of Ontario in the early 1990s. The CNSC issued Ontario's Ministry of Northern Development and Mines (MNDM) a waste nuclear substance licence for Agnew Lake on January 20, 2011. The licence is valid until January 31, 2021. For the foreseeable future, the site will remain under long-term monitoring and maintenance.

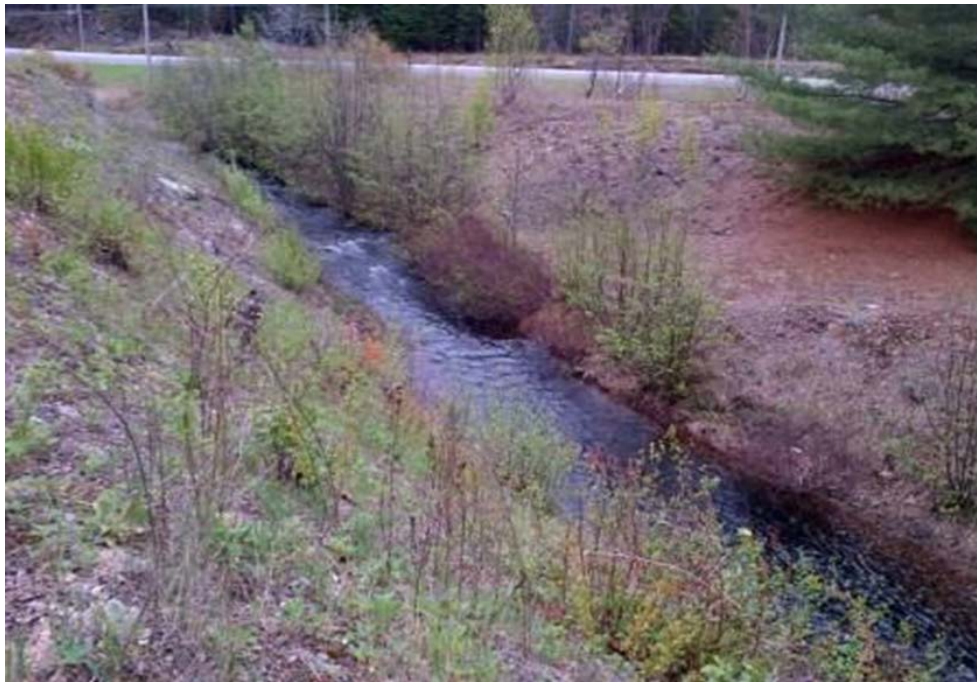
Figure 17.1: Madawaska – Bentley Creek Dam

The site includes the footprint of the mining operation, a number of capped and sealed openings, underground workings and two tailings dams. Site discharge is through Bentley Creek to Bow Lake or directly to Bow Lake (see figure 17.1).

In 2015, EWL Management Ltd. undertook maintenance work to improve the cover and surface water management on the tailings management areas. At the time of the CNSC's inspection, contractors were clearing vegetation in order to add an extra layer of soil material to the cover. This work was conducted to limit radiation from the tailings, improve surface water quality and reduce future maintenance.

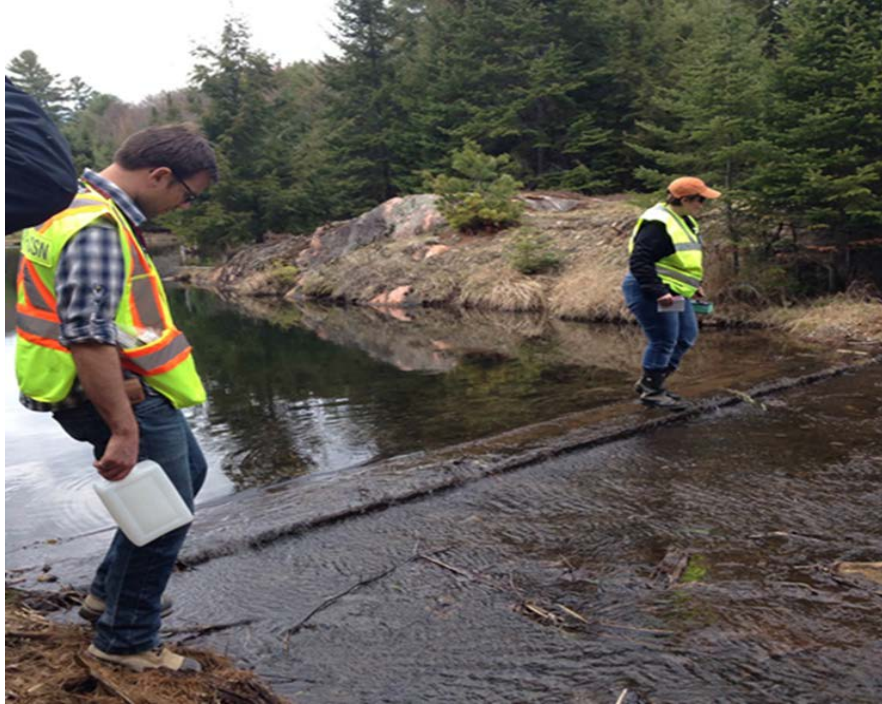
Figure 18.1: Bicroft spillway, 2016

Bicroft is located on the south side of Highway 118, about 2 kilometres west of Cardiff, Ontario. Barrick Gold Corporation is the owner and licensee of the Bicroft tailings storage facility. On December 14, 2010, the CNSC issued Barrick Gold a waste nuclear substance licence for Bicroft. The licence is valid until February 28, 2021. For the foreseeable future, the site will remain under long-term monitoring and maintenance (see figure 18.1).

In 2015, CNSC staff found the site was well managed and maintained and that there were satisfactory environmental protection measures and procedures in place. CNSC staff made recommendations to the licensee that maintenance improvements could be made to the site by removing larger trees on certain dams and beaver cuttings more regularly to ensure the overall integrity of the dams.

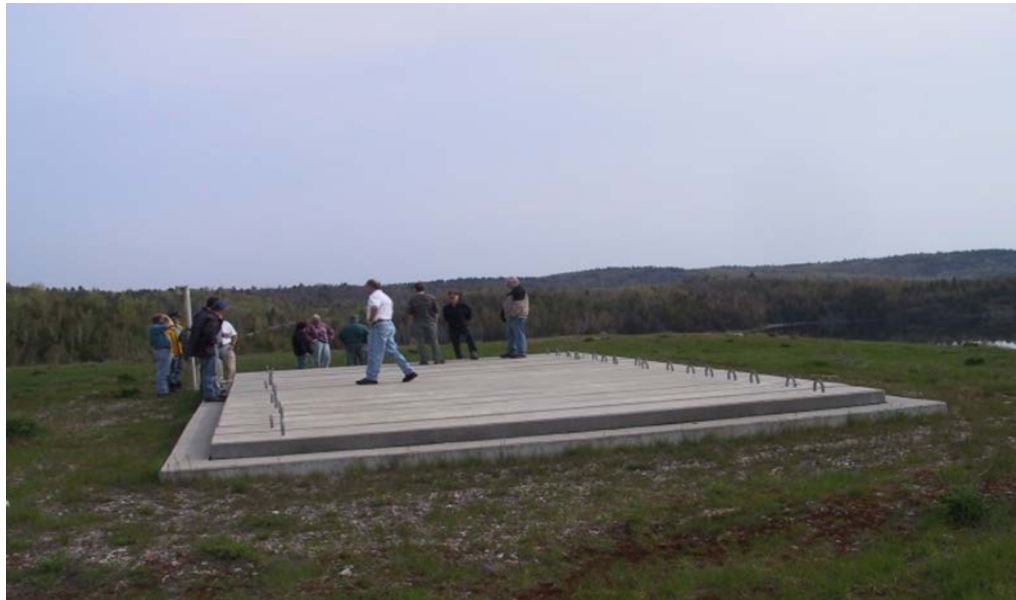
Figure 21.1: Denison mine shaft cap

The mine sites have been decommissioned and there are no mining or milling structures remaining. The TMAs are in the long-term care and maintenance phase which includes water treatment, source and watershed monitoring. The Denison mine site contains two TMAs that are covered by water and contain a total of 63 million tonnes of uranium mine tailings. The Stanrock site is a dry TMA with 6 million tonnes of uranium mine tailings.
