NRC·CMRC CONSTRUCTION

Nail Laminated Timber Compartment Fire Tests

Report No.: A1-014149.1

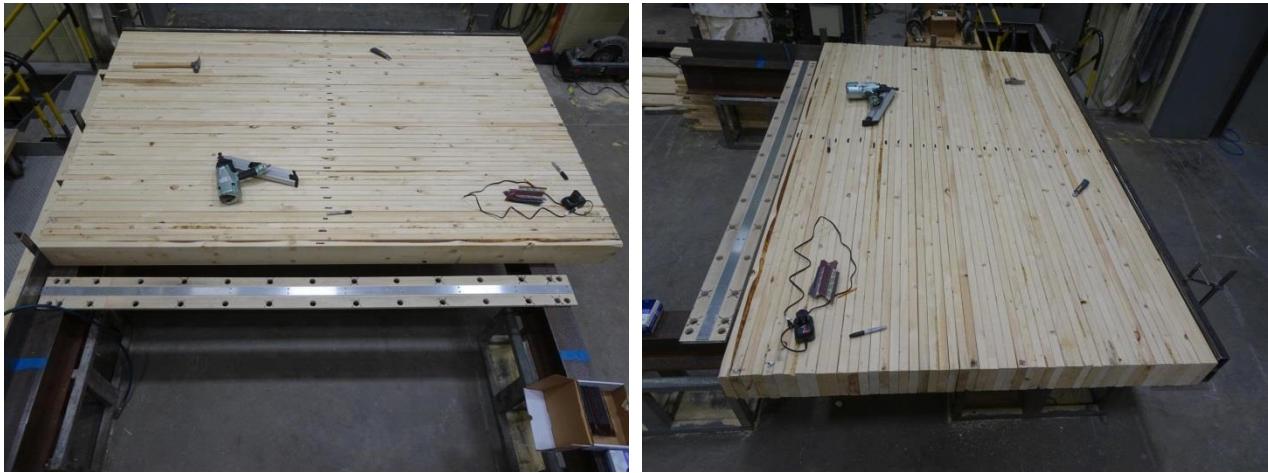
Figure 1. Photographs of NLT panel fabrication.

The NLT panels with 38 mm x 140 mm (2 x 6) laminations were used for fully encapsulated assemblies. The NLT panels with 38 mm x 184 mm (2 x 8) laminations and/or 38 mm x 235 mm (2 x 10) laminations were used for fully exposed assemblies. The ceiling panels for Test NLT-2 were made using the 38 mm x 184 mm (2 x 8) laminations and 38 mm x 235 mm (2 x 10) laminations alternately to form an uneven surface.

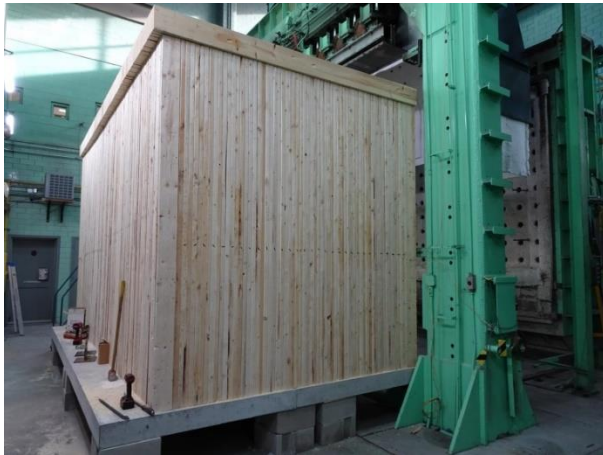
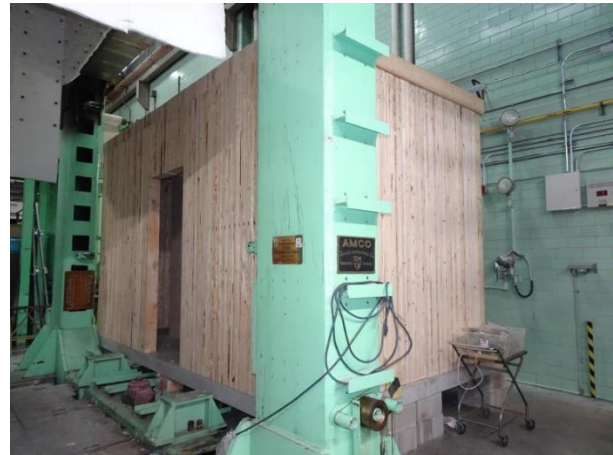
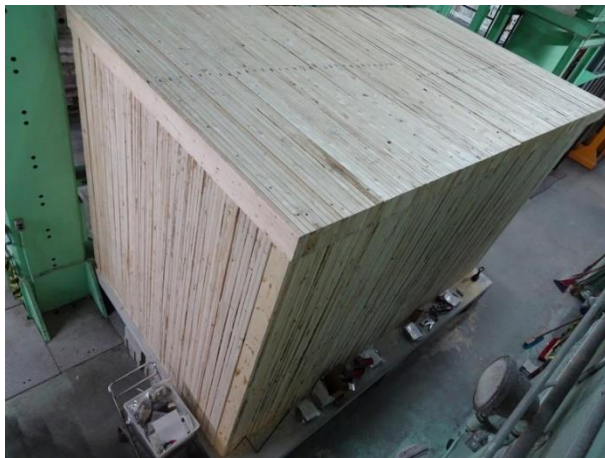
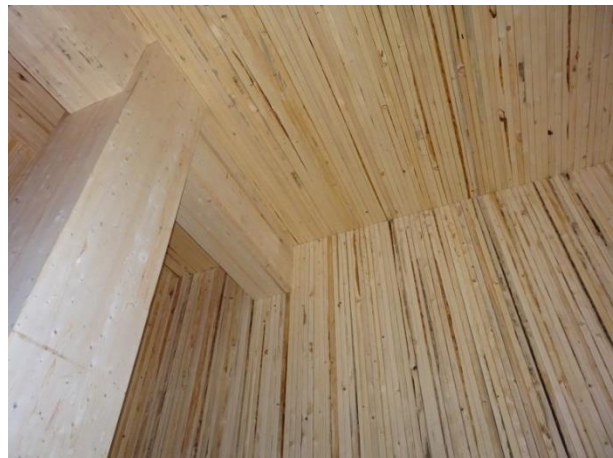
(a) outside view of NLT Walls A and D

(b) outside view of NLT Walls B and C

(c) outside view of NLT ceiling, Walls A and B

(d) inside view of NLT compartment with Glulam beam/column

Figure 6. Photographs of test compartment construction.

Figure 3 and **Figure 4** show the schematics of four NLT compartments erected on a concrete slab floor for the fire tests. Each test compartment consisted of eight NLT panels. For the ceiling, Wall A and Wall C assemblies, each assembly consisted of two NLT panels connected using 180 mm long screws at 45° on each panel every 300 mm. Wall B and Wall D assemblies consisted of a single NLT panel. The perpendicular connections of the adjacent walls and ceiling to walls were butt joints with 280 mm long screws at 300 mm spacing. (Both were SWG screws made of steel with zinc coating, CSK head and partial thread). **Figure 5** illustrates the details of the NLT connections. **Figure 6** shows photographs of the NLT enclosure during construction. The interior dimension of the NLT enclosure was 4.5 m long x 2.4 m wide x 2.8 m high. No structural load was used other than the self-weight of the NLT assemblies.

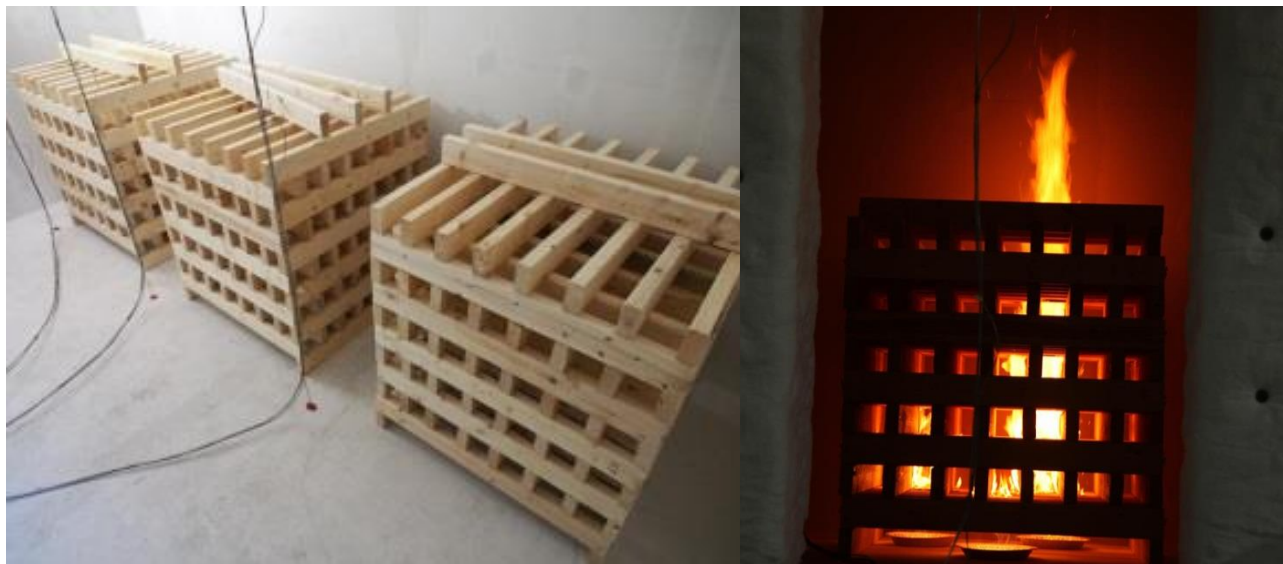
Three wood cribs, made of 38 mm x 89 mm x 900 mm spruce pieces with a total weight of 360 kg, were used as the fuel load for each test. Each wood crib had ten layers with eight spruce pieces per layer. The wood cribs provided a fire load density (FLD) of 550 MJ/m² in the room. This value is identical to recent CLT compartment fire tests [1, 4].

Three small plates which contained a total of 600 mL methyl hydrate were placed underneath the middle crib as the ignition source. A torch was used to ignite the methyl hydrate which ignited the wood crib (see **Figure 8**).

Figure 8. Photographs of (a) wood cribs and (b) middle crib ignition.

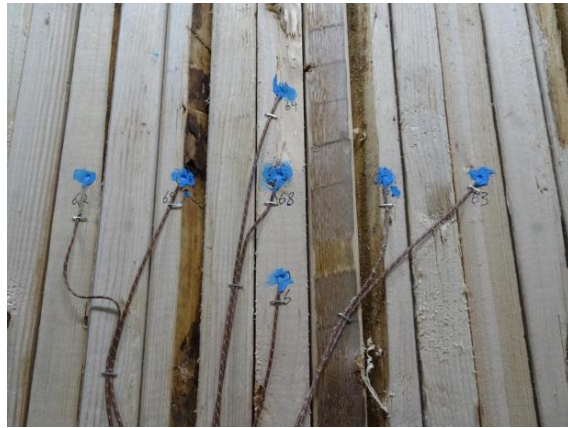
Figure 13 shows photographs of a group of embedded thermocouples. The embedded thermocouples were type K, glass-sheathed, 20-gauge, bare-bead thermocouples (Model GG-K-20-SLE-1000 from Omega). All holes drilled to install the embedded thermocouples were sealed with 3M Fire Barrier sealant FD150+ to maintain the integrity of the NLT panels and gypsum board. The thermocouples installed between layers of gypsum board and between gypsum board and NLT were run such that a length of approximately 150 mm ran along the surface of the NLT or gypsum board. This was to reduce the impact of heat transfer along the wire and minimize the effect of the holes drilled for installation.

(a) Holes drilled from exterior side of NLT and sealed with 3M Fire Barrier sealant

(b) 150 mm wire run along NLT interior surface

(c) 150 mm wire run along gypsum board surface

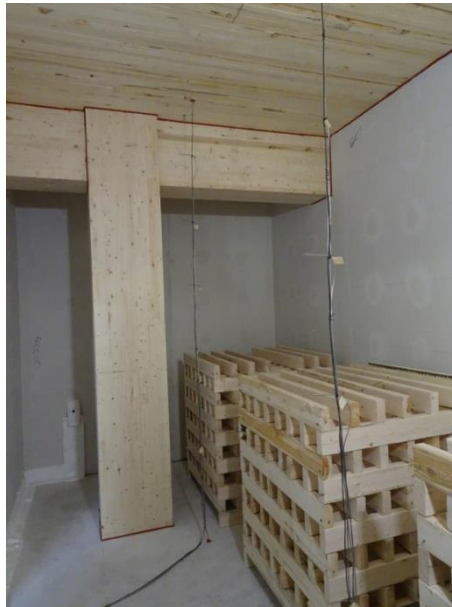
Figure 14. Fully exposed NLT ceiling, Glulam beam and column for Test NLT-1.

Test NLT-1 was conducted on February 7th, 2019 with a fully exposed NLT ceiling (2x8 laminations) and fully exposed Glulam beam and column. The Glulam beam was exposed from three sides with a total exposed surface area of 2.46 m²; the Glulam column was exposed from four sides with a total exposed surface area of 4.81 m². The combined exposed surface area of the beam and column was equal to 19% of the perimeter walls. The NLT walls (2x6 laminations) were all lined with two layers of 12.7 mm (1/2 in.) thick Type X gypsum board. **Figure 14** is a photograph of the test compartment before Test NLT-1.

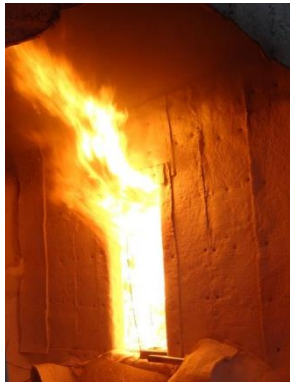
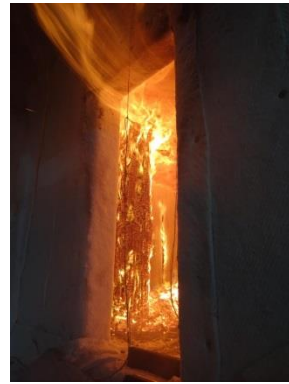
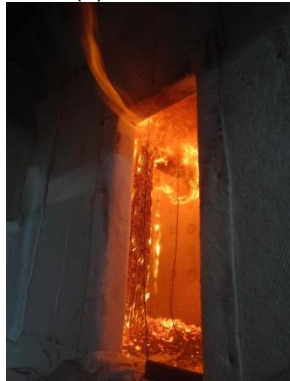
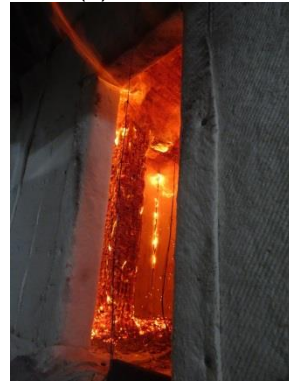
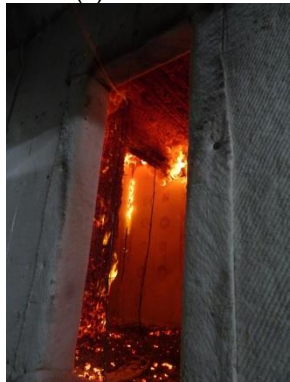
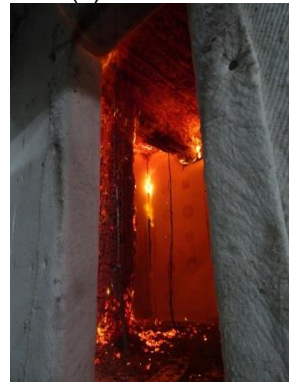
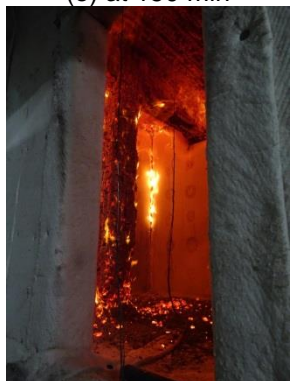
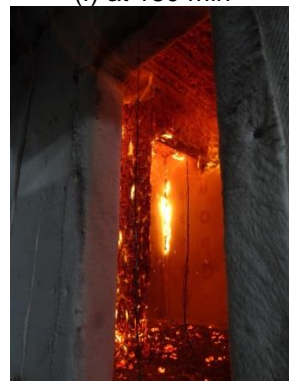
Figure 15 shows some photographs of the mass timber room during the fire test. Test NLT-1 started with ignition of the middle crib. The fire ignited the ceiling above at 3.0 min. Flame started to come out from the top of the doorway opening at 3.2 min, followed by large fire plume issuing from the doorway opening. Flashover occurred at 3.7 min. By 40 min, the fire plume from the opening reduced significantly and the interior of the room became visible. Char was observed to have formed on the NLT ceiling and Glulam beam and column. The flaming combustion of the exposed ceiling, beam and column continued to decline as time elapsed. However, there were constant flames coming from the gypsum-board protected walls through gypsum board cracks (indicating NLT charring behind the gypsum board) and along some gypsum board junctions.

The fire plume ceased to continuously issue from the opening at 120 min. There was no more flaming combustion on the ceiling afterwards but flaming continued on the Glulam column and along some gypsum-board junctions and cracks on the walls. These fire conditions had no obvious changes until the end of the test. Two layers of gypsum board still remained on the walls at the end of the test. At 251 min, water spray was applied to extinguish the remaining flames.

Figure 15. Fully exposed ceiling, beam and column in mass timber room during Test NLT-1.

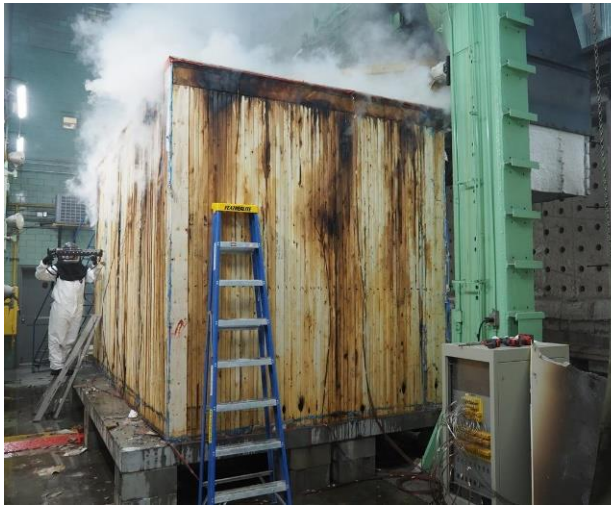
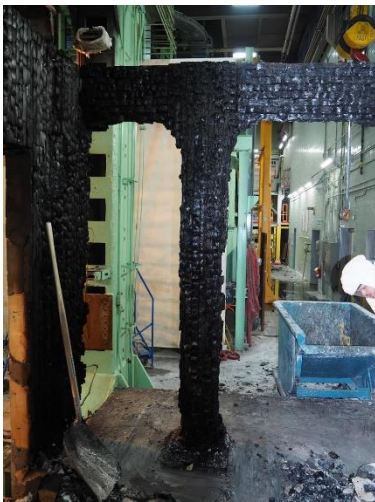
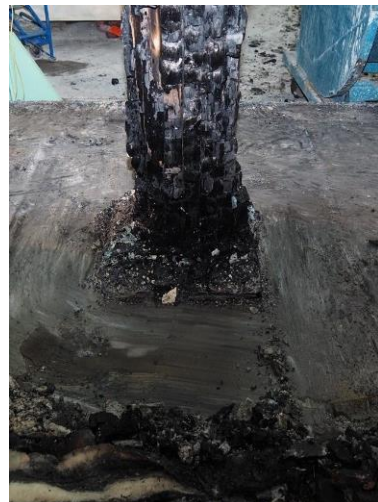
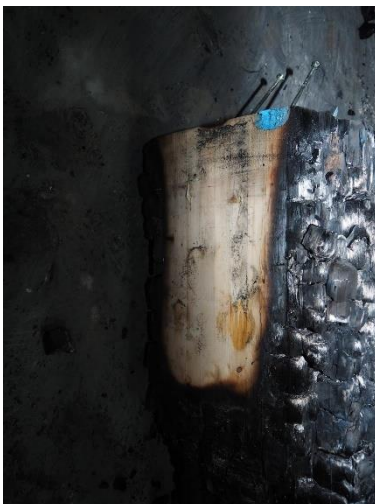
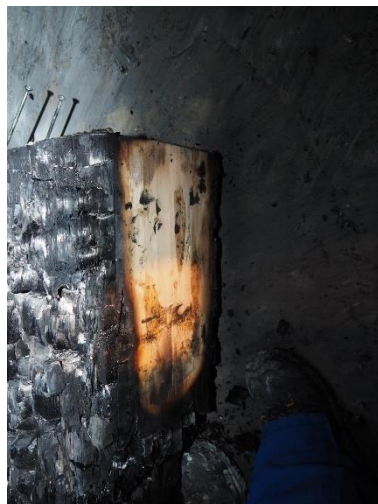
(a) NLT exterior (gypsum board removed)

(c) Glulam beam and column

(d) bottom portion of Glulam column

(e) an end surface of Glulam beam

(f) another end surface of Glulam beam

Figure 21. Photograph of mass timber elements after Test NLT-1.

After Test NLT-1, the NLT panels and Glulam beam and column in the compartment were examined for char. **Figure 21** shows photographs of the NLT and Glulam elements after Test NLT-1.

Figure 23 shows the sampling locations and remaining depths of the Glulam beam and column after the fire test. Given the original cross section of 327 mm x 457 mm for the three-side exposed beam and 457 mm x 457 mm for the four-side exposed column, the char depth was in a range of 93 mm to 137 mm for each exposed side of the Glulam in 251 min, translating to a char rate of 0.37 to 0.55 mm/min.

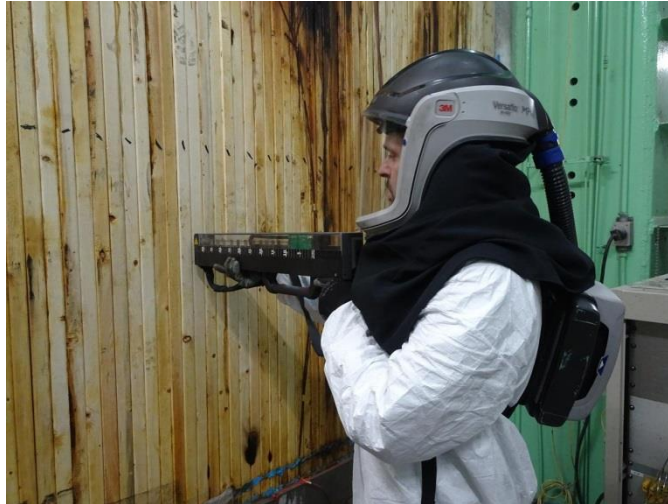
Figure 22. A Resistograph drill used to determine NLT char depth after the test.

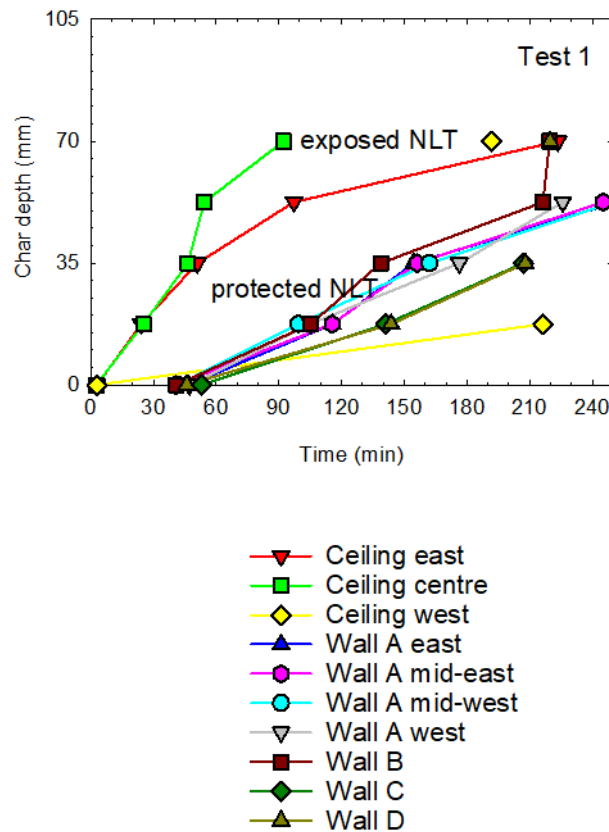
Using data from **Table 4** (time to reach 300°C in NLT), the char front inside NLT is plotted versus time in **Figure 24**, assuming that NLT started to char at 300 °C. The plots show that the char rate generally slowed down with the increasing char depth, which acted as a thermal barrier against the advance of the char front. For the exposed ceiling, the NLT char rate was changed from 0.82 mm/min initially to 0.14 mm/min as the char front moved deeper. For the wall assemblies with the gypsum board protection, the char rate was approximately 0.26 mm/min.

Figure 24. NLT char depth versus time in Test NLT-1.

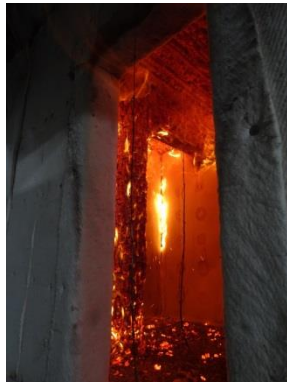
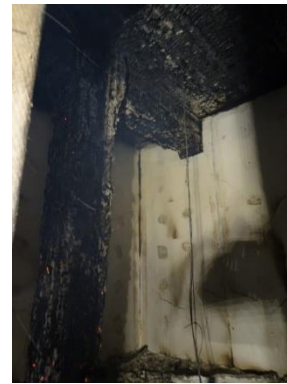
(a) NLT room at 240 min

(b) CLT room at 220 min

Figure 25. Comparison of Test NLT-1 and Test CLT-4.

Figure 25 and **Table 6** compare the results from the two tests. While the fire was completely self-extinguished in Test CLT-4, the NLT wall panels in Test NLT-1 continued to char behind the gypsum board with flames through gypsum board cracks and joints keeping the room hot. The char was much deeper in NLT panels than in CLT panels. During both tests, two layers of gypsum board remained on the walls; the times to reach 300°C at their interfaces were similar. The experimental results indicated that, in term of limiting mass timber contribution to the compartment fire, CLT performed better than NLT in this test arrangement primarily due to the tighter fitting lumber elements in the CLT compared to NLT lumber elements with small gaps.

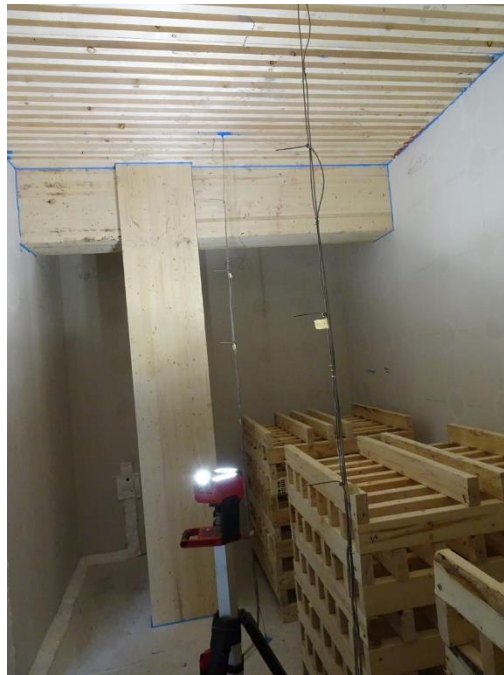
Figure 26. Fully exposed uneven NLT ceiling, Glulam beam and column for Test NLT-2.

Test NLT-2 was conducted on February 26th, 2019 with a fully exposed uneven NLT ceiling (alternate 2x8 and 2x10 laminations) and fully exposed Glulam beam and column. The Glulam beam was exposed from three sides with a total exposed surface area of 2.46 m²; the Glulam column was exposed from four sides with a total exposed surface area of 4.81 m². The combined exposed surface area of the beam and column was equal to 19% of the perimeter walls. The NLT walls (2x6 laminations) were all lined with two layers of 12.7 mm (1/2 in.) thick Type X gypsum board. **Figure 26** is a photograph of the test compartment before Test NLT-2. Except for the uneven ceiling, Test NLT-2 was essentially the same as Test NLT-1 in the experimental configuration.

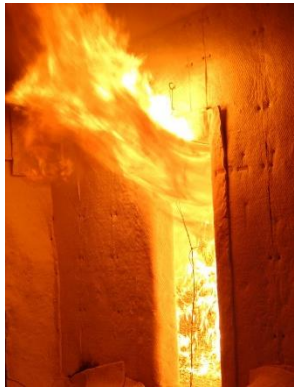
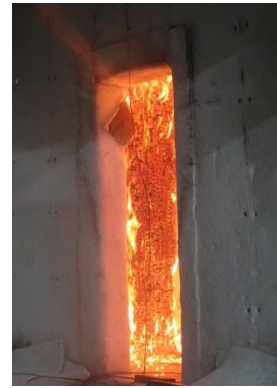
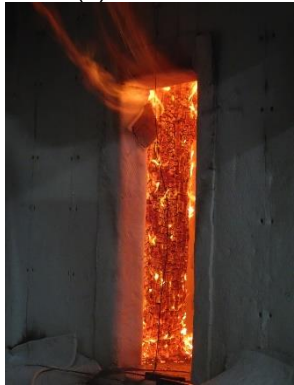
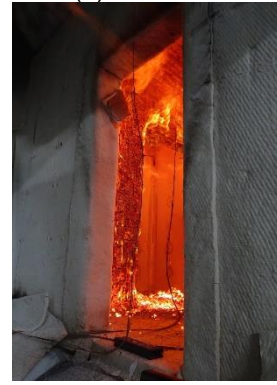
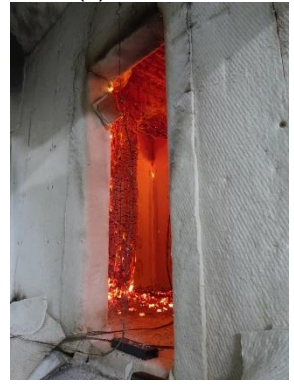
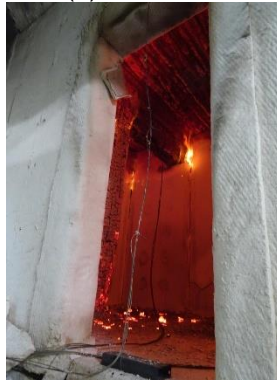
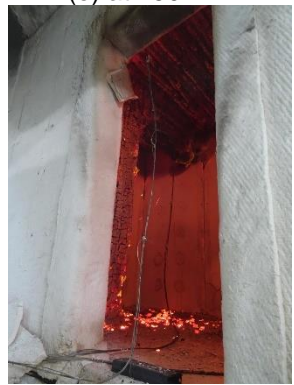
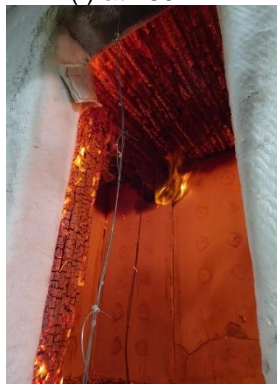
Figure 27 shows some photographs of the mass timber room during the fire test. Test NLT-2 started with ignition of the middle crib. The fire ignited the ceiling at 2.5 min. Flame started to come out from the top of the doorway opening at 3.0 min, followed by large fire plume issuing from the doorway opening. Flashover occurred at 3.9 min. By 40 min, the fire plume from the opening reduced significantly and the interior of the room became visible. Char was observed to have formed on the NLT ceiling and Glulam beam and column with reduced burning as time elapsed; the flame on the NLT ceiling surface was less than on the Glulam beam and column. The fire plume ceased to issue from the opening at 120 min; the flame on the NLT ceiling were self-extinguished with flame remaining only along the edges of Glulam beam and column and some gypsum board joints and cracks. At 180 min and afterwards, only a few small flames remained on the Glulam surface and joint with gypsum board. The test was terminated at 240 min. At the end of the test, two layers of gypsum board were still on the walls although some cracks existed. At 241 min, water spay was applied to extinguish the remaining small flames.

Figure 27. Fully exposed ceiling, beam and column in mass timber room during Test NLT-2.

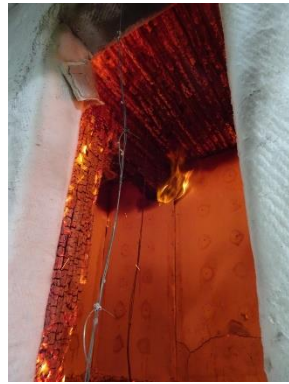
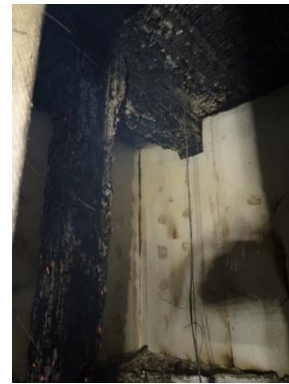
(a) NLT room at 240 min

(b) CLT room at 220 min

Compared with Test CLT-4 where the fire was completely self-extinguished, Test NLT-1 and Test NLT-2 had the protected NLT wall panels continuously charring behind the gypsum board with flames through some gypsum board cracks and joints. The char was much deeper in the NLT tests than in the CLT test. The test results also indicated that, in terms of reducing timber contribution to the fire, CLT performed better than NLT in this test configuration as the lumber elements in the NLT panels were not as tightly fitted as the lumber in the CLT panels. The NLT tests showed the issues of continued charring of the protected NLT walls behind the gypsum board, which prevented fire decaying to the full extent as in Test CLT-4. In this specific scenario with the full ceiling exposed, the two layers of gypsum board protection appeared to be insufficient to limit the contribution of the protected NLT walls to the fire.

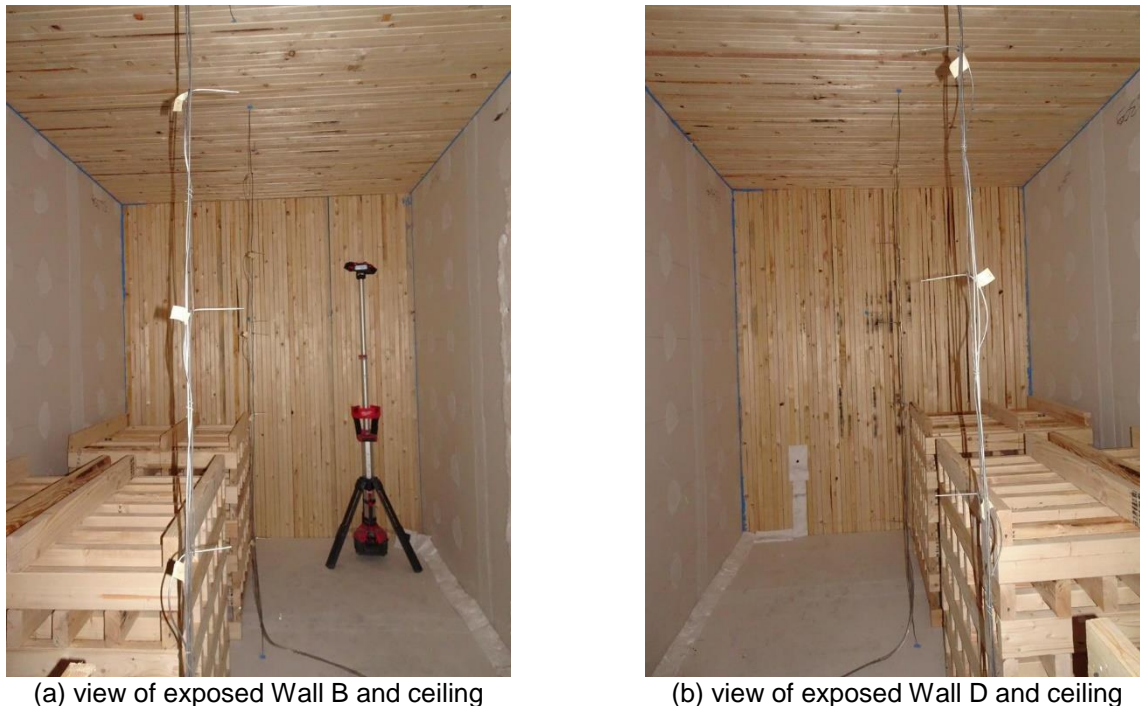
Test NLT-3 was conducted on March 14th, 2019 with fully exposed ceiling, Wall B and Wall D (2x8 laminations). Wall A and Wall C (2x6 laminations) were lined with two layers of 12.7 mm (1/2 in.) thick Type X gypsum board. **Figure 37** shows photographs of the NLT compartment before Test NLT-3.

Figure 37. Fully exposed NLT ceiling, Wall B and Wall D for Test NLT-3.

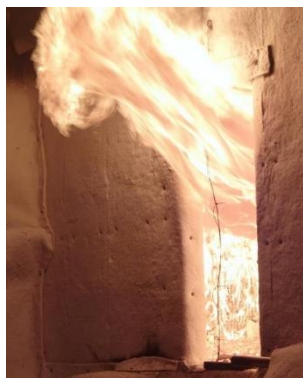
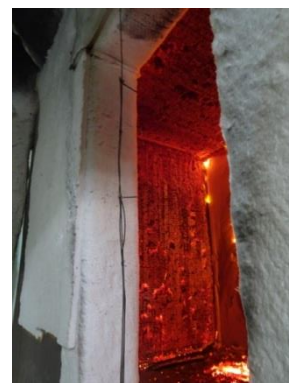
(a) NLT room at 120 min

(b) CLT room at 120 min

Although Test NLT-3 only lasted half as long as Test CLT-5, the exposed NLT panels charred deeper than the exposed CLT panels in the ceiling, Wall B and Wall D. Again, the experimental results indicated that, in term of reducing mass timber contribution to the compartment fire, CLT performed better than NLT in this test arrangement as the lumber elements in the NLT panels were not as tightly fitted as the lumber in the CLT panels.

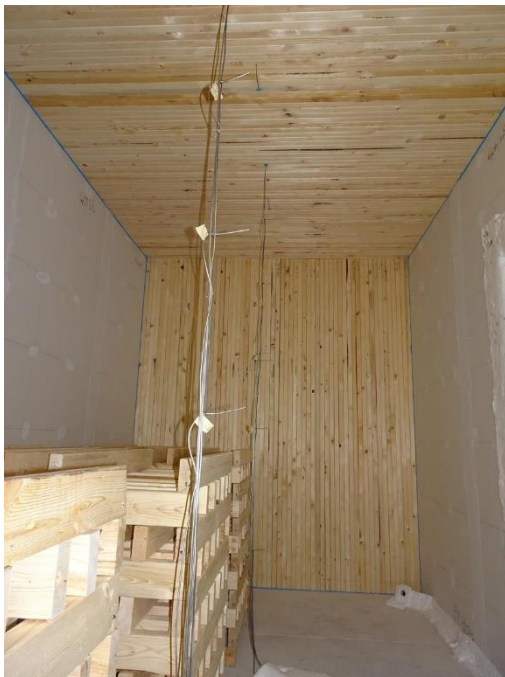
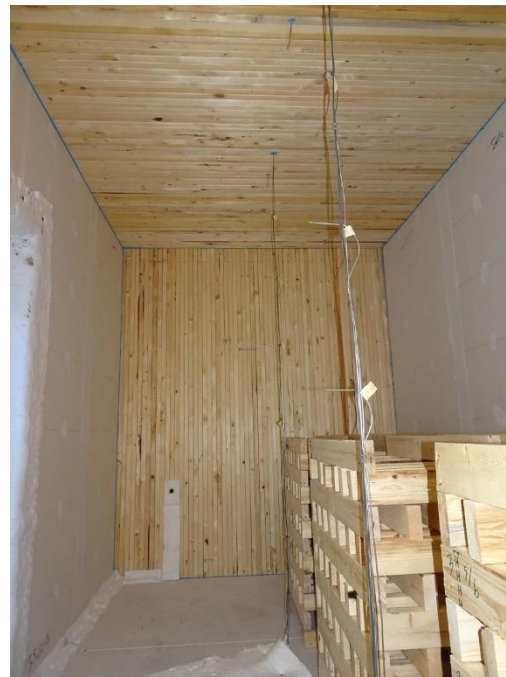
(a) view of exposed Wall B and ceiling

(b) view of exposed Wall D and ceiling

Figure 46. . Fully exposed NLT ceiling, Wall B and Wall D for Test NLT-4.

Test NLT-4 was conducted on March 27th, 2019 with fully exposed ceiling, Wall B and Wall D (2x8 laminations). Wall A and Wall C (2x6 laminations) were lined with three layers of 12.7 mm (1/2 in.) thick Type X gypsum board. Test NLT-4 was essentially the same as Test NLT-3 in the experimental configuration, except that three layers of gypsum board were installed on Wall A and Wall C. **Figure 46** shows photographs of the NLT compartment before Test NLT-4. Test NLT-4 aimed to investigate the feasibility of increasing the degree of encapsulation to limit the contributions of the protected walls to fire while still keeping the same total area of exposed surfaces as Test NLT-3.

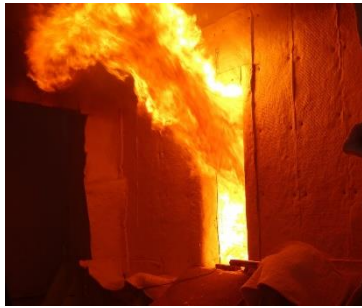
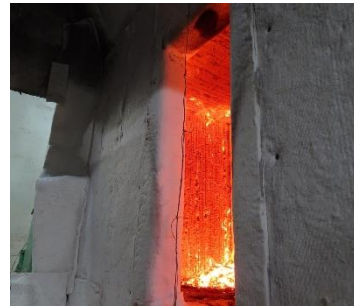
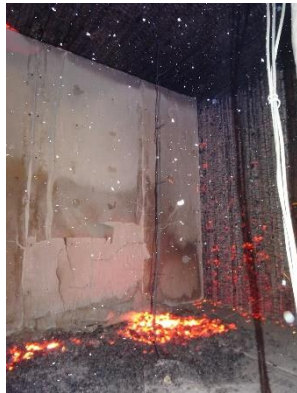
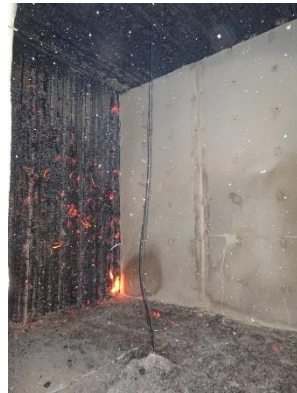
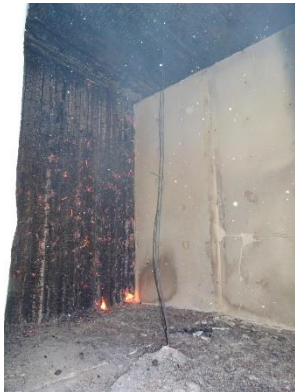
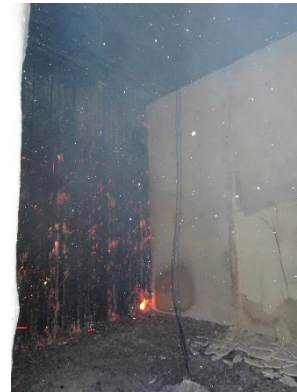
Figure 47 shows some photographs of the NLT room during Test NLT-4. The test started with ignition of the middle crib, which ignited the ceiling above at 2.5 min. Flame started to come out from the top of the doorway opening, followed by large fire plume issuing from the doorway opening. Flashover occurred at 3.3 min. At 50 min, the fire plume reduced significantly and the interior of the room became visible. The char on the exposed ceiling, Wall B and Wall D was visibly formed to slow down burning on the exposed NLT surfaces. At the same time, the face layer gypsum board on Wall A was observed to lose a 1.2 m wide section from the floor to 0.6 m height at the location near the middle wood crib. At 60 min, the fire plume ceased to issue from the opening. Flaming combustion on the ceiling, Wall B and Wall D was reduced as time elapsed and eventually ceased at around 90 min. The face layer gypsum board on Wall A fell off further to a 1.2 m wide x 1.2 m high section at the same location near the middle wood crib at 90 min. Since the face layer gypsum board was missing in this area, a vertical crack was observed on the mid layer gypsum board; small flames came out through the crack later at 150 min, indicating NLT burning behind the gypsum board (see also **Figure 47(g)**). At 167 min, the fall-off section of the face layer gypsum board doubled to a 2.4 m wide x 1.2 m high area on Wall A in its mid-length portion near the floor. Nevertheless, until the end of the test, three layers of gypsum board remained on approximately 70% of the surface area on Wall A with only small flame from the gypsum board crack near the mid-length, and no flames on the exposed surfaces. As four hours had passed without fire recurrent, the test was terminated at 255 min.

Figure 47. Photographs of the NLT room during Test NLT-4.

Test NLT-4 demonstrated that this test configuration of fully exposed ceiling, Wall B and Wall D along with increased encapsulation on Wall A and Wall C using three layers of the gypsum board successfully led to continuous fire decay with self-extinguishment on the exposed NLT surfaces and also limited the contributions of the protected NLT walls to the fire.

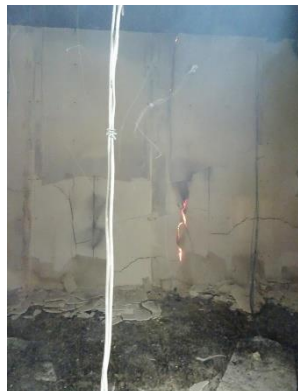
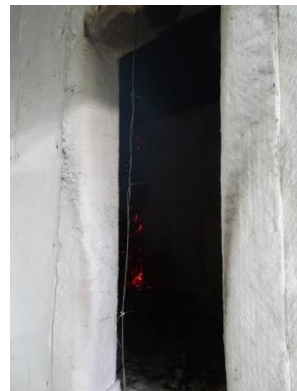
(f) Wall A (partial), Wall D and ceiling at 210 min

(g) Wall A (central) and ceiling at 210 min

(h) Wall D and ceiling at 240 min

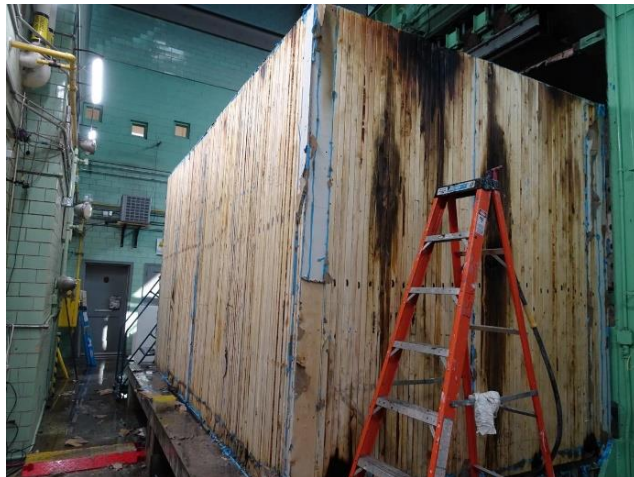
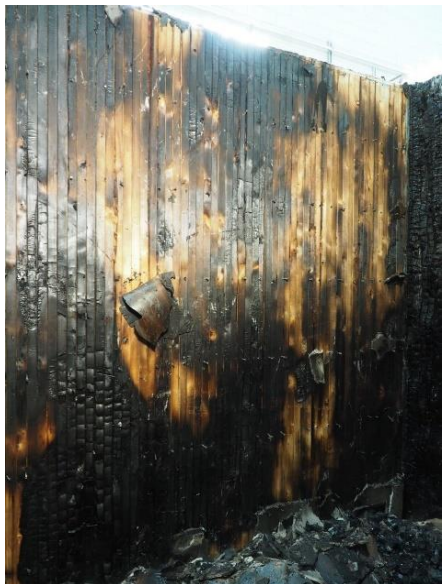
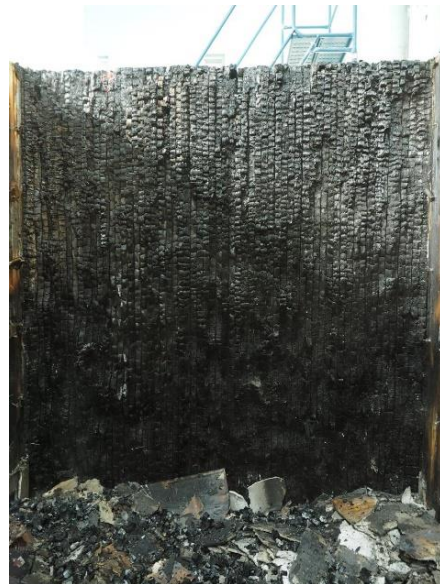
Figure 53. Photograph of mass timber elements after Test NLT-4.

After Test NLT-4, the NLT panels were examined for char. **Figure 53** are photographs of the NLT panels after Test NLT-4, showing the char on the NLT panels. As shown in **Figure 53(c)**, the gypsum-board protected NLT panels only had limited surface char.

(a) NLT exterior (gypsum board removed)

(c) Wall A (interior gypsum board removed)

(d) Wall B (interior)

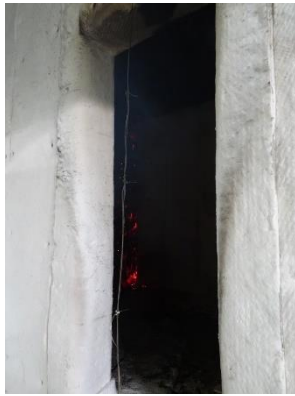
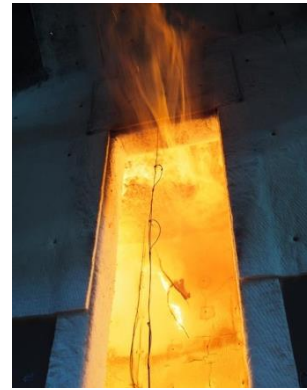
(a) NLT room at 240 min

(b) CLT room at 240 min

Test NLT-3 caused intense fire without significant decay and had to be terminated just after two hours. The previous Test CLT-5 (cf. **Figure 55**) had recurrent fire at 220 min after a long period of fire decay including flame self-extinguishing on the exposed CLT panels. This was largely due to the two layers of gypsum board being insufficient in this test configuration to protect Wall A and Wall C, which charred continuously behind the gypsum board and eventually became exposed to fully involve in the fire.

Test NLT-4, with the same amount of exposed NLT but enhanced encapsulation on Wall A and Wall C, led to continuous decay of the fire and much reduced contributions of the timber to the fire during the four-hour long test. The flames on exposed NLT panels eventually self-extinguished in Test NLT-4. As demonstrated by Test NLT-4, it is feasible to have this large amount of exposed timber surfaces without causing undue contribution to the fire with the enhanced encapsulation on the protected areas. Although Test NLT-4 lasted twice as long, the char depths were much less in Test NLT-4 than in Test NLT-3 for all NLT panels. The char depths were also significantly less in Test NLT-4 than in Test CLT-5 in all areas.
