Oil Spill at Deception Bay, Hudson Strait

R. O. Ramseier, G. S. Gantcheff
and L. Colby

SCIENTIFIC SERIES NO. 29

*INLAND WATERS DIRECTORATE,
WATER RESOURCES BRANCH,
OTTAWA, CANADA, 1973*

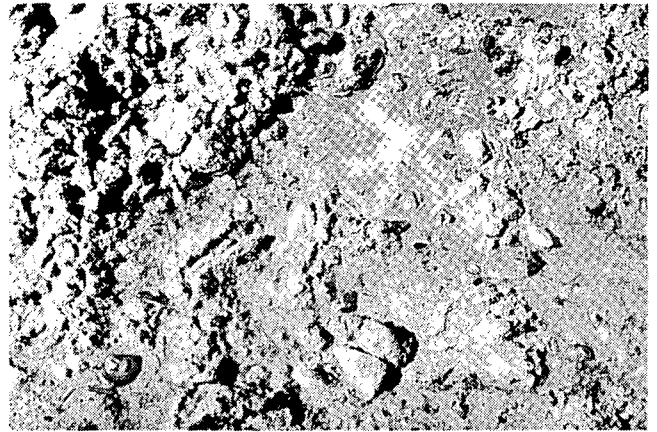
Figure 17. Oil in permafrost.

- (i) *Permafrost*. A large quantity of snow and debris was deposited as the avalanche ran out onto the sea ice (Figure 15). A dirt layer from one to three inches thick covered the entire area. It originated predominantly from the fill on which the tank farm rested, with some fill from the road above the tank farm. Both the dirt layer and the snow itself were saturated with diesel oil (Figures 17 and 18). Figure 18 also shows some frost crystals which formed from the evaporation of gasoline. The surface layer on which the ice crystals formed was frozen hard. The ice crystals were somewhat yellowish in appearance.

On the team's arrival, Tank Nos. 2 and 6 were feeding this system with oil and it appeared that equilibrium had not been reached. For this reason, and in the light of soil analysis made later, it was believed that the amount of oil in the soil on the days preceding our arrival was in the order of 6% by weight decreasing with time. When leaking from the two damaged tanks stopped, the rate of drainage, washing and leaching slowed. On June 16, the amount of oil in the soil was down to about 1¹/₂%.

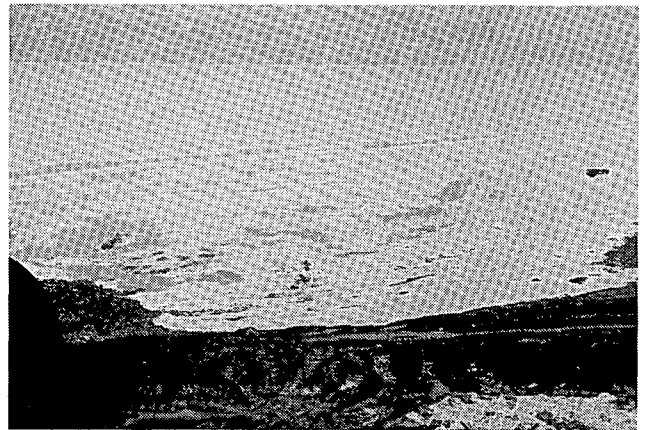
Figure 19. Shore fast ice.

(ii) *Shore-fast Ice*. The shore-fast ice extended from the shore to the tidal-crack network (Figure 19). A structural and textural analysis revealed that it was mostly porous snow ice with a grain size of 2-4 mm. Its origin was wind-blown snow. The tides, averaging 12 feet, made the surface and bottom of the shore-fast ice very irregular; and ideal place for absorption and pooling of oil.

(iii) *Tidal-Crack-Network*. The tidal cracks are clearly visible in Figure 19 between the smooth sea ice surface and the shore-fast ice. The spilled oil flowed up and down the crack system, and into the shore-fast ice, depending on the tide and prevailing wind.
