**A Preliminary Assessment of the
Goderich Harbour Rubblemound Breakwater's
Effects on Coastal and Fluvial Processes**

Craig T. Bishop

July 1987

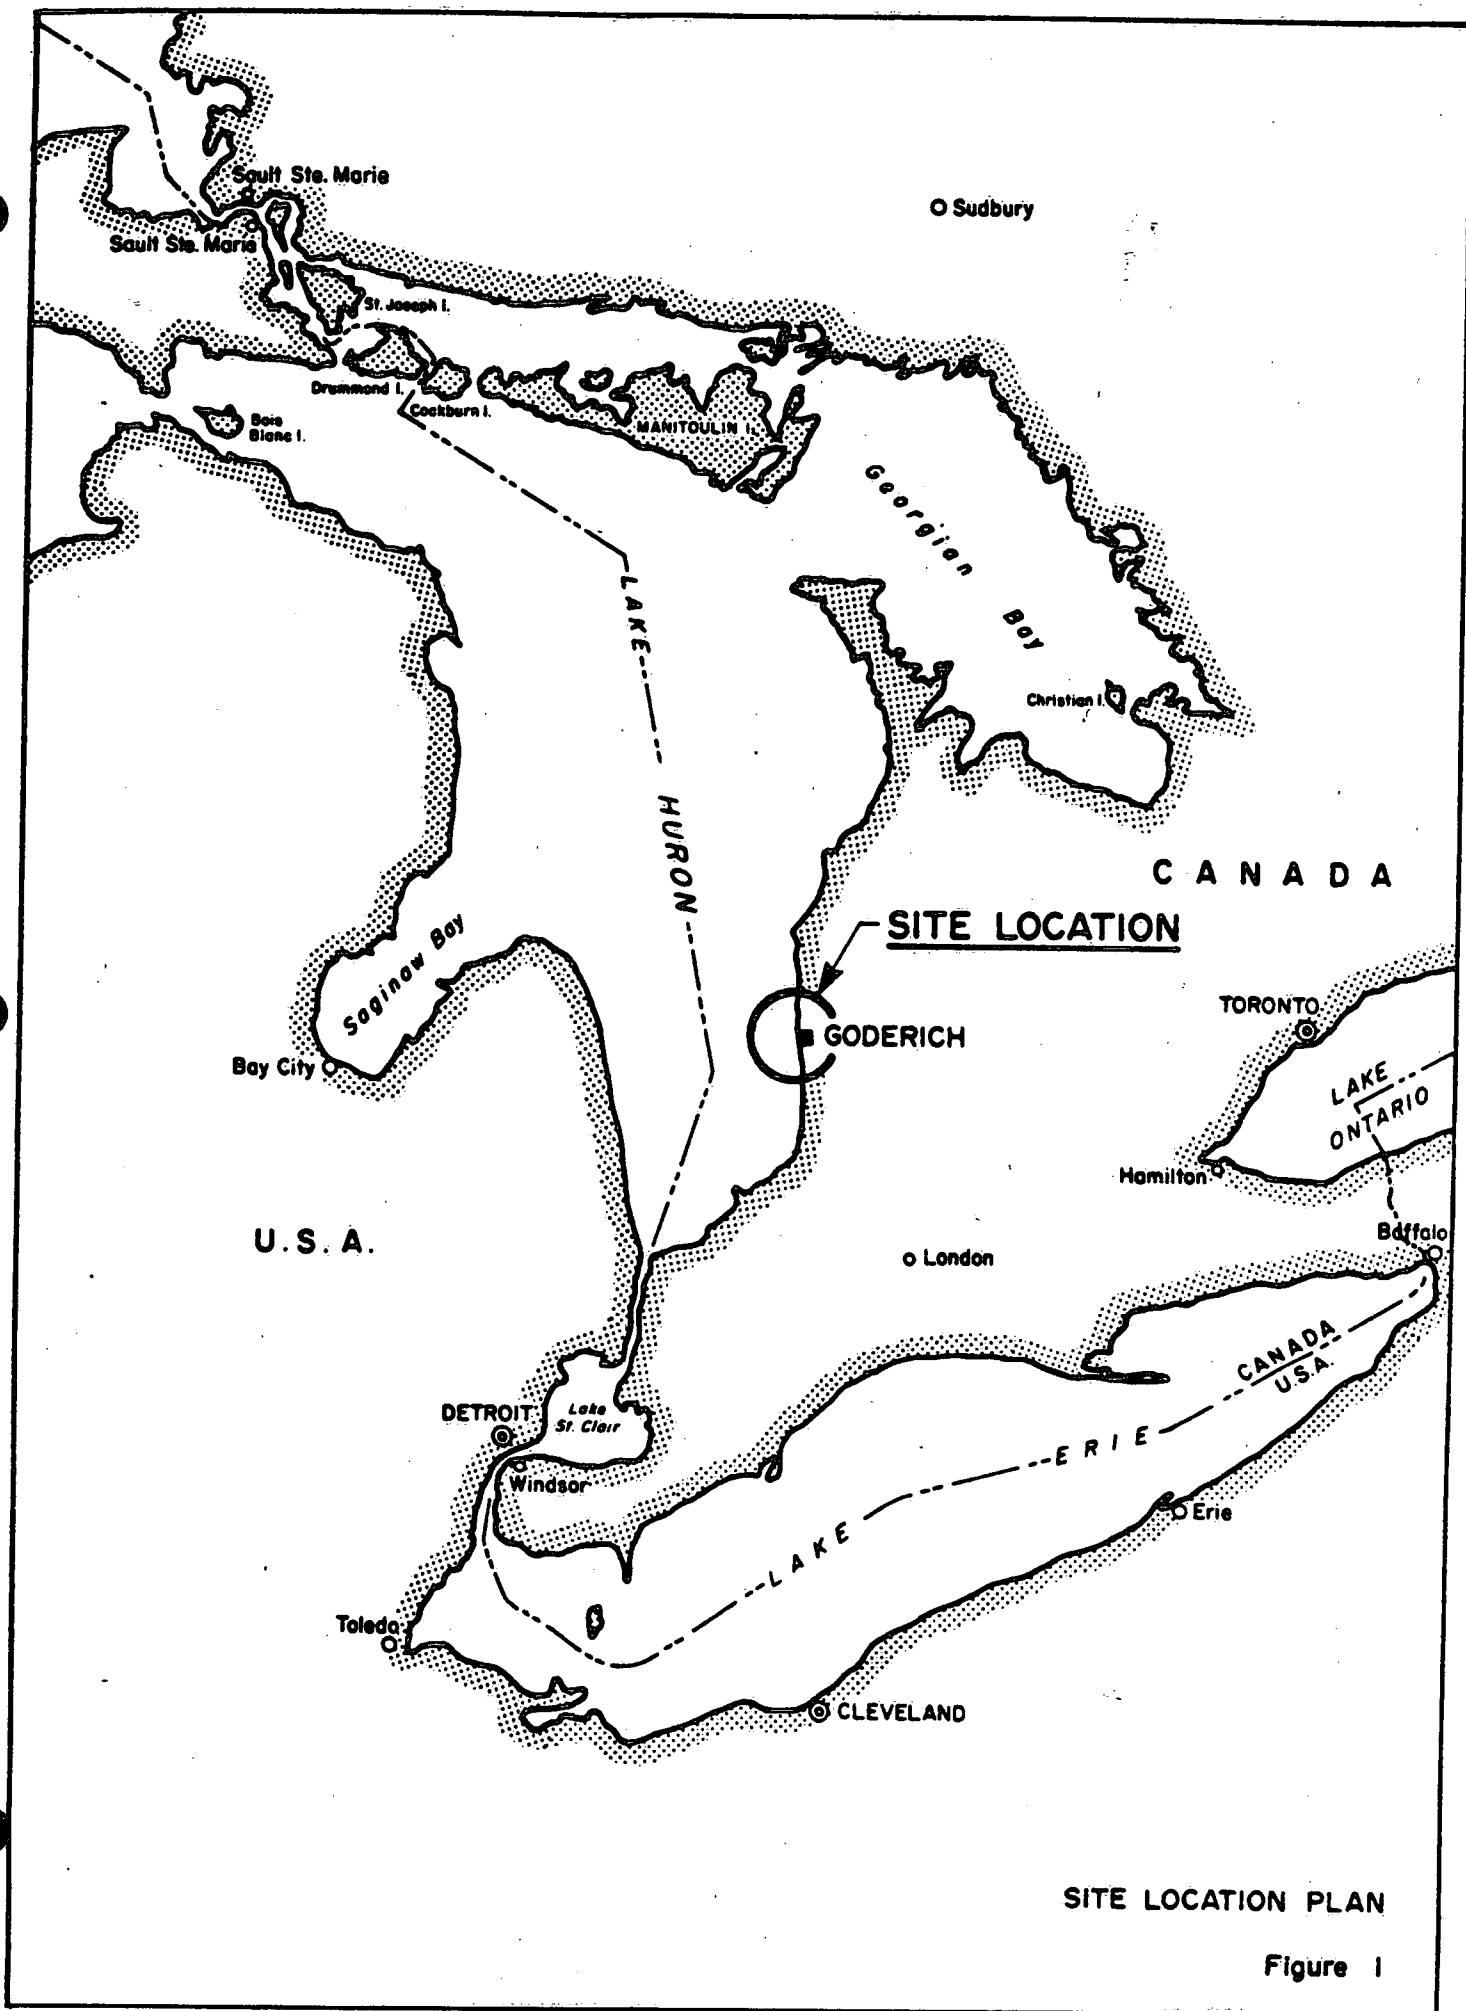
Figure 1

SITE LOCATION PLAN

Transport Canada expanded Goderich Harbour in order to provide a new dock for Domtar Ltd. by having Public Works Canada design and construct a 610 m long rubblemound breakwater in 1984-85 (Figures 1 and 2). Prior to approval of the project, environmental concerns were raised about the possibility of the breakwater causing increased sediment deposition at the mouth of the Maitland River and increased erosion rates south of the Harbour. River mouth deposition might aggravate flooding problems on the Maitland River and might lessen the navigability of the mouth of the Maitland River for pleasure craft. Accordingly, Transport Canada agreed to fund a monitoring programme at Goderich in order to assess the new breakwater's impact on coastal and fluvial processes. Construction of the breakwater began in November 1984 and final armouring was completed in December 1985. By the end of January 1985 the partially built breakwater extended lakeward about half its final length (DPW, Progress Chart, 1985) and can be assumed to have been acting as a substantial, if not total, barrier to the southward littoral drift from that time onward.

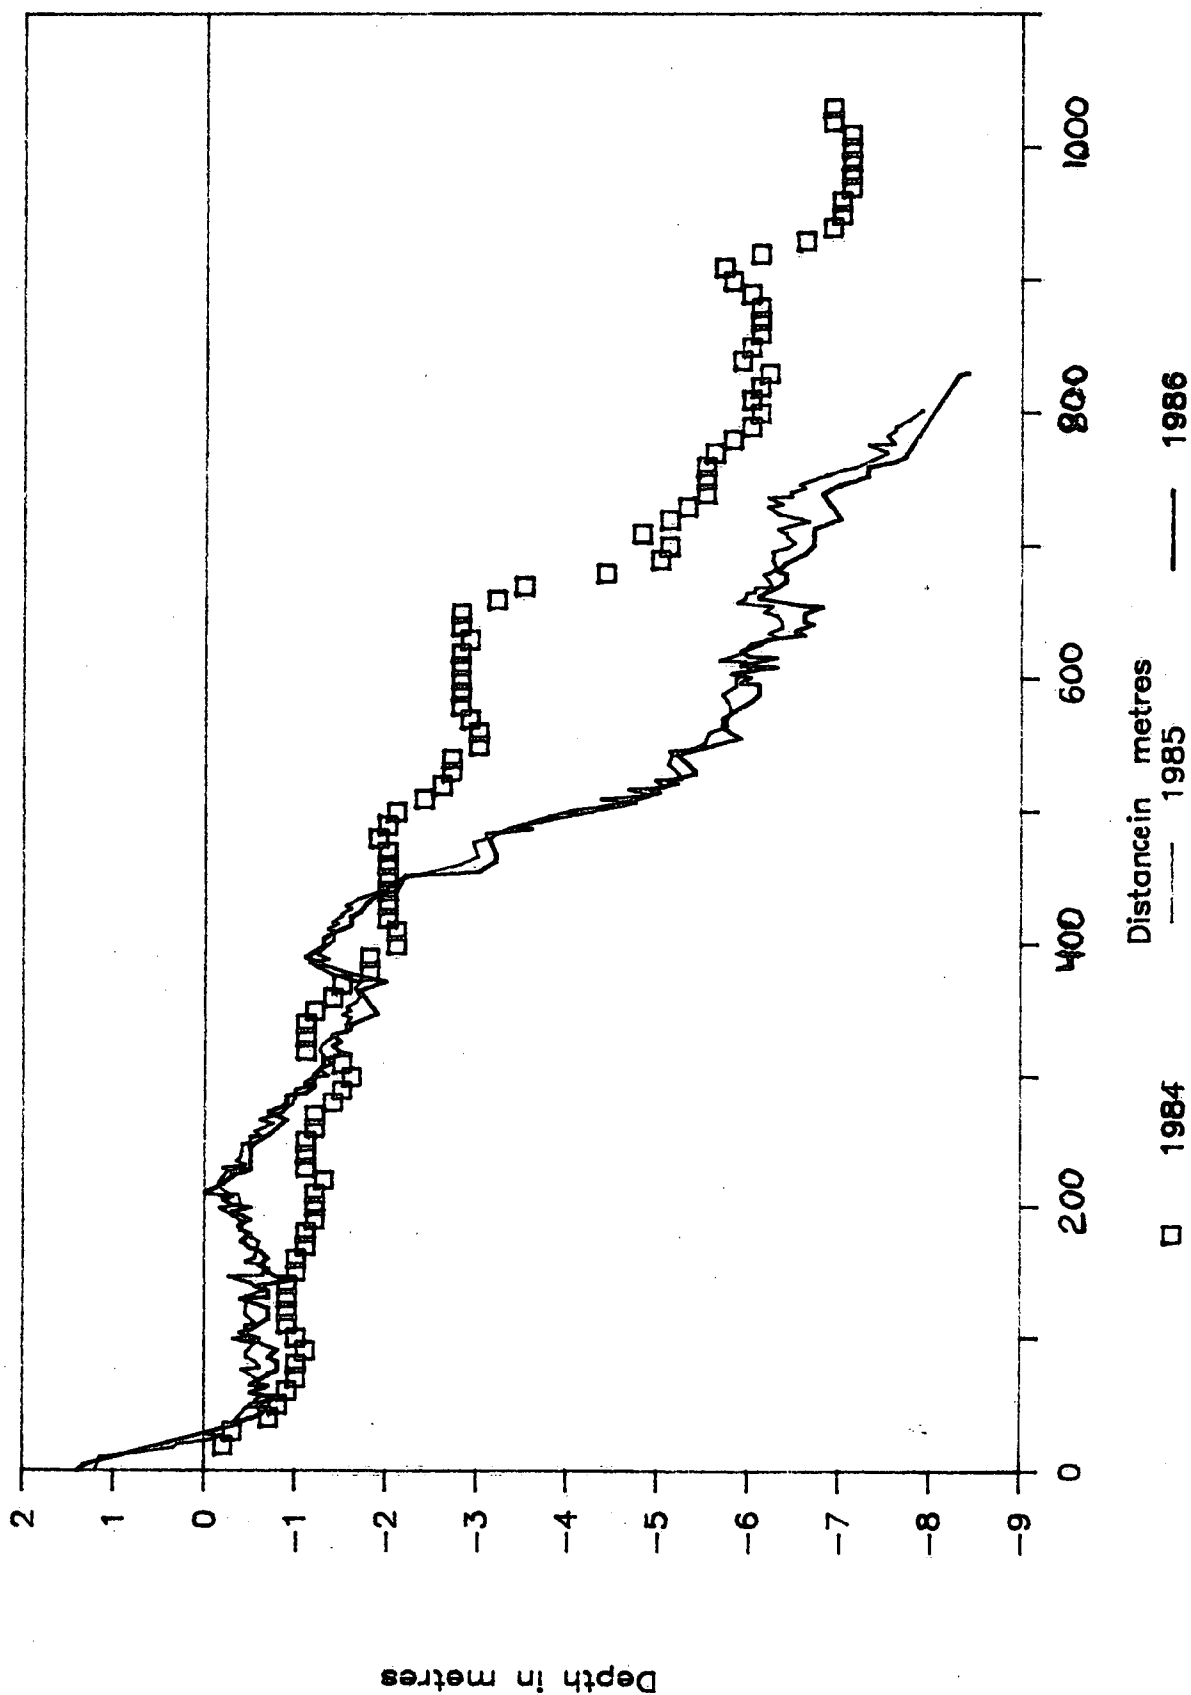
Figure 14. Profile of H90

The 1984, 1985 and 1986 range line profiles are shown in Figures 10 to 14. Differences at profiles H86 to H88 are minor. However, significant differences do appear between PWC and HYDAC surveys for profiles H89 and H90. At these locations the shore perpendiculars are considerably off a due east-west direction. These directional differences are thought to be the reason for the differences in the profiles because no strong trend to erosion or accretion is evident at profiles H86 to H88 where directional differences are minor. This agrees with expectations that the rubblemound breakwater's effect on downdrift erosion should be minimal. Harbour structures existing prior to 1984, plus the dredged entrance channel, probably prevented any sand-sized littoral drift from passing the harbour. Thus, Goderich Harbour, both before and after construction of the new breakwater, can be considered a man-made littoral cell boundary.
