**ICE BREAKUP AND JAMMING IN THE  
RESTIGOUCHE RIVER, NEW BRUNSWICK:  
1987-1988 OBSERVATIONS**

**S. Beltaos and B.C. Burrell**

**NWRI CONTRIBUTION 90-169**

DECEMBER 1990  
NWRI Contribution 90-169

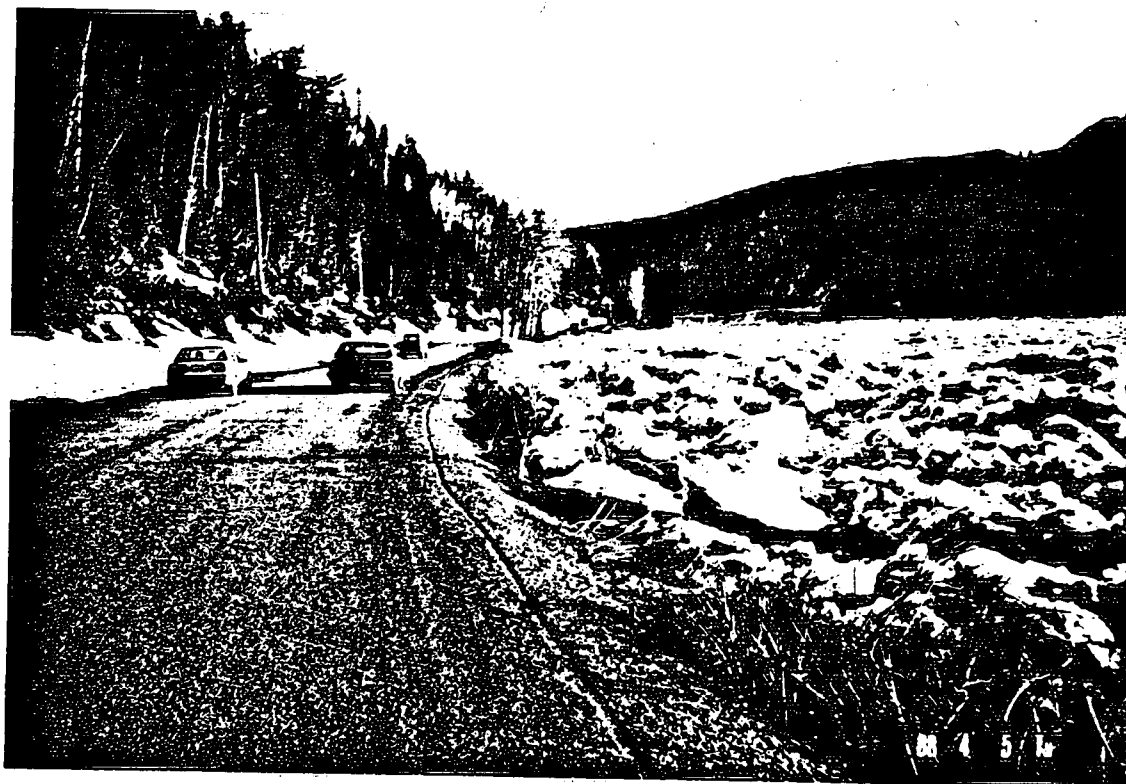
9. April 5, 1850. → u/s from ~ .6 km above toe of jam (location ~ 21.2 km). Note jam threatening road.

While no flooding occurred, the low section of the N.B. river road was not much above the jam level (photo 9). For later reference and survey, a set of "water level" photos were taken; these are views of the ice or water level against identifiable objects on the river banks. Under favourable conditions, the water level can be determined to within a few centimetres.

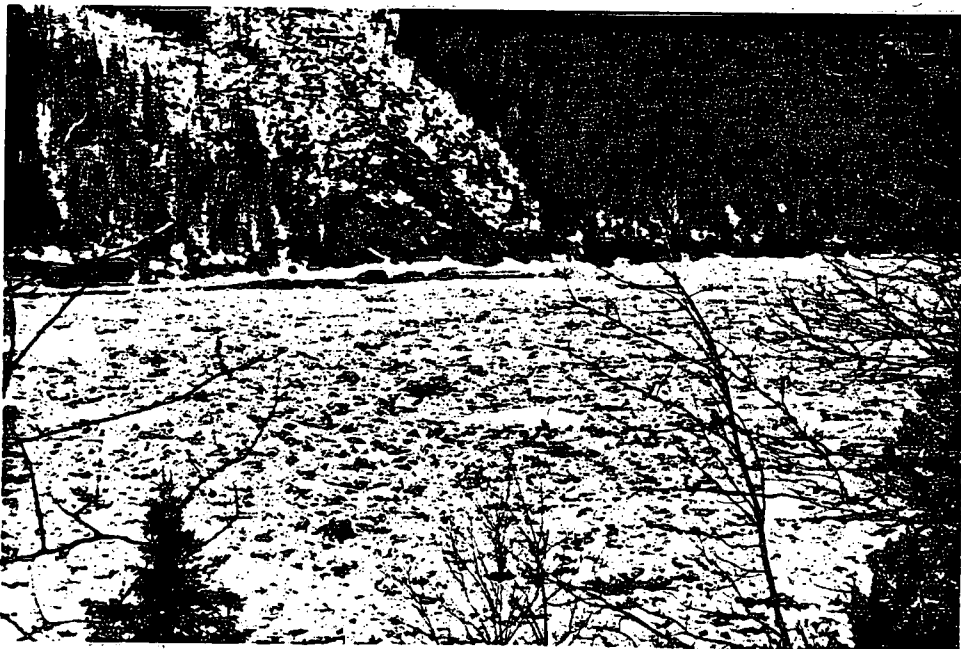
13. April 6, 1020. → RB, slightly d/s of flooded section of N.B. River Rd.

0600-1200: It was reported that the ice ran near Wyer's Brook at a speed of 20 km/h (5.6 m/s), at about 0630. This suggests that a surge went by, most likely caused by the release of an ice jam farther upstream. No significant changes were seen in the ice cover downstream of yesterday's jam except for general enlargement of the open leads. At the toe of the jam, a small lead had developed in the sheet ice cover (photos 10 & 19). This feature is typical of ice jams in large streams. About 400 m above the toe, ice blocks were on the road surface (photo 11) which was flooded 200 m farther upstream. High water marks were visible, about 0.6 m above the prevailing water level, likely a result of the surge mentioned earlier. Photo 12 shows an ice pile near the toe and photo 13 shows flooding of the New Brunswick river road.

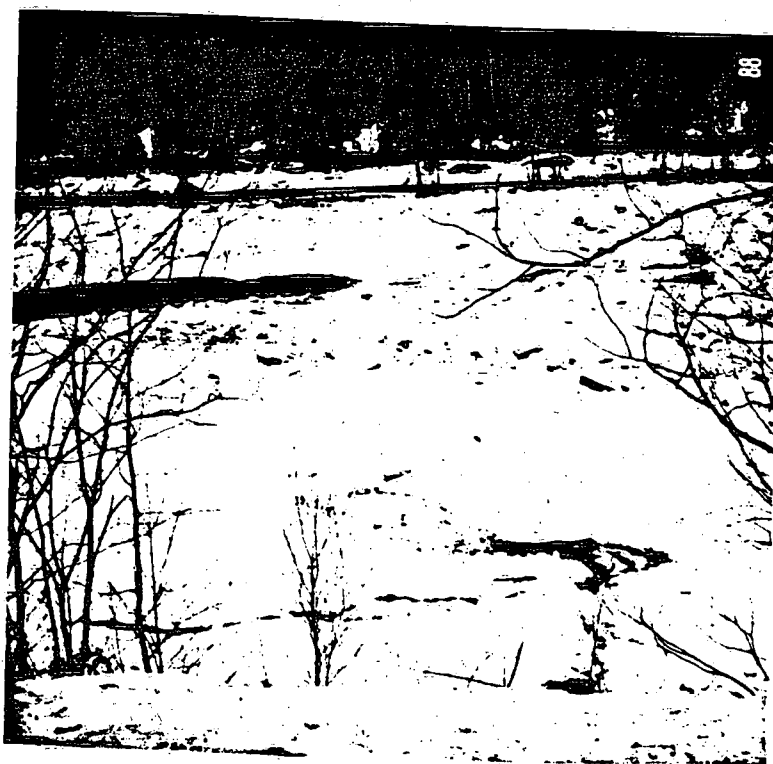
27. April 7, 1020. Restigouche R. → RB at toe of jam. Note enlargement of lead since previous day.

At about 0730, the ice jam consolidated near Wyer's Brook, thus dividing into two jams separated by a short section of open water. The lead at the toe had enlarged and extended into the ice rubble as well (photo 27). The water in the lead was "boiling" while ice blocks from the jam moved infrequently in the lead. At the Matapedia confluence, severe deterioration of the ice was evident. The Restigouche was partly open between the confluence and the railway bridge and fully open between this bridge and the highway bridge. Low sections of the river roads on both banks remained flooded (Ph. 28).

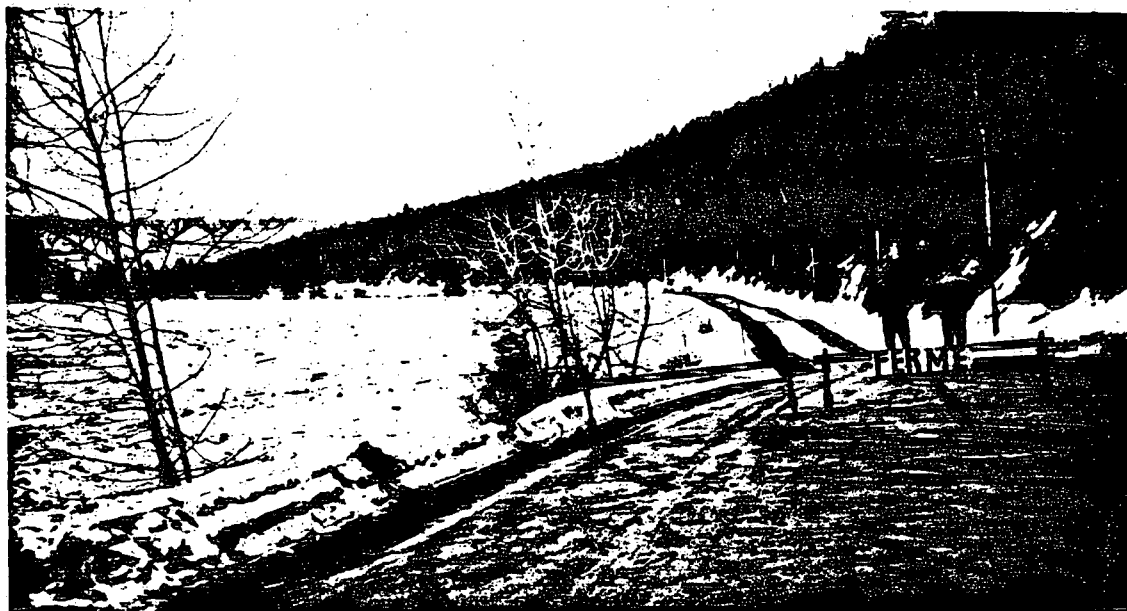
28. April 7, 1030. → u/s; Quebec River Rd. flooded and closed.

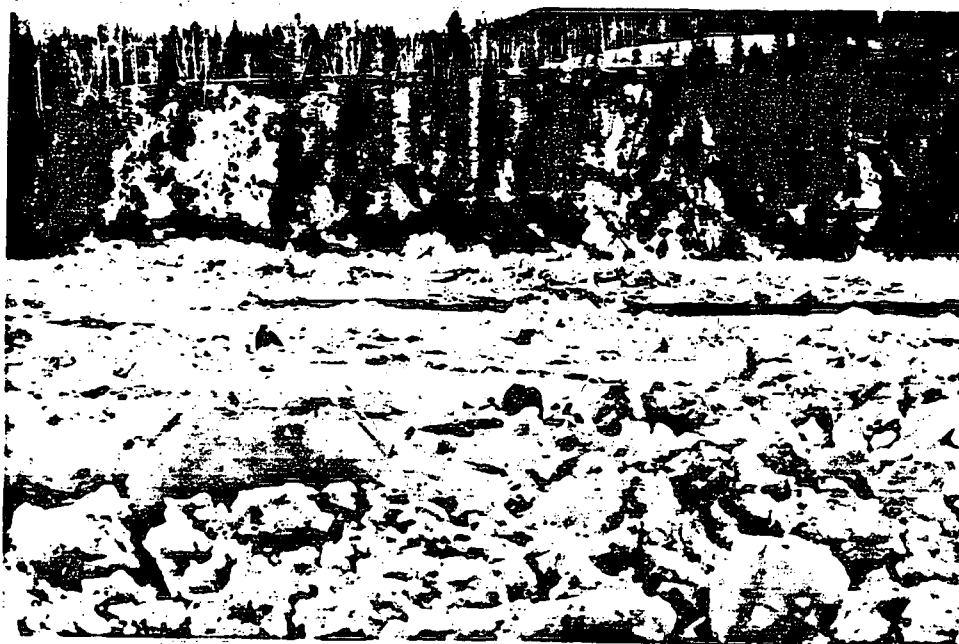
29. April 8, 0923. → LB at toe of jam. Note enlarged lead and ice rubble emerging well above water surface, suggesting that rubble was grounded.

0700-1200: The open water section between the two jams near Wyer's Brook was 400 m long. The lead at the toe of the downstream jam had elongated considerably (Ph. 29 & 30) and joined a much larger lead farther downstream. Open water sections and leads were now more frequent in the sheet ice cover below the jam. The railway bridge was loaded with wagons full of heavy rock, a common practice to prevent movement of the superstructure in case of severe ice jams and runs. The Matapedia river was inspected again and little change was found since the previous day. It was mostly ice-covered except for a 9 km section, starting 4 km below Routhierville and extending upstream. This is well above the mouth. Shear walls were present in this reach, 1.2 m high and comprising ice blocks 10 cm - 30 cm thick.

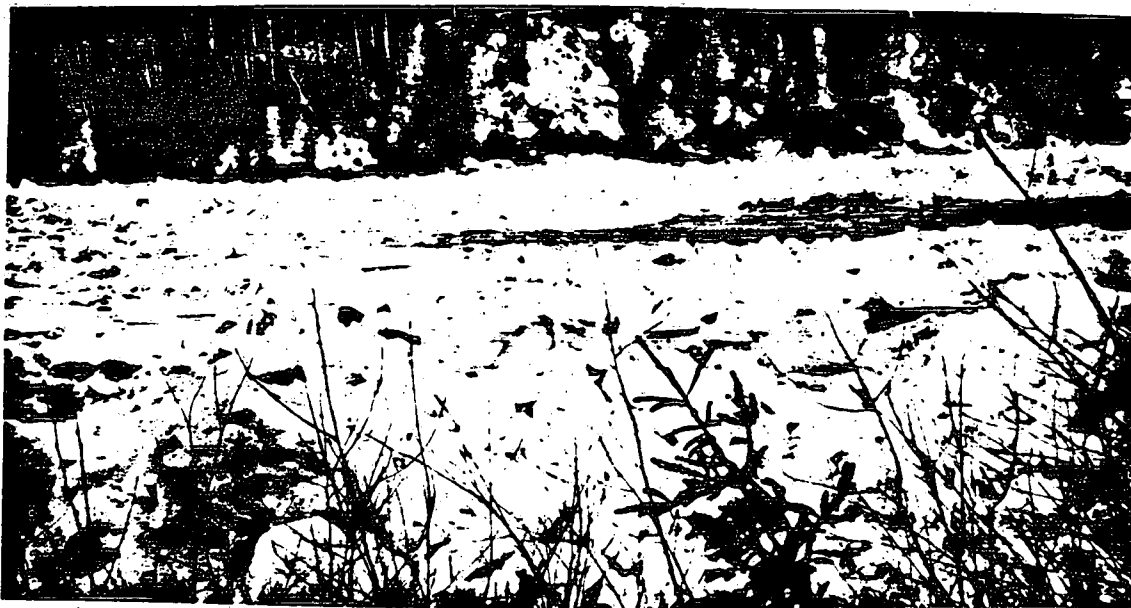
32. April 9, 0900. → LB at toe of jam. Open lead has extended into jam. Ice fragments are carried in lead. Water "boils" visible.

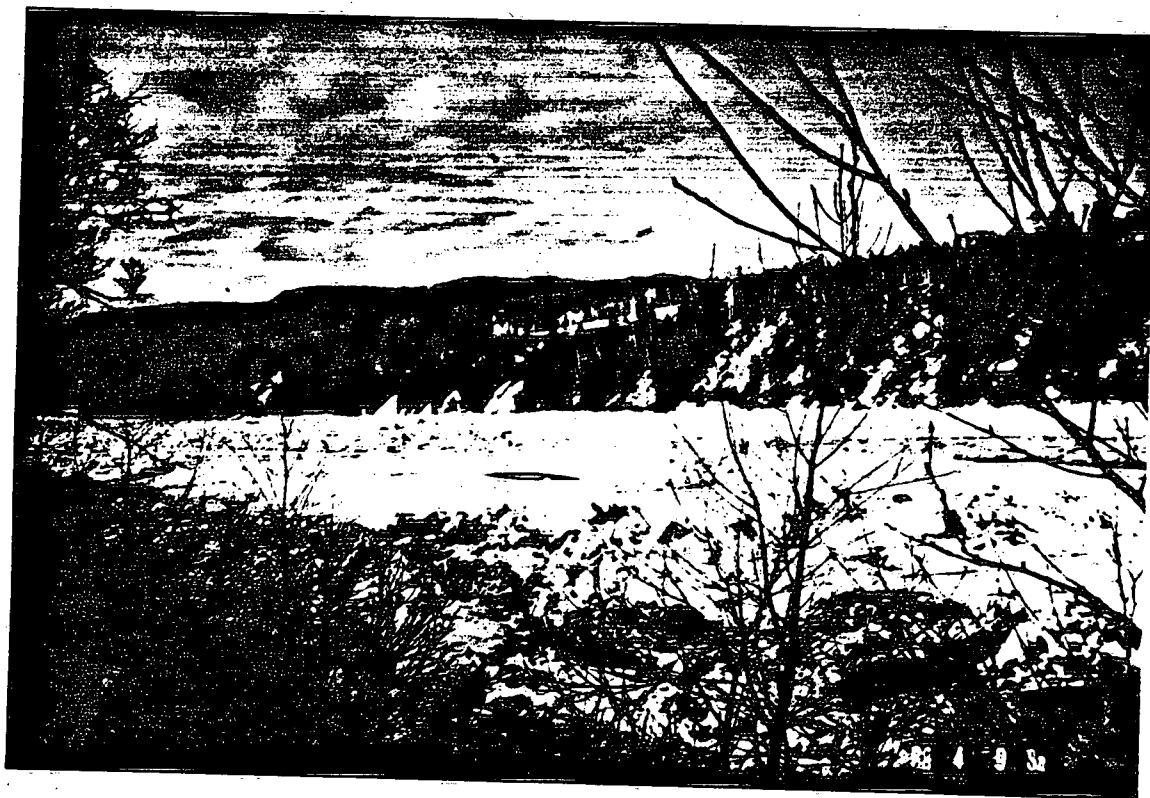
37. April 9, 0945. → u/s, from (former) toe. Release of ice jam. Rubble and sheet ice in motion.

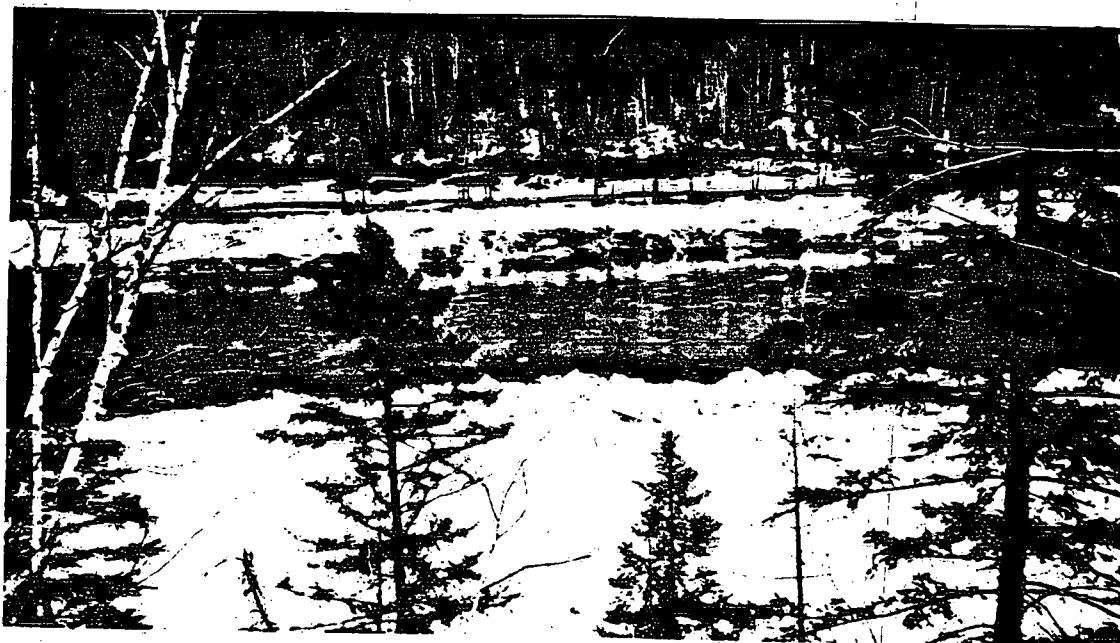
38. April 9, 1430. → RB at (former) toe. Note high shear walls.

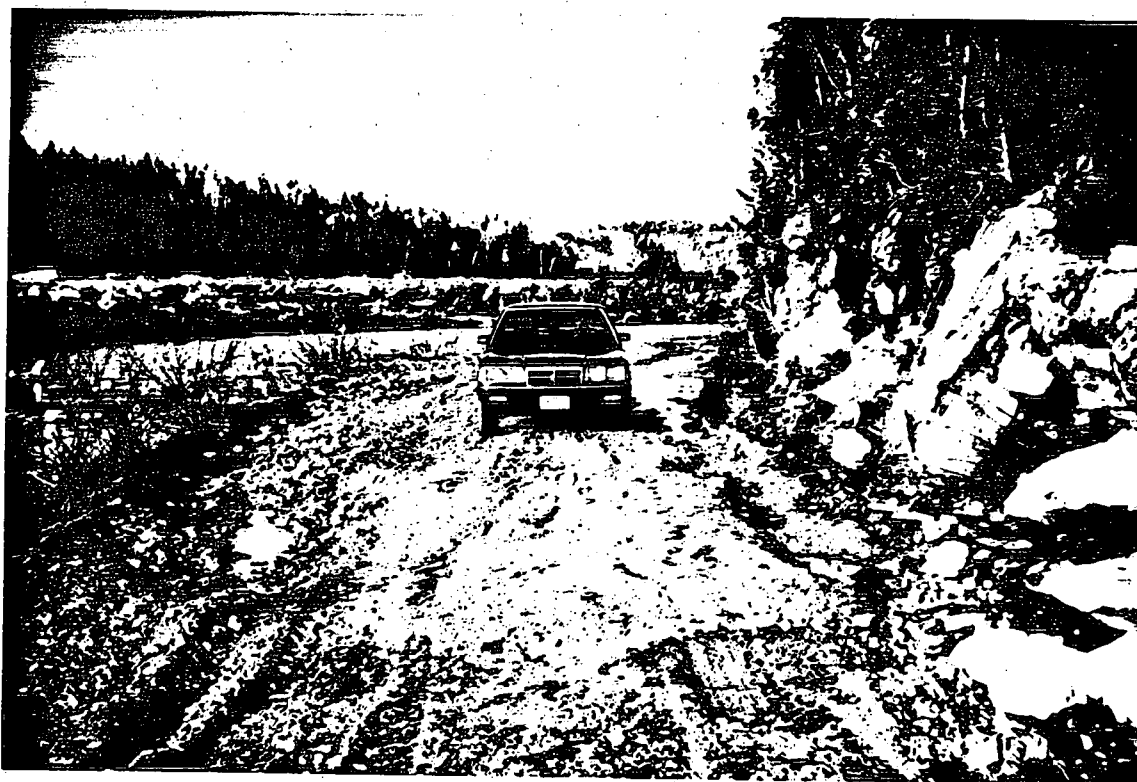
45. April 11, 1800. → d/s near Wyer's Bk. Road damaged by flooding.

No changes occurred overnight, other than consolidation of existing jams. Post-breakup conditions were observed from the air in the afternoon (Ph. 43). The Restigouche, Matapedia, Patapedia and Upsalquitch were completely open except for a small amount of ice rubble in the lower Restigouche, upstream of the sheet ice cover in the wide section starting at Atholville. Evidently, most of the rubble from upstream had been transported under the sheet ice. Shear walls were evident along the Restigouche and Matapedia (Ph. 43, 44) but not in the Patapedia. Ground inspection, revealed some road damage by flooding (ph. 45).
