**COHESIVE PROFILE EROSION BY WAVES**

**C. Bishop, M. Skafel and R. Nairn**

**NWRI Contribution No. 92-24**

This paper was presented at the 23rd International Conference on Coastal Engineering held 4-9 October 1992 in Venice, Italy. This NWRI version is made available prior to publication of the Conference Proceedings.

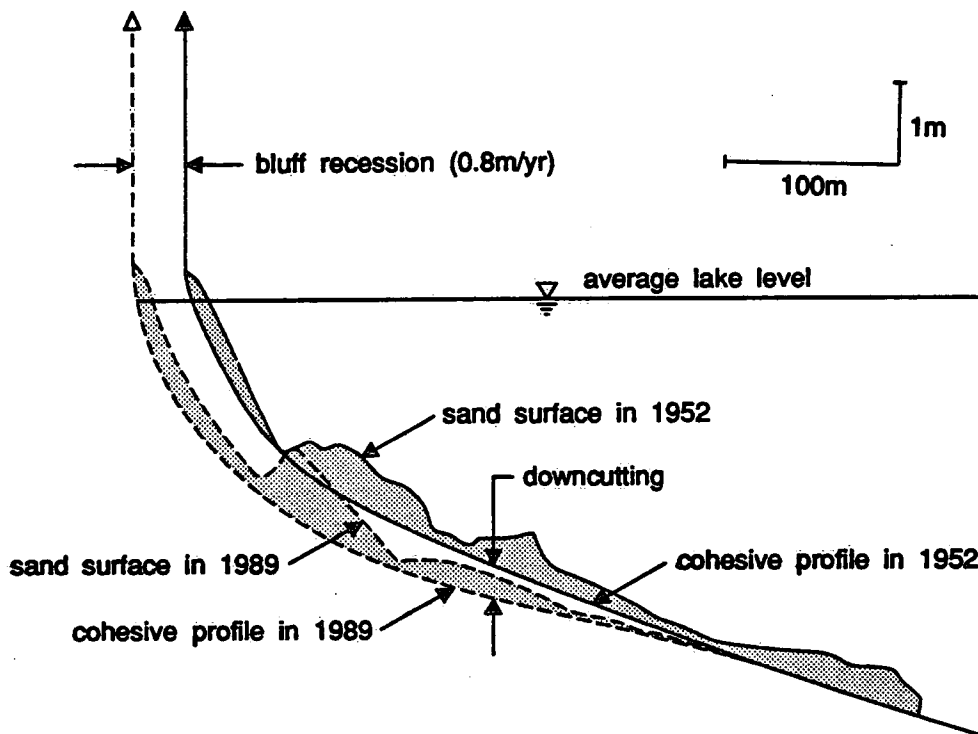
Fig. 1 Lake bottom and till profiles in 1952 and 1989 at Scarborough Bluffs, Lake Ontario (after Nairn, 1992).

The erosion process on a cohesive coast can be demonstrated by a comparison of two cross-sections of a bluff and nearshore profile at a site in Lake Ontario (Nairn 1992). Figure 1 shows the estimate of the underlying cohesive profile and the sand cover in 1952 and again in 1989. The bluff face has receded about 30 m over this 37 year period for an average recession rate of 0.8 m/yr. In order for this to occur, the nearshore lake bed had to be downcut considerably. Furthermore, the profile shape in 1952 is very similar to that in 1989; it has simply shifted shoreward by 30 m. In a review of many field data sets throughout the Great Lakes, profiles were generally found to retain their shape as they receded (Nairn 1992). There appears to be an equilibrium or preferred cohesive profile shape.

The mean water level was raised again to 95 cm and 50 h of waves were run without adding any sand. Fig. 13 shows the beginning and end profiles, and the erosion rate, for TS4 after 400 h (of the series of four water levels). The profile has shifted shoreward and has steepened slightly at its top end. The erosion rate starts near zero around the highest mean water level, quickly reaches a maximum near the dominant plunge point of the breakers at the highest mean water level, then decreases quite uniformly in the offshore direction. These trends agree with the field results depicted in Figure 1.
