RIDLEY ISLAND PORT CONSTRUCTION ACTIVITIES - 1982

Background and Environmental Monitoring

Regional Program Report No: 83-02

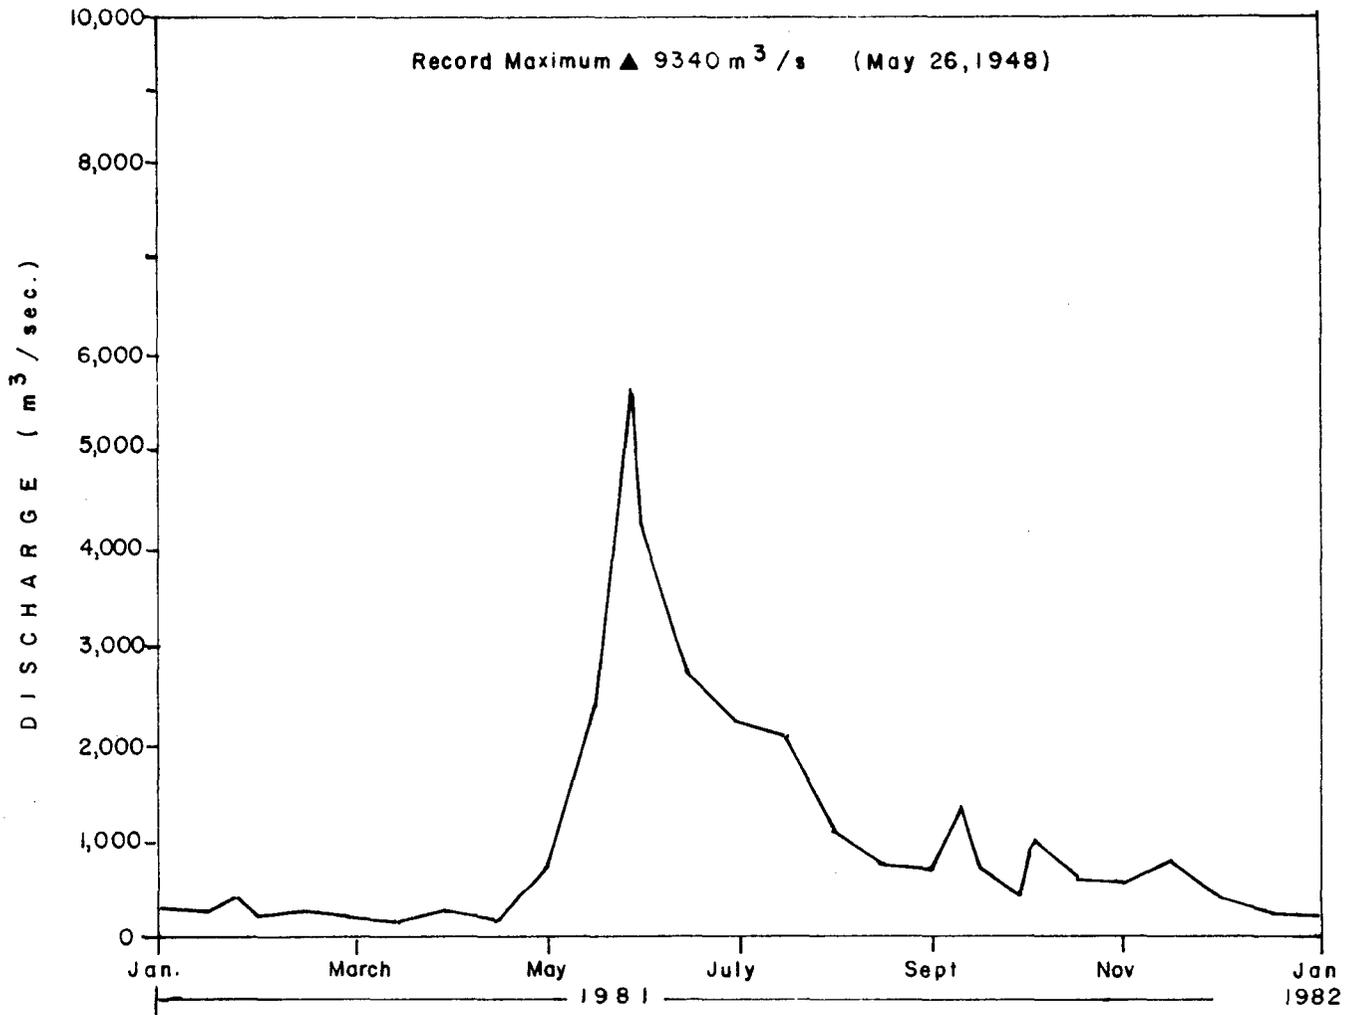
FIGURE 4 SKEENA RIVER HYDROGRAPH AT USK - 1981
(Data adapted from Inland Waters Directorate,
Environment Canada)

The Skeena is one of the principal rivers of British Columbia in terms of drainage area, discharge and sediment load. Figure 4 shows the discharge hydrograph for the river at Usk (upriver from Terrace) for 1981, a fairly typical year. The annual runoff peak occurs in May or June as a result of snowmelt. Usually there is a smaller autumn peak which is caused by heavy rainfall. Except in the form of snow, there is little in the way of storage capacity in the Skeena River system. The average annual discharge at Usk is about 900 m³/s. The minimum recorded flow is 52 m³/s. The median annual flood peak is 4730 m³/s., while the flood peak in 1948, the highest recorded, was 9340 m³/s. Obviously such large variations in flow directly affect the volume of freshwater and river-borne sediment present in the Skeena Estuary.

Mean Discharge 925 m³/s
Maximum Daily 5600 m³/s on May 27, 1981
Minimum Daily 186 m³/s on March 14, 1981
Total Discharge 29,200,000,000 m³

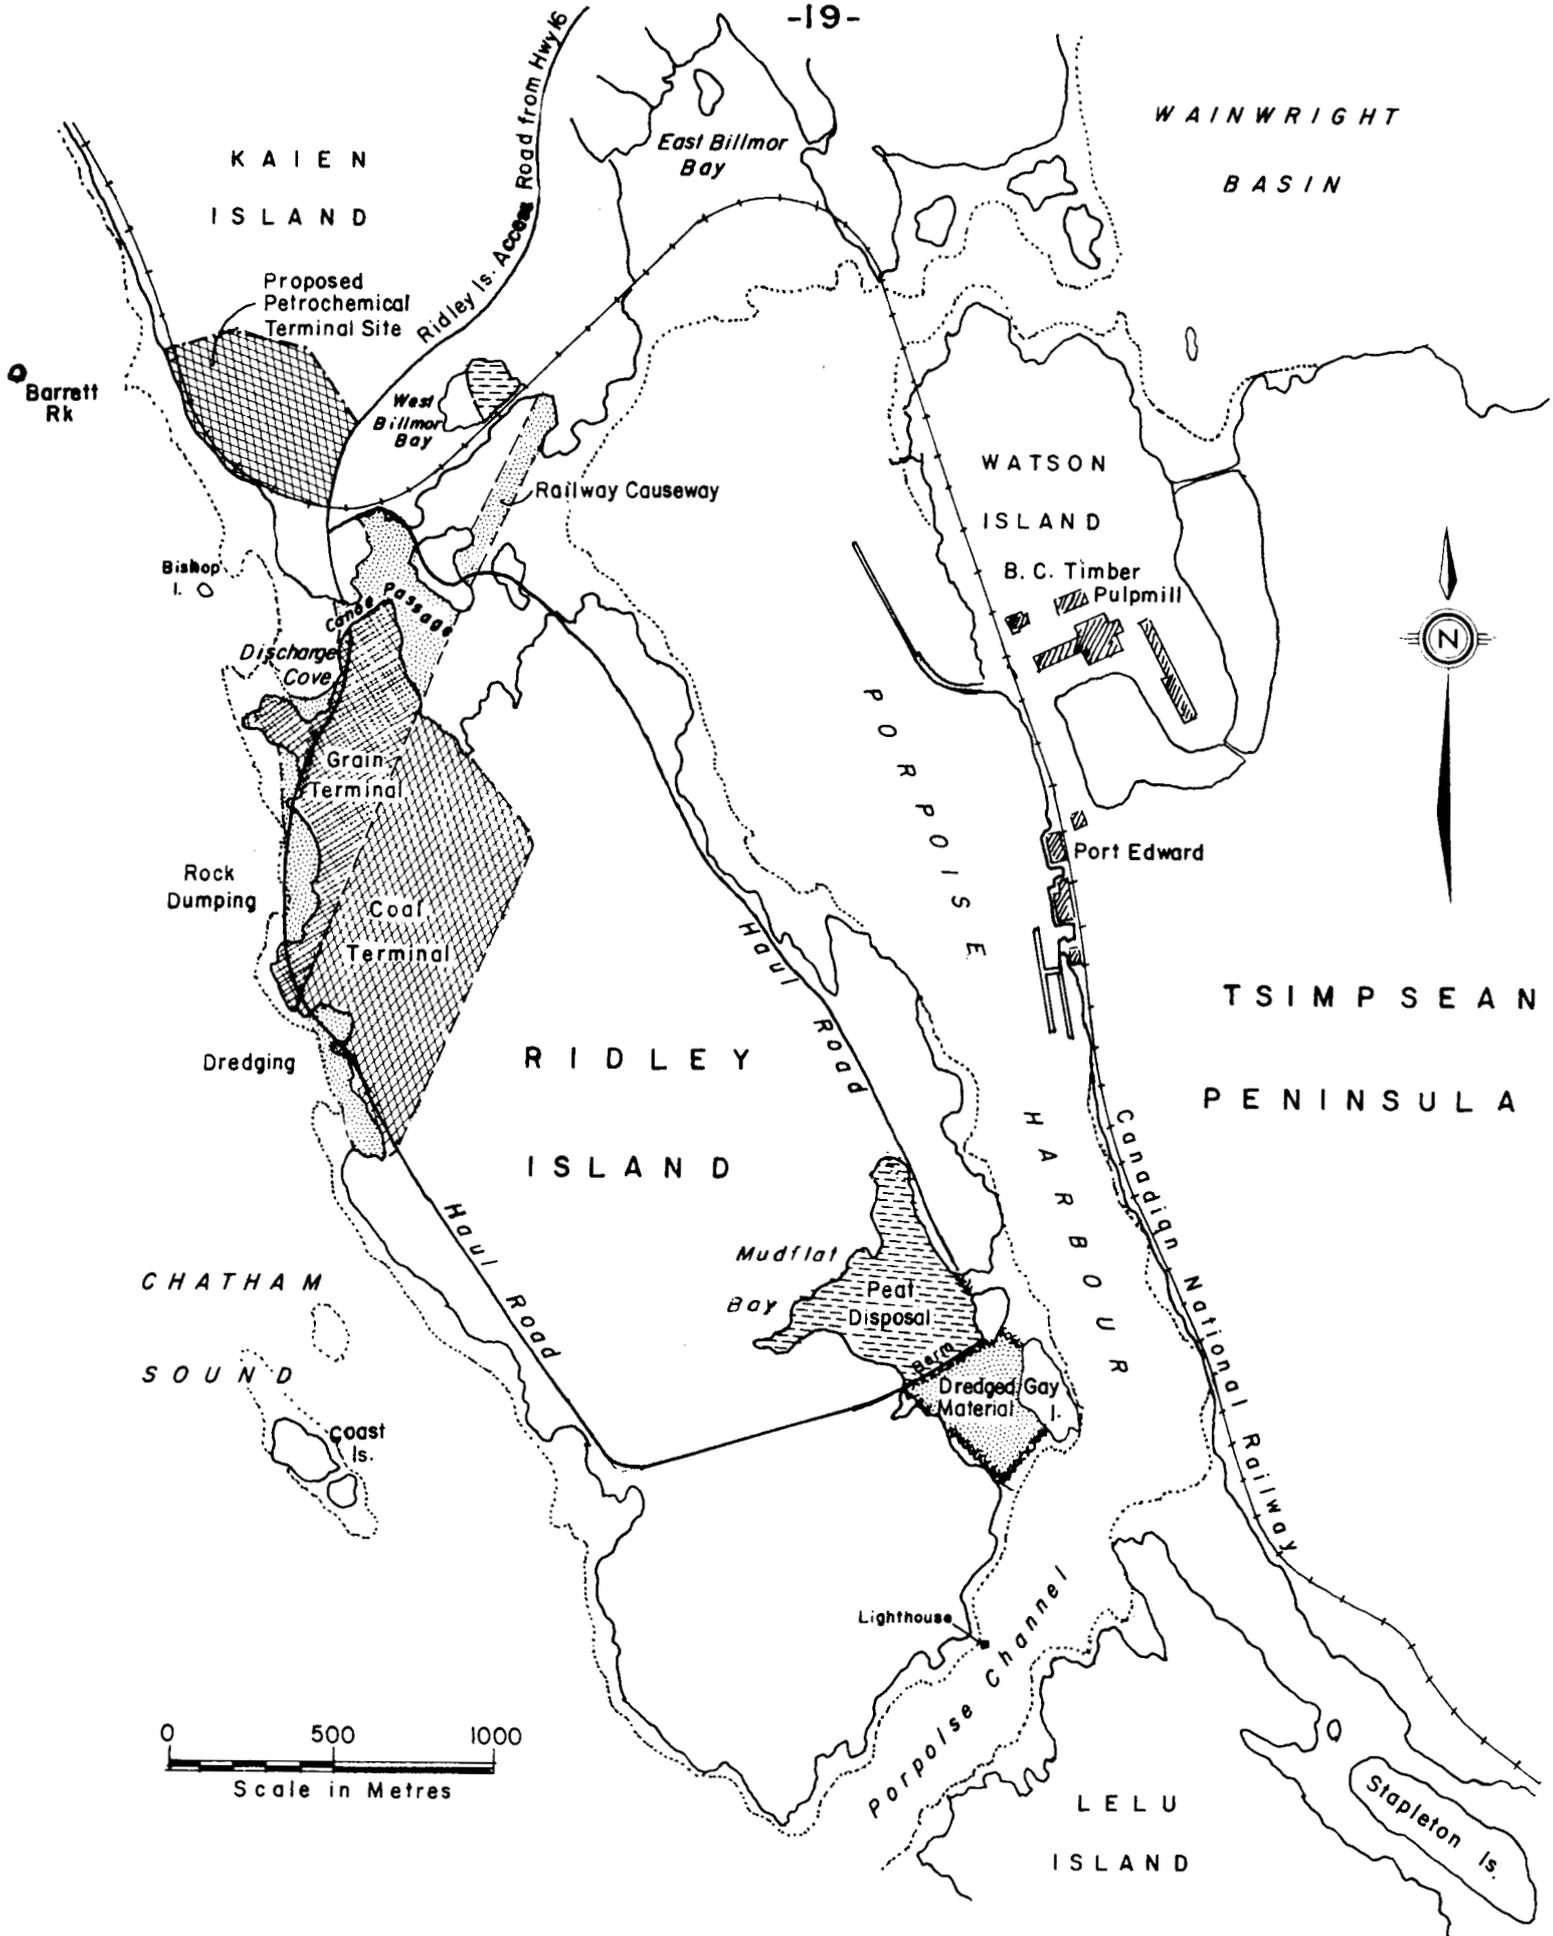
FIGURE 5 RIDLEY ISLAND CONSTRUCTION SITUATION - 1982

At the southern end of the causeway is the grain terminal site (Figure 5). It occupies a 15 ha site and 2 ha waterlot on northwestern Ridley Island. It is due to be completed by December 1984 and is designed to export 3 million tonnes of grain per annum. During the first half of 1982 site grading work was in progress but a labour dispute stopped work during the latter part of the summer. The coastal indentations on the western side of the grain terminal were being "straightened" by construction of a new haul road between the headlands.

Between southern Kaien Island and northern Ridley Island a railway causeway was being constructed. It will carry about 20 tracks when completed. Construction of the road and rail causeways has closed off Canoe Passage. Peaty overburden has been dumped into West Billmor Bay also (Figure 5).

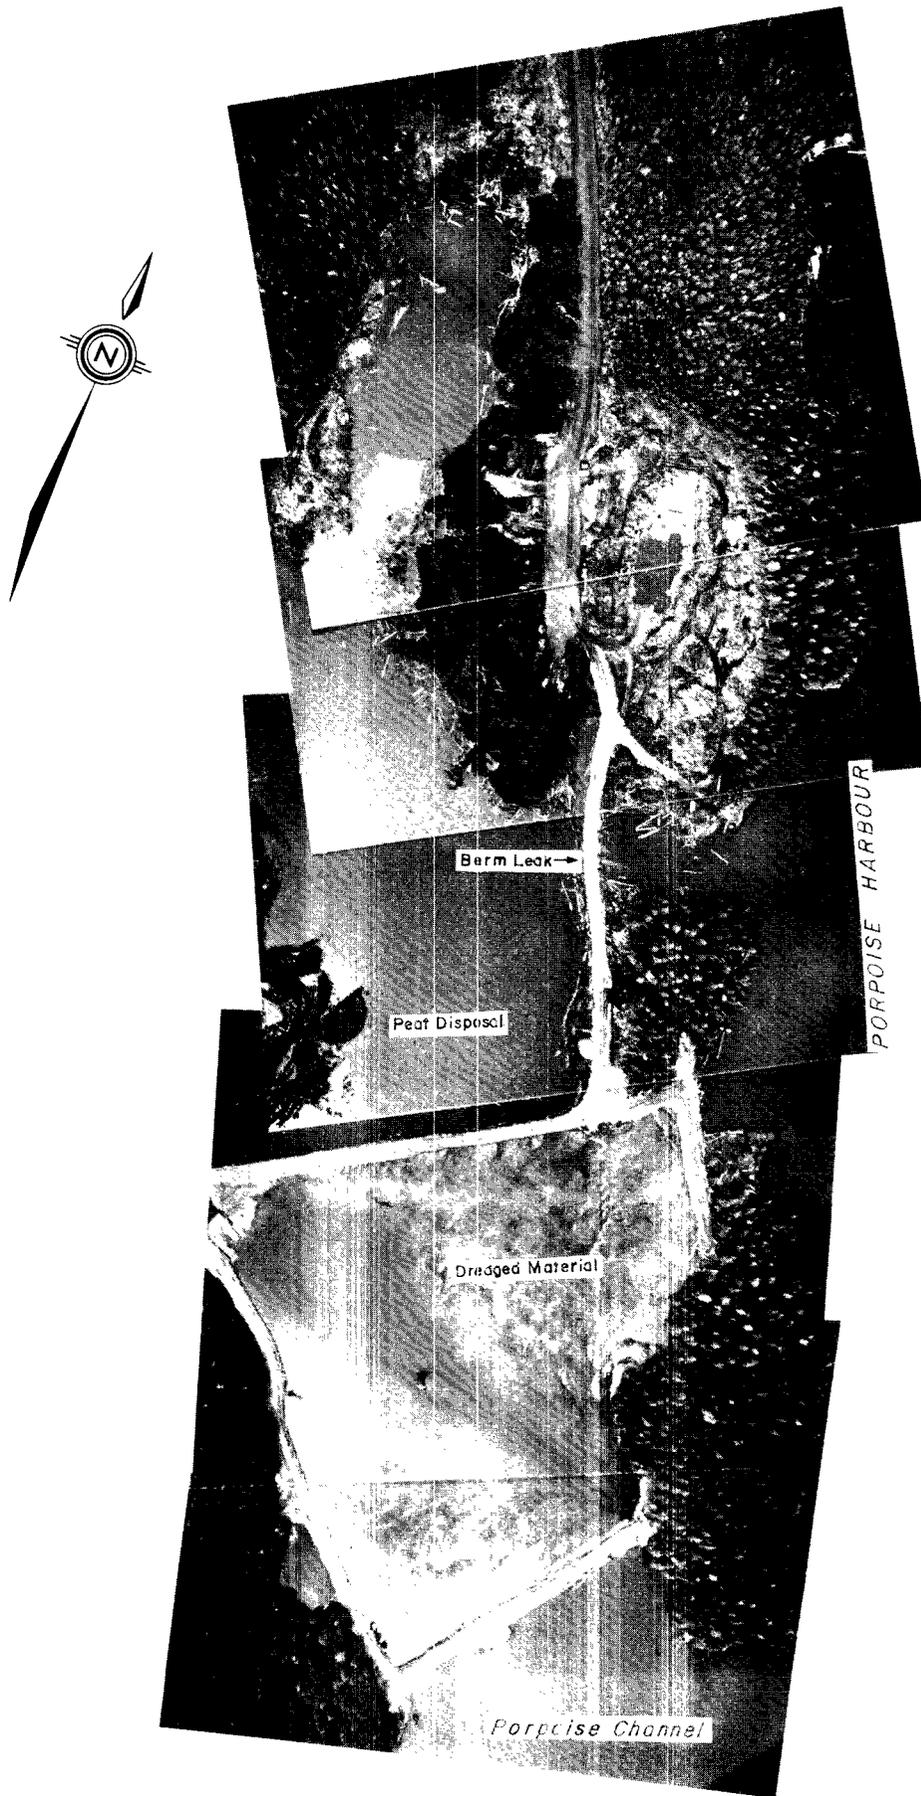
PLATE 4

AERIAL VIEW OF PEAT AND DREDGED MATERIAL CONTAINMENT AREAS

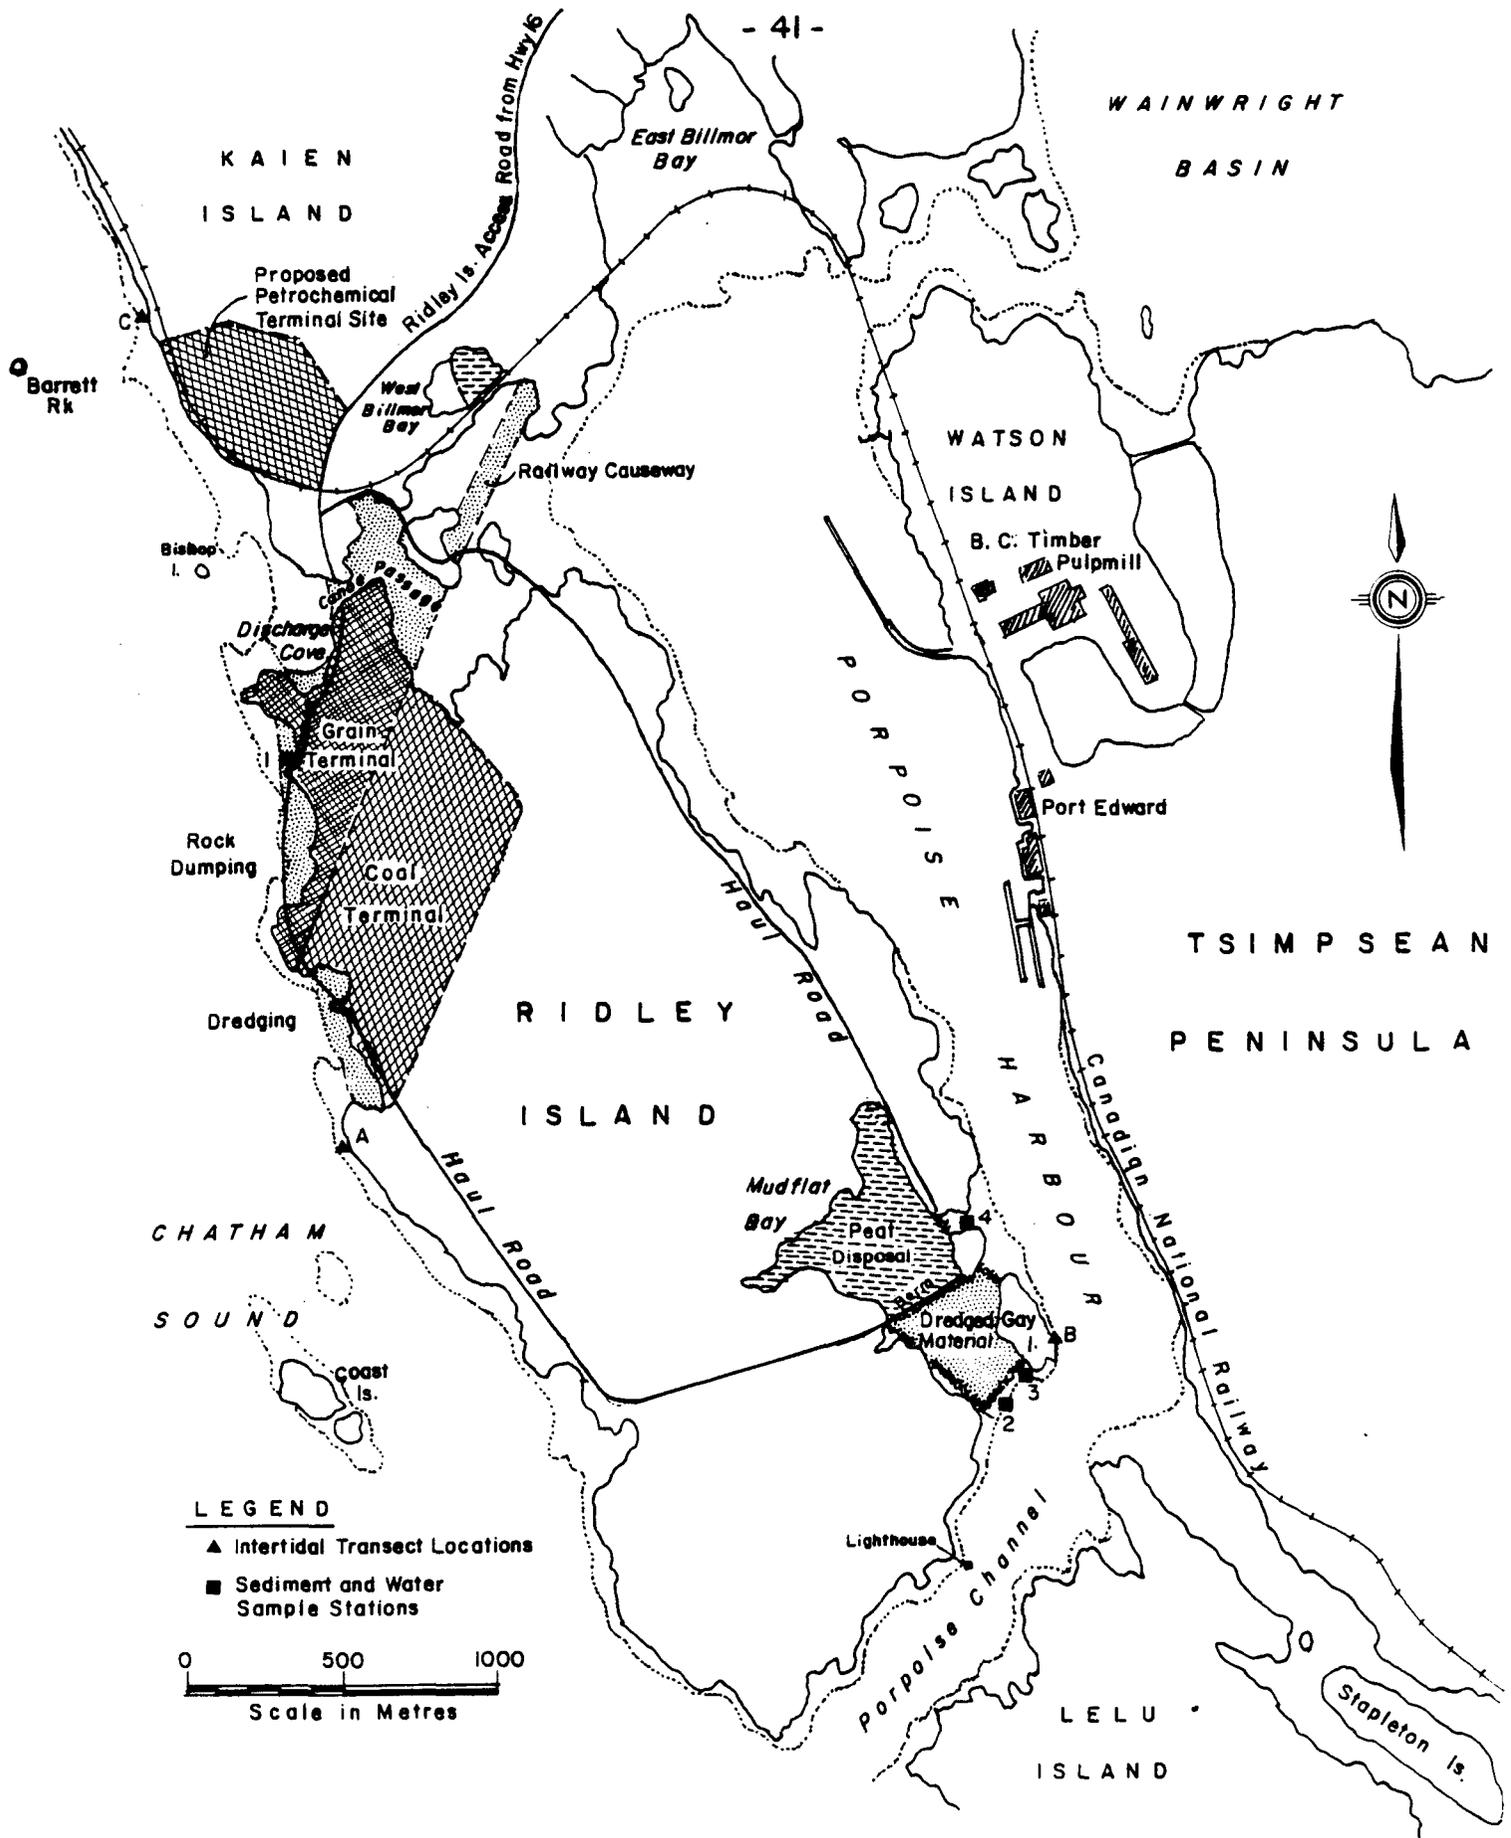
FIGURE 7 INTERTIDAL TRANSECT LOCATIONS AND SEDIMENT AND WATER SAMPLE STATIONS

Intertidal transect "A" was located on the west coast of Ridley Island (see Figure 7), at a point just south of the coal terminal construction site, in an area untouched by construction activities. The site was chosen to be useful in gauging the effects that infilling the coastal indentations will have on adjacent areas and, in addition, for comparing the species colonizing the new intertidal zone with the pre-existing one. The area chosen had a large number of individuals from diverse species (see Table 2).

Intertidal transect "B" is situated on the east coast of Gay Island on Porpoise Harbour. Overall diversity and numbers appeared low as compared with transect "A". This may be the result of the pulpmill effluent which is discharged into Porpoise Harbour.
