Environmental Surveillance in the Vicinity of the Canadian Cellulose Co. Ltd. Pulpmill at Prince Rupert, British Columbia.

Surveillance Report
EPS 5-PR-77-8

Pacific Region
May, 1977

G.A. Packman

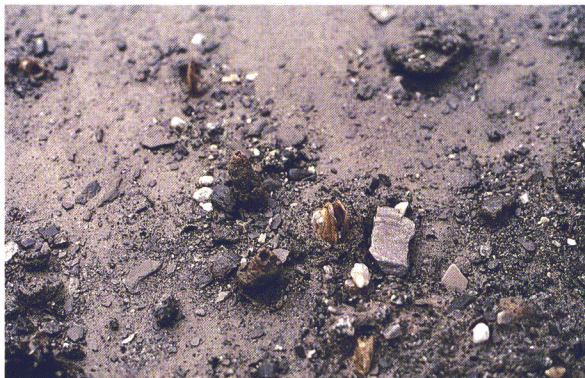
"Discharge Cove", the first area examined was characterized by an appearance of almost complete sterility. The infaunal organisms had been killed but had not decayed in the least, suggesting that microbial populations had been eliminated as well (Plate 1). While the rocks were completely bare, some of the mud flats were covered with a thin layer of fibre (Plates 2 and 3). Below the surface of the flats, the sediments were composed of black hydrogen sulphide ooze indicative of strongly reduced conditions. Approximately 100 metres away from the outfall along the southerly shore, the rocks became coated with an orange ooze probably containing bacterial and/or algal slimes and the calcareous remains of barnacles were observed (Plate 4).

Plate 1. Discharge Cove. Close-up of dead bivalves on mudflat.

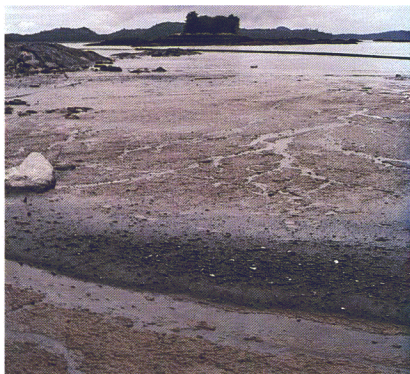
The benthic grab samples obtained revealed no extensive spreading of pulpwood fibre into Chatham Sound. Fibre was observed to cover some portions of the intertidal zone in "Discharge Cove" and some fibre was obtained in the sample from Station DC-1; however, there was no evidence of fibre or reduced sediments in Chatham Sound itself.

Plate 2. Tidal Flats in Discharge Cove showing fibre deposits.

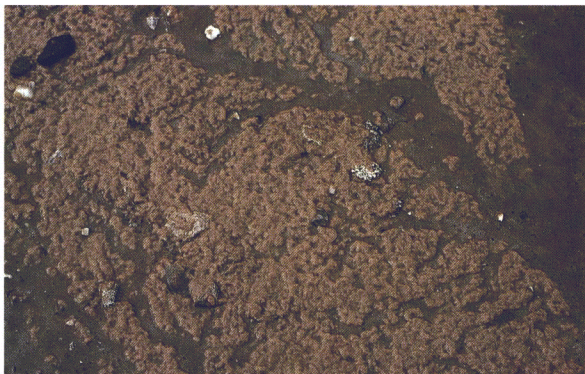
Plate 3. Close-up of fibre deposits on Discharge Cove tidal flats.

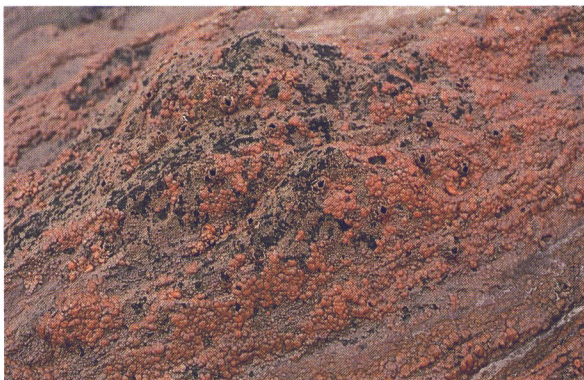
Plate 4. Discharge Cove Entrance. Close-up of slime showing dead barnacle shells.

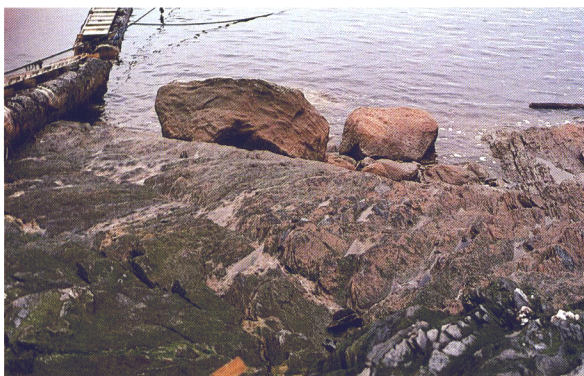
At Station 2 (Landing Point) the coating of orange slime came to an abrupt end, being replaced by patches of chlorophytic algal growth (Plate 5). A short distance south of this point, stunted growths of Fucus sp. were noted. Also noted were growths of Enteromorpha sp. and small populations of Littorina sp., Balanus sp., Acmaea sp., and Gammarid amphipods. However, at the time only 50% of the barnacles (Balanus sp) were found to be alive. It was noted that the live barnacles and limpets possessed extremely soft shells, presumably the result of the effects of the spent sulphite liquor discharge. Large populations of polychaetes (Capitella sp.) were also observed, underneath loose rocks.

Plate 5. Discharge Cove Entrance. Transition from orange slime to unicellular Chlorophyta.

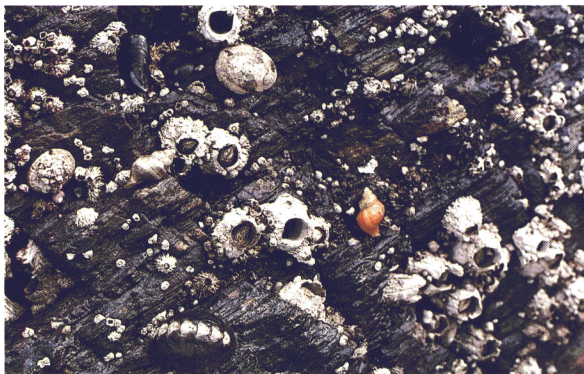
Plate 6. 0.8 km south of Discharge Cove showing the naturally diverse faunal composition.

At Station 4, 0.5 nautical miles (912 m) south of "Discharge Cove", the biotic communities appeared typical of a natural environment, (Plate 6). Appendix III summarizes all species found.
