# GemEng Lightweight Fireproof Boom: Oil Containment Testing at OHMSETT

Technology Development  
Report EPS 4-EP-83-5

Environmental Protection Programs Directorate  
November 1983

EPS 4-EP-83-5  
November 1983

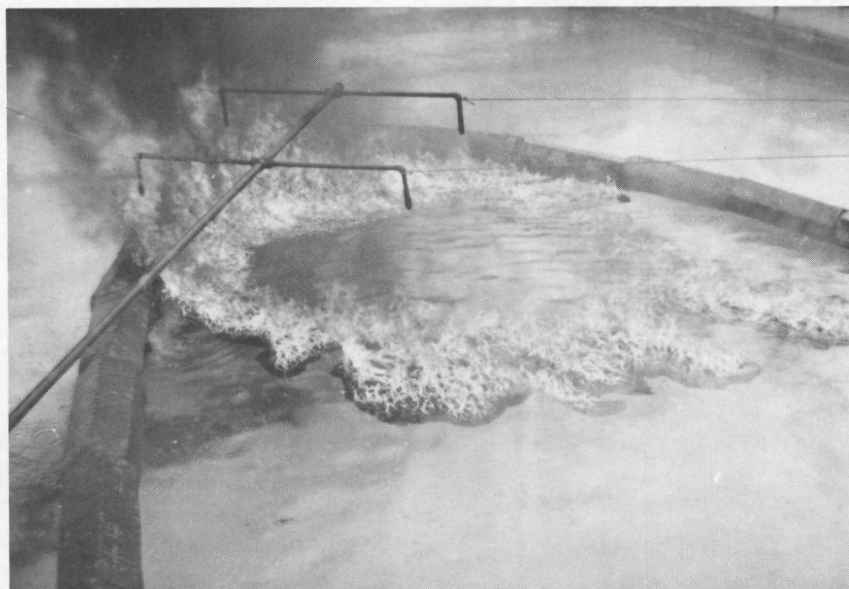
FIGURE 10

**GEMENG BOOM UNDER FIRE DURING TEST 21R**

The boom is being towed at 0.25 kn in calm water. The circular flames in the foreground resulted from the ignition of a bucketful of Murban crude oil added during the test. This was the longest test run with burning oil, lasting 7 min 25 s.

During the high speed fire test, the Murban crude oil was entrained and lost by the boom. The entrainment on the high speed tests looked about the same as the tests with the Circo oil. Burning oil was also lost through the ball and socket joints. This oil continued to burn close to the rear boom face (within about 1 metre). When resurfacing entrained oil encountered this oil, it too was ignited. Figure 10 shows the boom during the second fire test.

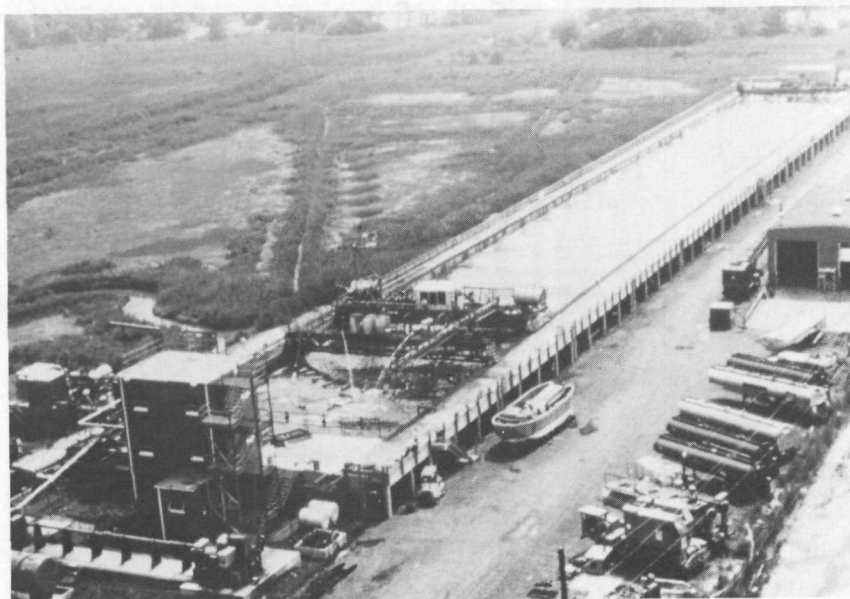
The U.S. Environmental Protection Agency operates the Oil and Hazardous Materials Simulated Environmental Test Tank (OHMSETT) located in Leonardo, New Jersey. This facility provides an environmentally safe place to conduct testing and development of devices and techniques for the control and cleanup of oil and hazardous material spills.

The primary feature of the facility is a pile-supported, concrete tank with a water surface 203-m long by 20-m wide and with a water depth of 2.4 m. The tank can be filled with fresh or salt water. The tank is spanned by a bridge capable of exerting a horizontal force up to 151 kilonewtons while towing floating equipment at speeds to 3.3 m/s (6.5 kn) for at least 40 seconds. Slower speeds yield longer test runs. The towing bridge is equipped to lay oil or hazardous materials on the surface of the water several
