ISSUE 1, 2018

Flight Comment

Crash Scene Hazard Management

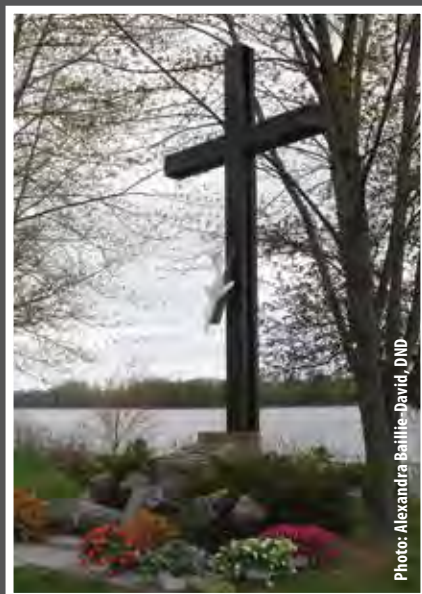
Our centre-fold poster portrays the Crash Scene Hazard Matrix, a valuable tool used based on the Risk Management process that is modifiable to suit the needs of any safety organisation. The poster also includes images of two levels of PPE available in both military and commercial off-the-shelf products. This poster can be used as a visual tool to provide guidance on the assessment of hazards, mitigation of risk and the type of protective equipment to be worn at a crash site.

In the end, DFS produced the following matrix describing the *minimum* expected risk level of each of the five crash scene hazard categories. The CraSH Matrix is intended to serve as a quick-reference and simple starting point for crash scene hazard management. At the same time, investigators remain free to modify the risk levels when necessary based on specific crash site circumstances. DFS has rewritten the chapter on Crash Scene Hazard Management (previously entitled "Blood Borne Pathogens") in its Airworthiness Investigation Manual (the investigation standards manual for the CAF). The new approach is being taught on the CAF Flight Safety course for aircraft accident investigators and the medical course for Aviation Medicine providers.

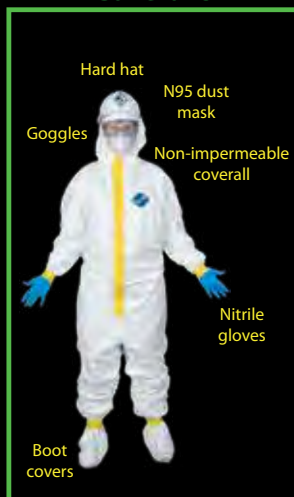
Low Risk

Coveralls

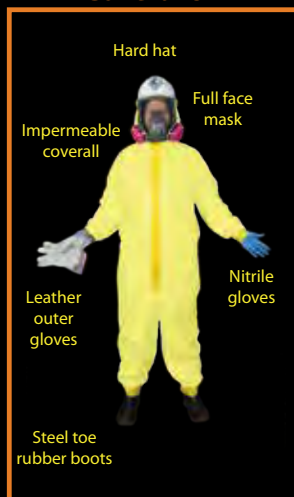
High Risk

Coveralls
