PRELIMINARY REPORT OF FORT WELLINGTON

NATIONAL HISTORIC PARK

Preliminary Report of the 1970 Excavations

Conducted at Fort Wellington National Historic Park,

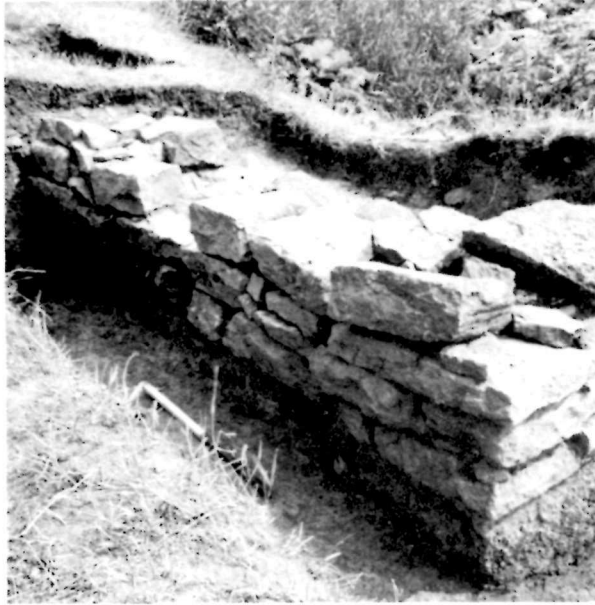
Figure 6. Post-excavation view of 2H39B9: the west side of the west wall showing the character of the masonry. (2H-92 X)

The wall was built of roughly coursed and roughly shaped unmortared limestone. The courses were neither continuous nor regular. The east and west walls were of much better construction than the north and south walls. There was no consistent pattern of either the interior or exterior sides of the walls being built in a more finished manner. The west or exterior side of the west wall was much better than the east or interior side (Fig. 6). But the west or interior side of the east wall was better built than the east or exterior side of the east wall. The courses of the wall were formed in two ways. The courses of the west wall consisted of two rows of stones with the roughly shaped and finished sides facing out (Fig. 7). Most of the length of the other walls were formed of courses of a single row of stones with only one side finished (Fig. 8). The north and south walls of the foundation were very crudely built, except at the

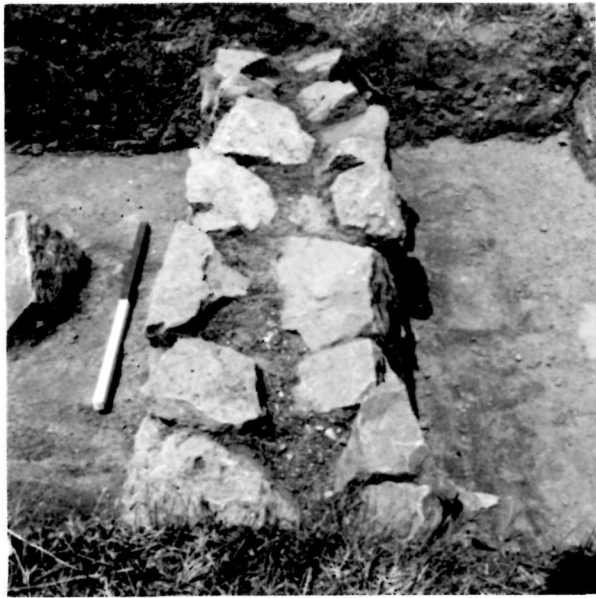
Figure 7. Post-excavation view of 2H39B3: the top of the wall showing the character of the masonry. (2H-65 X)

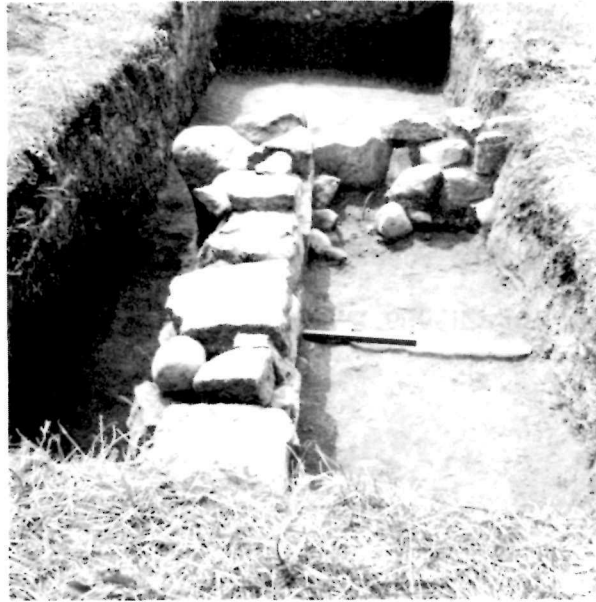
Figure 8. Post-excavation view of 2H39B10: the top of the east wall.

When the east wall was excavated in lot 2H39B4, a layer of wood fragments was found on the top of the wall. These fragments were very decomposed but the grain of the wood appeared to be running east-west across the width of the wall. The fragments were probably the remains of the flooring of the structure that stood on the foundation. No traces of sleeper beams were found. No further evidence was found for the superstructure of this building.

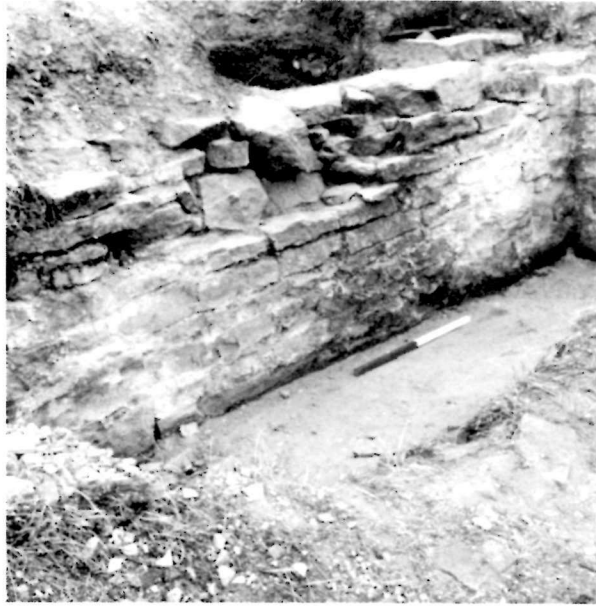
Figure 10. Post-excavation view of the south wall of the 2H39D foundation showing the character of the masonry. (2H-117 X)

The walls were constructed of shaped limestone laid in heavily mortared semi-regular courses. The courses are fairly continuous but are of slightly varying thickness (Fig. 10). The thickness of the wall is made up of two to three rows of stones in each course with shaped stones forming the straight sides of the wall (Fig. 11). The base of the wall extended down to floor level, but no deeper. It was based on the sandy clay of the undisturbed subsoil of the area. Two colours of limestone were used in the construction of the walls. The corners were built in a pigeon gray coloured stone; the remainders of the walls as preserved were built of a dull brownish gray limestone. The pigeon gray stone had a great deal of mortar spattered on the surface, the other stone did not. Though the stone colour changed, there were no outstanding discontinuities of coursing or construction apparent.

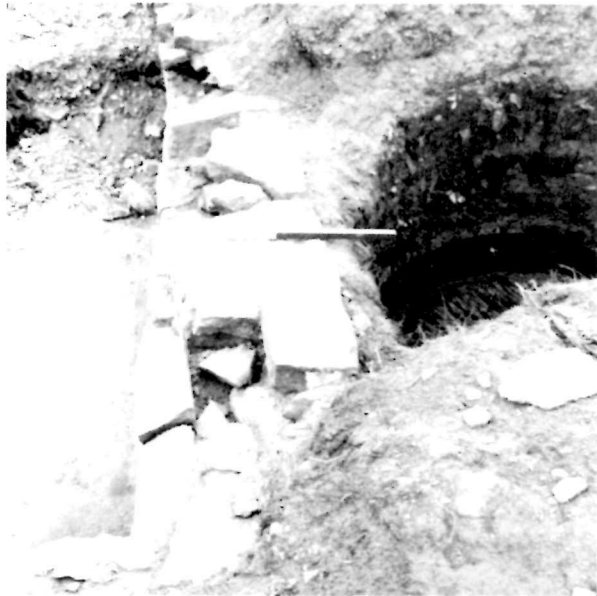
Figure 11. Post-excavation view of the south wall of the 2H39D foundation showing the character of the masonry and the wooden hog's head. (2H-118 X)

The hog's head had 32 staves and four of its iron hoops were preserved. The sides were preserved to a height of 2.48 ft., measured from the upper edge of the hoop found in 2H39D3 to the bottom. The bottom of the barrel was 3.8 ft. below the surface. The maximum diameter of the barrel was that of the highest hoop, 4.53 ft. The maximum diameter of the bottom was 3.77 ft.

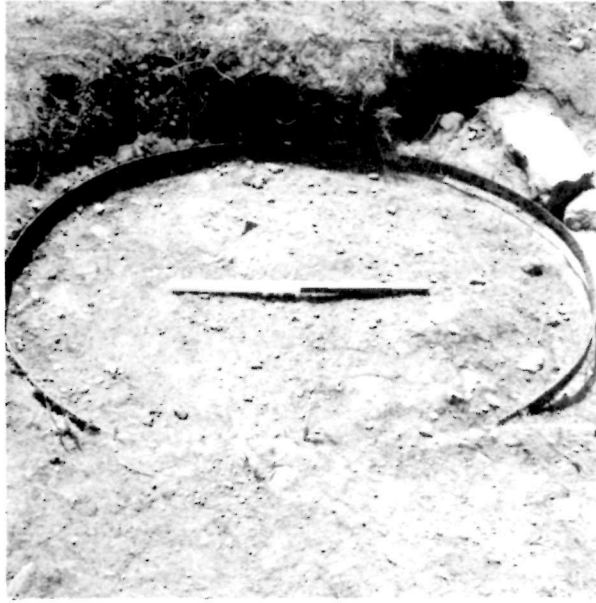
Figure 12. Post-excavation view of 2H39D3 showing the barrel hoop.
(2H-87 X)

Prior to excavation there was a round shallow depression about 4 ft. in diameter just south of the southeast corner of the housepit. When the sod was removed from this area in lot 2H39D3, a round metal barrel hoop was found (Fig. 12). The area enclosed by this hoop was excavated as lot 2H39D9, and a large hog's head was located. The sides were not preserved any higher than 0.50 ft. above the bottom, but the limits of the barrel could be discerned because of the hoops and the difference between the very sandy fill and the sandy clay of the surrounding soil. This hog's head was designated lot 2H39D14, and described in detail but not removed.

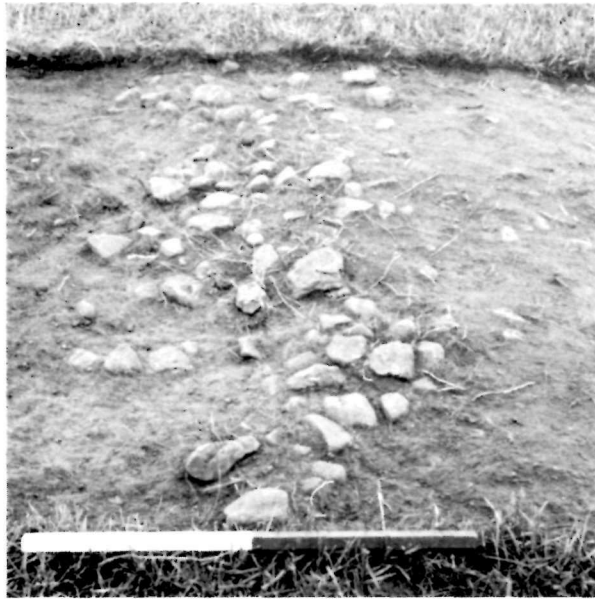
Figure 13. Post-excavation view of 2H39C1 showing area of small
stones. (2H-72 X)

The excavations in suboperation 2H39C were designed to uncover any extant remains of the west side of the wooden palisade that connected the fort and the water battery. Excavation uncovered a narrow path-like feature of small stones and grass roots (Fig. 13). This feature was oriented north-south and was 2.0 ft. wide at the north side of the suboperation and 3.0 ft. wide at the south side of the suboperation. The arrangement of the stones was completely random and without pattern: however, the west side of the feature was much more regular than the east side. This feature was located about 0.22 ft. below the surface. There were fewer small stones west of the feature than there were east of it.
