MANUSCRIPT REPORT NUMBER 79

EXCAVATIONS AT CASTLE HILL

NEWFOUNDLAND IN 1969

Bruce A. Morton

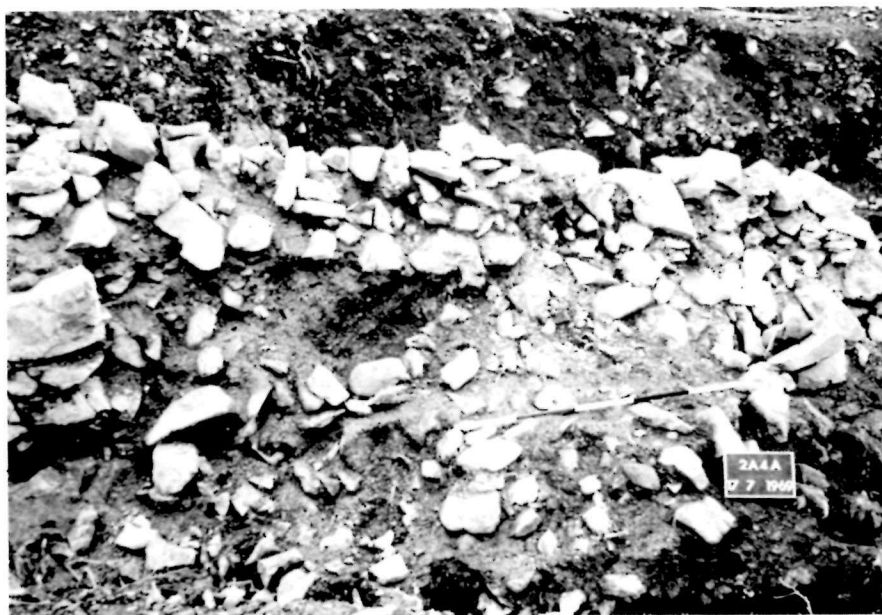
Figure 6.

2A-26 M: North end of west curtain wall looking east  
before excavation. Sub-operation 2A4A.

The major task undertaken was the stratigraphic excavation of the west curtain wall (Figs. 6,7) and its subsequent reconstruction. As well, the interior of the redoubt was re-excavated and features therein were stabilized as found for site development purposes. Similarly, the N.E. corner of the original entrance on the east side of the fortress was re-established and the modern bridge, providing access to the interior of the redoubt over the ditch, was re-oriented for the sake of authenticity and, incidentally, easier accessibility.

In order to properly stabilize the west curtain wall, excavations were conducted along the total length of the face to bedrock (Figs. 6,7).

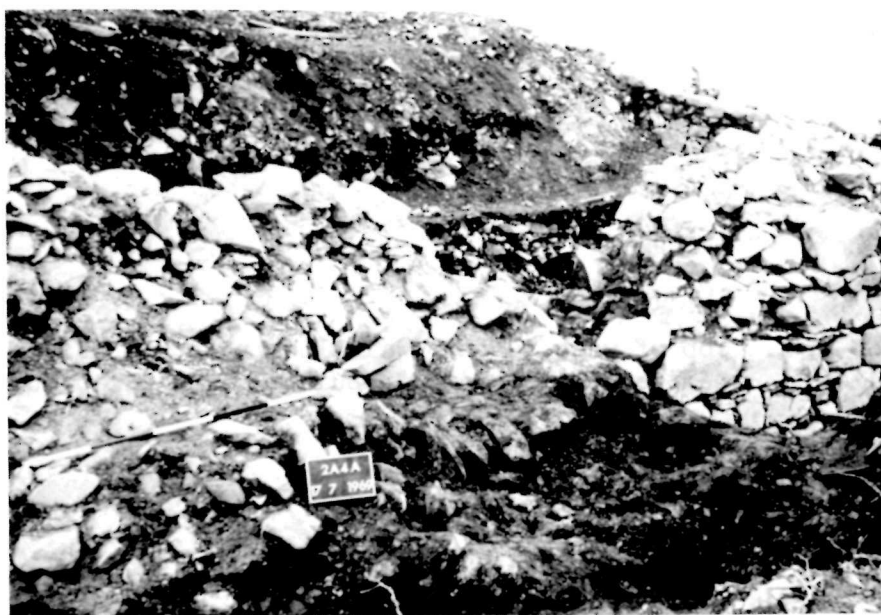
Figure 7.

2A-27 M: South end of west curtain wall looking S.E.  
before excavation. Sub-operation 2A4A.

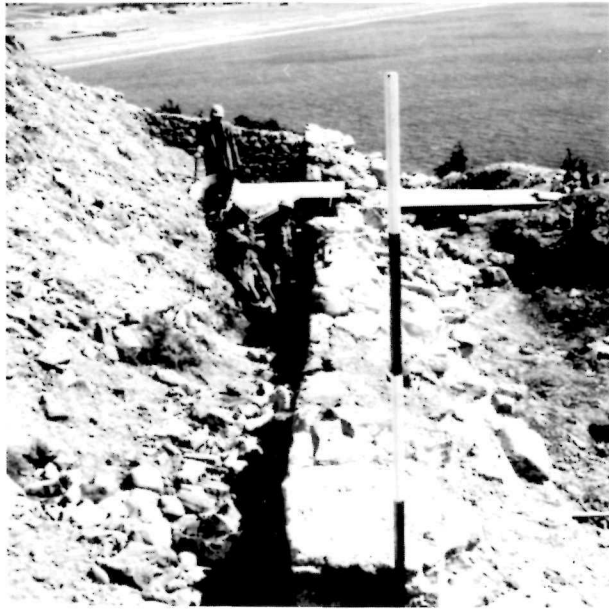
Figure 8.

2A-7 X: Top of west curtain wall looking south during excavation. Sub-operation 2A4A.

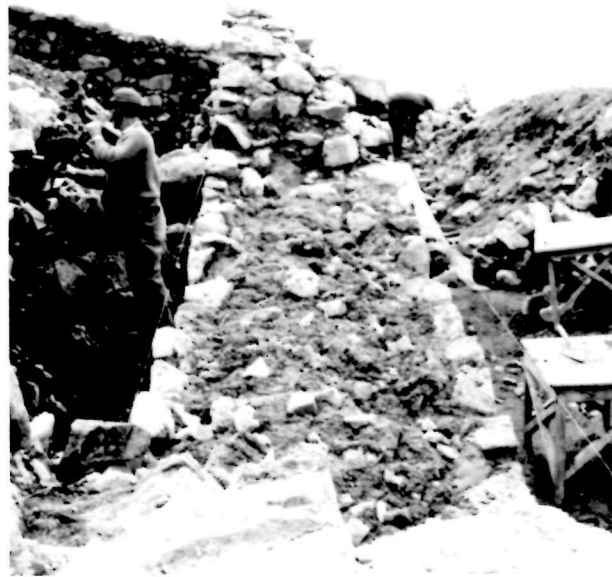
Figure 9.

2A-24 X: Top of west curtain wall looking south at the centre section being rebuilt. Sub-operation 2A4A.

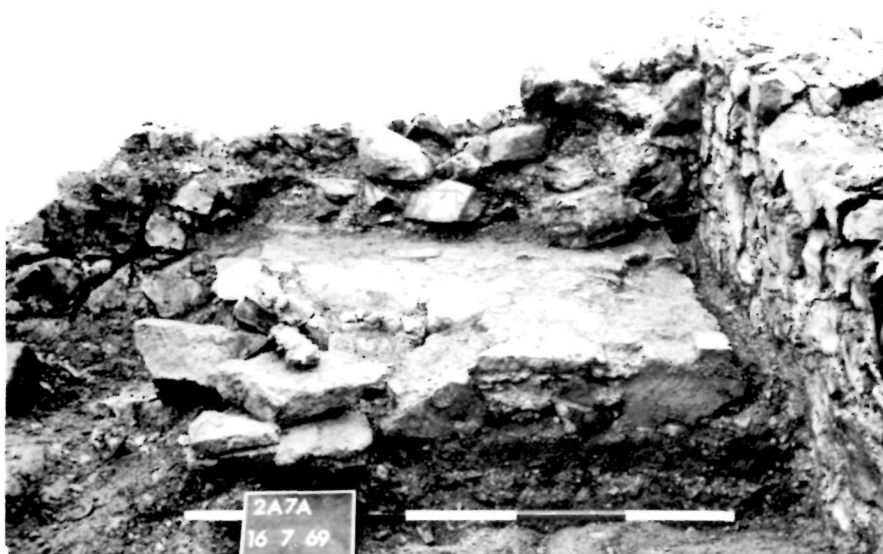
Figure 10.

2A-14 M: British hearth base looking south as uncovered  
in 1969. Sub-operation 2A7A.

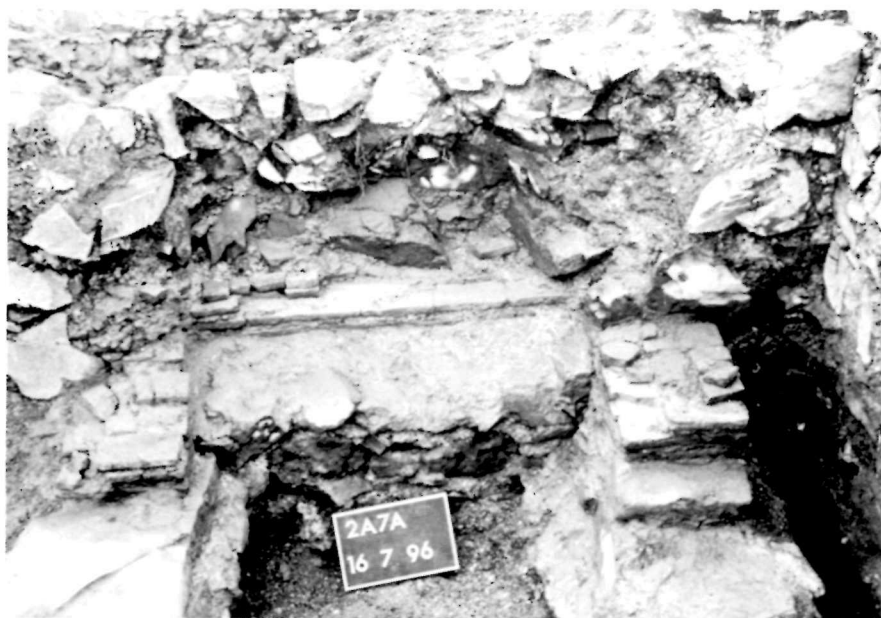
Figure 11.

2A-18 M: French fireplace looking south as found beneath  
British hearth. Lot 2A7A4.

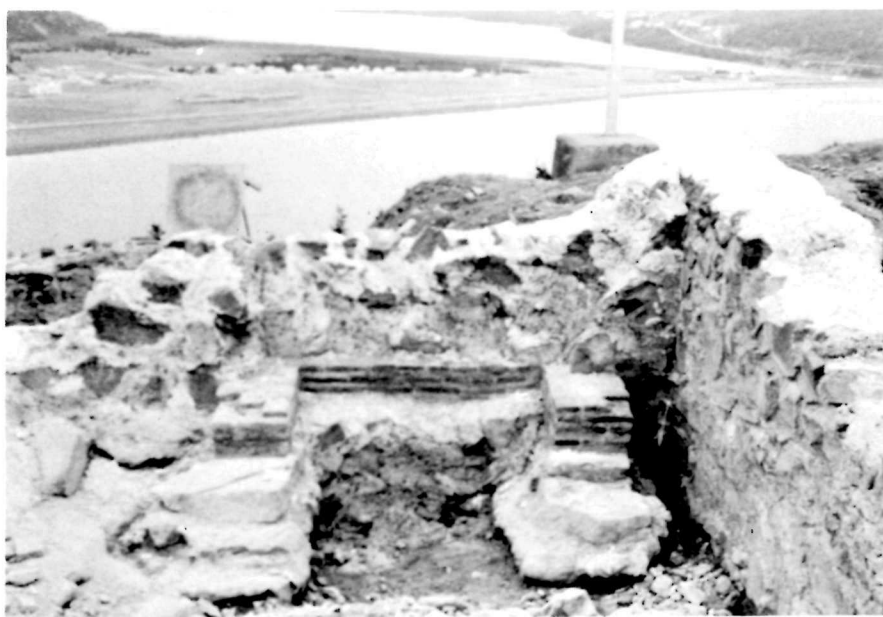
Figure 12.

2A-10 M: French fireplace restored, before final levelling  
looking south. Sub-operation 2A7A.

The back of the fireplace was represented by a line of bricks, three rows wide which was recessed into the wall for a distance of 0.7 ft. In front of this back wall of bricks, and directly beneath it, was a heavy mortar concentration which extended northward for a distance of 0.7 ft. in the S.W. corner of the fireplace and 1.1 ft. in the S.E. corner. Beneath this mortar shell, and extending to the bedrock within the confines of the fireplace interior, was a sterile ash layer. Interior measurements of the fireplace were 3.3 ft. wide by 1.7 ft. in depth (Fig. 12).

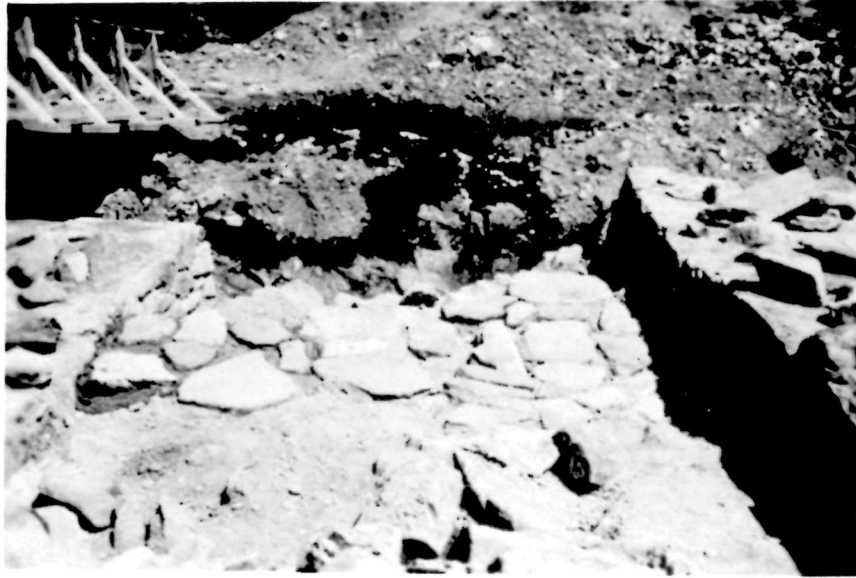
Figure 13.

2A-7 T: Flagstones in entranceway looking east.  
Sub-operation 2A8C.

Work in the entranceway of the fort showed there to have been flagstones mortared to bedrock. Several of these were found in situ and in the course of our stabilization work, these were cemented in place and several more were added in order to produce a more consolidated picture in this area (Fig. 13).

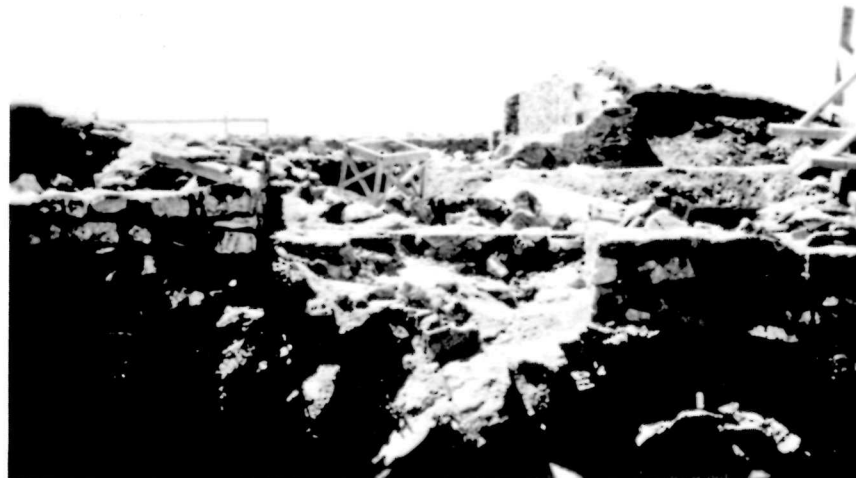
Figure 14.

2A-8 T: Restored N.W. corner of entranceway and flagstones  
looking west. Sub-operation 2A8C.

completely excavated and the bedrock flushed clean, mortar stains in the N.E. corner of the sub-operation (where the two strings intersected) gave the investigators further proof as to where the N.E. corner of the entranceway had been originally (Fig. 14).
