NATIONAL HISTORIC SITES SERVICE

MANUSCRIPT REPORT NUMBER 89

1969 EXCAVATION AT THE ROMA SITE

E. Frank Korvemaker

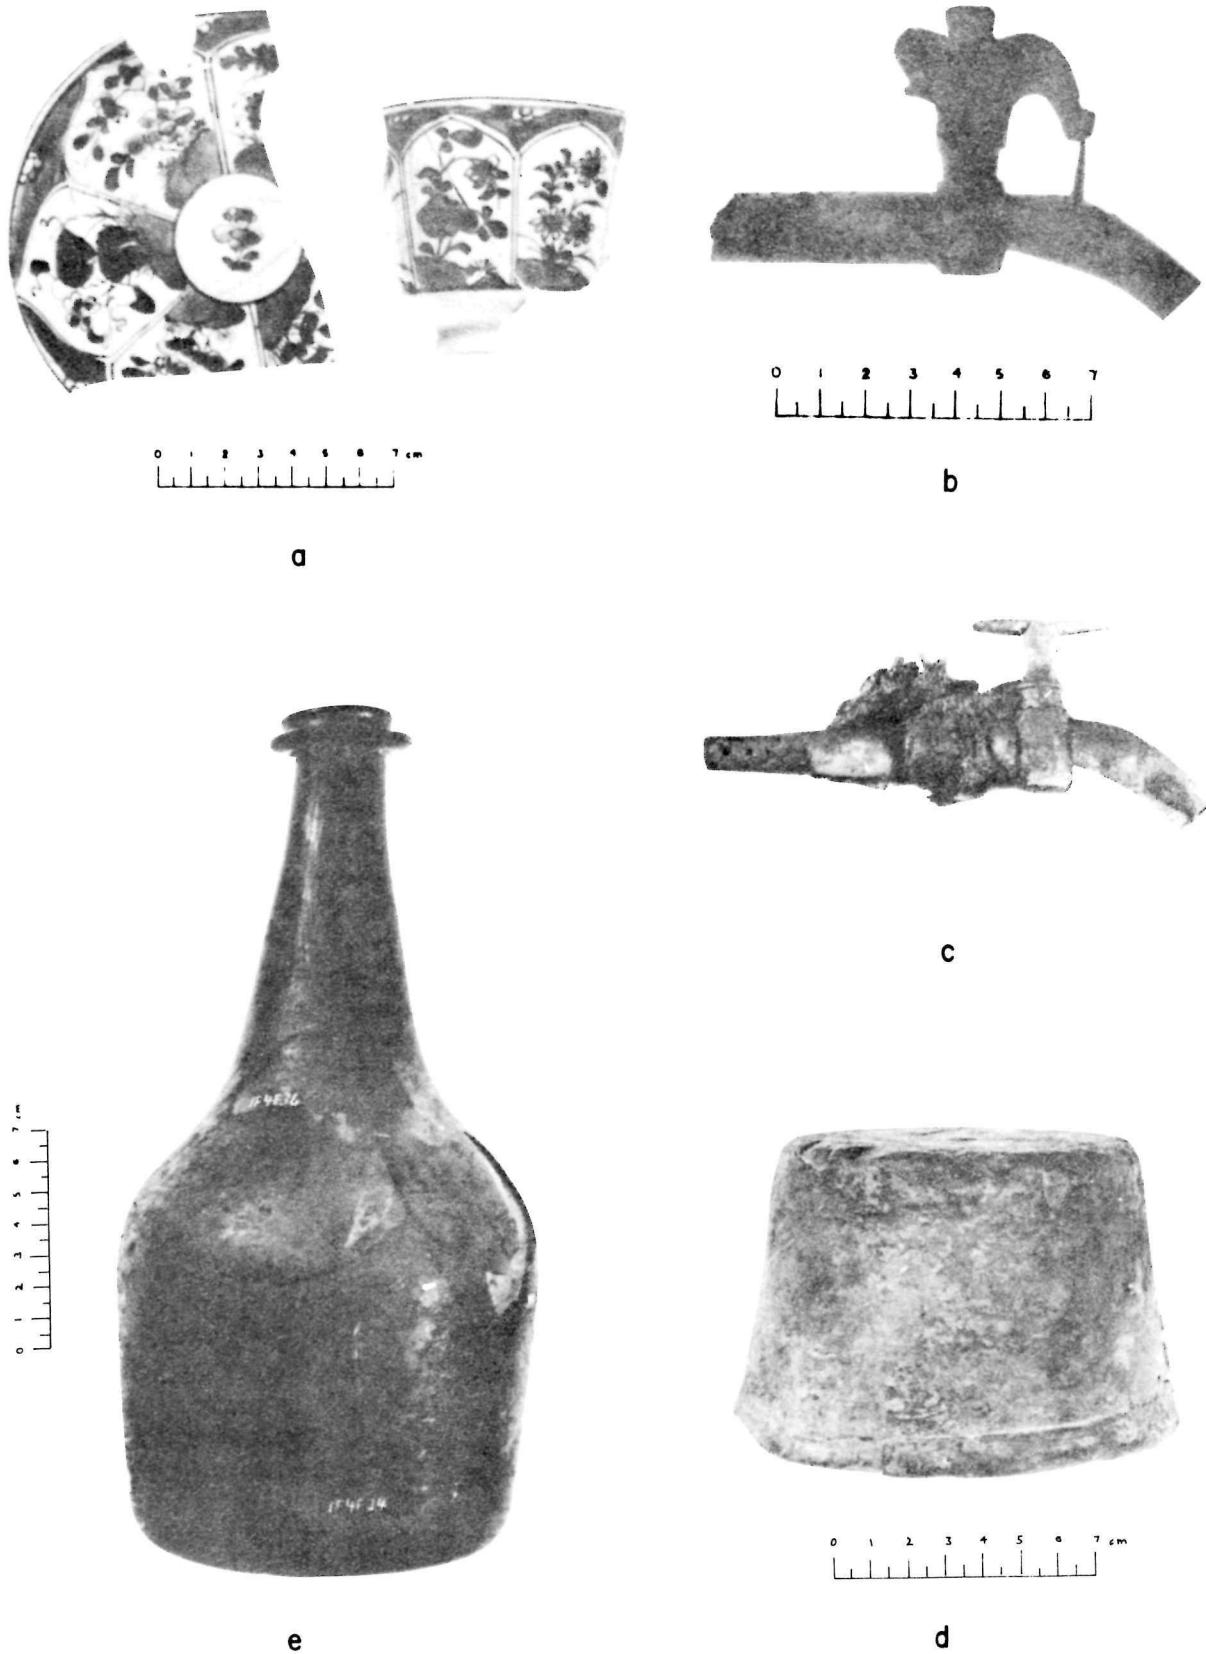
FIG. 5

- 5 18th century French artifacts: a, porcelain saucer and cup (RA-916M); b, brass spigot (RA-470M); c, brass spigot with original string and wood (RA-388B); d, lead ingot (RA-915M); e, wine bottle (RA-914M).

the west end). Numerous porcelain and bottle glass fragments were found in and on top of this layer, as were two brass spigots and a lead ingot (Fig. 5). These artifacts all correlate with those of the trash pit (sub-operation 1F11F) and the Company house (operation 1F15), where similar artifacts were uncovered.

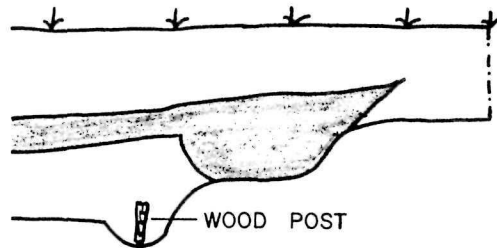
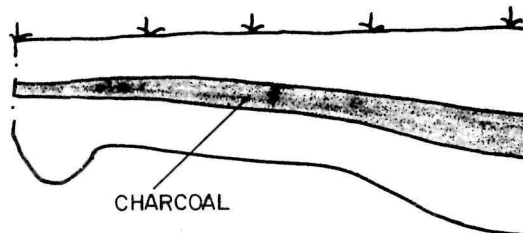
View of Cellar Entrance profiles

a. South wall

b. North wall

A series of depressions and slopes, which apparently formed part of the original stairs into the cellar, were found in the west end of the trench (Fig. 4). A profile view along the south trench wall in this area reveals a stain-like pattern, with a footer trench containing two posts and a post hole located at the base of this stairway (Fig. 6a). The stain pattern portrayed in Figure 6a is actually a hole cut into the floor of the entrance after Roma left the site and used for an ash deposit. This feature is further discussed under the stratigraphic section of this report. A more accurate picture of the stairway is to be seen on the north side of this trench, where a somewhat different pattern is revealed. A shallow trench is located at the upper end of the stairway and there is no clear outline of any individual stairs at this point (Fig. 6b).

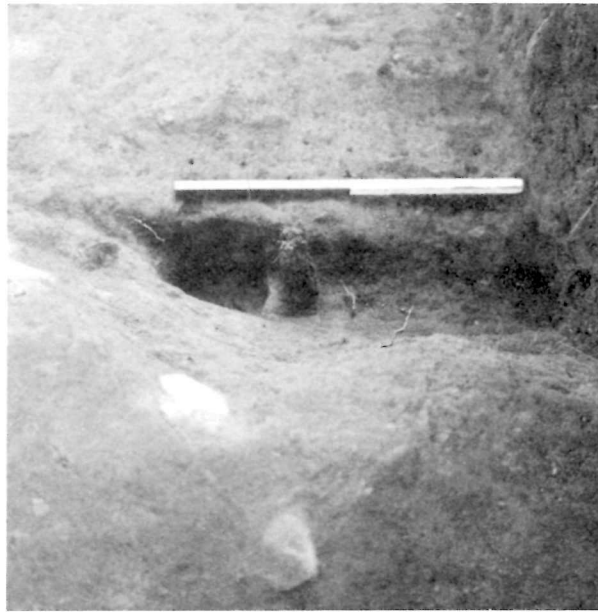
7a View of post in post hole, at entrance to the storage cellar. Sub-operation 1F4. Two foot scale (1F-814X).

was found in this particular hollow, a single vertical post 0.7 ft. long and 0.1 ft. in diameter was found immediately south of this depression (Fig. 7a). A similar post was found at the south end of the depression in the south wall of the trench. The latter post was 1.0 ft. long and also in a vertical position. At one time this footer trench may have contained a single or several horizontal beams serving as additional support for the vertical posts, or as bracing between various posts.

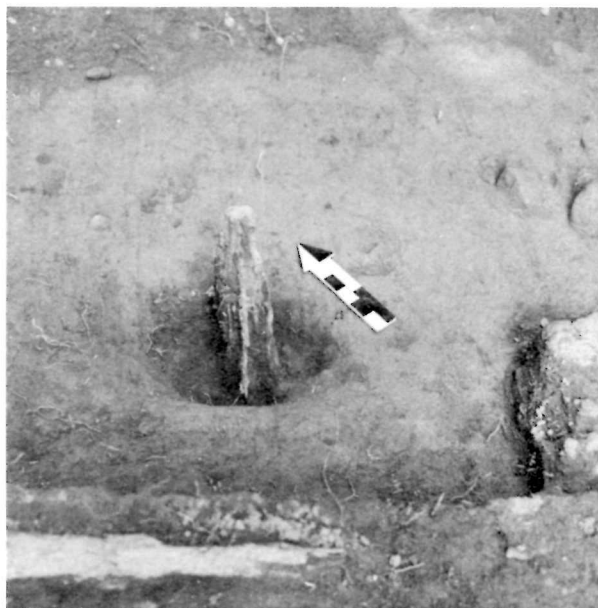
7b View of vertical post in hole near north wall of storage cellar and nail concentration. Six inch scale. Sub-operation 1F4 (1F-622X).

cellar, a single post in a post hole was found just north of the wood beam concentration near the east end of sub-operation 1F4E, with a small accumulation of nails just east of the post (Fig. 76). This wooden post was 1.25 ft. long, 0.18 ft. wide, and 0.1 ft. thick, and sloped slightly to the north at 78 degrees, differing substantially from the 50 to 60 degree slope of the north wall of Roma's storage cellar. Also, the post is located about three feet south of the base of the north wall and hence may have originally stood vertical and supported the roof in an upright position. The almost circular post hole around the post is 0.45 ft. in diameter and 0.55 ft. deep, suggesting that the original post had a substantial diameter and could quite easily have been used as a main support for the roof of the cellar.

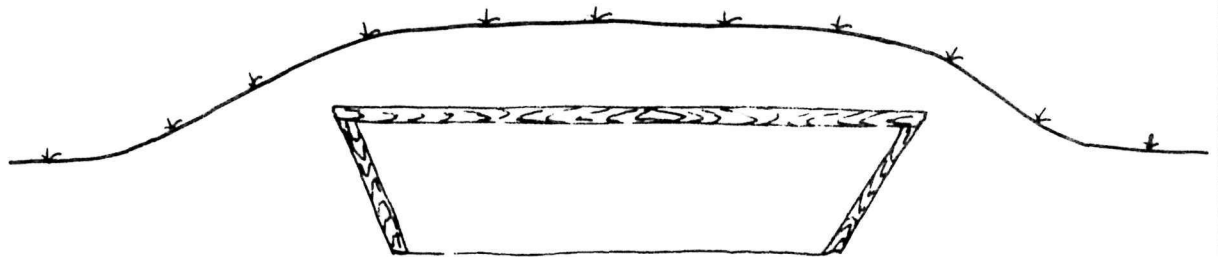
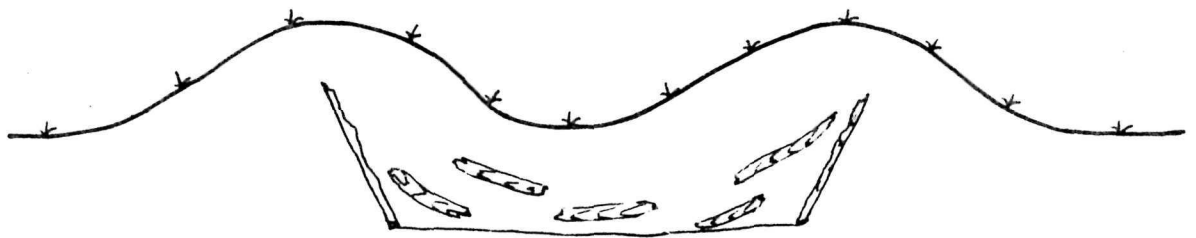
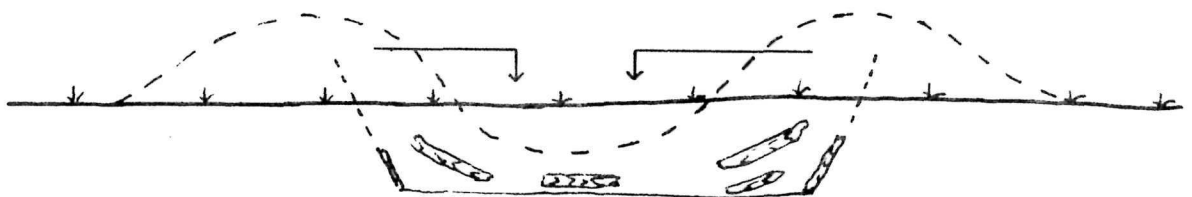
Fig. 9

Original Cellar before collapse

Cellar after collapse (east end)

Cellar after collapse and removal  
of mounds (west end)

- a. a sterile, undisturbed sandstone wherein the cellar was originally excavated by Roma in 1732 (yellowish-red sandstone - 5YR; 4/6);
- b. a very thin occupation layer often times undetectable (dark, reddish-brown sand - 5YR; 3/4);
- c. relatively loose sand fill deposited on the floor of the cellar after the collapse of the roof (yellowish-red sand - 5YR; 4/6);
- d. fill deposited over the collapsed roof by farmers in the 19th century to level the sides and fill the interior of the depression (mixture of all soil colors - predominantly yellowish-red sand - 5YR; 4/8);
- e. brown loamy sand forming a plow zone (dark brown loam - 7.5YR; 3/2);
- f. a thin covering of decomposing evergreen needles mixed with loam (dark brown loam 7.5YR, 3/2; Fig. 9).

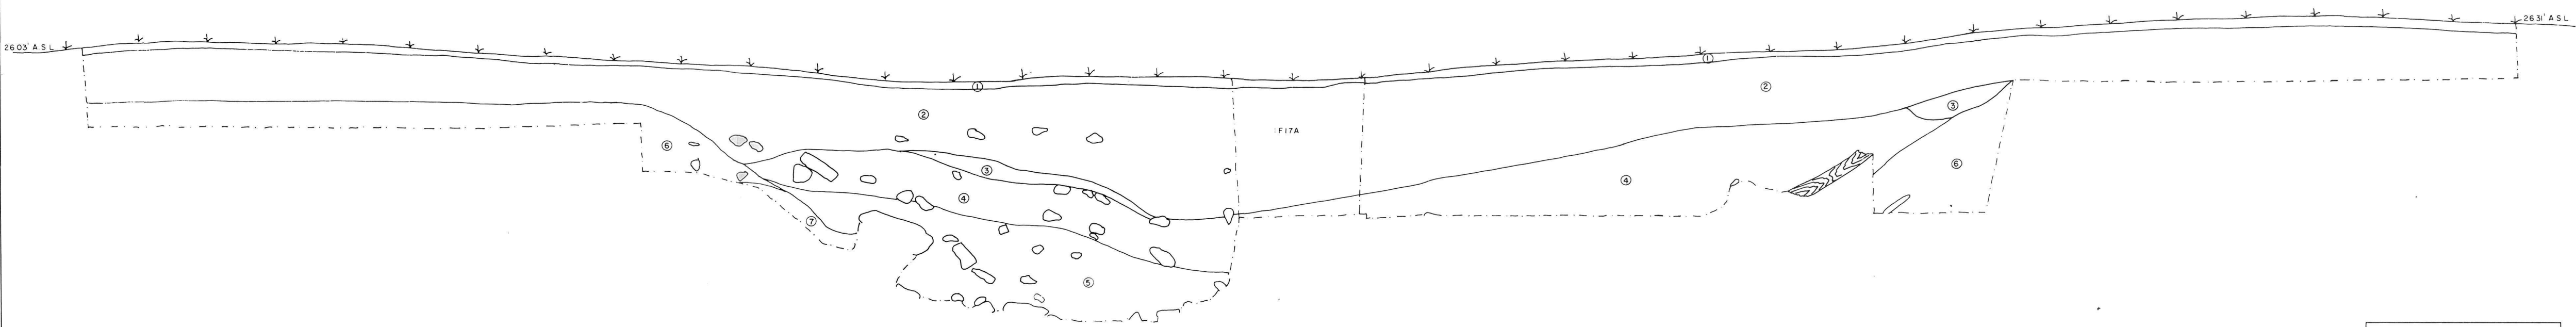
ROMA SETTLEMENT P.E.I. SITE IF	
WEST FACE STRATIGRAPHY OF SUB-OPERATIONS IF17D & E	
0 1 2 FT.	
LEGEND	
++ TURF	○ FIELD STONES
--- WOOD	- - EXCAVATION LIMITS

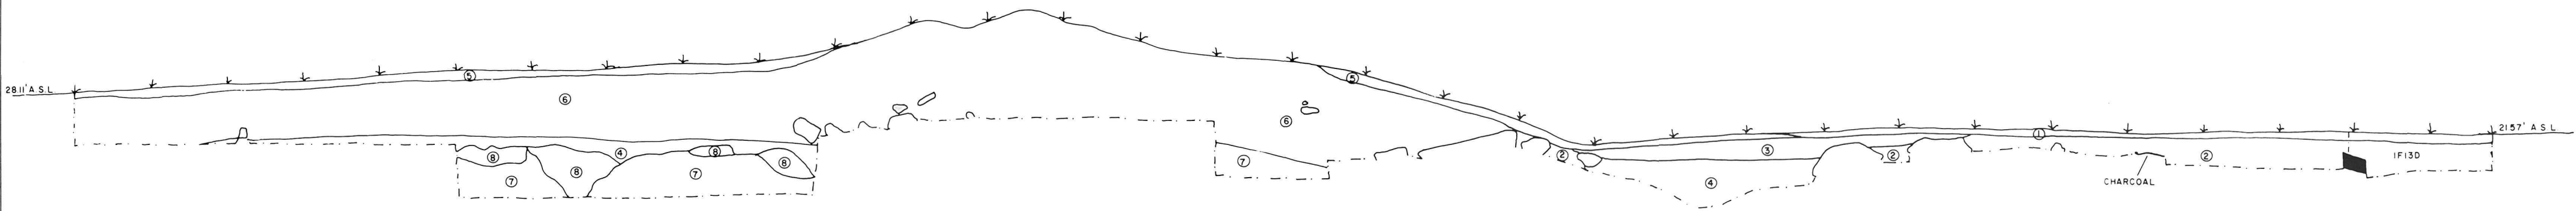
ROMA SETTLEMENT P.E.I. SITE IF	
CENTRE FACE STRATIGRAPHY OF SUB-OPERATION IF18A	
0 1 2 FT.	
LEGEND	
TURF	FIELD STONE
BRICK	EXCAVATION LIMITS

A stone concentration in 1F18A and B may be indicative of a fireplace base. However, much of this structure has either been removed on purpose, graded by road grading machines over the past 30 years, or removed when a ditch was constructed along the north side of the road. This ditch runs directly through the stone feature, destroying it beyond functional recognition. Brick fragments are scattered throughout the southern half of sub-operation 1F18A. In addition, several stones were found just southeast of this operation in sub-operation 1F13D. These stones probably relate to the other stones previously mentioned.

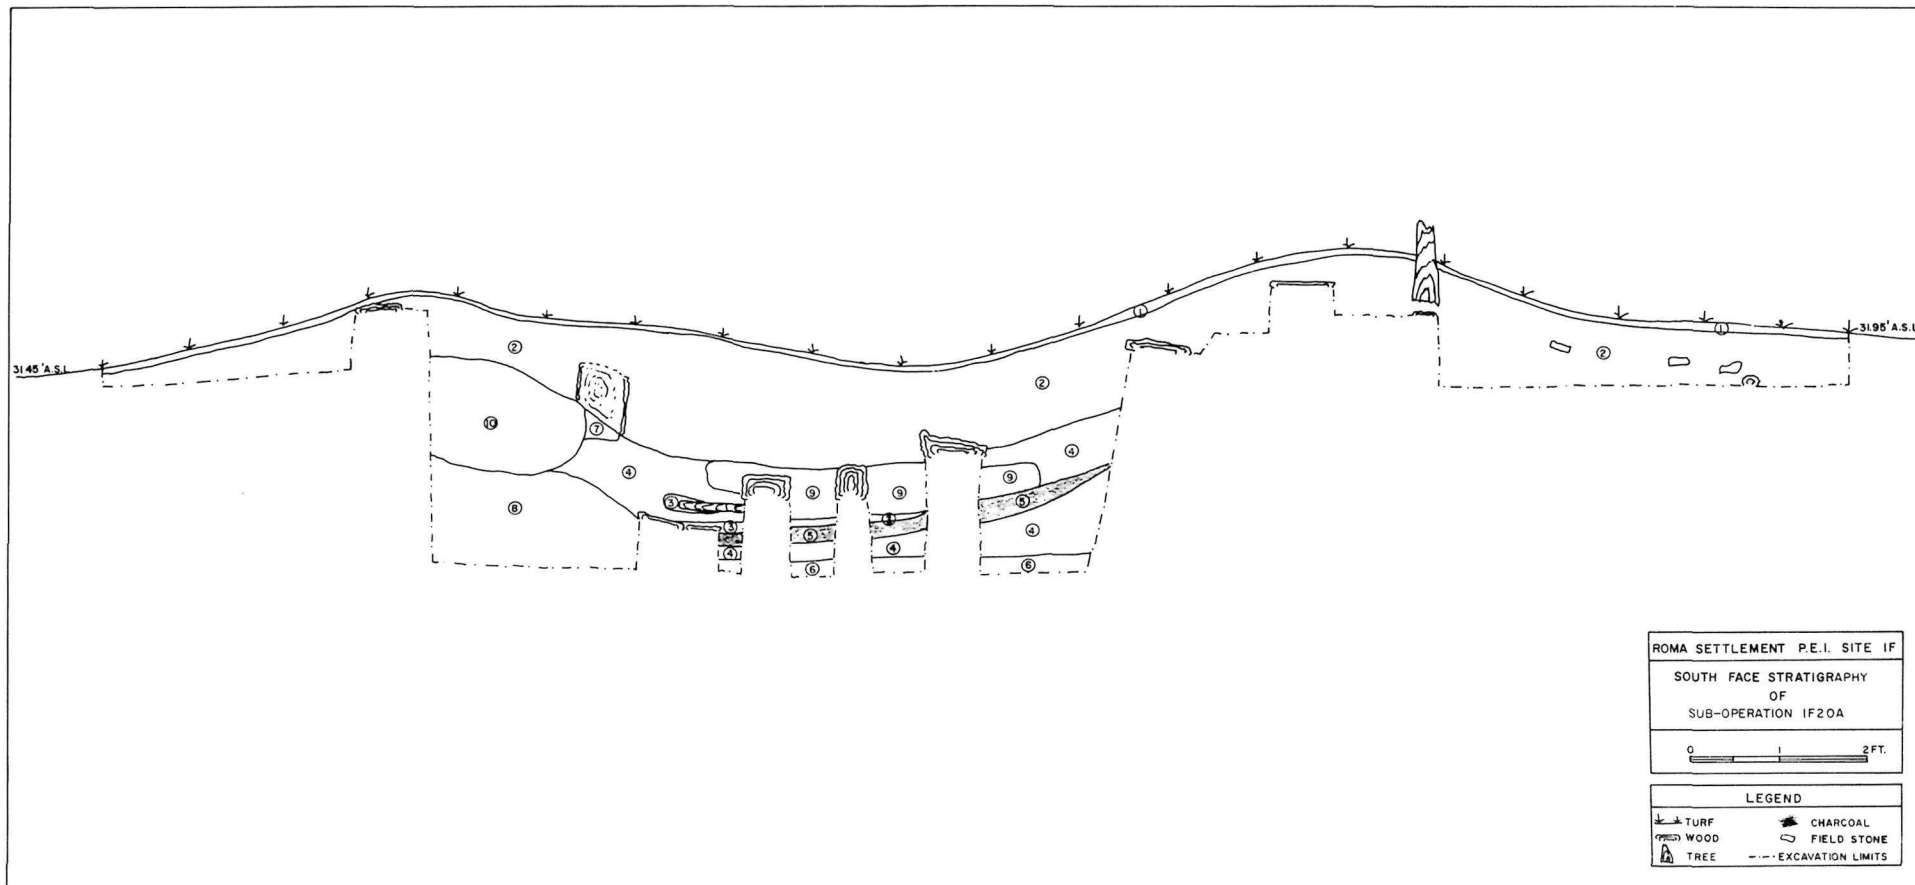
Fig. 18

1. Dark brown laom turf (7.5YR; 3/2).
2. Dark brown loam (7.5YR; 3/2).
3. Yellowish-red sand (5YR; 4/8).
4. Brown loam (7.5YR; 4/2).
5. Charcoal.
6. Yellowish-red compact sand (5YR; 4/6).
7. Pinkish-grey sand (5YR; 6/2).
8. Yellowish-red sand (5YR; 5/8).
9. Dark brown sandy loam (7.5YR; 3/2).
10. Ant hill.

destruction of the superstructure by fire - which is indicated by the layer of charcoal - layer 5 - above the brown loam. The presence of the dark brown loam below the charcoal suggests the possibility that this building may have been vacated for a period of time prior to its consumption by fire, and that a general stage of decay had already set in when the structure was destroyed.

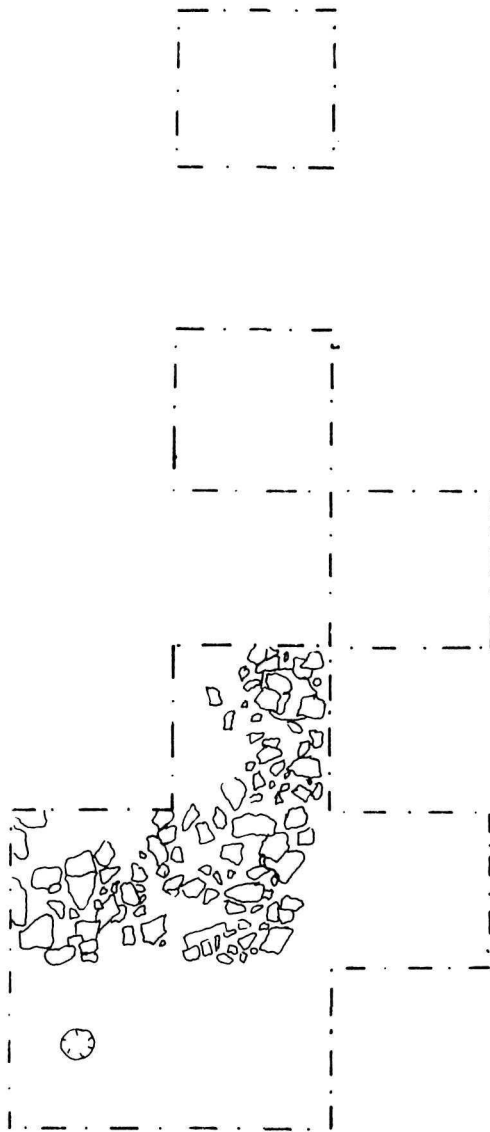
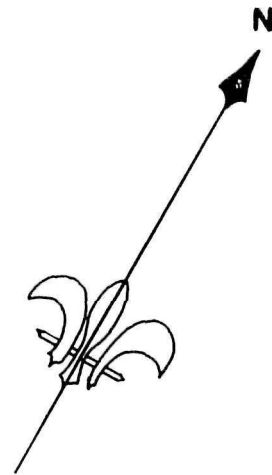
PLAN OF  
BOY SCOUT WELL  
SUB-OPERATION IF16A

In operation 1F16 - located northwest of the Company house - a rise in the landscape suggested the presence of a building in this region. Excavation at various places revealed a conglomeration of field stones - forming no discernable pattern - and a 0.8 ft. diameter hole in the ground (Fig. 20). The hole was apparently that drilled by the Boy Scouts in the 1930's in an unsuccessful attempt to obtain fresh water on Brudenell Point for the De Roma Boy Scout Camp. The well descends to a minimum depth of ten feet, at which level the hole appears to be blocked by a stone. The rubble stones found in the area north of the well may have been used to construct a platform around the well. Several local informants have indicated the presence of such a well in this portion of the site but were unable to locate it precisely upon inspection of the area. The modern artifacts found in association with this well would appear to further confirm the speculation that this well was constructed by the Boy Scouts.
