NATIONAL HISTORIC SITES SERVICE

MANUSCRIPT REPORT NUMBER 90

1970 EXCAVATION OF THE ROMA SITE

Report on the 1970 Excavation
at the Roma Site, P.E.I.

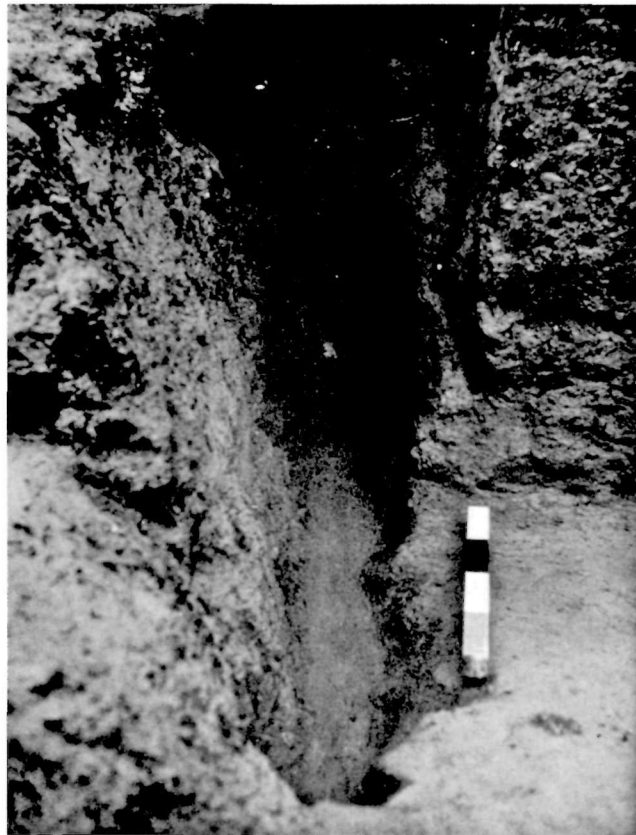
Figure 8: 1F4 - Plan and profile of the storage
cellar entrance. Letters A, B,
C, D, E, F represent the eleva-
tions referred to in the text.
(1F-72-102-18)

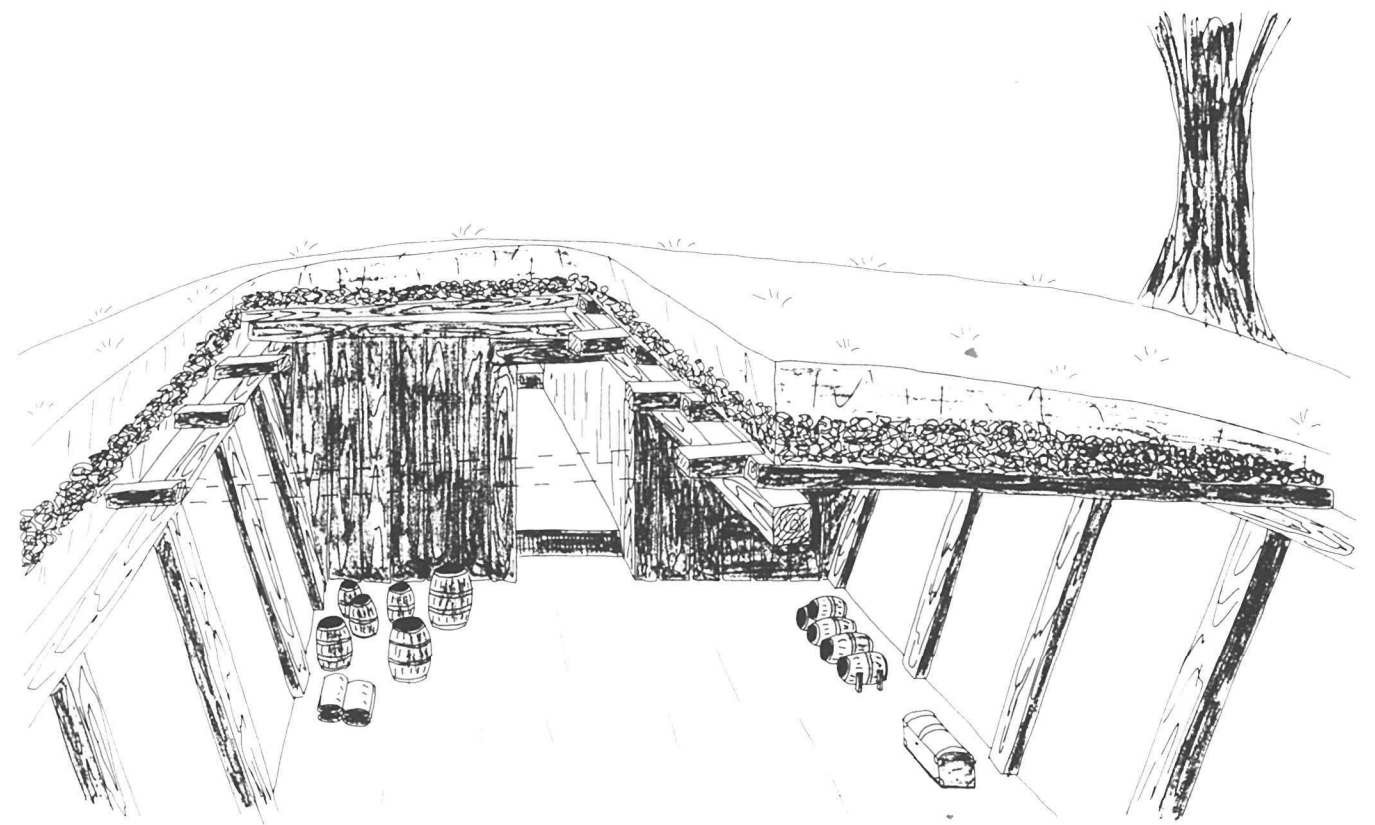
FIGURE 10

Figure 10: 1F4 - Reconstruction drawings of the main entrance to
the storage cellar. (1F-72-104-4)

MAIN ENTRANCE — FACING EAST

MAIN ENTRANCE — FACING WEST

the passageway might deteriorate and collapse. If the two chambers had been perfectly aligned, then the constriction between them would have consisted of a three-sided formation for each wall. Such a feature would have been susceptible to damage and erosion on three exposed faces, rather than the present dual-face pattern. Moreover, the passageway would appear to have been of a more durable nature because of the common wall technique, since pressure from the roof would be less likely to cause the present formation to collapse than it would two relatively small projections coming out of each wall.

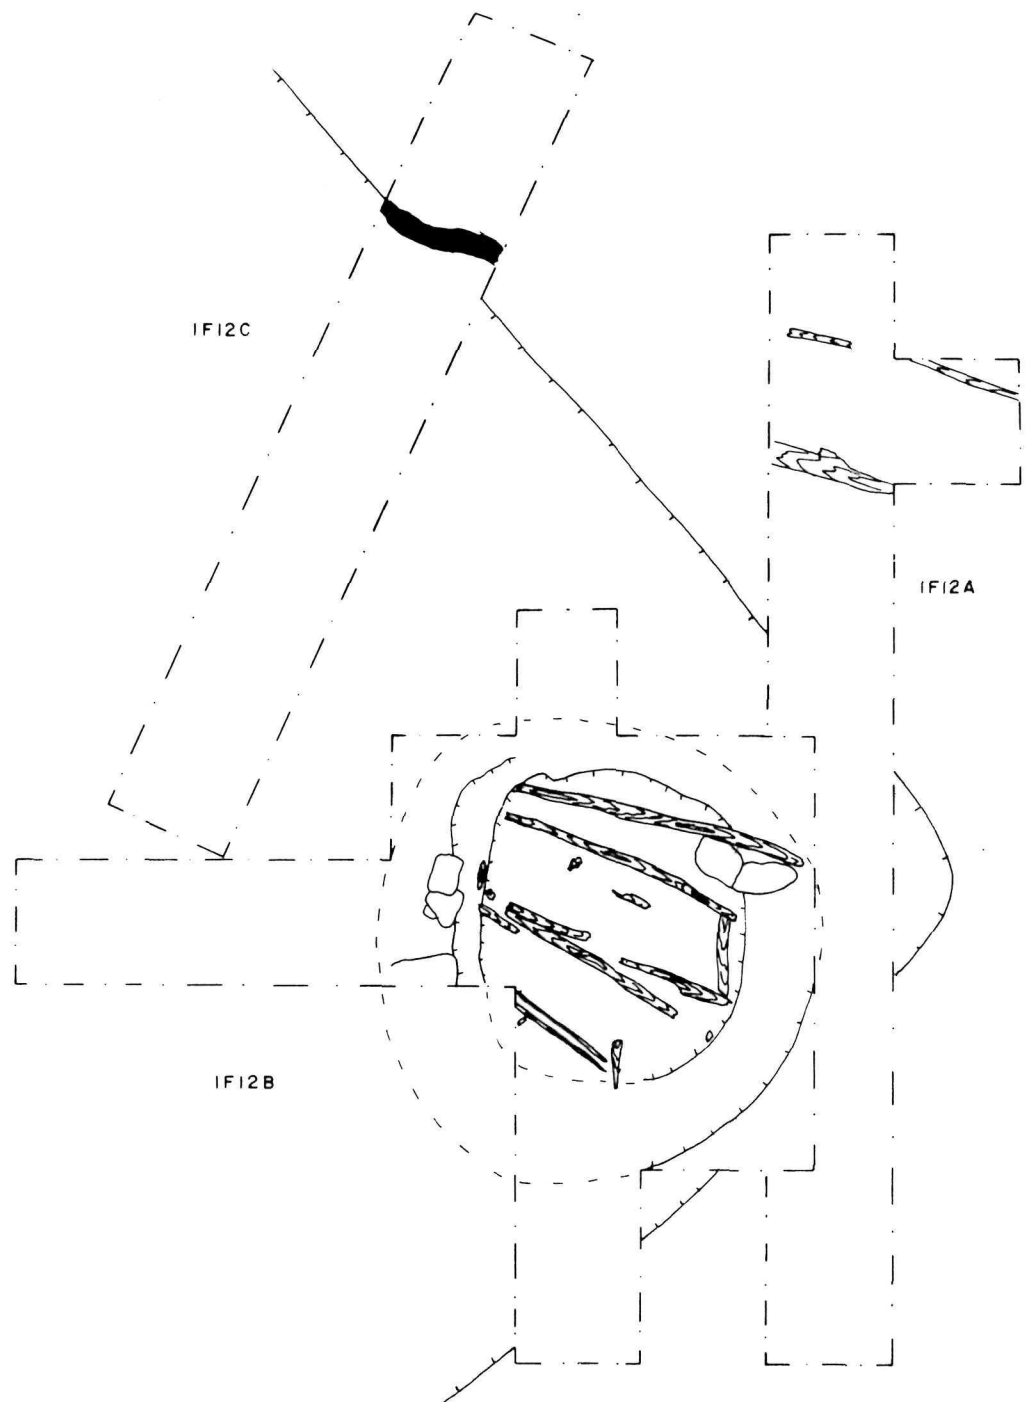
Figure 11: 1F12 - Excavation plan of unidentified French
building No. 1. (1F-72-102-20)

The small cellar depression which was found in the corner of the L-shaped surface depression appears to have been rectangular or possibly circular in shape (Fig. 11). At its base (24.6 ft. ASL), the cellar is 12.5 ft. long and 10.5 ft. wide; while at its highest point (29.0 ft. ASL) it spans a postulated area of 18 by 17 feet. The slope of the cellar walls lack uniformity, but appear to range around 40 degrees on the average.

Aside from the irregularly sloping cellar walls, various charred wooden beams and wood fragments were found on the floor of this structure. These appear to consist primarily of collapsed floor or ceiling joists and were oriented in a northwest-southeast position. The four major beams measured 5, 8, 10, and 12 ft. in length, while the remaining wood sections varied

The four longest beams lie roughly parallel to each other and could constitute the total number of original floor or ceiling joists which covered the cellar. In their collapsed state the space between them varies between 1.2 to 4.0 ft. Only two beam segments of any meaningful size were found oriented in a roughly opposite north-south direction. One such segment measured 3.3 ft. in length, 0.45 ft. in width, and 0.15 ft. in thickness; while the other piece had a length of 2.2 ft., width of 0.3 ft., and thickness of 0.1 ft. These sections may be remnants of a floor or roof covering the larger charred joists; however, the lack of additional evidence makes definite functional analysis of these wood sections most difficult.

Unlike the storage cellar (operation 1F4), this cellar shows no evidence of any vertical supports for the joists, nor were any post holes found in the floor of the cellar. In addition, no evidence of any stairway or other form of entrance into the cellar could be located. Presumably access to the cellar was obtained by a ladder let down through an opening in the floor covering the cellar.

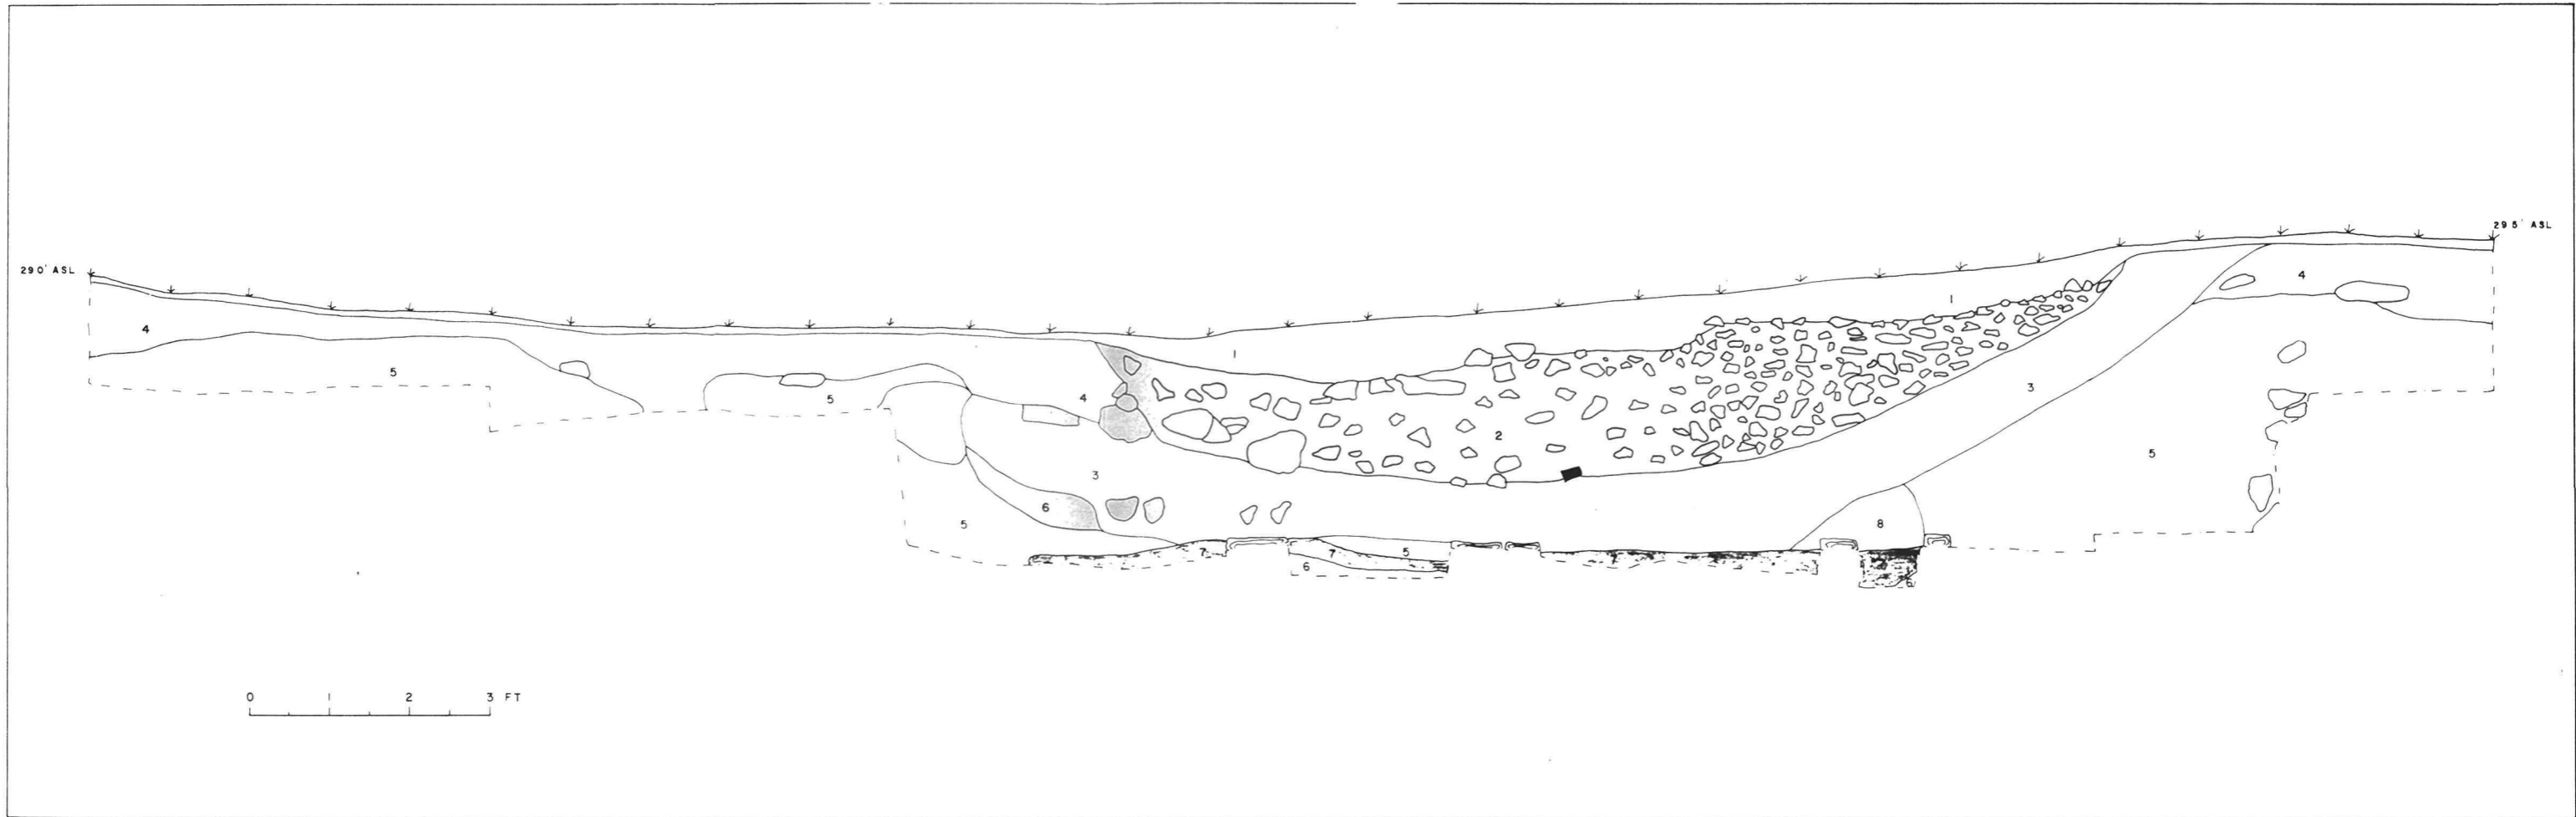
FIGURE 12

Figure 12: 1F12B - Stratigraphic section through Unidentified
French building No. 1.

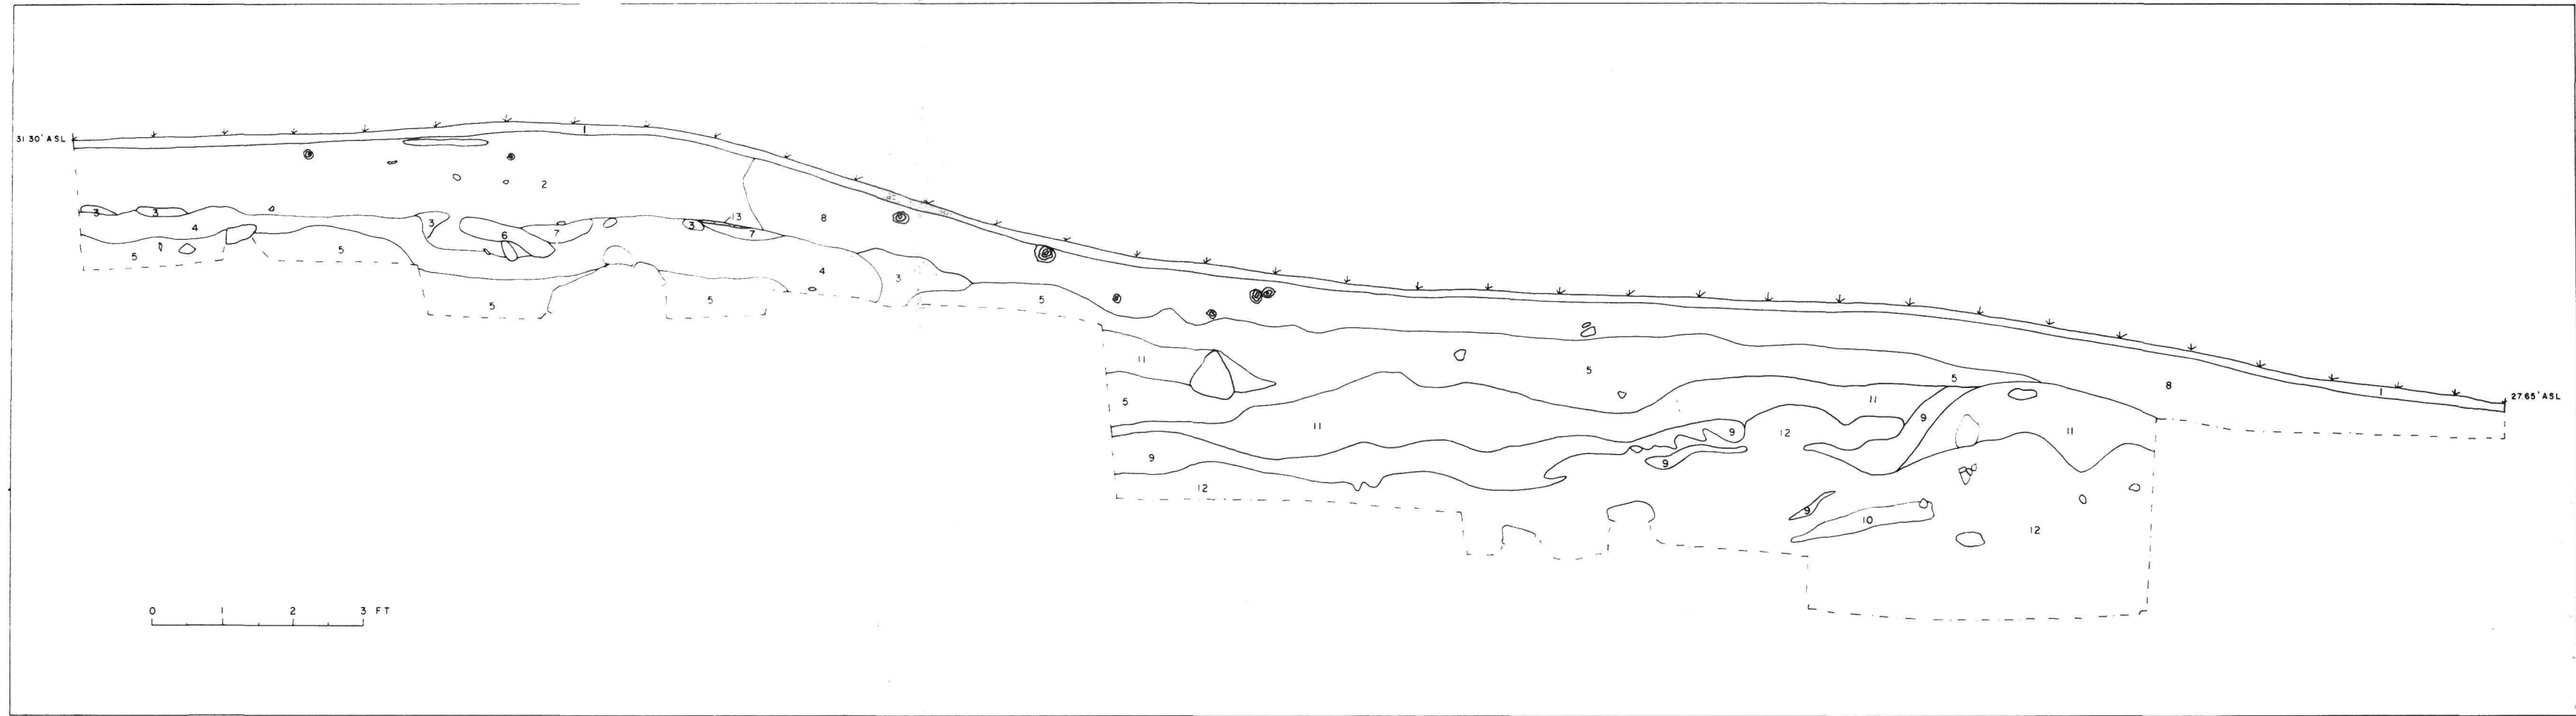
FIGURE 13

Figure 13: 1F12C - Stratigraphic section through L-shaped depression.

The wood fragments and charcoal stains found in sub-operation 1F12A lie more or less parallel to the charred beams found in the cellar depression. These stains were found almost six feet above the floor of the cellar - at 30.2 ft. ASL - and appear to extend in a westerly direction at least as far as sub-operation 1F12C, where a similar stain was uncovered. The total extent or function of this building is impossible to determine without additional excavation and possibly historical documentation. However, these stains may relate to the small cellar depression in some manner, or to additional evidence of a French building located 55 ft. north of this area, in sub-operation 1F22A. The possibility also exists that these stains relate to neither of these two features, but form part of a separate third structure.

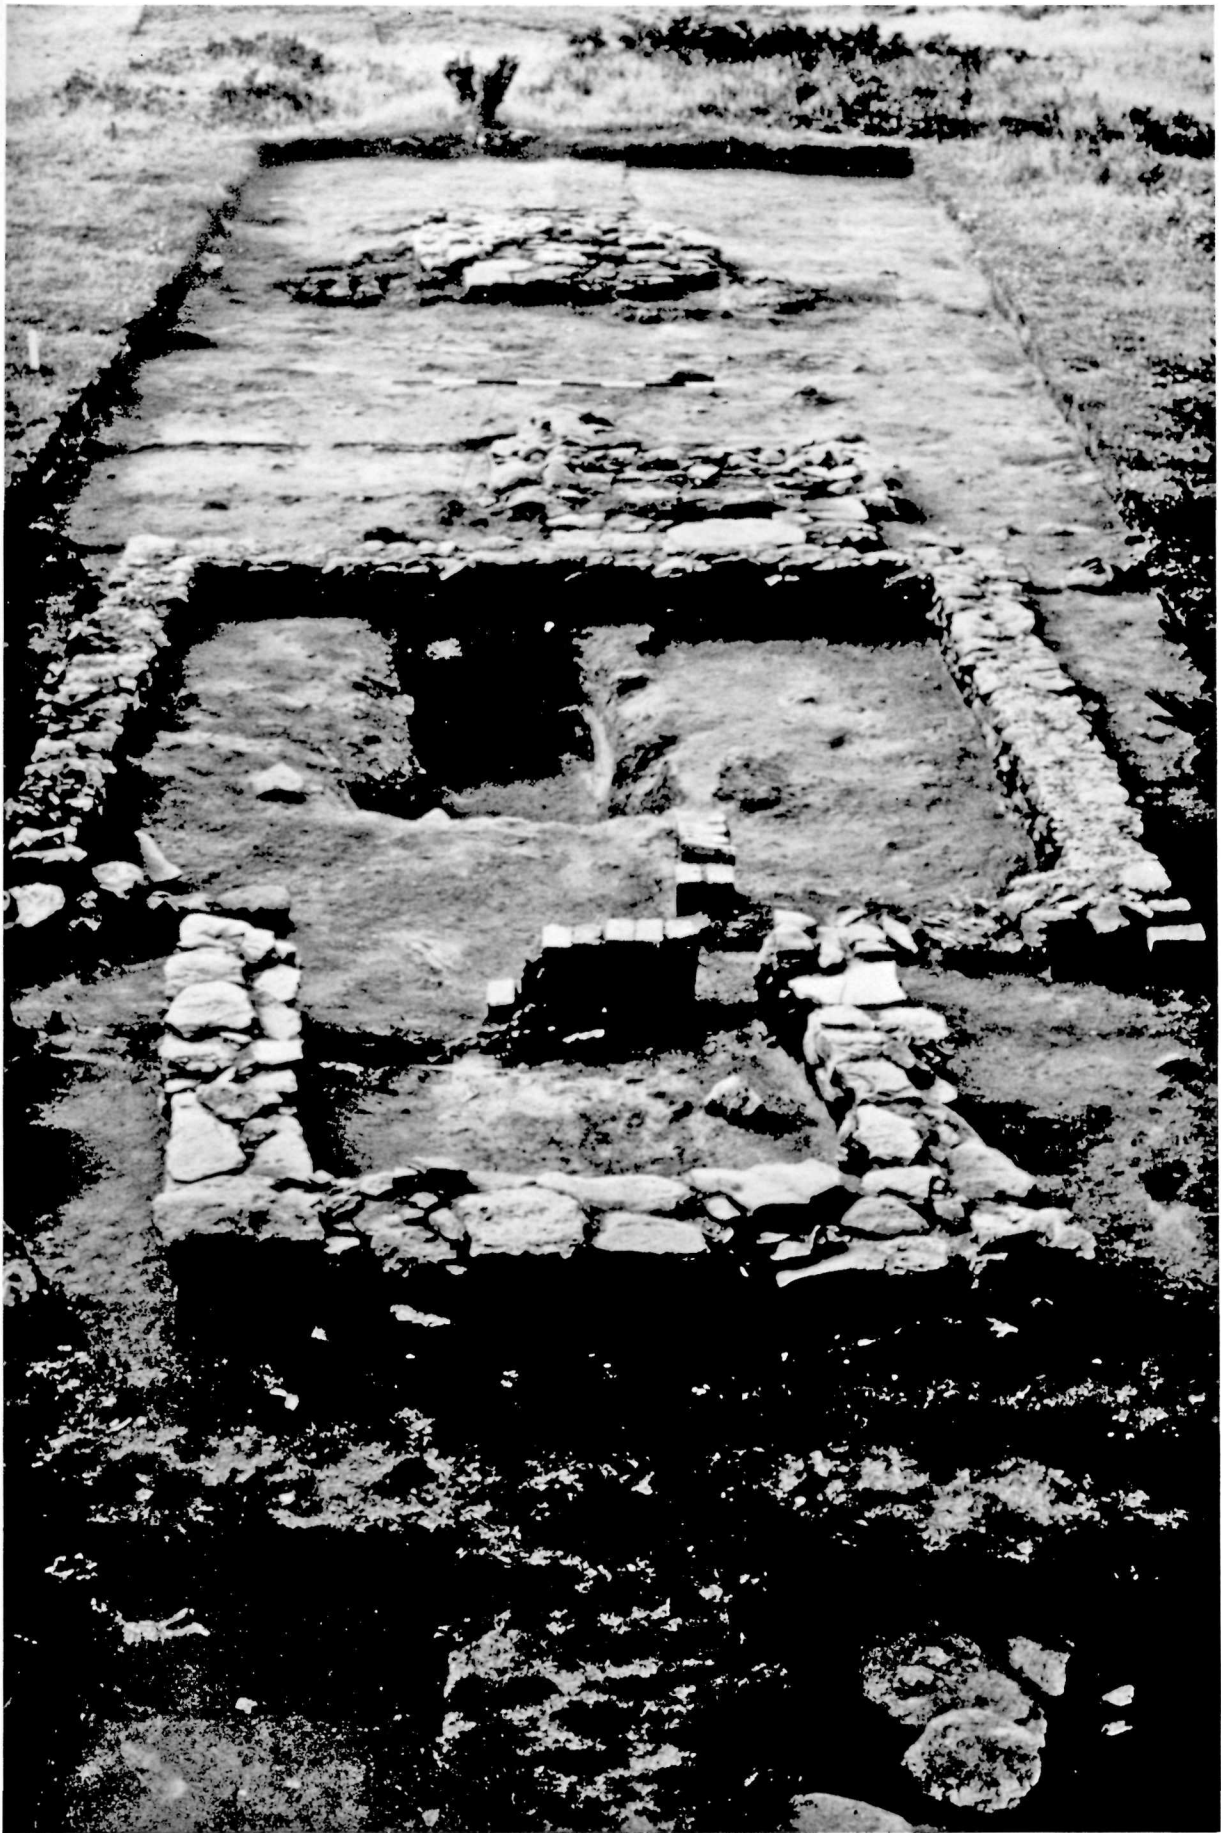
FIGURE 15

Figure 15: 1F15 - Excavation plan of the company house and
Brudenell Point houses.

The Brudenell Point house appears to have undergone a form of destruction equally as devastating as that experienced by the company house. Like the latter building, the Brudenell Point house was destroyed by fire and suffered heavily from the removal of structural hardware and other building materials, presumably to be used in the construction of a different house elsewhere. Hence, all that remains of this small dwelling are the foundations of the house and its annex, plus remnants of a brick structure along the interior north wall of the house (Figs. 14 and 15).

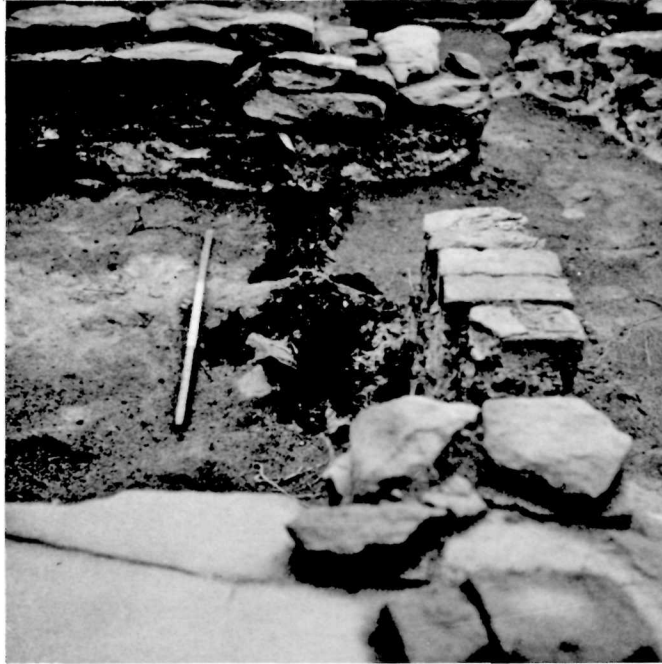
Figure 18: 1F15 - Southern hearth foundation of the company
house, facing south. 3 ft. scale.
(1F-952T, 1F-953T)

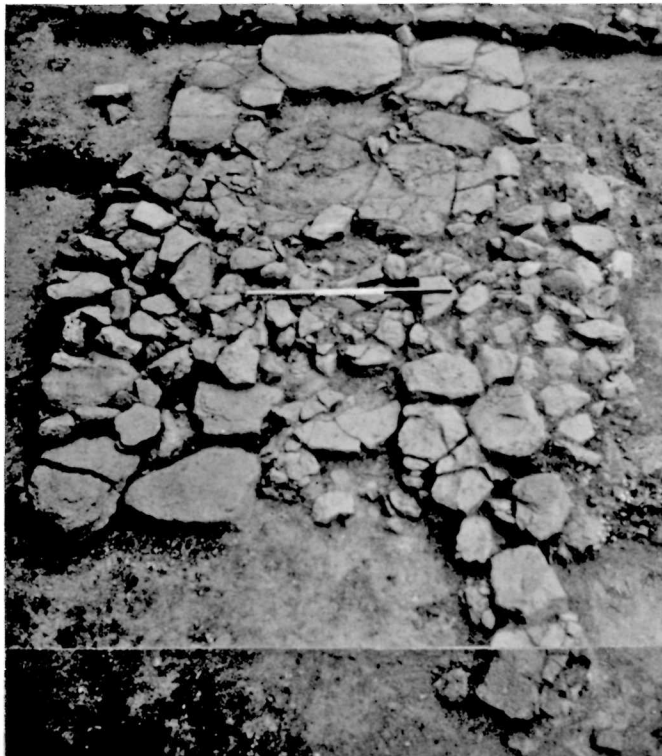
Figure 17: 1F15 - View of the northern hearth foundation
of the company house, facing north.
3 ft. scale. (1F-1030X, 1F-1031X)

The two hearth foundations were the major features to be uncovered in the company house, and these were found to be in a fairly good state of preservation. Both foundations were of the back-to-back variety and were constructed primarily of small field stones; although the hearth floors were made of larger, flat flagstones. Despite the fact that a portion of the southern hearth has been removed from the northern foundation, enough of it remains to indicate the original size (Fig. 17). This feature has a maximum length of 13.0 ft. (north-south) and width of 8.5 ft. across the centre of the hearth foundation (excluding the bricks along the east side). The flagstone floor of the northern hearth measured 6.0 ft. in depth and has a 3.2 ft. long by 1.0 ft. wide recess on either side. According to the stones outlining the hearth floor, the size of the hearth itself tapered from a 7.0 ft. width at the front to approximately 4.3 ft. at the back, and appears to have been no deeper than 1.8 ft. (excluding the probable vertical stone or wood mantle

supports). A fragment of a wood plank 1.0 ft. long, 0.7 ft. wide, and 0.1 ft. thick was uncovered in the eastern recess. This fragment may have been part of one of the floor boards or have supported part of the mantle frame. There is, as yet, no explanation for the series of yellow bricks found along the east side of both the northern and southern hearth foundations.

The southern hearth of the northern foundation is a virtual replica of its northern counterpart, with the backs of the two hearths separated by a distance of 2.2 ft. The back of this hearth is 0.5 ft. wider than that of the northern one, being 4.8 ft. wide.

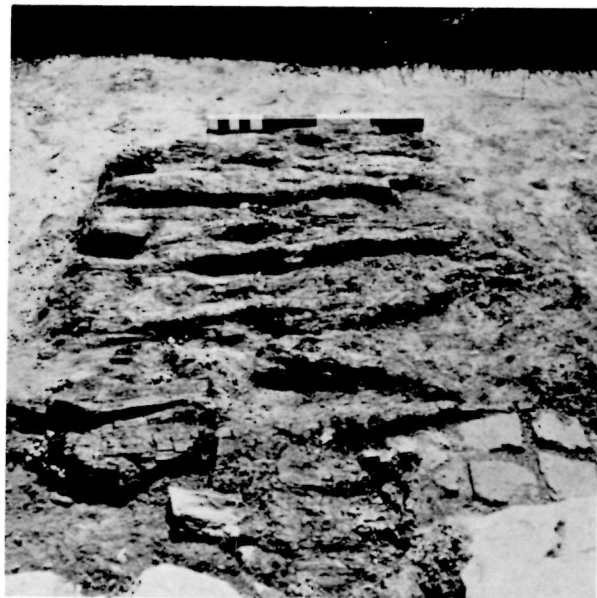
Figure 20: 1F15J - View of the charred wood remains forming part of the company house floor east of the southern hearth foundation facing east. 2 ft. scale. 1F-916X.

On the east side of the hearth, the only well preserved section of the company house floor was found (Fig. 20). It apparently consisted of five well defined planks, as well as a possible sixth plank along the east side of the hearth. These planks varied in length between 0.7 and 3.2 ft. and in width between 0.3 and 1.0 ft. The thickness ranged from 0.03 to 0.1 ft. and the elevation on top of this segment of the floor was 27.22 ft. ASL.

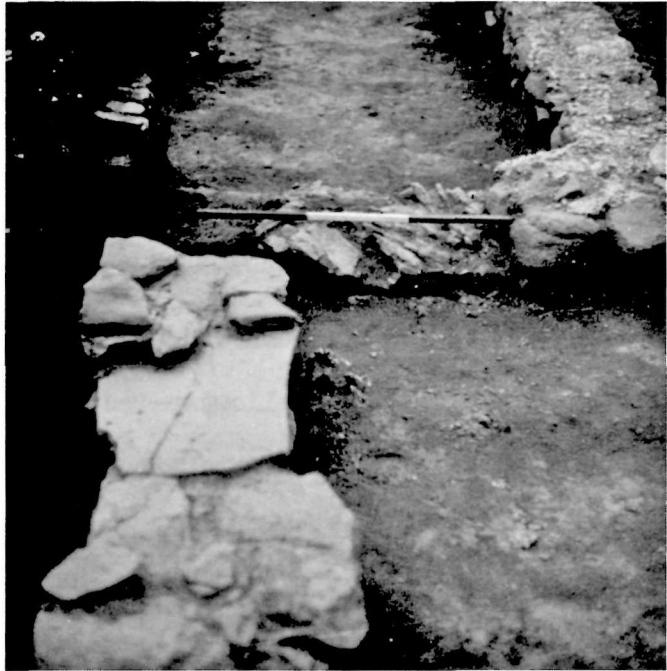
Figure 24: 1F15 - View of the brick formation in the centre of the north wall of the Brudenell Point house, facing west. 3 ft. scale. 1F-1056X.

The north foundation wall of this building may originally have been complete; however, only the northeast and northwest corners of this wall are still in existence (Figs. 22 and 23). Part of this wall definitely appears to have been removed; however, it is difficult to state whether this happened during the time that the annex was constructed or after the house burned down. Alternately, the large gap in the north wall may have been the original location for a brick hearth. Evidence for such a structure consists of two sets of bricks: one set, oriented north-south, lies within the main room of the house; the other, oriented east-west, lies across a portion of the north annex to the building (Fig. 24).

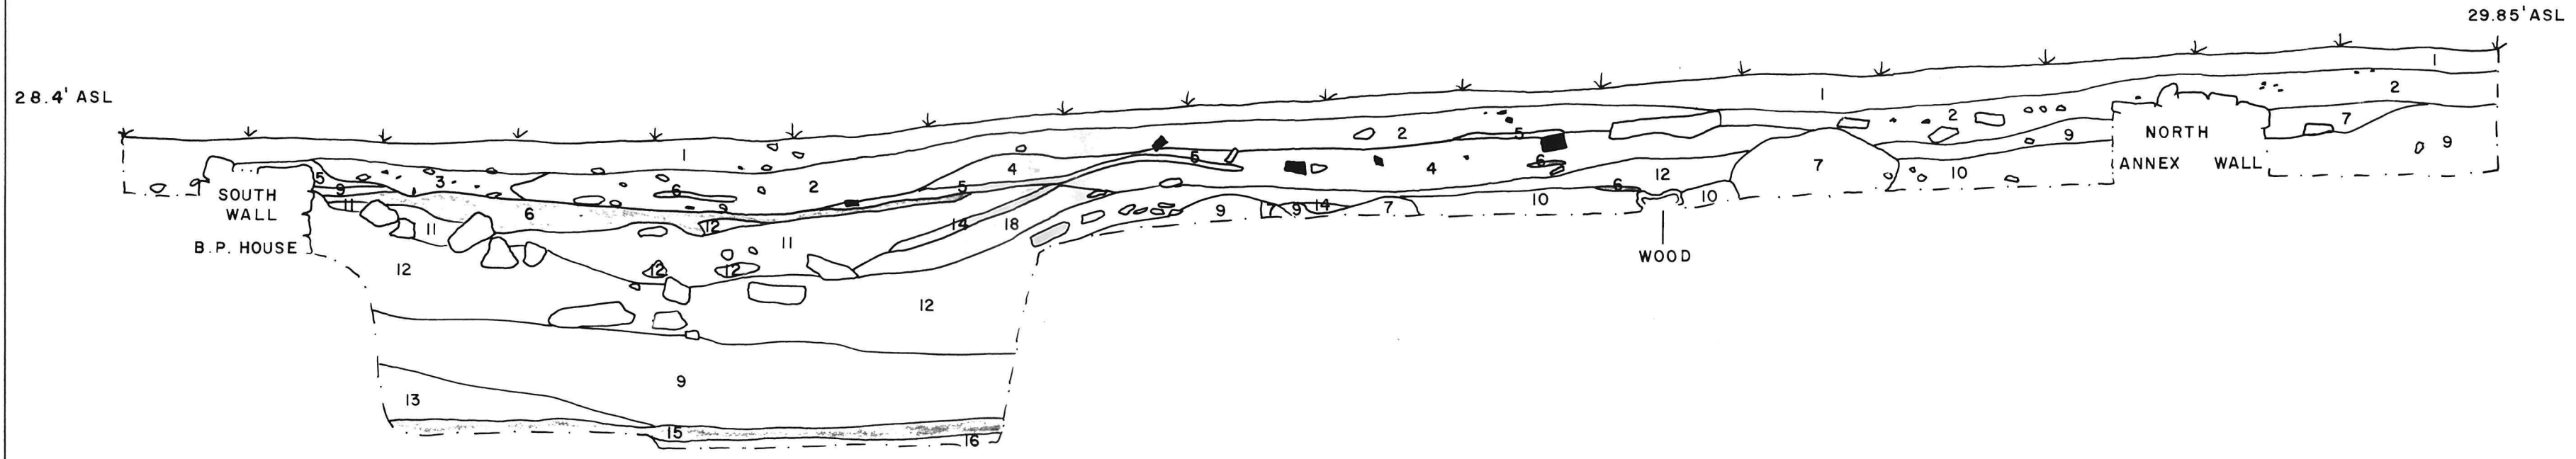
FIGURE 26

Figure 26: 1F15 - Stratigraphic section through the Brudenell
Point house.

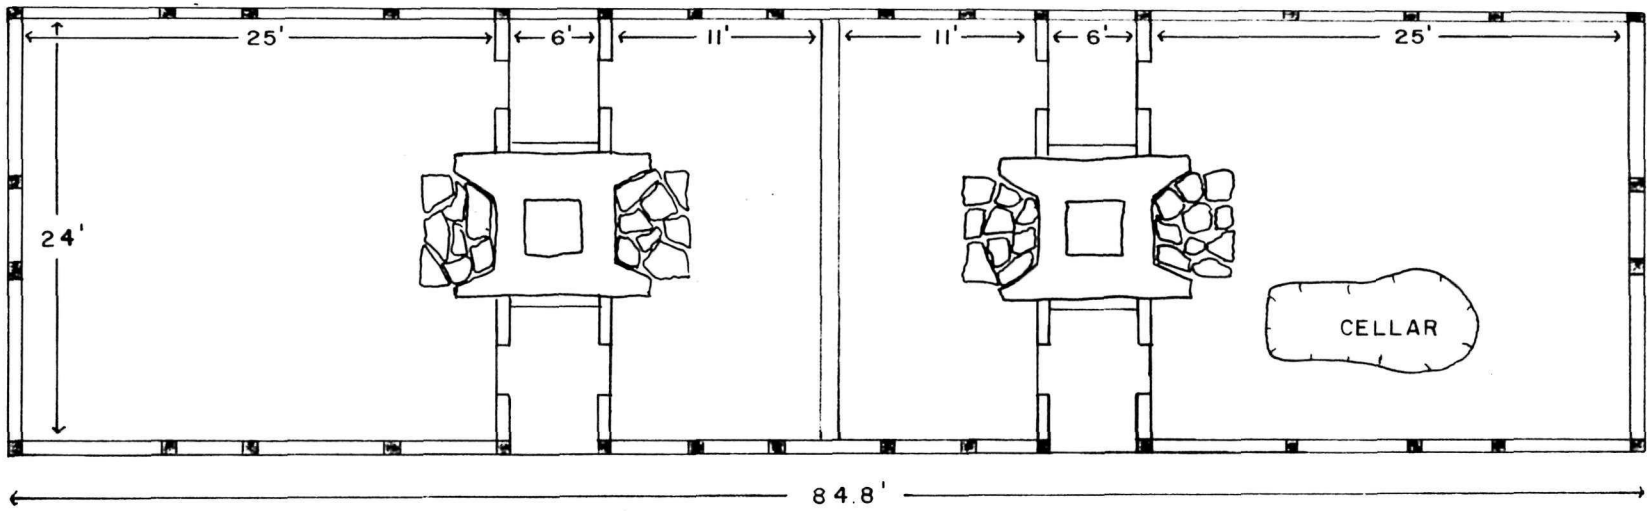
Figure 27: 1F15 - Hypothetical Reconstruction plan and elevation
view of the company house. (1F-72-104-1).

PLAN VIEW

ELEVATION VIEW

The destruction of the wooden, two story, 80 ft. long company house by fire in 1745; the removal of stones and structural hardware from the ruins by later settlers; and the effects of about 150 to 200 years of cultivation over the site of the building left very little of the original house intact by the time archaeological excavations commenced in 1968. The foundations of two back-to-back hearths, several charred floor board fragments, and some charred floor joists or their equivalent soil stains were all that was found after three seasons of excavation. No exterior walls were located (although evidence of these may still be found beyond the limits of the present excavation), and a portion of the building was entirely removed where the Brudenell Point house foundation is located - leaving a large gap in this section of the company house floor plan.

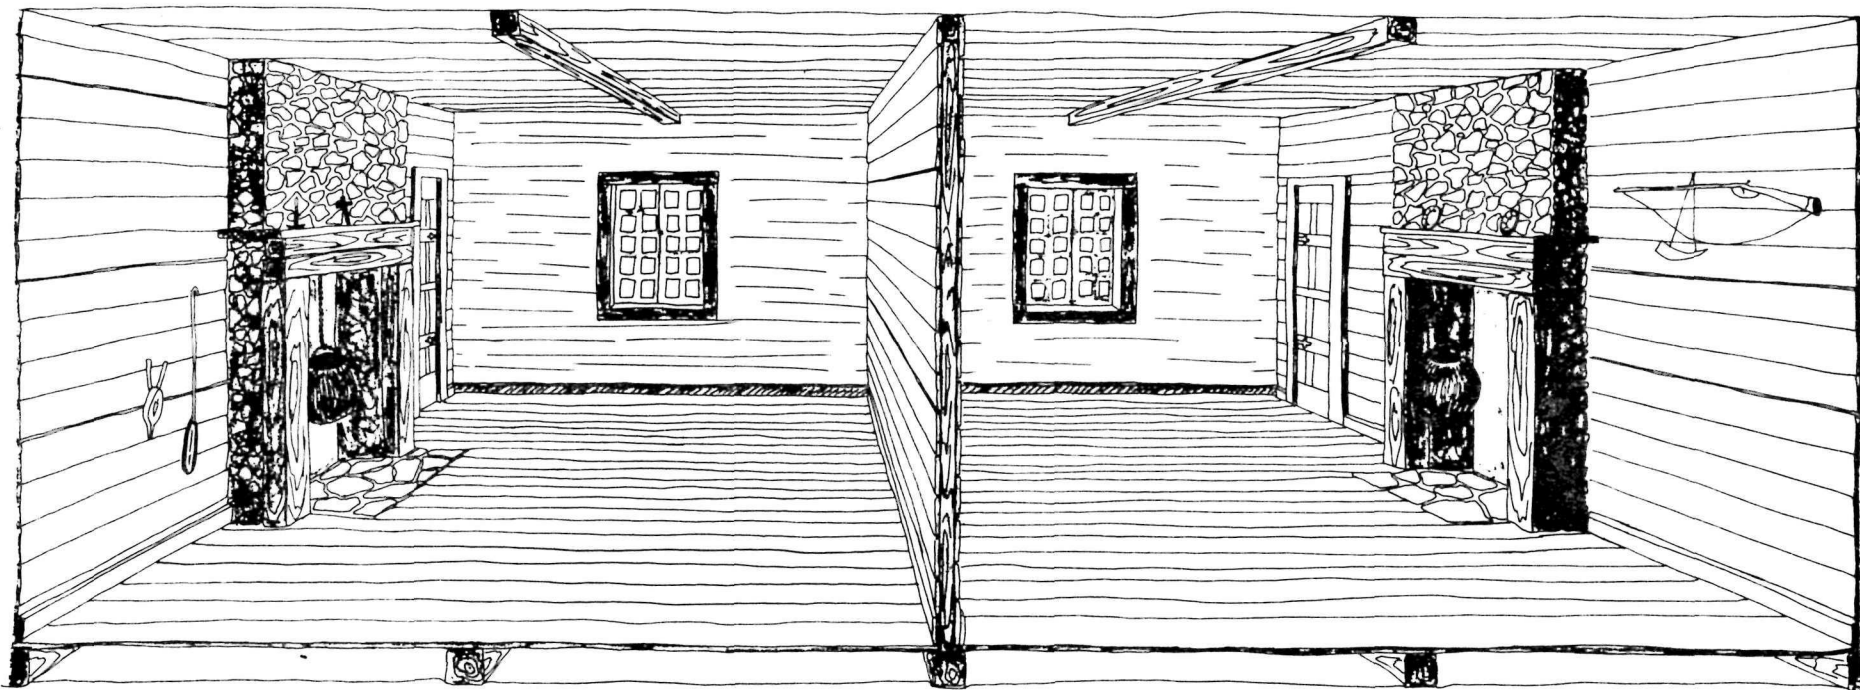
Figure 28: 1F15 - Hypothetical interior reconstruction of the
centre rooms of the company house.
(1F-72-104-3).

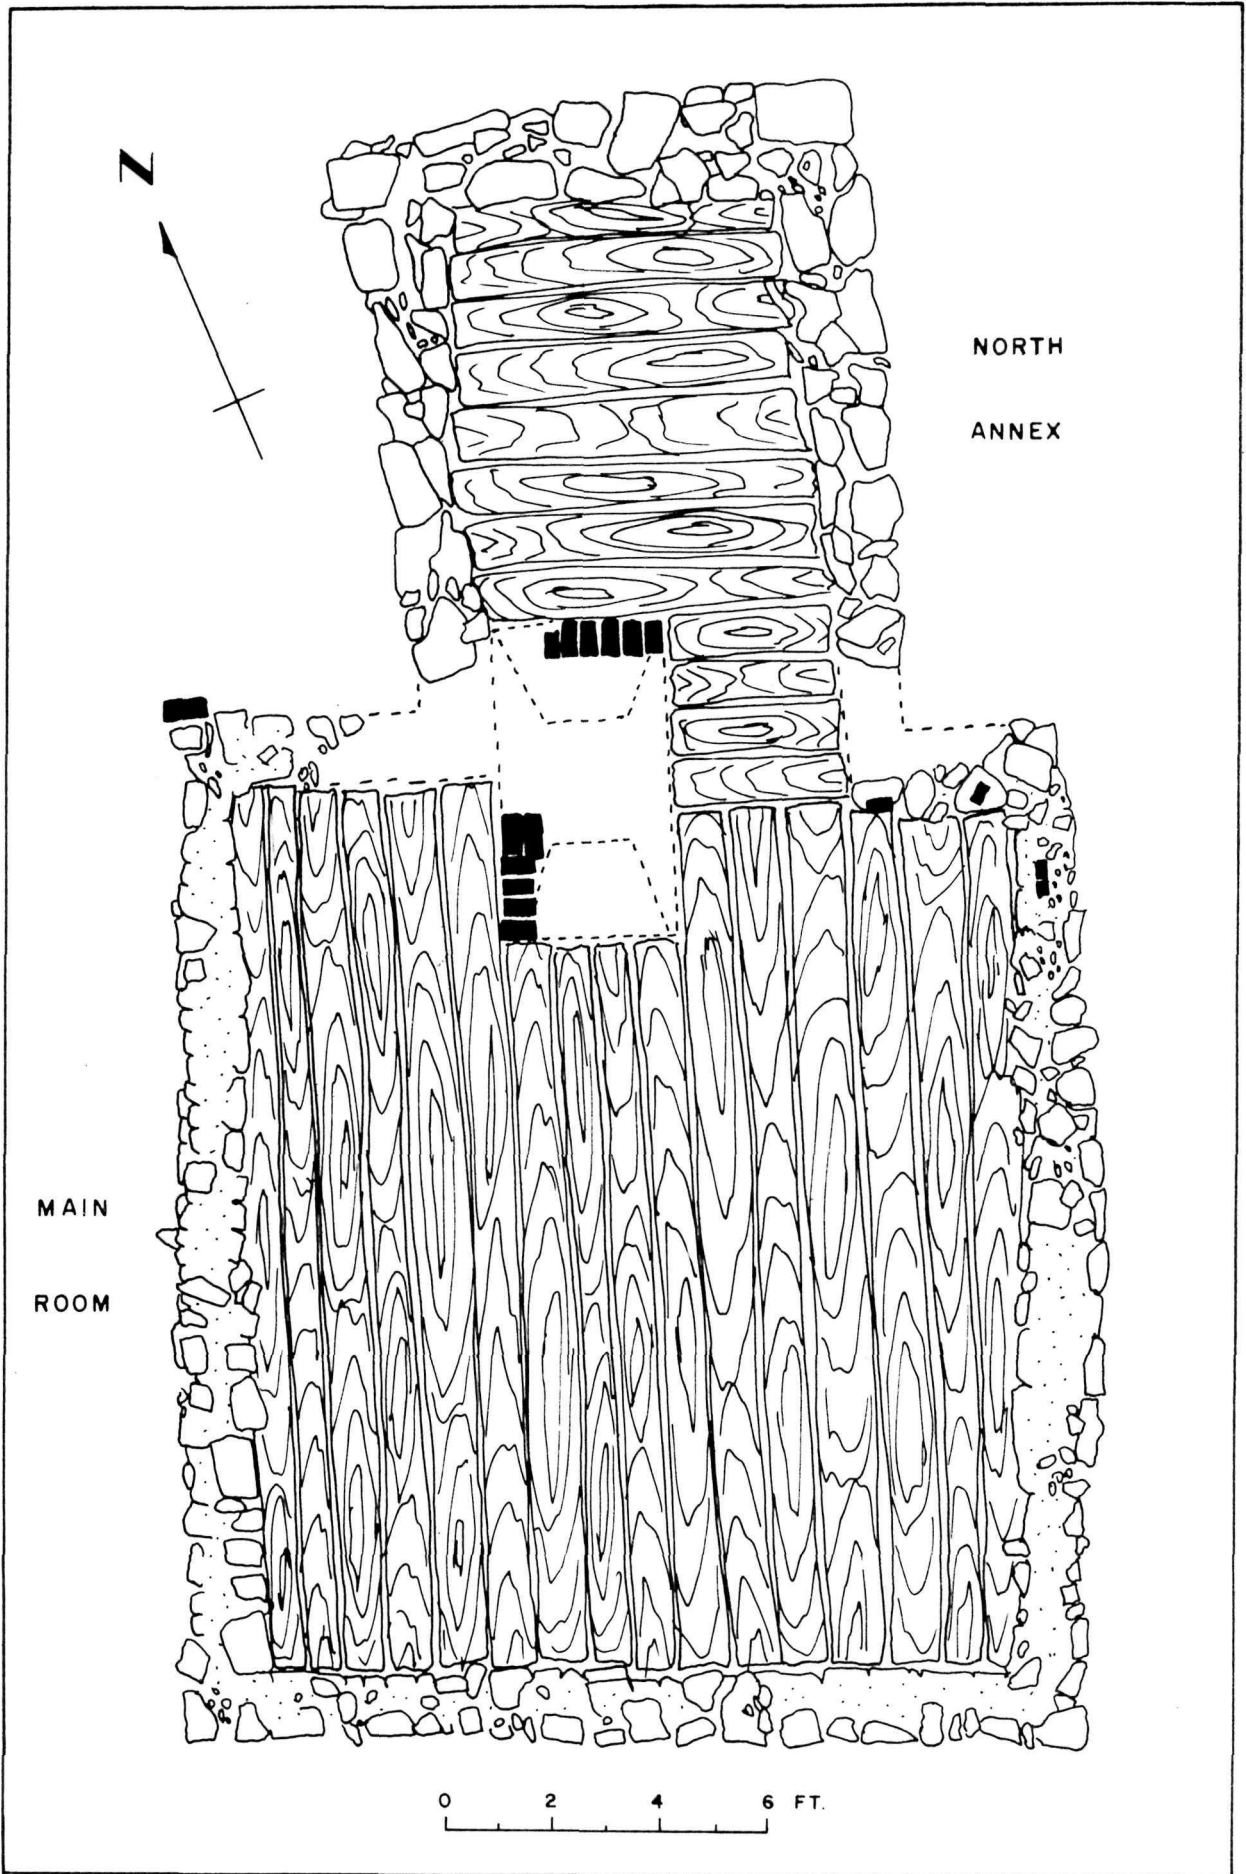
Figure 29: 1F15 - Reconstructed floor plan of the Brudenell
Point house. (1F-72-102-25).

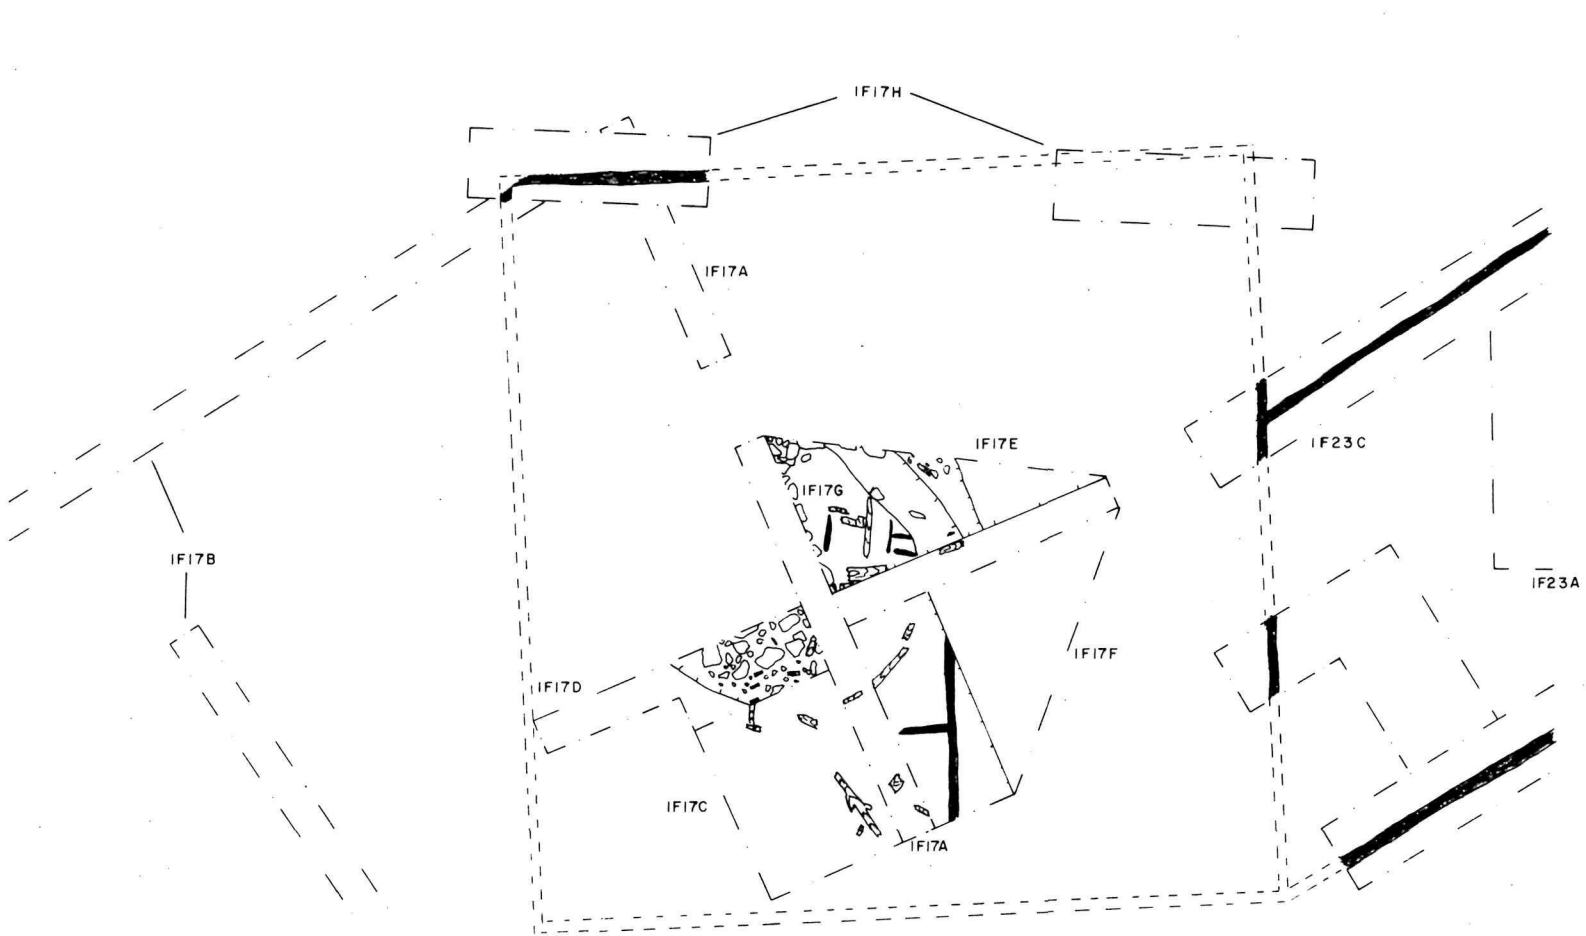
Figure 30: 1F17 - Excavation plan of unidentified French
building No. 2. (1F-72-102-38).

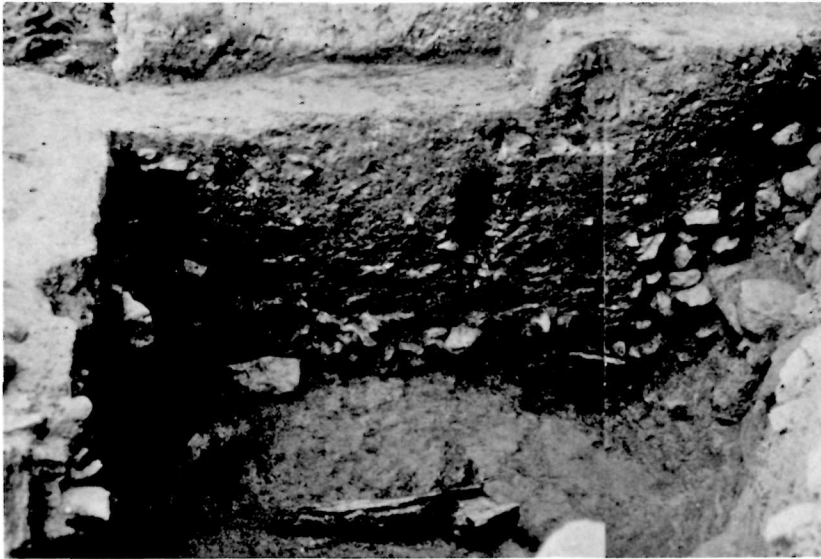
Figure 31: 1F17G - View of the cellar depression and south
trench wall stratigraphy, facing south.
Note wood fragments at base of trench.
No scale. 1F-1105X, 1F-1106X.

the apparent base of the depression - located at 7.6 ft. below the surface (or 19.8 ft. ASL) - a number of floor joist stains and some wooden plank fragments were found (Fig. 31), as well as the first relatively heavy concentration of 18th century artifacts to be found in this cellar depression.
