NATIONAL HISTORIC SITES SERVICE

MANUSCRIPT REPORT NUMBER 90

1970 EXCAVATION OF THE ROMA SITE

Report on the 1970 Excavation
at the Roma Site, P.E.I.

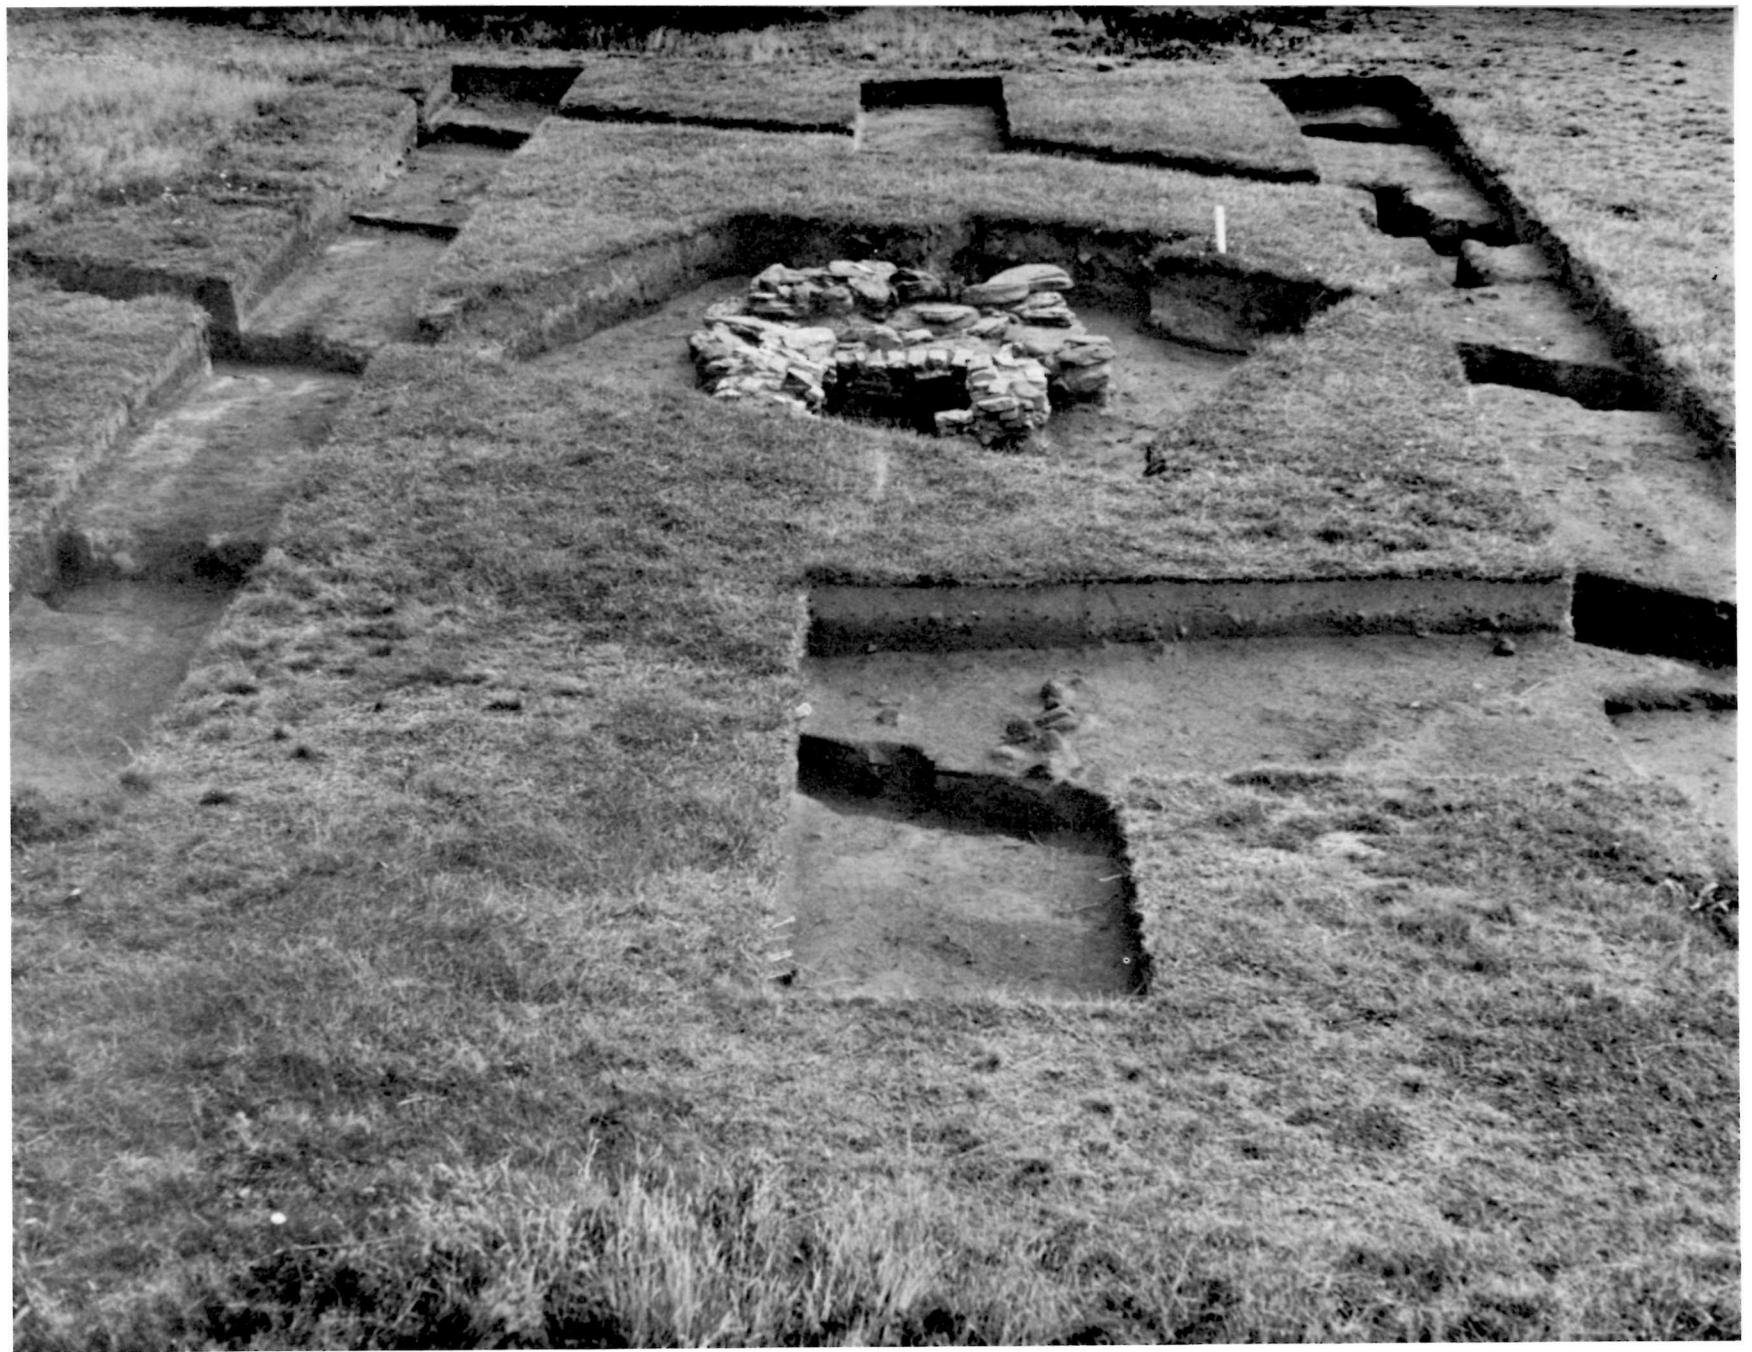
Figure 35: 1F23 - Excavation plan of the blacksmith shop.
(1F-72-102-35).

Removal of the dark brown loam plow zone over the assumed location of the east wall of the blacksmith shop revealed a dark brown stain in the yellowish-red subsoil and a few wood remains of the wall (Fig. 35). Approximately 49 ft. of the anticipated 52 ft. length of this wall was exposed, as well as traces of several possible floor joists and a number of vertical posts. All of the posts were found within the footer trench which marks the location of the east wall, and exists only below the level of the 0.8 ft. thick plow zone.

when one considers the extended length of the east wall of the blacksmith shop (Fig. 35). Unfortunately, the southeast corner of the latter building was not exposed during the course of excavation to determine if these two walls also meet; nor were any vertical posts uncovered in this 0.5 ft. wide stain.

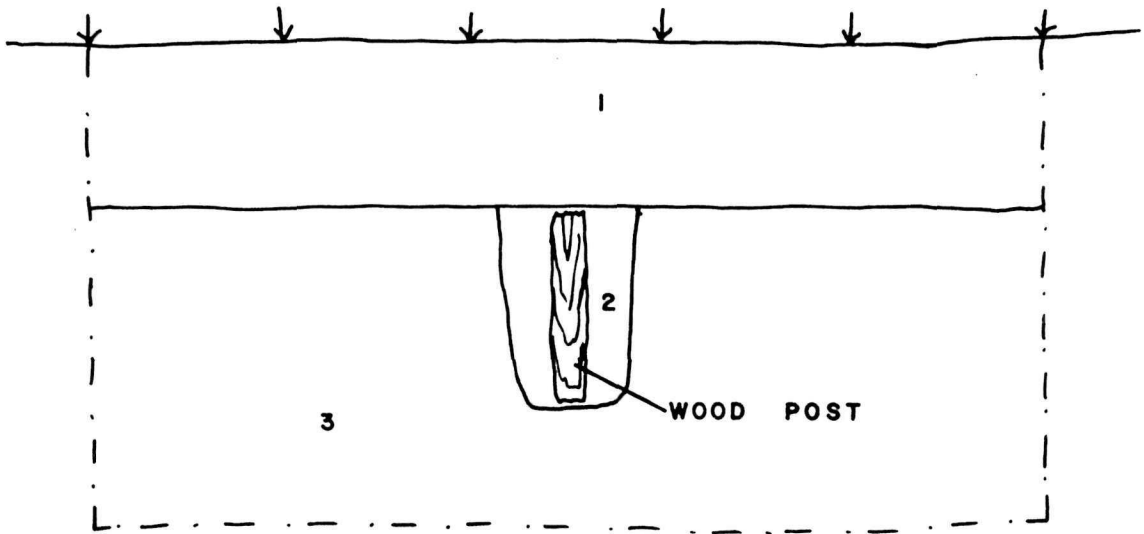
Figure 36: 1F23 - Typical section through footer trench for east wall of the blacksmith shop.

1. Dark brown loam (7.5 YR; 3/2).
2. Mixture of dark brown loam (7.5 YR; 3/2) and yellowish-red coarse sand (5 YR; 4/8).
3. Compact yellowish-red sand (5 YR; 5/8).
(1F-72-102-21).

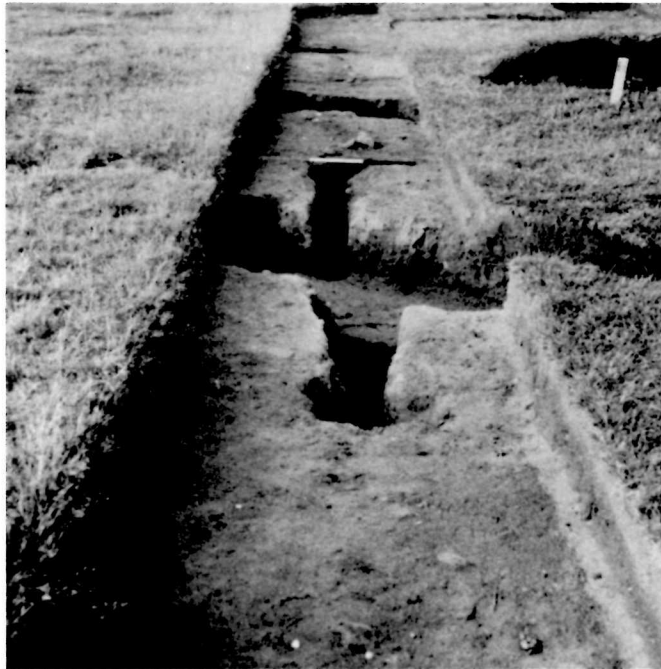
Figure 38: 1F23 - Plan view of forge foundation and two hypothetical reconstruction views. (1F-72-104-2).

Although total reconstruction of the blacksmith shop would be difficult without additional documentary or archaeological evidence, a reconstruction of the forge might be possible. From the archaeological data, the base level of the floor joists has been established with reasonable accuracy. This level has been placed at 26.0 ft ASL - about 1.3 ft. above the base of the ash box. The working level of the forge - situated about 2.5 ft. above the floor - would be over the ash box, while the chimney would be located over the north half of the forge foundation. A small depression in front of the ash box was created for the removal of the ashes. To facilitate movement on all three sides of the working area, this would probably have been covered by a trap door of some sort when not in use (Fig. 38).

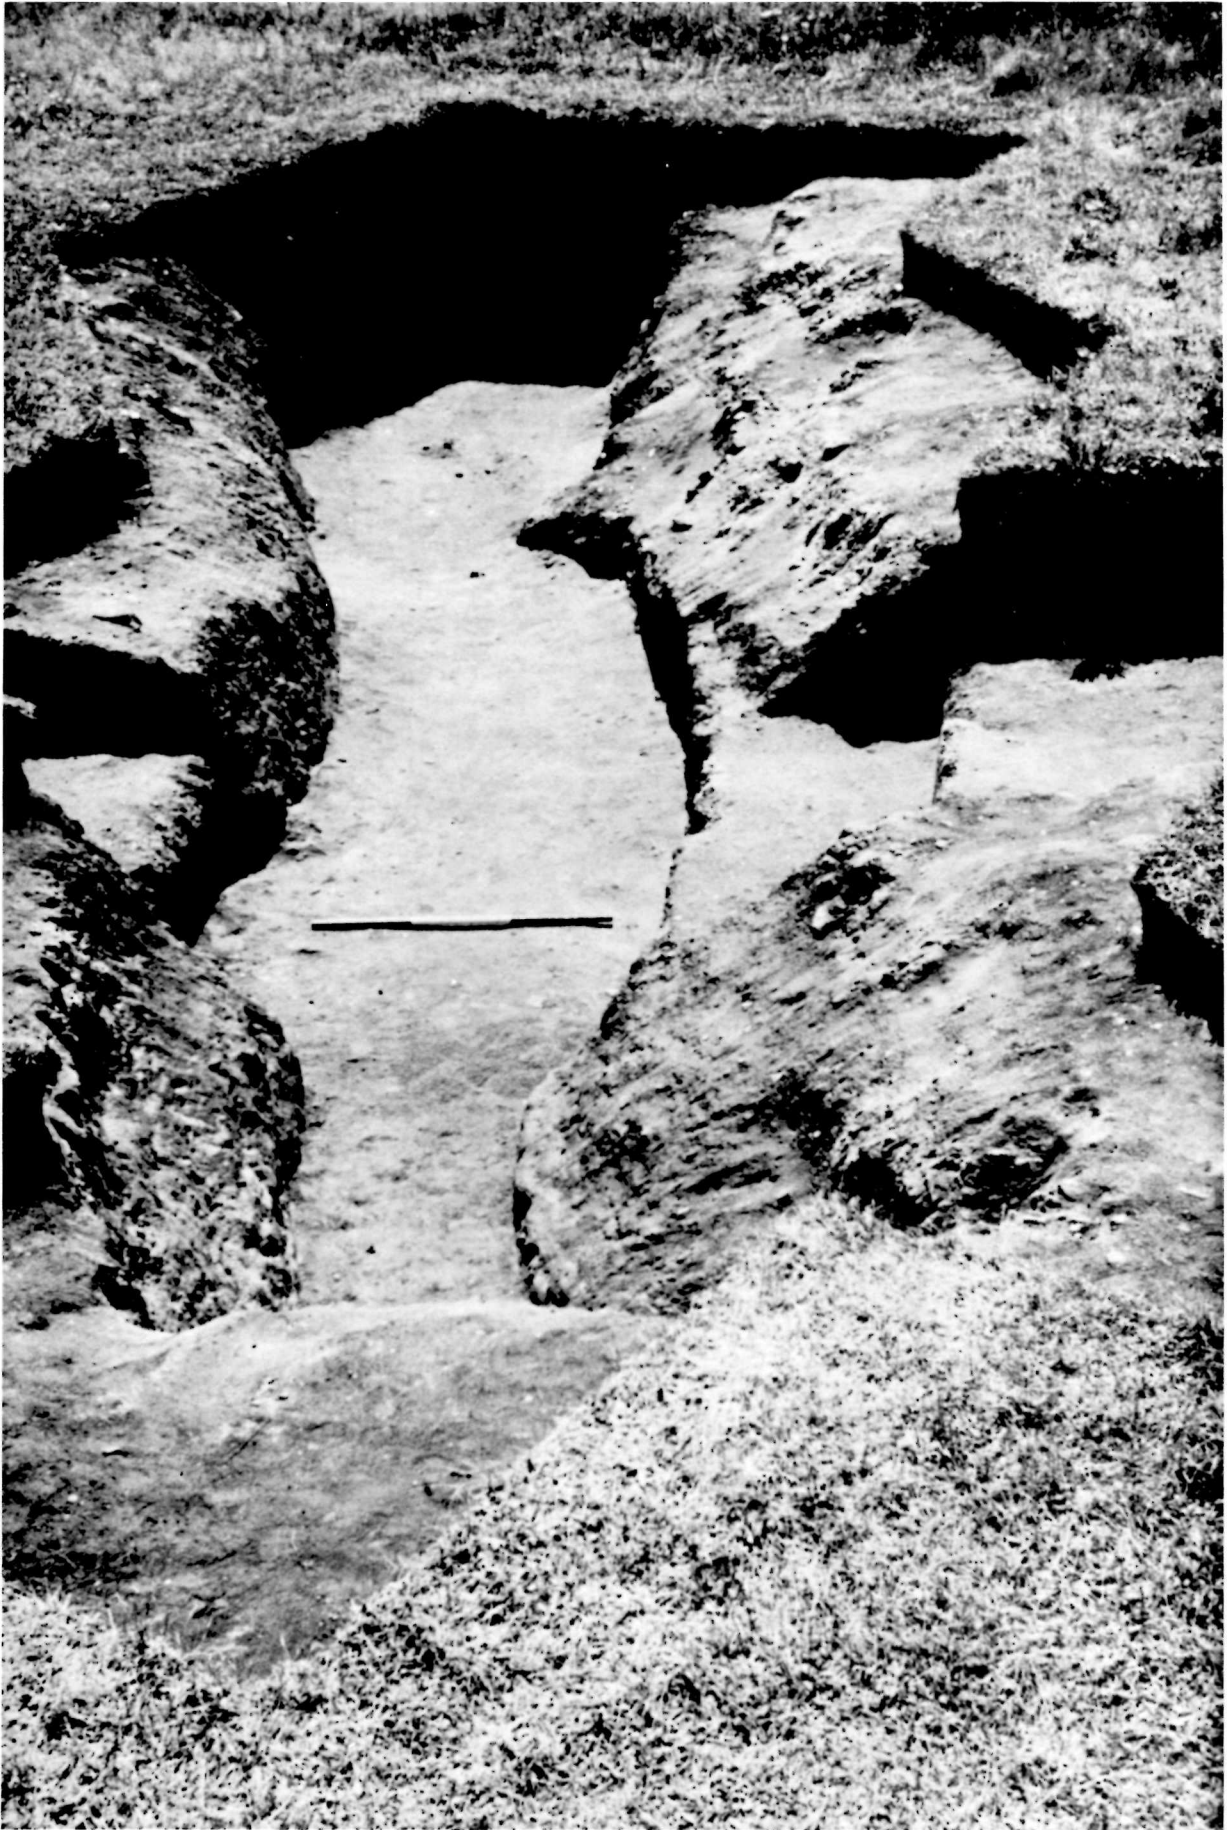
FIGURE 40

Figure 40: 1F24B - Stratigraphic section through the French
trash pit.

From the section drawing through the trash pit, the V-shaped outline of the pit can be seen to have an average depth of about 3.7 ft. below the surface, and an upper width of approximately 9.5 ft. (Fig. 40). The soil removed in 1968 (layer 7) consisted primarily of very dark brown loam mixed with thousands of oyster shells, while the layer excavated in 1970 was predominantly yellowish-red sand mixed with some dark brown loam (layer 2). The remainder of the soils beyond the limits of the trash pit depression constitute the undisturbed sterile sands of the site.

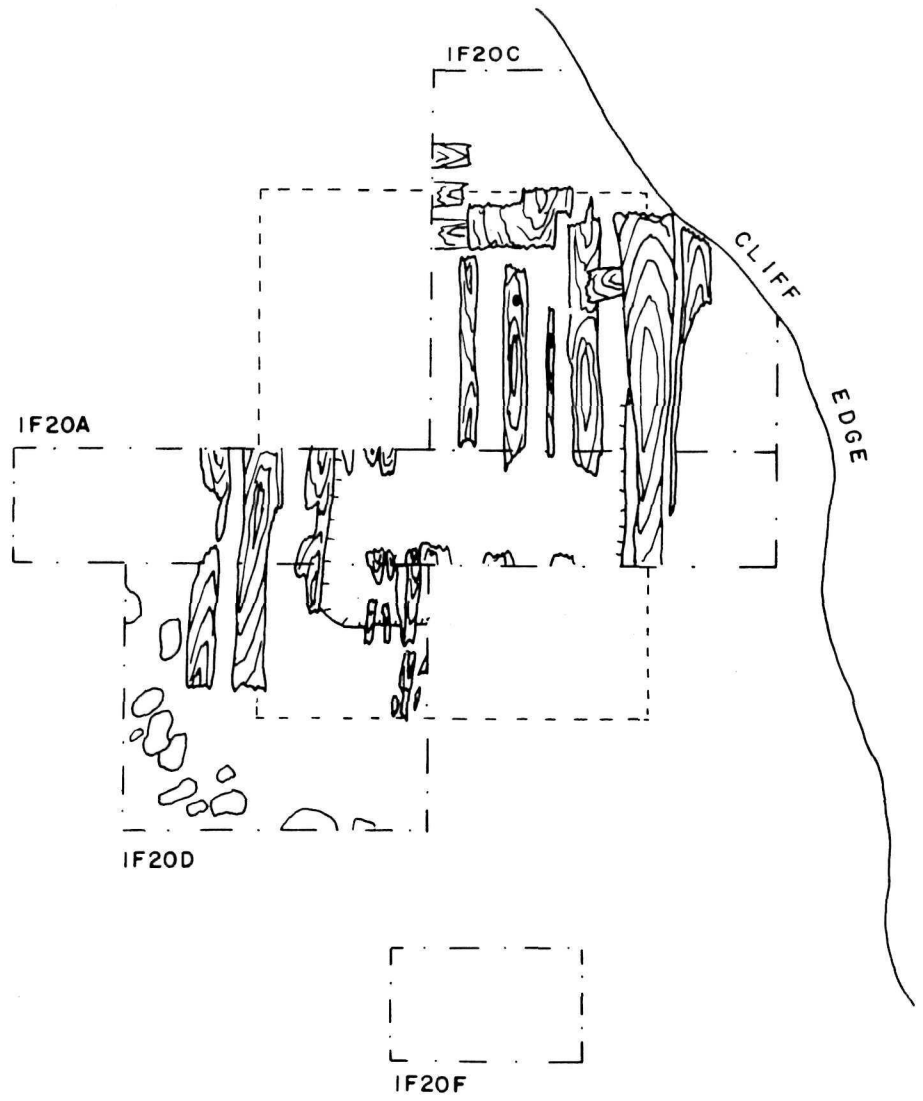
Figure 42: 1F20 - Excavation plan of unidentified building.
(1F-72-102-33).

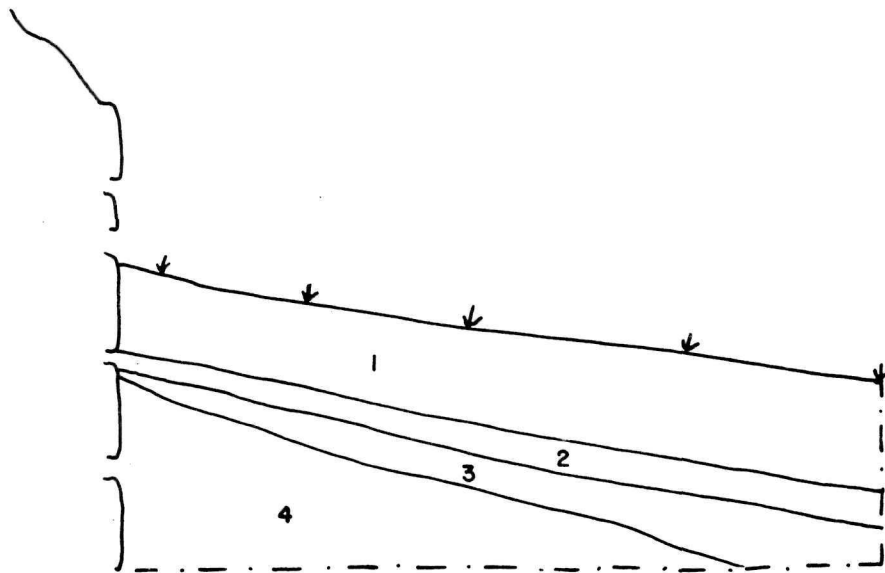
Figure 46: 4F1A - Stratigraphic section through Three Birches
site test trench.

1. Dark brown loam (7.5 YR; 3/2).
2. Dark brown loam (7.5 YR; 3/2), mortar detritus,
and brick fragments.
3. Charcoal.
4. Brown sandy loam (5 YR; 4/4).
