*BEHAVIOUR OF THICK-WALL
GALVANIZED PRODUCTS AT
ELEVATED TEMPERATURES*

J. J. SEBISTY AND R. H. PALMER

Mines Branch Research Report R 200

BEHAVIOUR OF THICK-WALL GALVANIZED PRODUCTS
AT ELEVATED TEMPERATURES

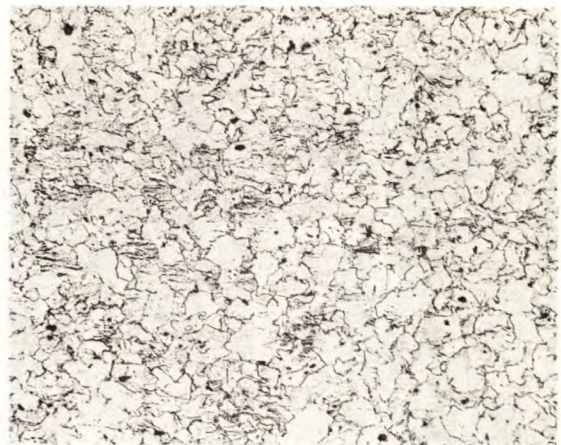
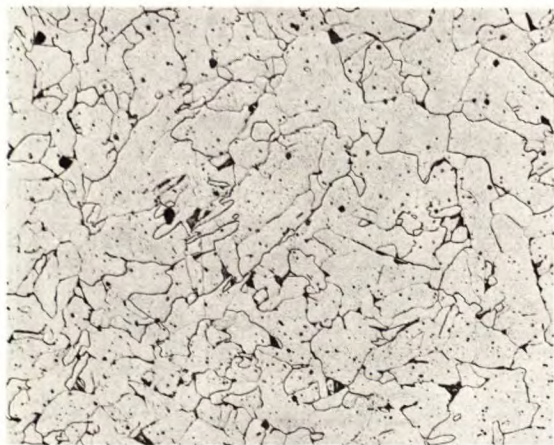
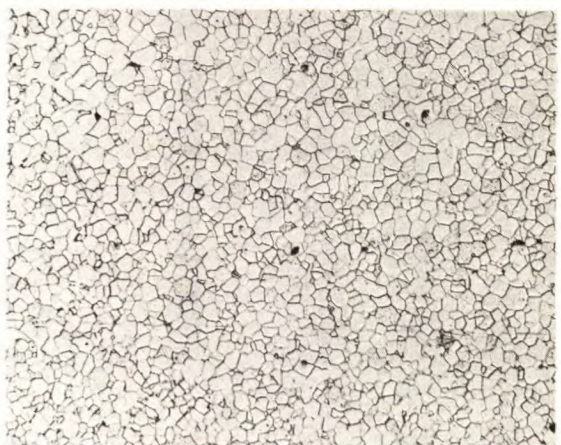
Figure 1. Microstructures of steel base in tubing, angle and bar products. X100.

The steel-base microstructures for the angle and bar products are also shown in Figure 1. Angle DA was a rimming steel with a fine-grained ferrite structure, whereas Angle CA and Bar CB were both semi-killed and had fine-grained pearlitic structures. Both of the latter were in the silicon range where, according to Sandelin⁽¹³⁾, accelerated galvanizing attack may occur. However, despite the similarity in steel-base composition and microstructure, as well as galvanizing preparation, Angle CA only was so affected. It had a very thick coating, made up largely of fine zeta crystals embedded in a zinc matrix (Figure 3(b)). Bar CB showed a more conventional layered-structure of iron-zinc alloy, as in Figure 3(c). It can only be assumed that the steel surface condition, as affected by processing history, in some way favoured accelerated attack of Angle CA but not of Bar CB.

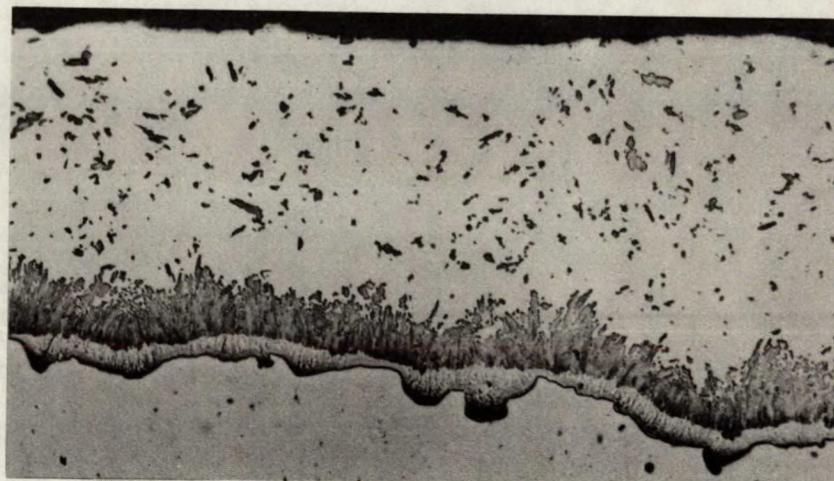
Figure 2. As-galvanized coatings on tubing products. Outer coatings are on left and inner coatings on right. X250 .

layer on the steam-wiped inner surface. It was, however, also partly dependent on the steel-base roughness, and on the attendant non-uniformity in iron-zinc alloy growth which influenced zinc drag-out (Figure 2). Minimum roughness was observed with the seamless tubing (DT) and, as Figure 2(b) suggests, this was reflected in much better coating-thickness uniformity on the inner and outer surfaces of this product.

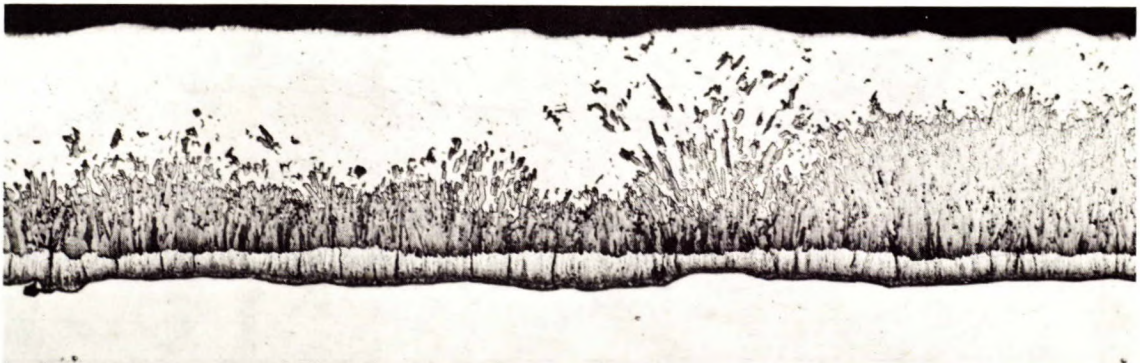
Figure 3. As-galvanized coatings on angle and bar products.
X250.

in Figure 3(b) was indicative of a reactive steel. The evident irregularity in reactivity at different points on the steel surface was retained throughout the different heating periods. As a result, the transformed coating developed an appearance as in Figure 17(a), with very thick fissured outbursts of the delta-prime phase being separated by areas showing more normal iron-zinc alloy growth.

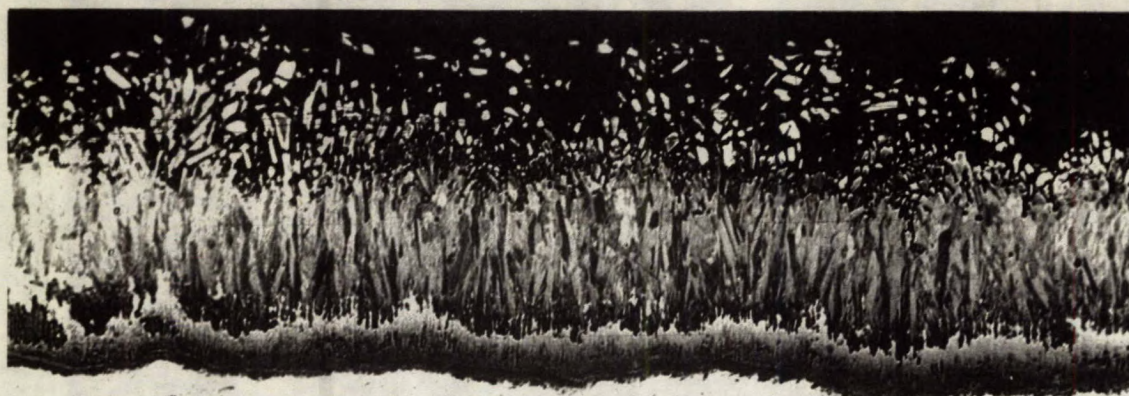
Figure 12. Coatings on Tubing ET heated at 250°C (480°F). X500.

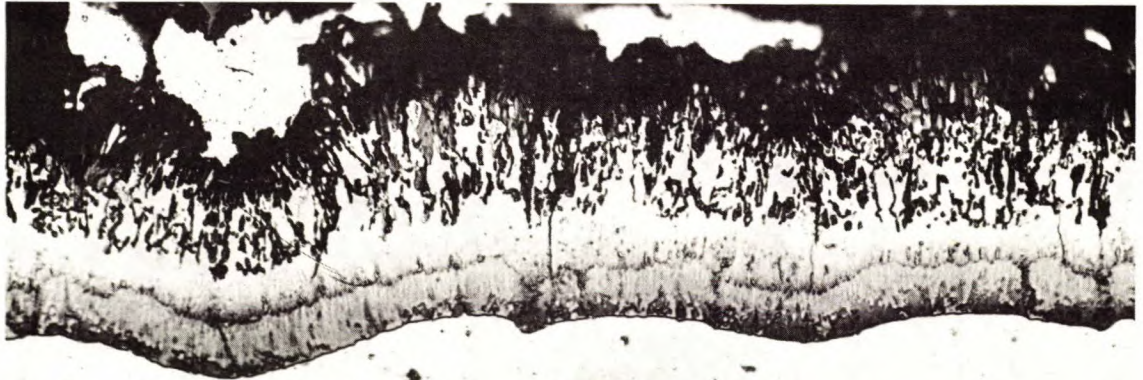
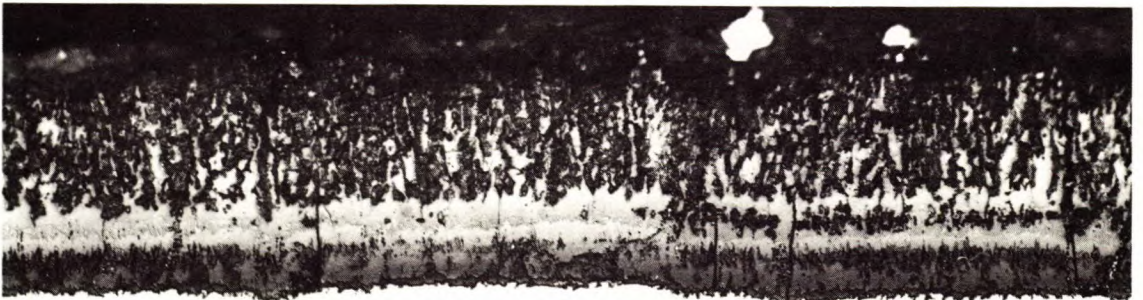
Figure 13. Outer coatings on Tubing CT heated at 300°C (570°F). X500.

The microstructural effects at this temperature essentially reproduced those found at the lower temperatures with, of course, more rapid onset of the various deterioration stages and more advanced long-term transformation changes. For example, the coatings on CT and ET revealed evidence of zinc separation within 4 hours. Tubing DT retained only a slight advantage at this temperature, since the same stage was reached in 8 hours. With all three products, most of the detached outer layer disappeared in less than 1 week, except in the thicker areas. Typical reaction effects with more prolonged heating of CT are shown in Figure 13. The characteristic transformation of the zeta phase to delta-prime in 4 weeks, leading to a heavily fissured outer band in the latter, can be seen in Figure 13(b). The depth of fissuring appeared to coincide with the boundary of the high-iron coherent-delta constituent. At 24 weeks, a complex intermixture of delta-prime and an unidentified dark-etching material, presumably an oxidation product, formed the bulk of the coating, as in Figure 13(d).

the shorter diffusion path through the thin coating present, was the probable explanation. Irregular fissuring of this layer, as evident in Figure 13, may also have been involved. In contrast, both DT and ET developed a fine filigree break-up (Figure 14), apparently as a result of transformation from the distinctive columnar zeta-phase structure evident with these products.

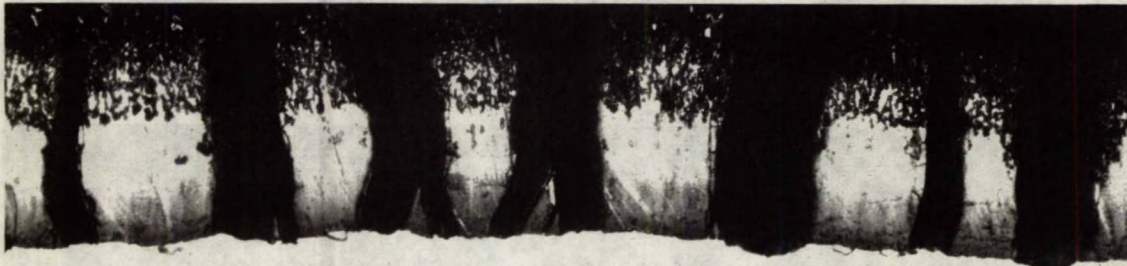
Figure 18. Microstructures of as-galvanized and heat-treated samples of Angle DA after bending. X250.

Although the depth of intergranular penetration of Angle DA in the above tests was minor in comparison with the section thickness, it was considered desirable to examine this further by bend tests. One-inch-wide pieces were removed from the legs of various samples and subjected to a zero-radius 180° bend by pressing between the platens of a tensile machine. Bending was first initiated by pressing a 3/4-in.-diameter (2-cm) mandrel down on the test pieces, which were roll-supported mid-way between the centre and ends of the 7-in. (17.5-cm) lengths used. Metallographic effects observed on the exterior bend of typical samples, inclusive of one heated at 400°C (750°F), are reproduced in Figure 18.

It can be seen that, with increasing exposure temperature, vertical cracking of the coating was more localized. Larger and larger blocks of iron-zinc alloy remained intact, thereby reducing the area of the steel surface which was subject to deformation and yielding in the bending process. This presumably accounts in part for the gross

"necking" gaps formed at the maximum temperature of 400°C (750°F). Yielding was initiated at preformed intergranular cracks and, to this extent, the penetration into the steel base during heating was detrimental. Nevertheless, the "rounded" form of the gaps suggests significant ductility below the crack roots. Embrittlement as such was thus apparently minimal for the type of stressing involved in the slow-bend test. It will be appreciated that a similar response cannot be extrapolated to notch-toughness impact tests, and more so because carbon rimming steels have inherently poor notch-toughness characteristics in any case.
