SHORE PROPERTY STUDIES &
TIDES, CURRENTS & WATER LEVELS
CENTRAL REGION

"A STUDY OF THE LAKE HURON STORM SURGE
OF AUGUST 22, 1971"

Prepared by: N.G. Freeman
Regional Tidal Officer

CANADIAN HYDROGRAPHIC SERVICE
MARINE SCIENCES BRANCH
ENVIRONMENT CANADA

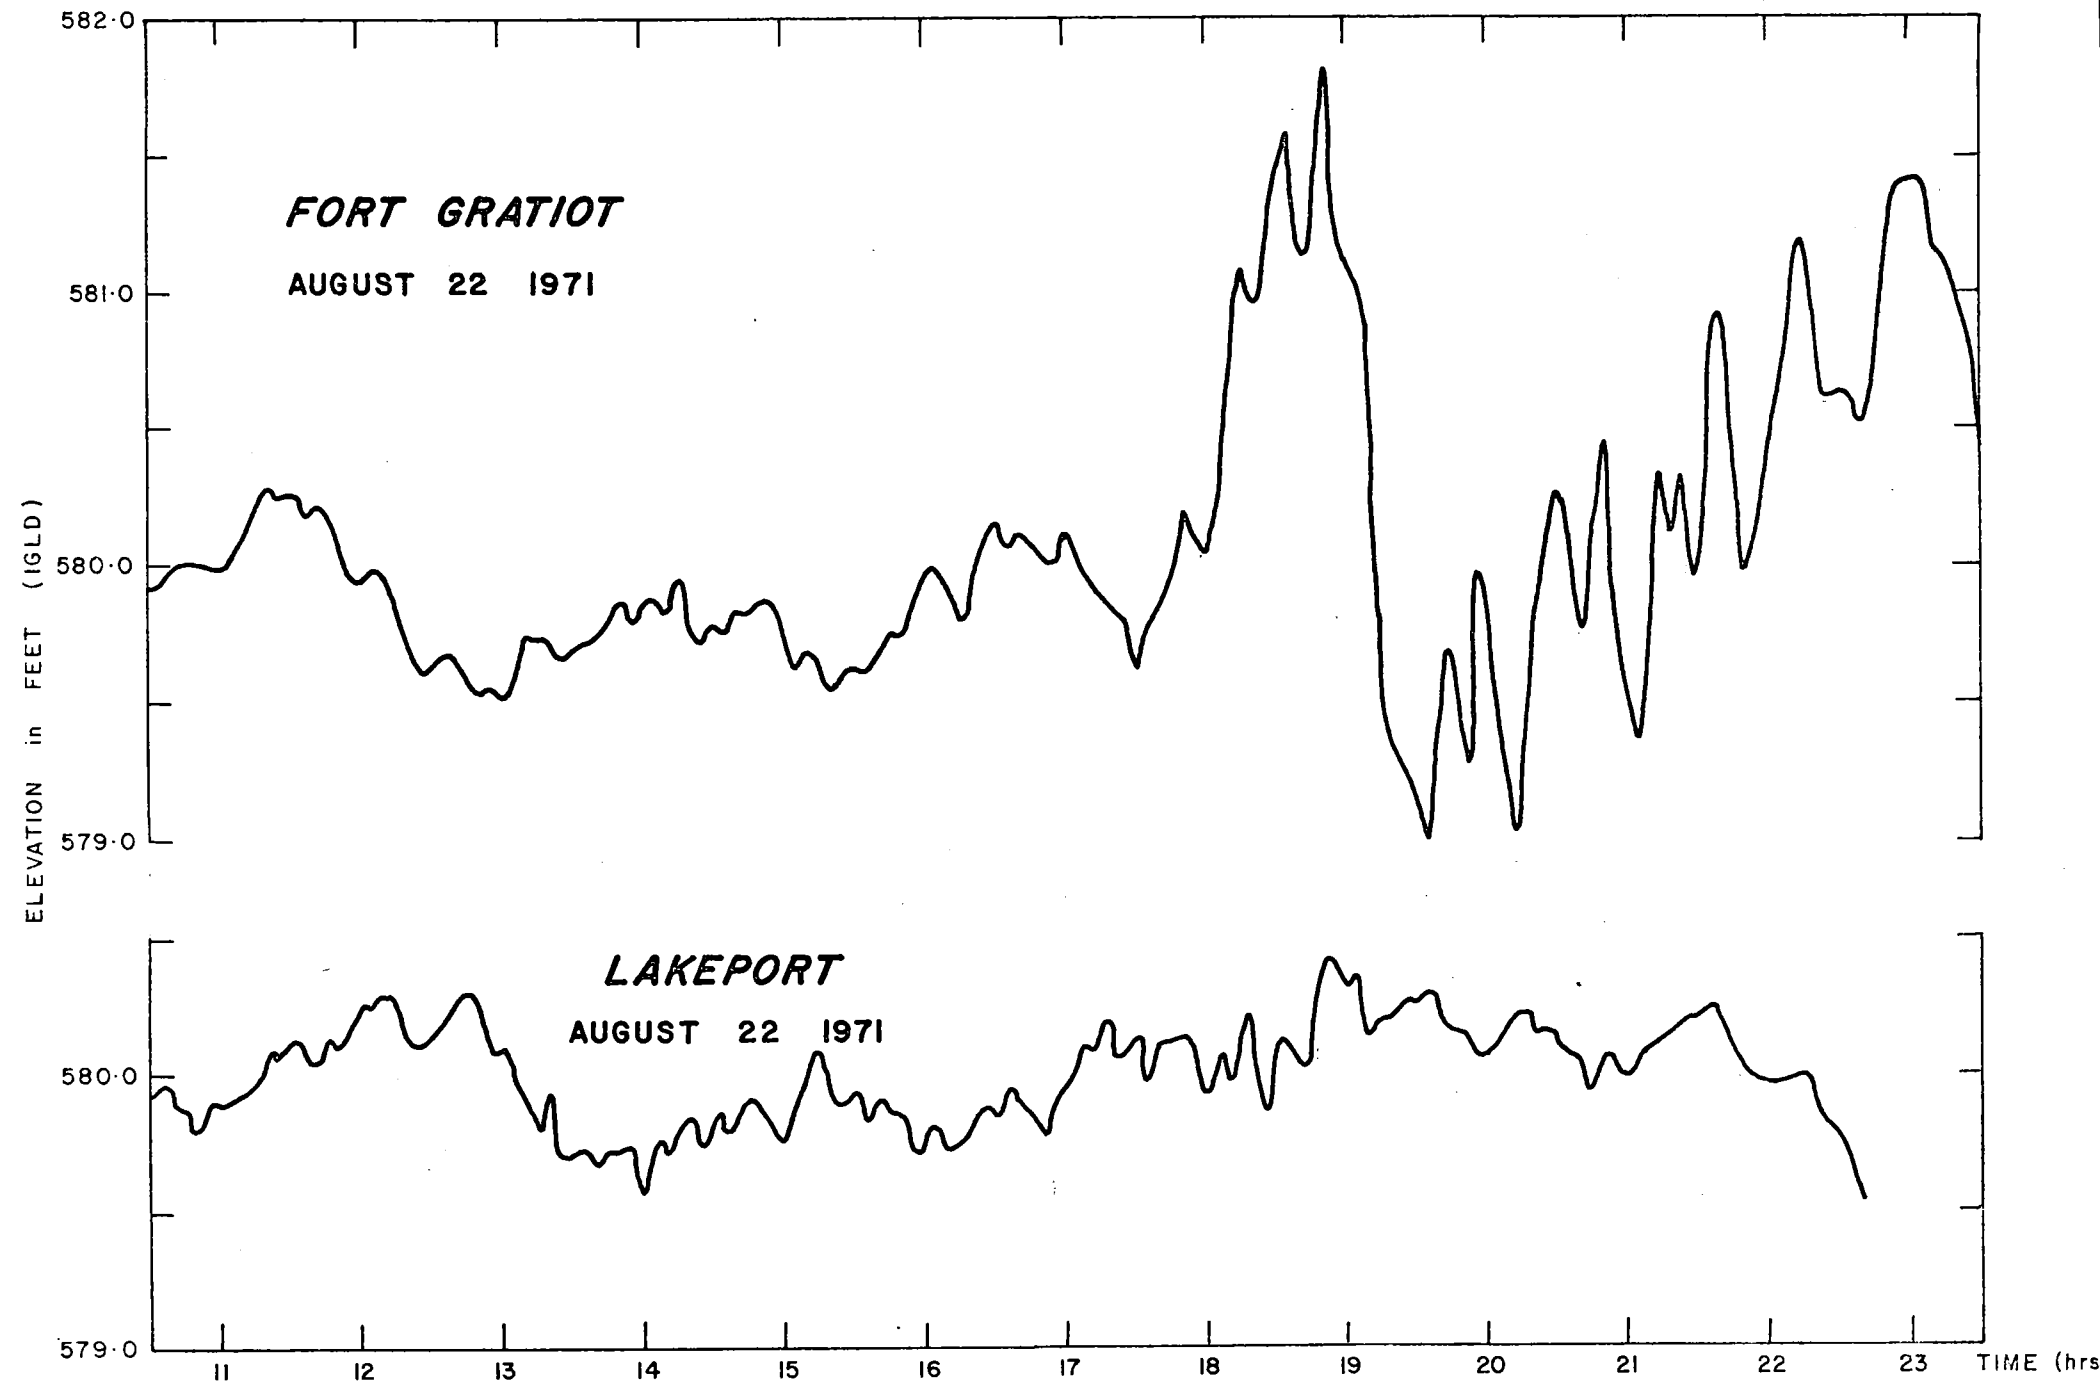
FIGURE 8

In Figure 8 the water level data at Lakeport and Fort Gratiot were plotted on an expanded time scale in an attempt to ascertain why the storm surge, and for that matter, the entire large scale wind set-up was only negligibly reproduced in the Lakeport record. From geophysical considerations it can be deduced that the passage of the intense portion of the squall line over the Lakeport area brought with it a solitary storm surge wave that bowed out due to a change in bathymetry, but was not recorded on the Lakeport gauge within the period of record. The salient explanation might be that the recording instrumentation was malfunctioning, as the record terminated abruptly at 2215 - however, this deficiency can be attributed to the general electrical failure in the area following the passage of the storm squall. An alternate interpretation is that the water level sensor dampened the storm surge fluctuations due to significant fouling of the water intake port in the stilling well - this deficiency illuminates the need for additional information on the effect of port size variation on the response time of water level gauges. In Platzman's

WATER LEVELS — — — LAKE HURON

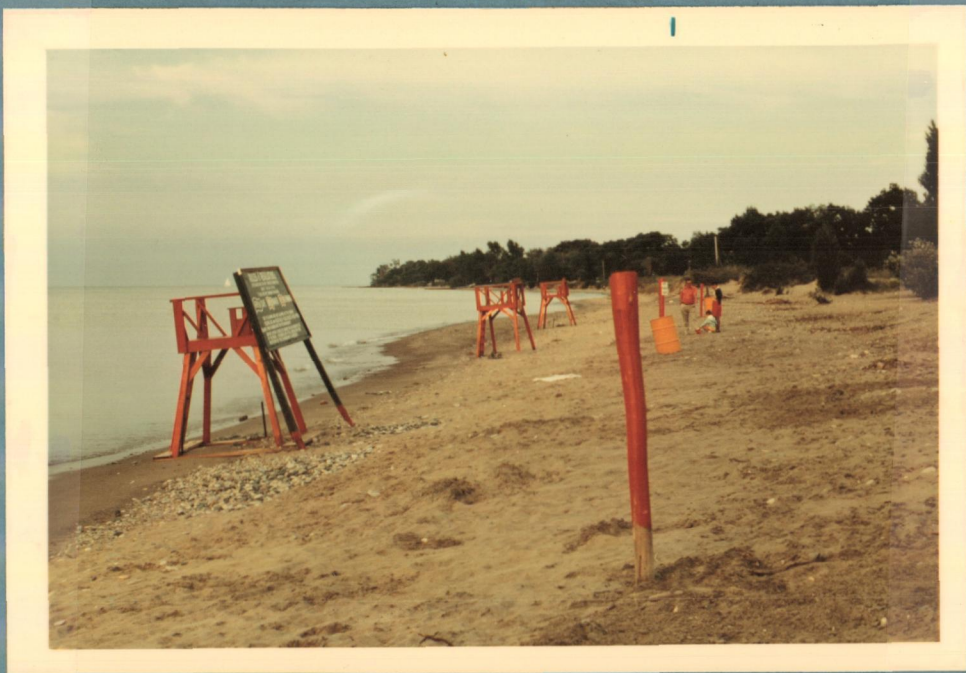
Photographs taken the day after the storm provided a qualitative "picture" of the extent of the onshore erosion damage (Plates 3 to 10). In Plate 3 it can be seen, by the exposure of the unpainted portion of the pole, that a half foot layer of sand, churned up by the uprush of the storm waves, has been scoured away during the downrush, leaving a layer of coarser sand and pebbles behind. The extreme penetration, by the storm generated waves, on this fairly wide beach is due to the storm induced two foot rise in water level. The extent of this penetration can be seen in Plate 4 by the exposure of tree roots far inshore and by the formation of a berm onshore - this horizontal deposit of beach material is normally found well offshore. In Plates 5 and 6, it can be

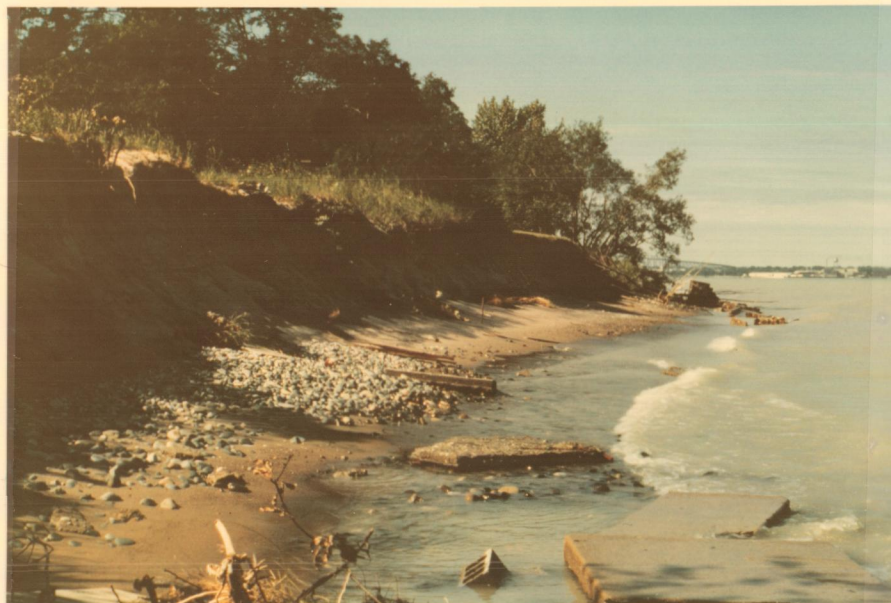
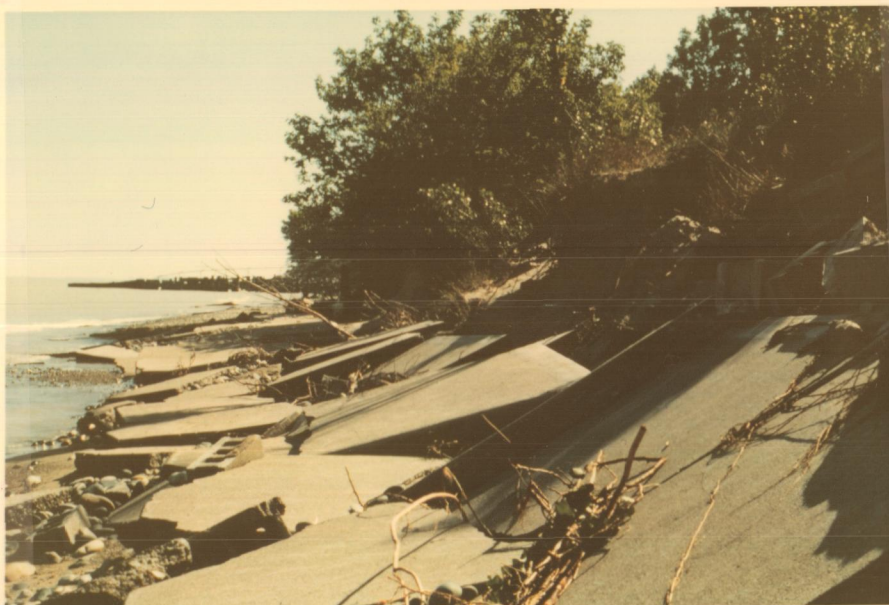
Plate 5

observed that an eight foot wide sidewalk has been severely undercut by the erosion of the supporting sandy bluff causing it to collapse. Plate 7 demonstrates the effective design and placement of groynes for the long term accumulation of littoral drift, while Plate 8 illustrates the deficiencies of such systems, especially when a sloping onshore beach cannot be established. Plate 9 is an example of the slower rate of erosion of the more cohesive clay at the toe of the bluff, along with the more rapid scouring of the upper layer of sandy loam. Again the rise in water level facilitated the attack of wind generated surface waves in penetrating higher on the bluff. In plate 10 the effects of the most severe localized erosion can be seen. The concrete foundations for the boat-house have been completely undercut, tree roots have been exposed, causing trees to topple, and ten feet of sandy bank have been lost to erosion.
