ARCTIC SURVEYS
PROJECT NUMBER 6600-76-1
MARCH - MAY, 1974

J.H. WILSON
HYDROGRAPHER-IN-CHARGE

Central Region's 1974 Arctic Survey was a continuation of our objective to completely chart the navigable waterways of the Arctic Islands.

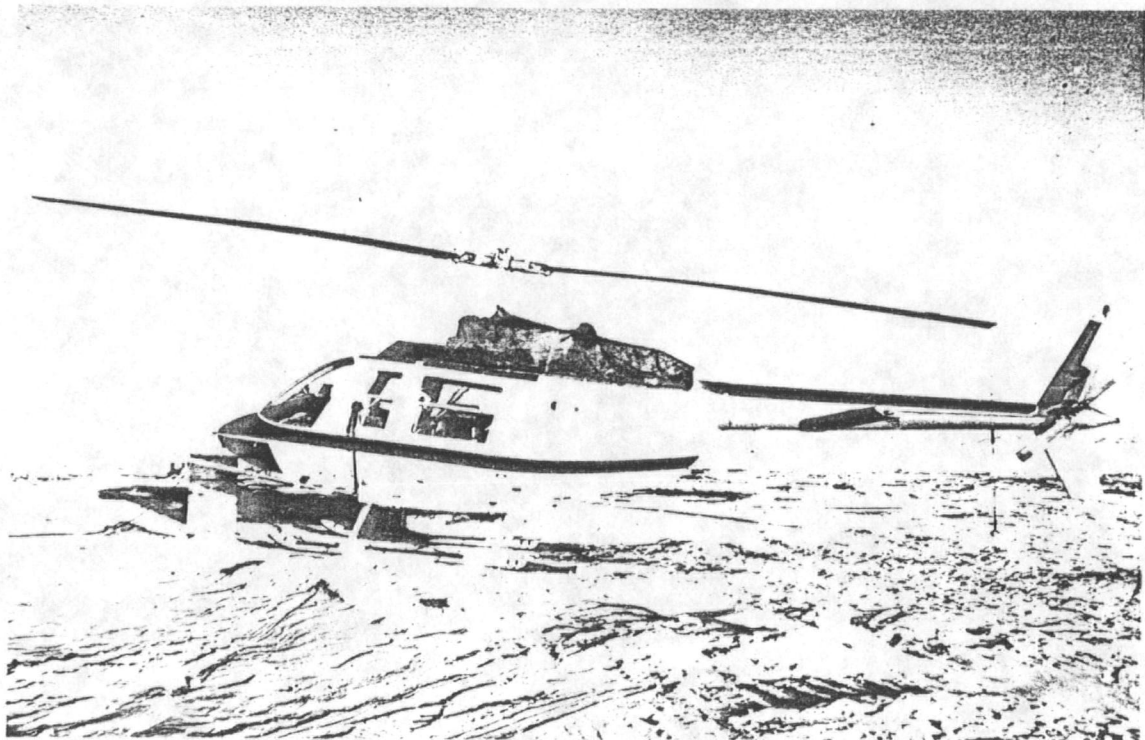
ECHO SOUNDER INSTALLATION
