FINAL REPORT

Title: BCN Project Final Report

1. REPORT NO. PR-110-000404	2. REPORT DATE February 8, 1982
3. TYPE OF REPORT AND PERIOD COVERED Final Report : June 1978 to June 1981	4. NO. OF PAGES
5. TITLE AND SUBTITLE Final Report - Broadband Communication Network (BCN) Project

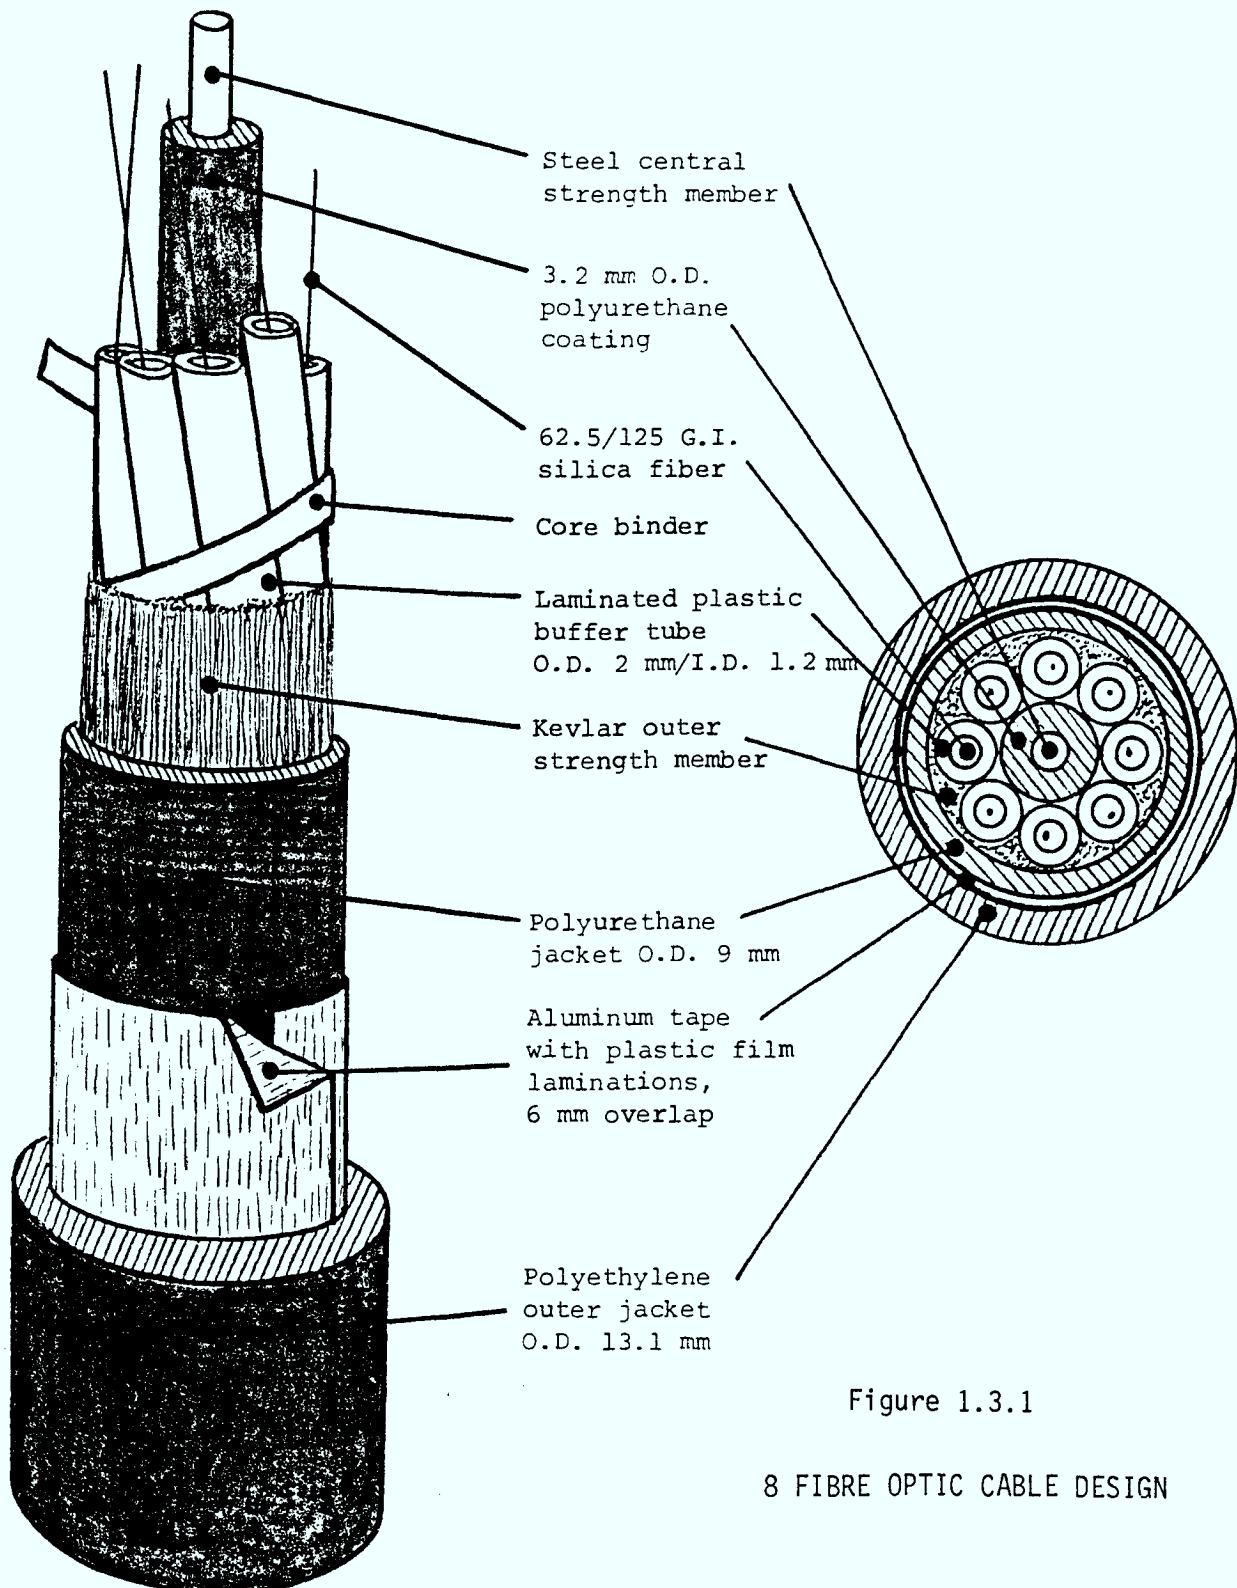
The cable consists of 8 fibres, each fibre enclosed in a buffer tube. The 8 buffered fibres are stranded concentrically around a plastic coated steel strength member. A non-hygroscopic core wrap encloses the buffered fibre and a layer of polypropylene yarn is stranded over the buffered fibre core to provide a cushioning layer. The outer sheath consists of an aluminum shield bonded to a polyethylene jacket providing an effective moisture barrier. Figure 1.3.1 illustrates the cross-sectional layout of the fibre optic cable.

8 FIBRE OPTIC CABLE DESIGN

The individual fibres are placed inside hollow thermo plastic (buffer) tubes. This approach is commonly referred to as the loose buffer tube approach. The design approach allows the cable to elongate or contract due to external loads and/or temperature over a certain range without applying any stress to the fibres themselves.

The loose buffer tubes are stranded around a steel strength member coated with plastic.

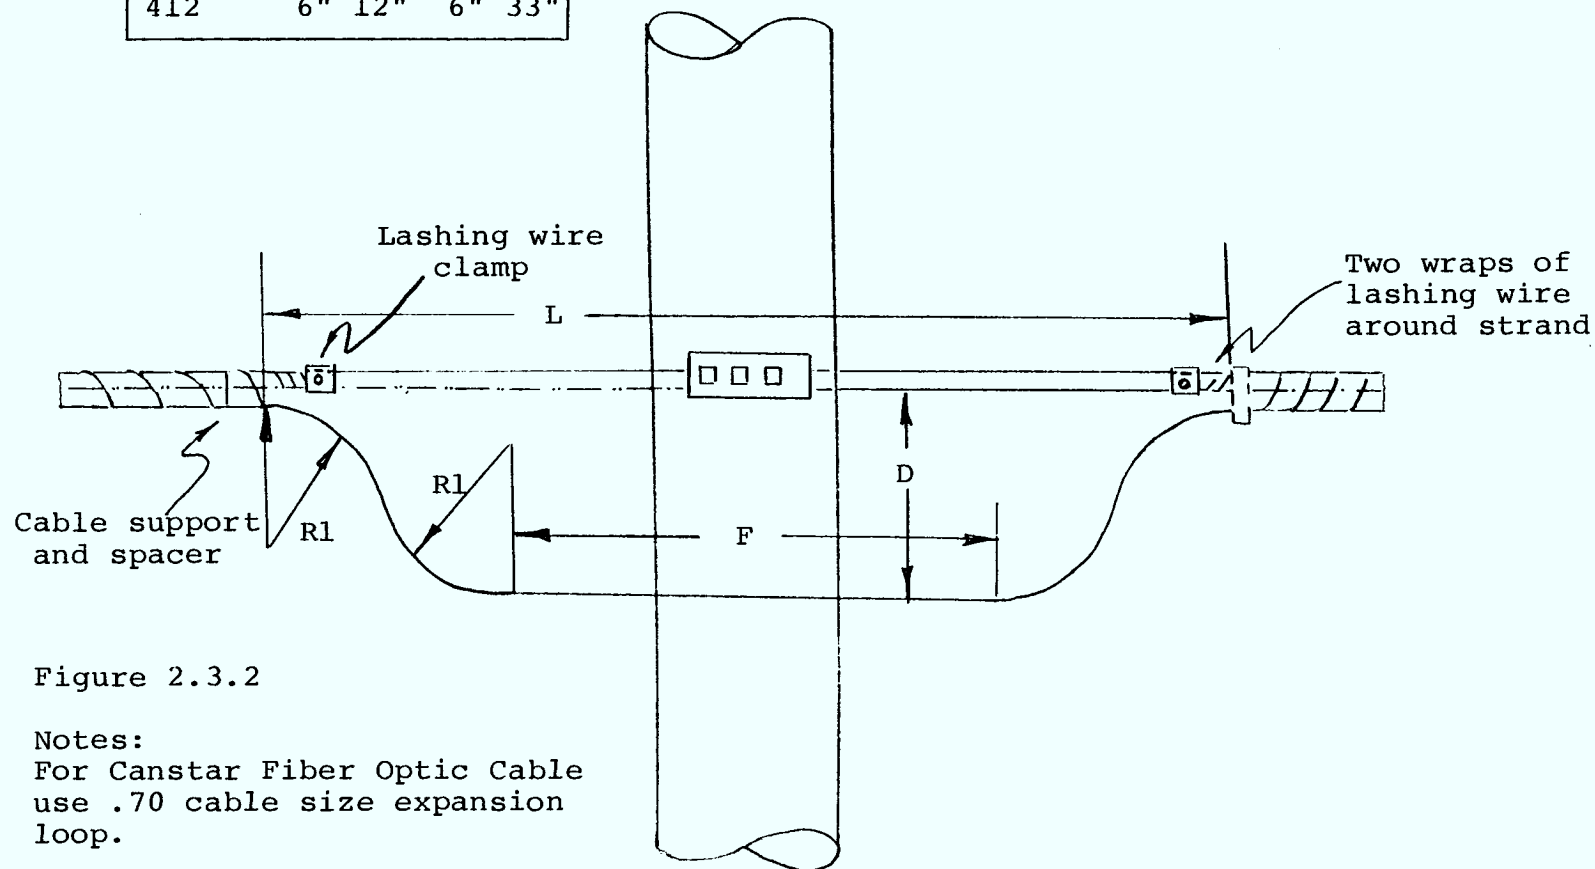
Figure 2.3.2

<u>Loop Dimensions</u>				
Cable Size	D	F	R1	L
750	8"	12"	12"	18"
500				
412	6"	12"	6"	33"

Notes:
For Canstar Fiber Optic Cable
use .70 cable size expansion
loop.

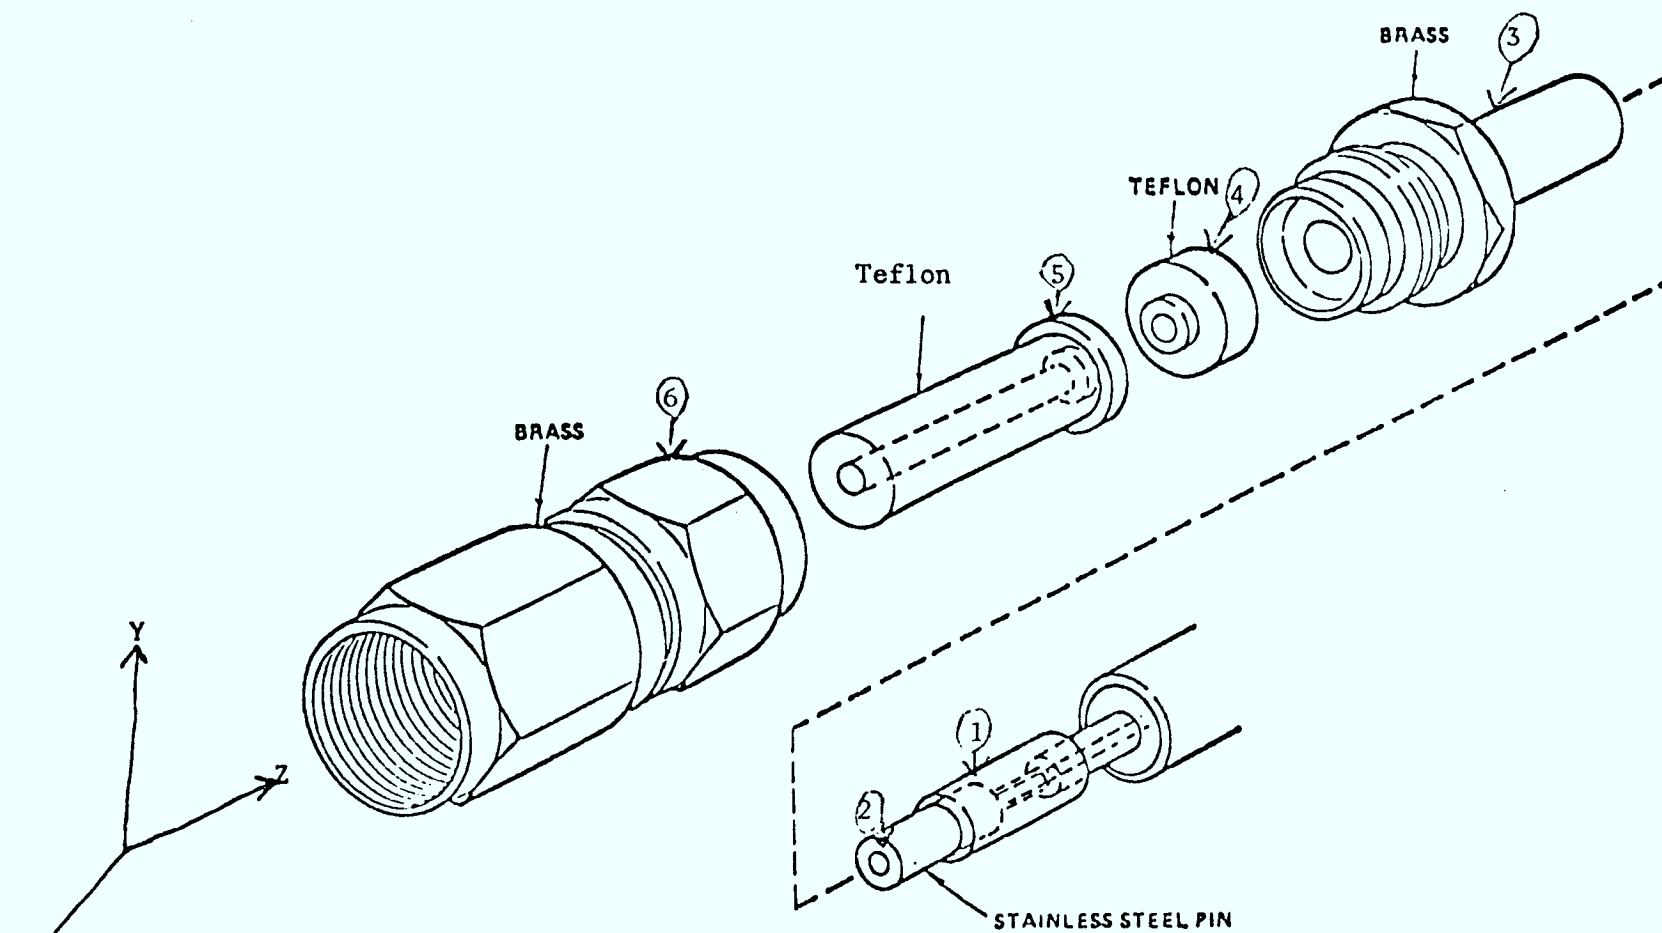
Fig. 4

HARRIS FIBER OPTIC CONNECTOR

EXPLODED VIEW (MALE)

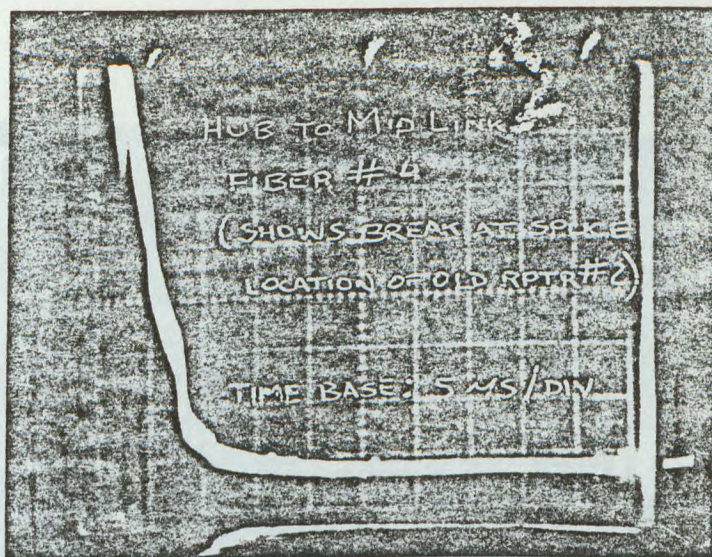
O-TDR RESPONSE

Figure 4.2.3 illustrates the response obtained from broken fibre #1 between the Hub and repeater site showing no reflection. Testing the fibre with the O-TDR from the other end should locate the break. The application note on the O-TDR is provided in Attachment IV of this section.

Link length 4.3 km.
Response of a non-continuous fibre.
Break shown 2.6 km away.

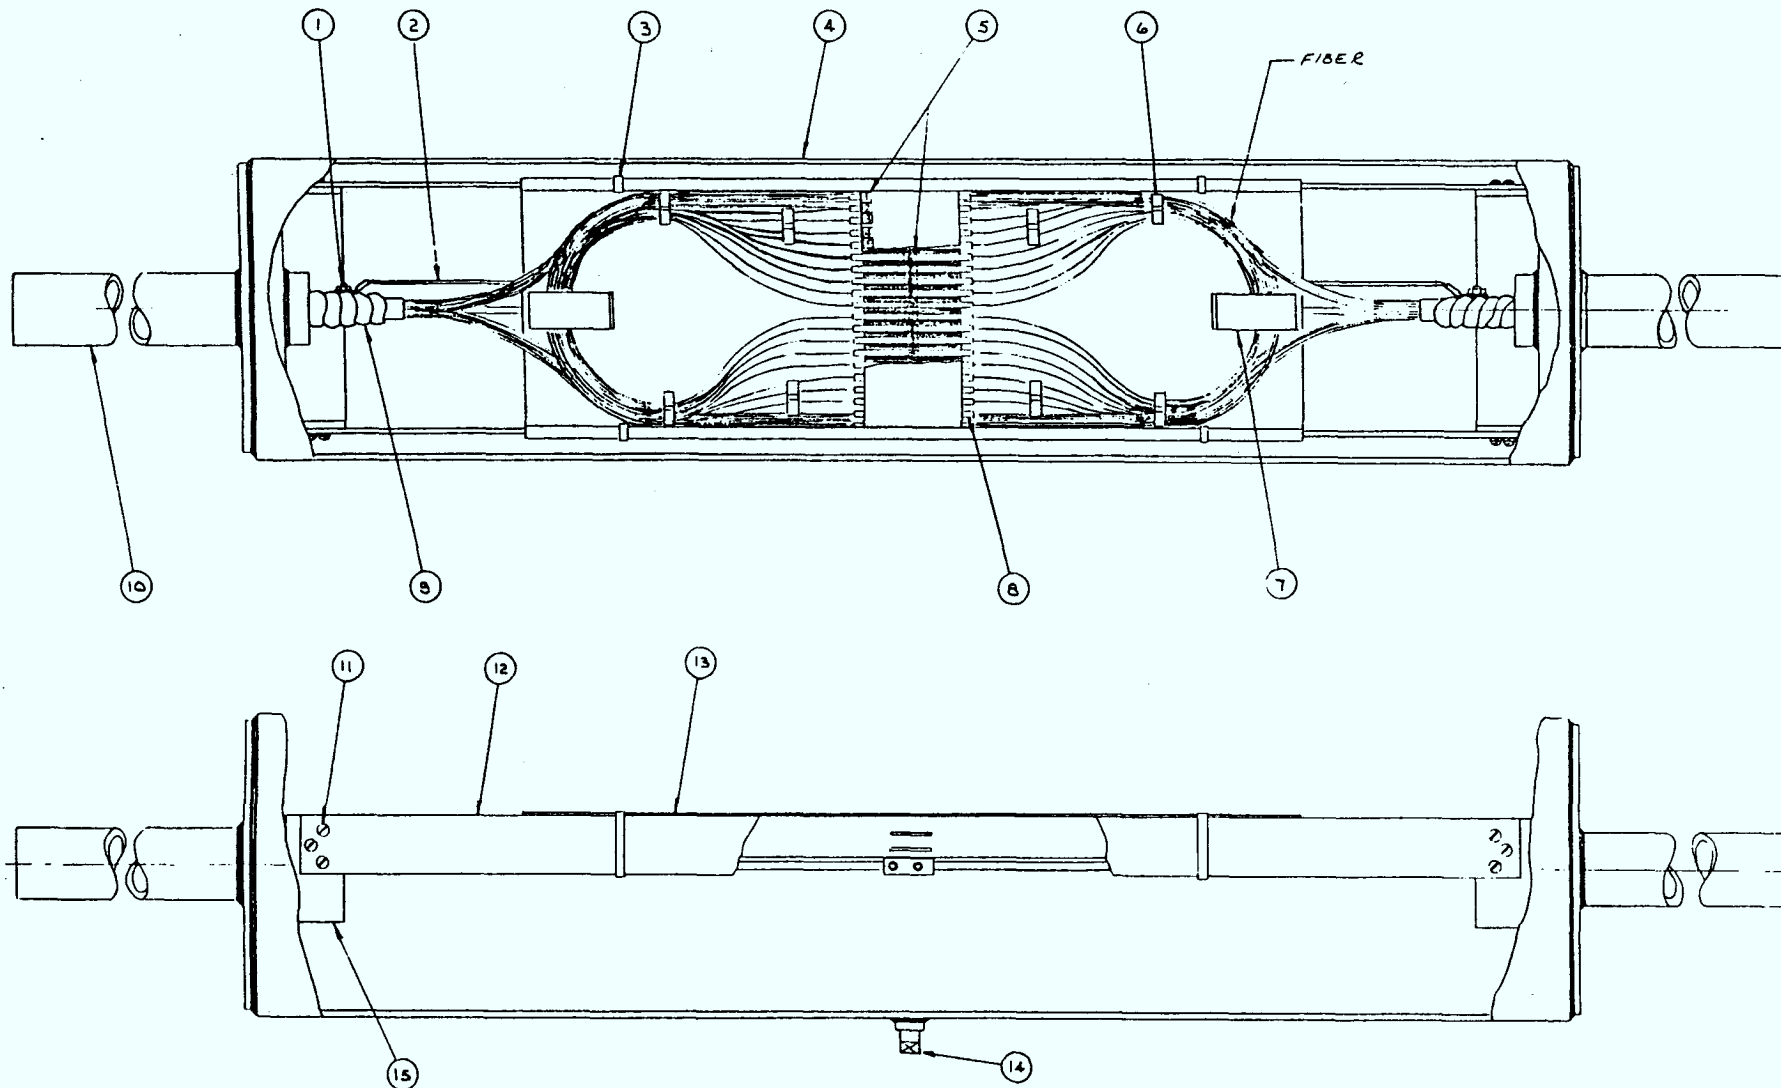
TYPICAL SPLICE ORGANIZER AND ENCLOSURE

1. BOND STUD COIN
 2. GROUNDING HARNESS
 3. CABLE TIE
 4. MAIN SLEEVE ASS'y
 5. WIRE MARKERS
 6. WIRE CLIP
 7. FLAT WIRE CLIP
 8. SUMITOMO SPLICE
 9. VINYL TAPE
 10. END DISC ASS'y, 1 1/4 AUX.
 11. #10-32 x 3/8 SCREW, BRASS, NI. PLTD. & SPRING L' WASHER
 12. TIE BAR
 13. TRAY
 14. 'C' PLUG
 15. TIE BAR END PLATE
- PROTECTION PACKAGE

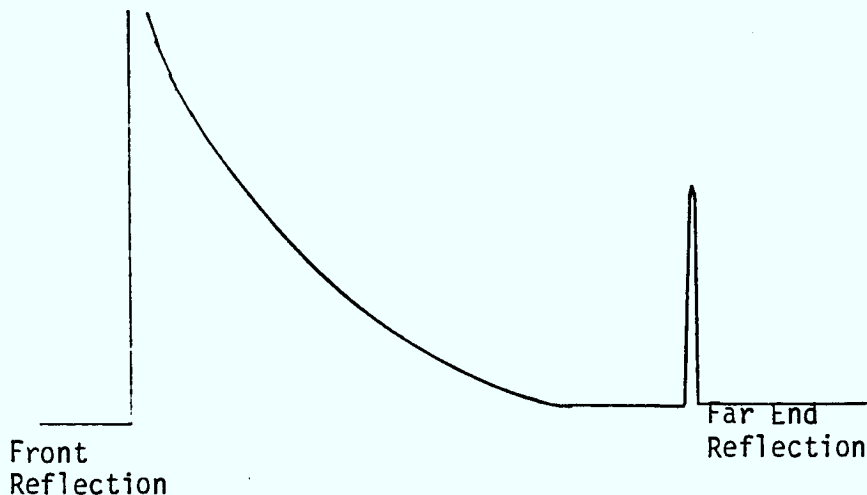
Figure 3

- 6) A front end reflection should immediately be evident, as in Figure 3. Depending on the alignment of the fiber's end, a far end reflection of noticeable height should also be seen.

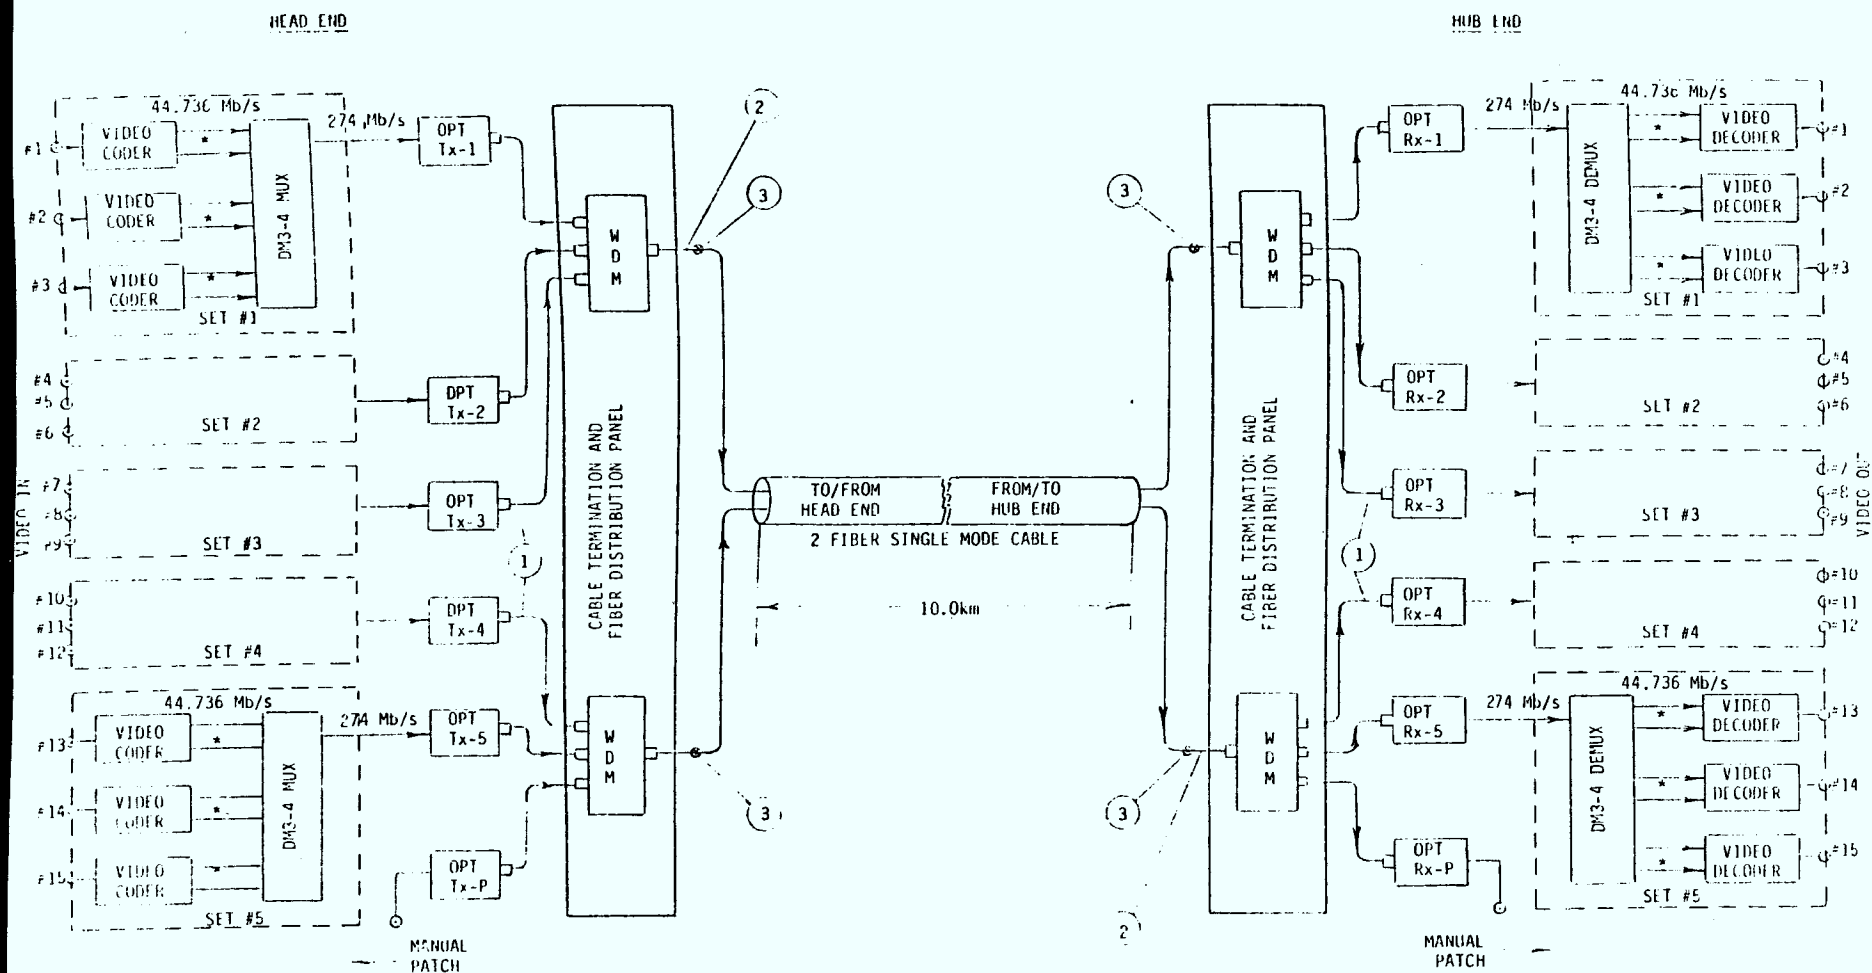
Figure 2.2.2
VIDEO FOTS - BROADBAND QUALITY

1. FIBER PATCH CORD
2. FIBER PIGTAIL CORD
3. SPLICE
- * 2 x's 45 MB SIGNALS

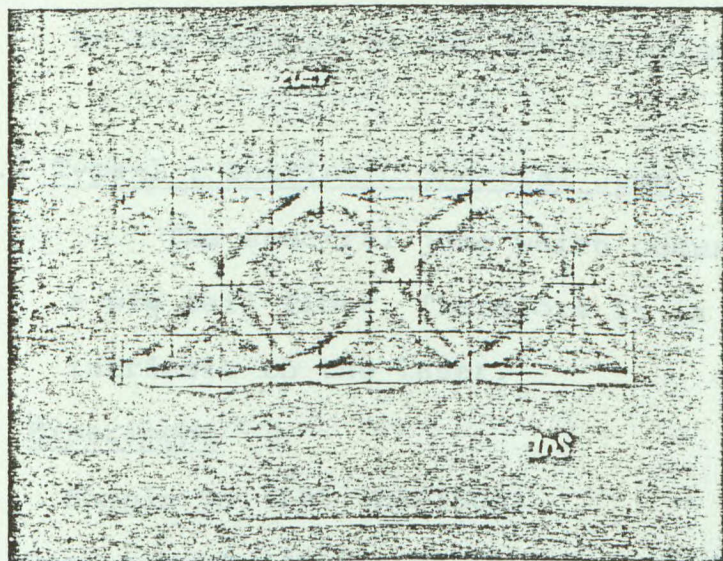
This is sufficient to cause significant increase in the probability of error at the sampling instant in a 300 mb/s 4km link due to eye closure. This effect is illustrated by the photo (fig.1) taken at the output of a receiver operating in a 4 Km 301 mb/s link. Significant systematic delay noise is seen occurring on the 1/0 transition. Random mode hops also occur, resulting in a falling edge which jitters less systematically.

APPROX. 0.7 NS SYSTEMATIC
DELAY JITTER AT 301 MB/S
NRZ, $2^{15}-1$ PN SEQUENCE,
4.3 KM FIBER LINK.
