**National Space Telecommunications Laboratory
FAILURE ANALYSIS GROUP**

***DEVICE AND MATERIALS ANALYSIS
FOR
CANADIAN INDUSTRY***

CRC SERIAL DOCUMENT 03-NSTL-15-0

Published September 1970

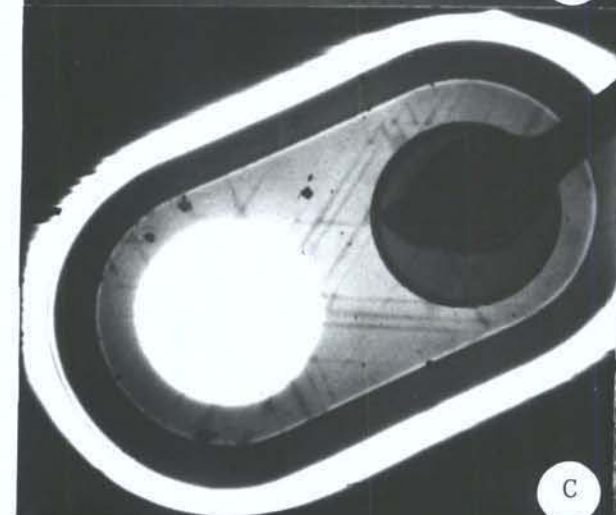
This series of micrographs shows details of the breakdown regions in a silicon guard-ring diode. (a) shows an emissive micrograph of the device and its surface detail, (b) is a sketch of the cross-section of the diode. In (c), p-n junction charge collection is used as the detection mode, revealing the junction depletion regions under zero bias. Note the outer bright ring which is the isolation diffusion and is not detected by (a), the emissive mode. In (d), the bright spot of (c) is shown in more detail at higher magnification and improved contrast. The dark lines are silicon crystal dislocations detected by the decrease of carrier lifetime in defect regions. In (e), increasing back bias has initiated carrier multiplication which is enhanced in the high field region at the crystal defects, (f) shows further increased bias and the onset of general junction breakdown.

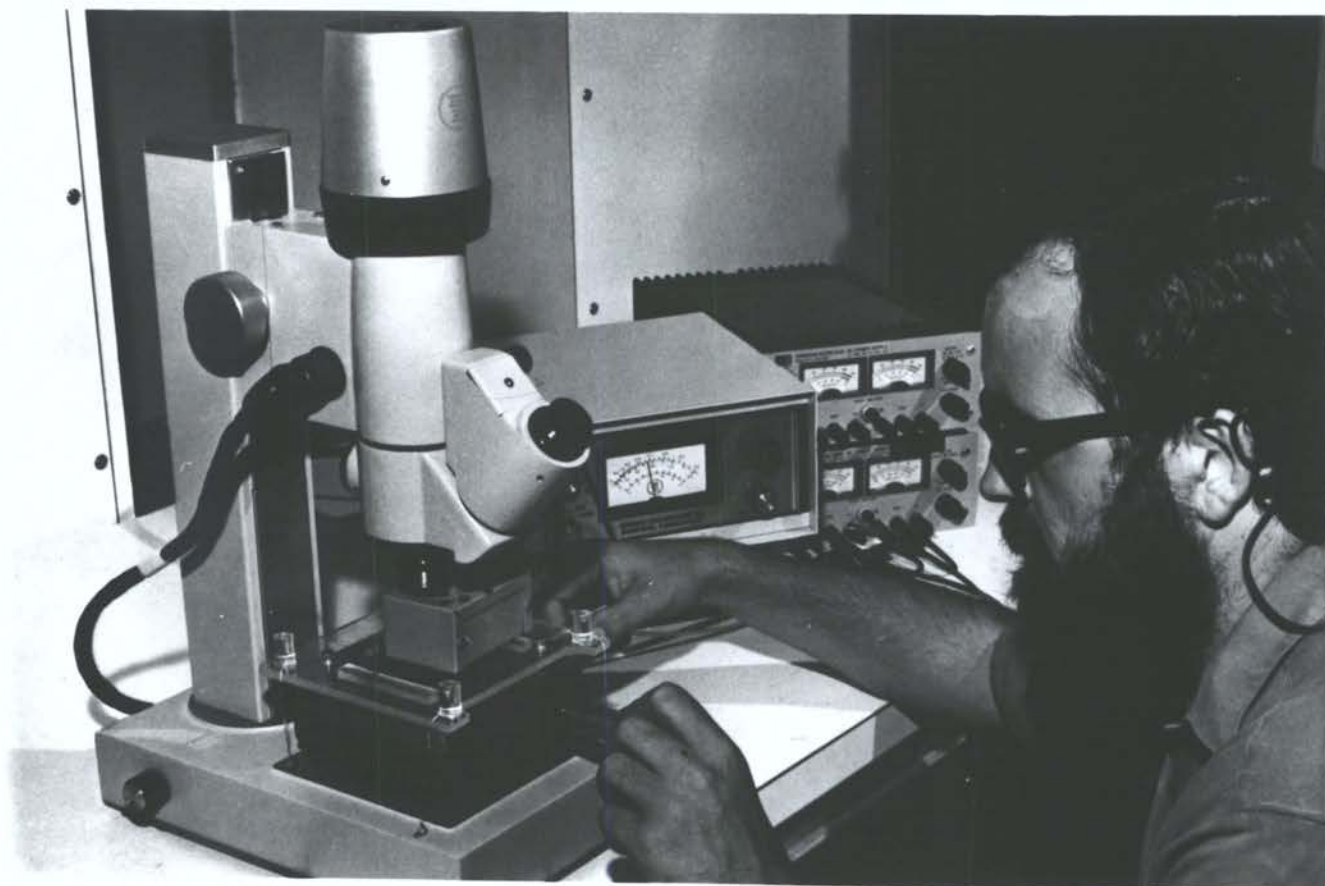
BARNES INFRARED MICROSCOPE
MODEL RM - 2A

Specifications:

| Spectral Range | - 1.8 to 5.5 microns |
| Optical Resolution | - 10 microns |
| Temperature Resolution | - typically 0.1°C at 100°C |

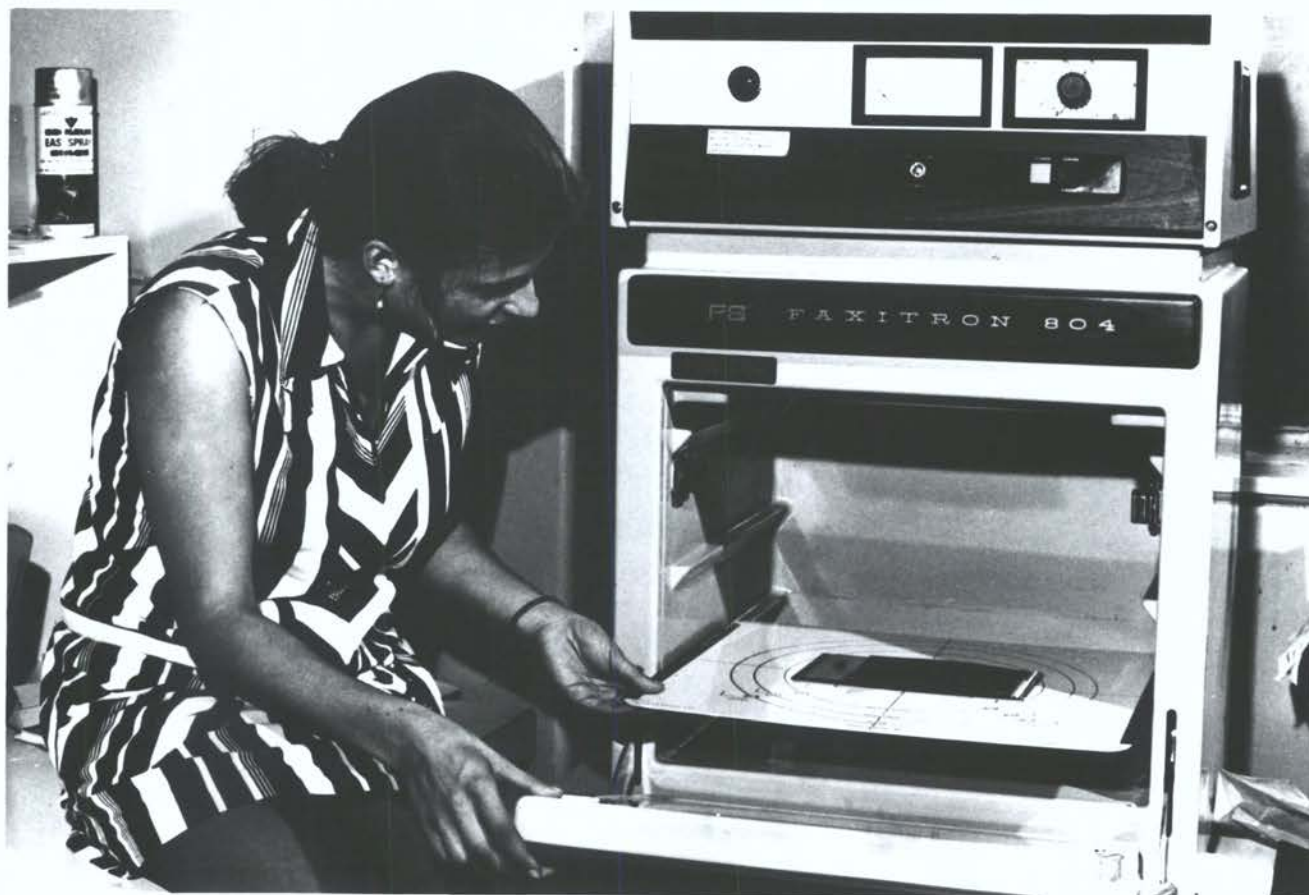
FAXITRON 804 RADIOGRAPHIC INSPECTION UNIT

Resolution - approximately 1 mil.
