Plastic deformation capacity of connections in tension

RETROFITTING NON-DUCTILE RC STRUCTURES FOR SEISMIC RESISTANCE USING POST-INSTALLED WING WALL, SHEAR WALL AND RC JACKET

AN OVERVIEW OF SEISMIC RETROFIT TECHNIQUES DEVELOPED AT THE UNIVERSITY OF OTTAWA

An Overview of Seismic Retrofit Techniques Developed at the University of Ottawa

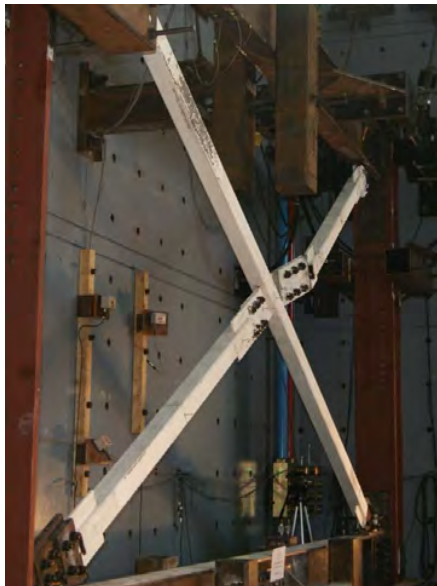
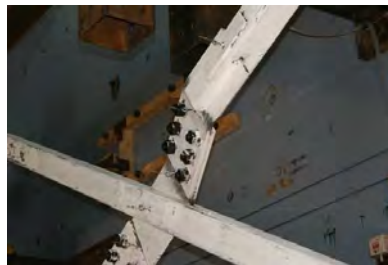
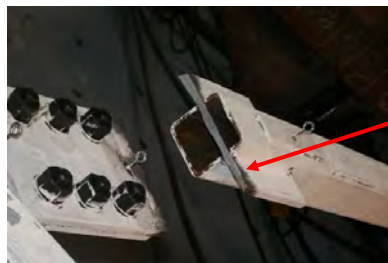
HSS 127x127x8.0 – Single Shear Connections

Fracture of plate due to low-cycle fatigue

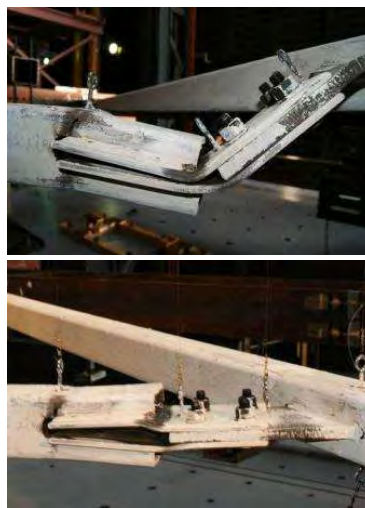
HSS 102x102x6.4 - Double Shear Connections

Plate buckling

Rupture of HSS

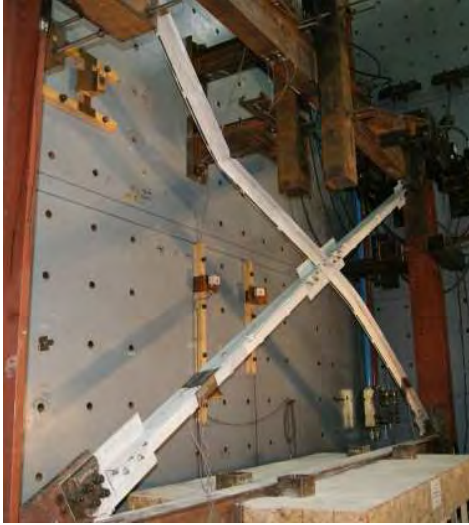
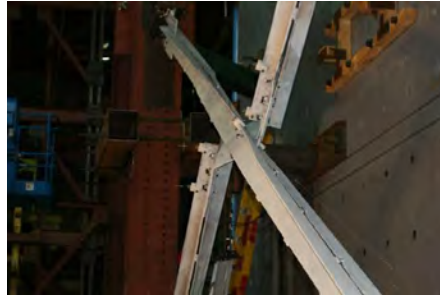
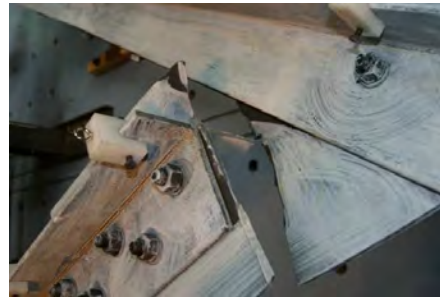
2L 127x75x9.5

**Plate buckling
and low-cycle
fatigue failure**

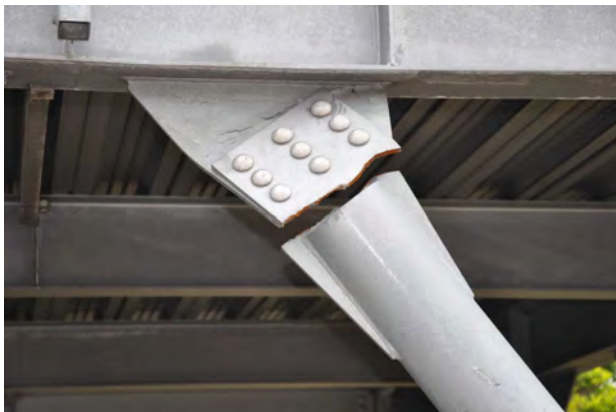
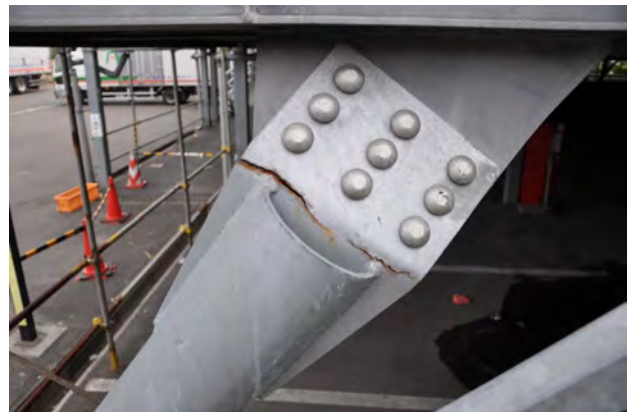
***Instability and low-cycle failures of brace connections
observed in past earthquakes***

2011 Tohoku Earthquake
<http://www.eqclearinghouse.org/2011-03-11-sendai/2011/08/03/eeri-steel-structures-reconnaissance-group/>

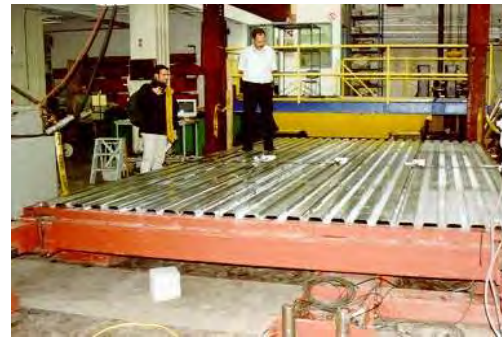
Cantilever Diaphragm Shear Test

Slip & disengagement
of the button punches
and brittle weld failure

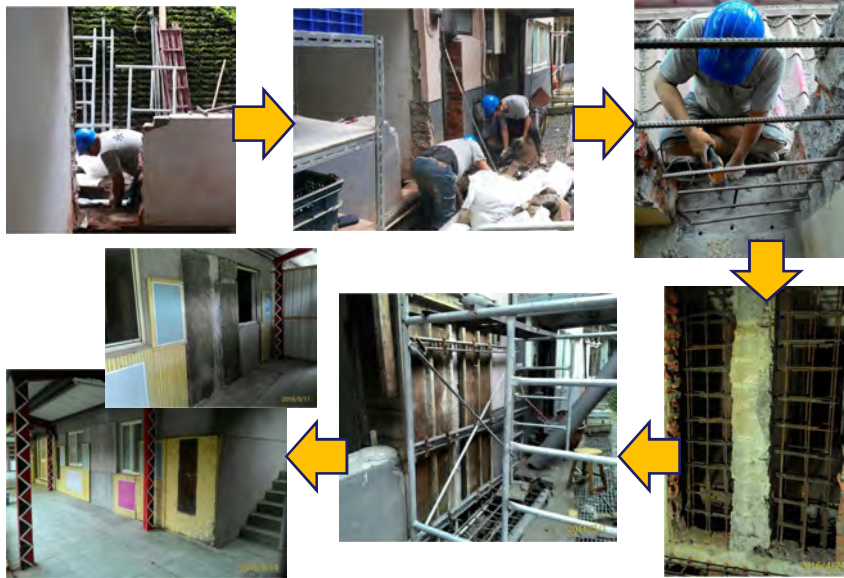
Practical construction procedure of RC wing wall

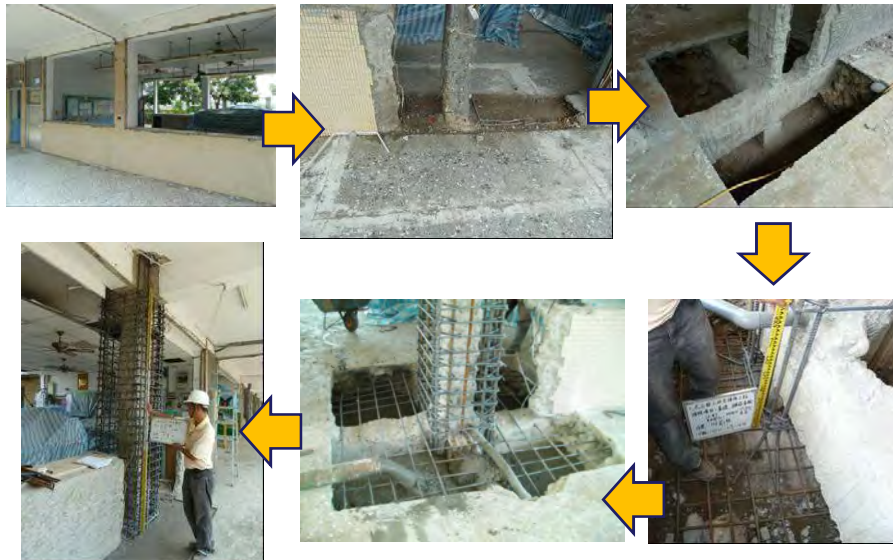
Practical construction procedure of RC jacket

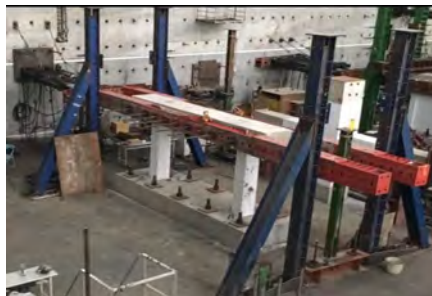
Test setup

Reversed cyclic loading test was conducted with increment drift at every step until failure

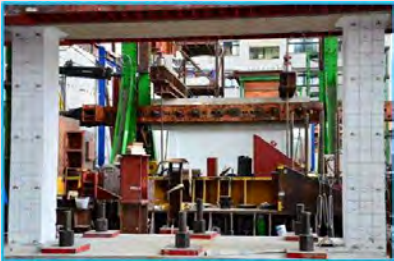
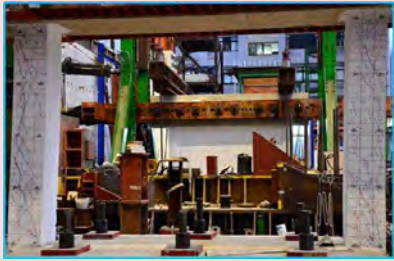
S1	Inter-story displacement ratio (drift ratio)	
	0.5%	2.0%
Crack propagation documentations

Status overview	The flexural cracks at the top and bottom of the column are gradually increase; some of the flexural cracks gradually turn into shear cracks; and the maximum crack width is 0.5 mm.	The shear cracks at the top and bottom of the column appear rapidly. The maximum crack width is about 3 mm in the column. At this drift, the maximum lateral force is reached and the overall lateral stiffness begins to gradually decrease.

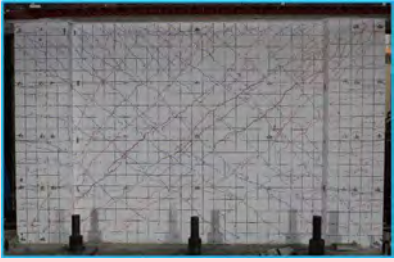
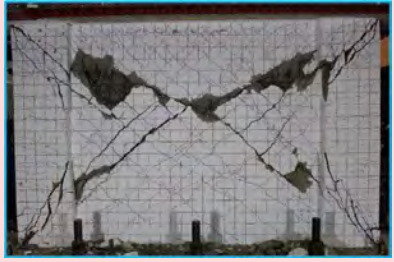
S2	Inter-story displacement ratio (drift ratio)	
	0.5%	1.5%
Crack propagation documentations

Status overview	The shear crack of the wall spreads to the top and bottom of the column. The flexural crack in the end of the column continues to increase. The maximum shear crack width is 4 mm in the diagonal direction of the wall panel.	The shear cracks of the wall continue to enlarged; spalling of concrete; slightly buckling of. At this drift, the lateral force dropped to about 30% of the maximum and the test is stopped.
