Water Resource Engineering Report 88-6

Ice Jams and Flood Forecasting, Hay River, N.W.T.

Final Report

Phase I

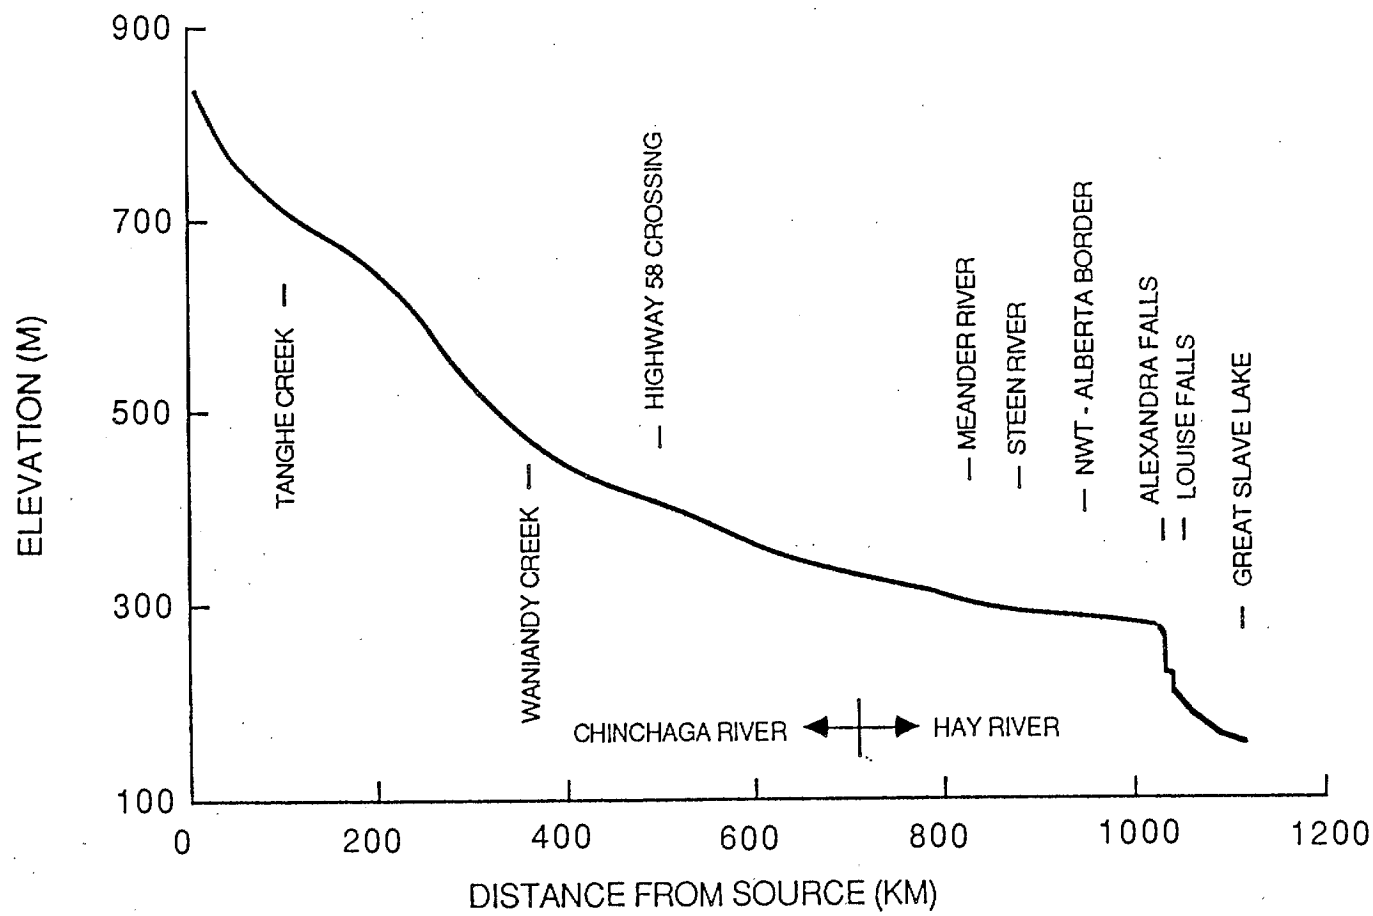
Figure 8 Longitudinal profile of the Chinchaga-Hay River

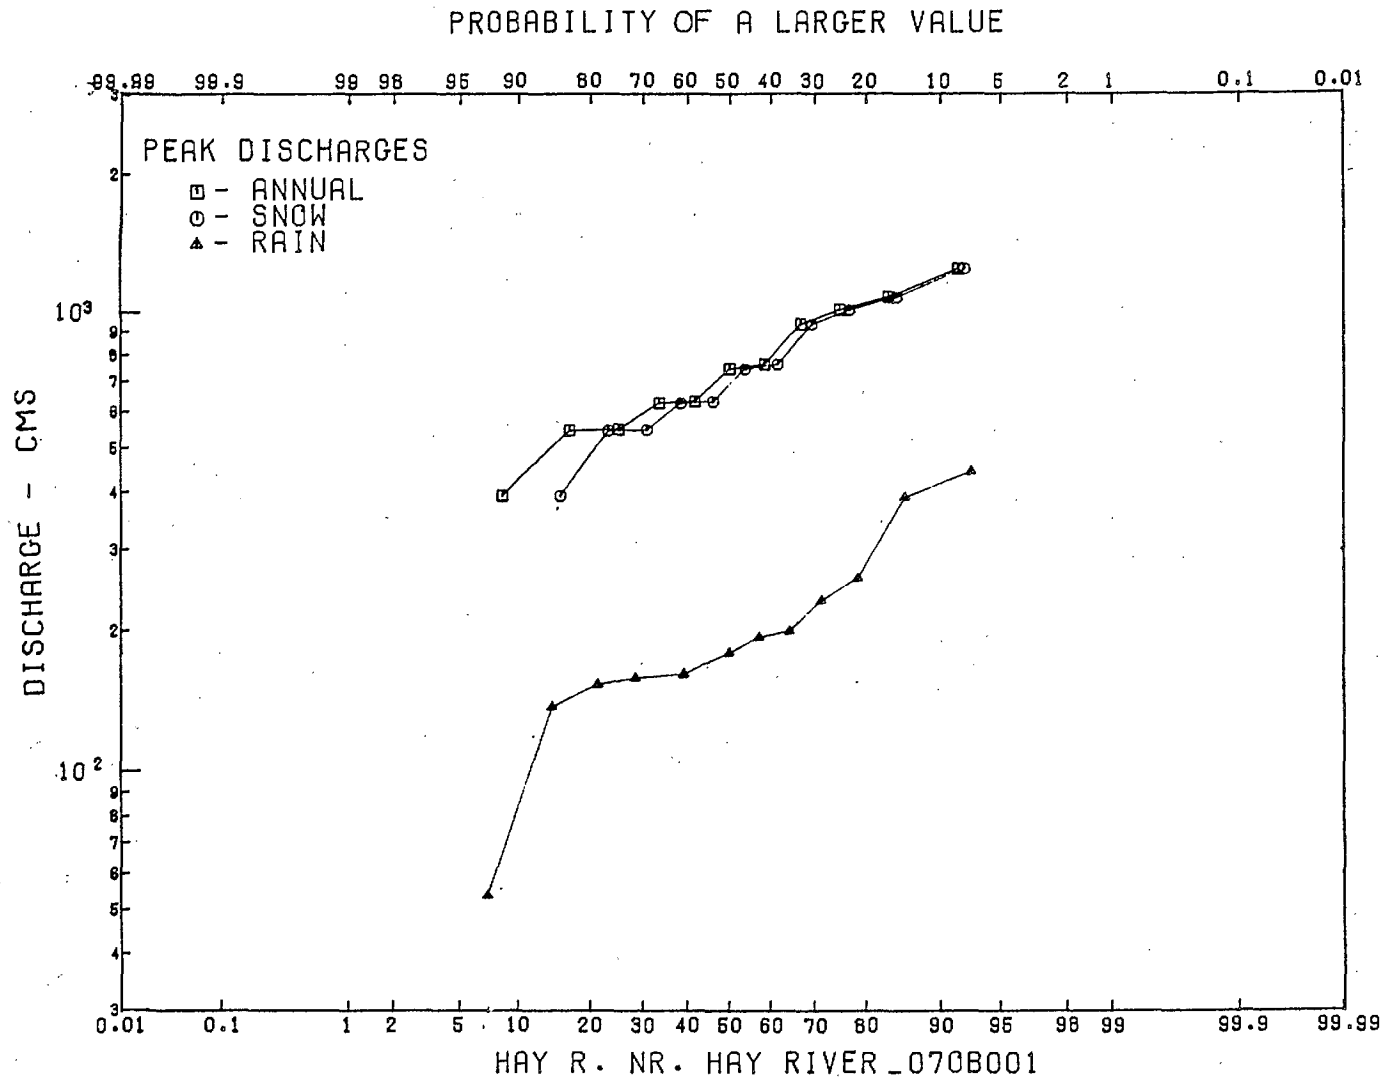
Figure 10 Exceedence probability distributions of annual, peak snowfall and rainfall discharges, Hay River at Hay River

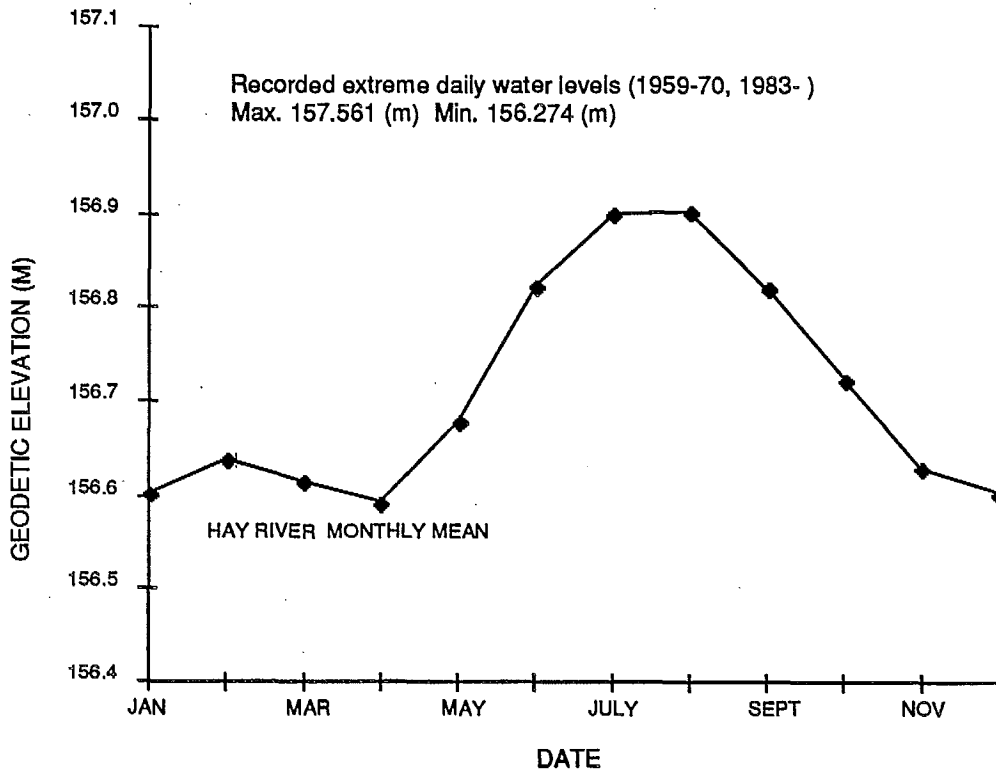
Figure 14 Typical annual variation of Great Slave Lake level at Hay River (from WSC data)

The nearshore lake bathymetry is shown in Figure 13. Because of its large expanse, the lake level varies little over the year, as indicated in Figure 14, particularly in late winter when the lake is not subject to storm surges. The most important feature of the bathymetry in Figure 13 is the shallow offshore bar, which is also evident in air photos of the area. The bar has been dredged off the East Channel and the east arm of the West Channel. While the location and details of the bar may change with storm activity on the lake, little maintenance dredging has been required at the East Channel mouth (DPW, personal communication). This suggests the bar is not too active.

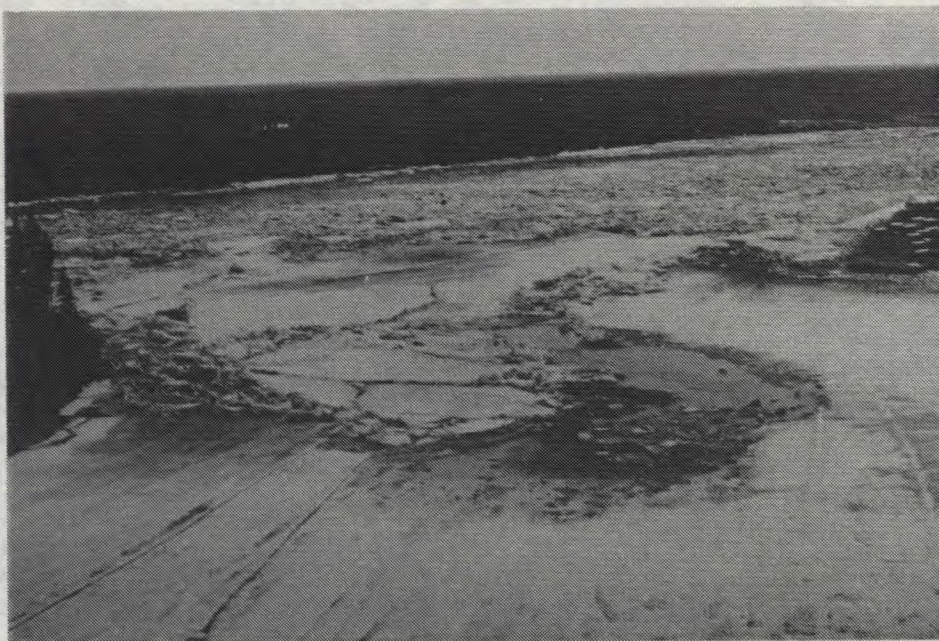
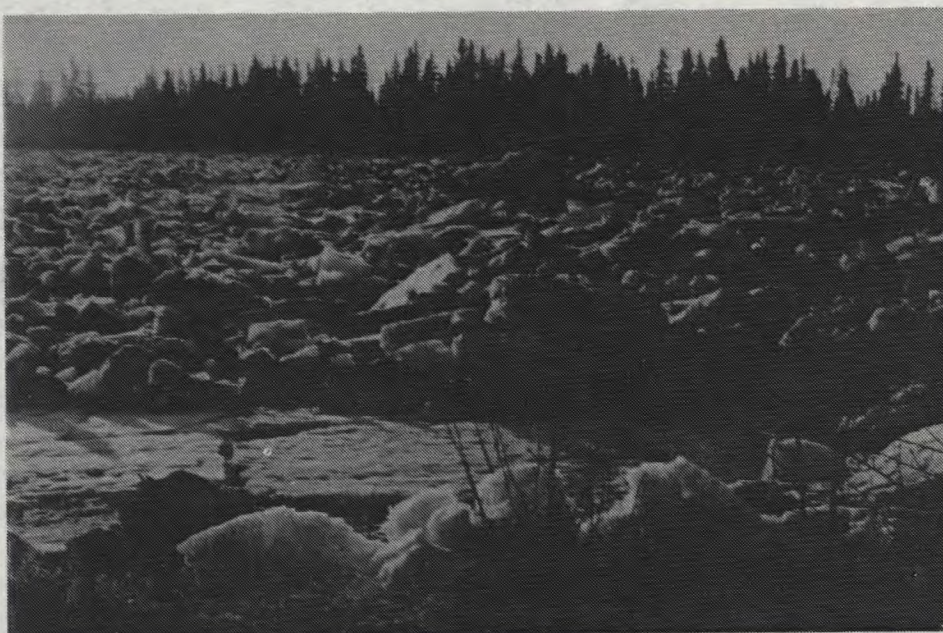
Figure 20 Toe of the ice jam at Island CD, 27 April 1987 looking (a) upstream over the toe and (b) from left to right bank across the pack near the toe.

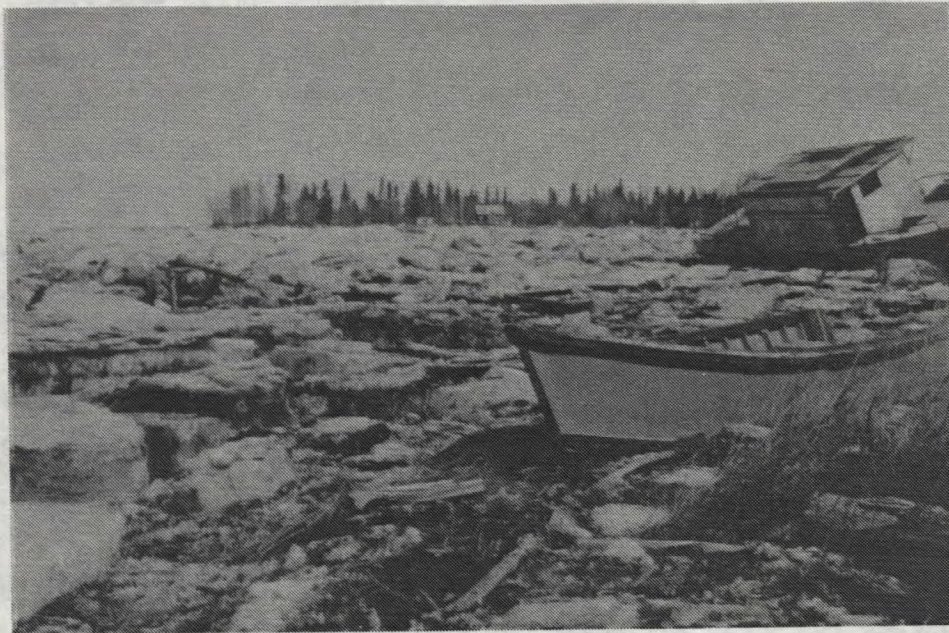
Figure 22 Ice jam in the east arm of the West Channel looking downstream from the Fishing Village, 29 April 1988

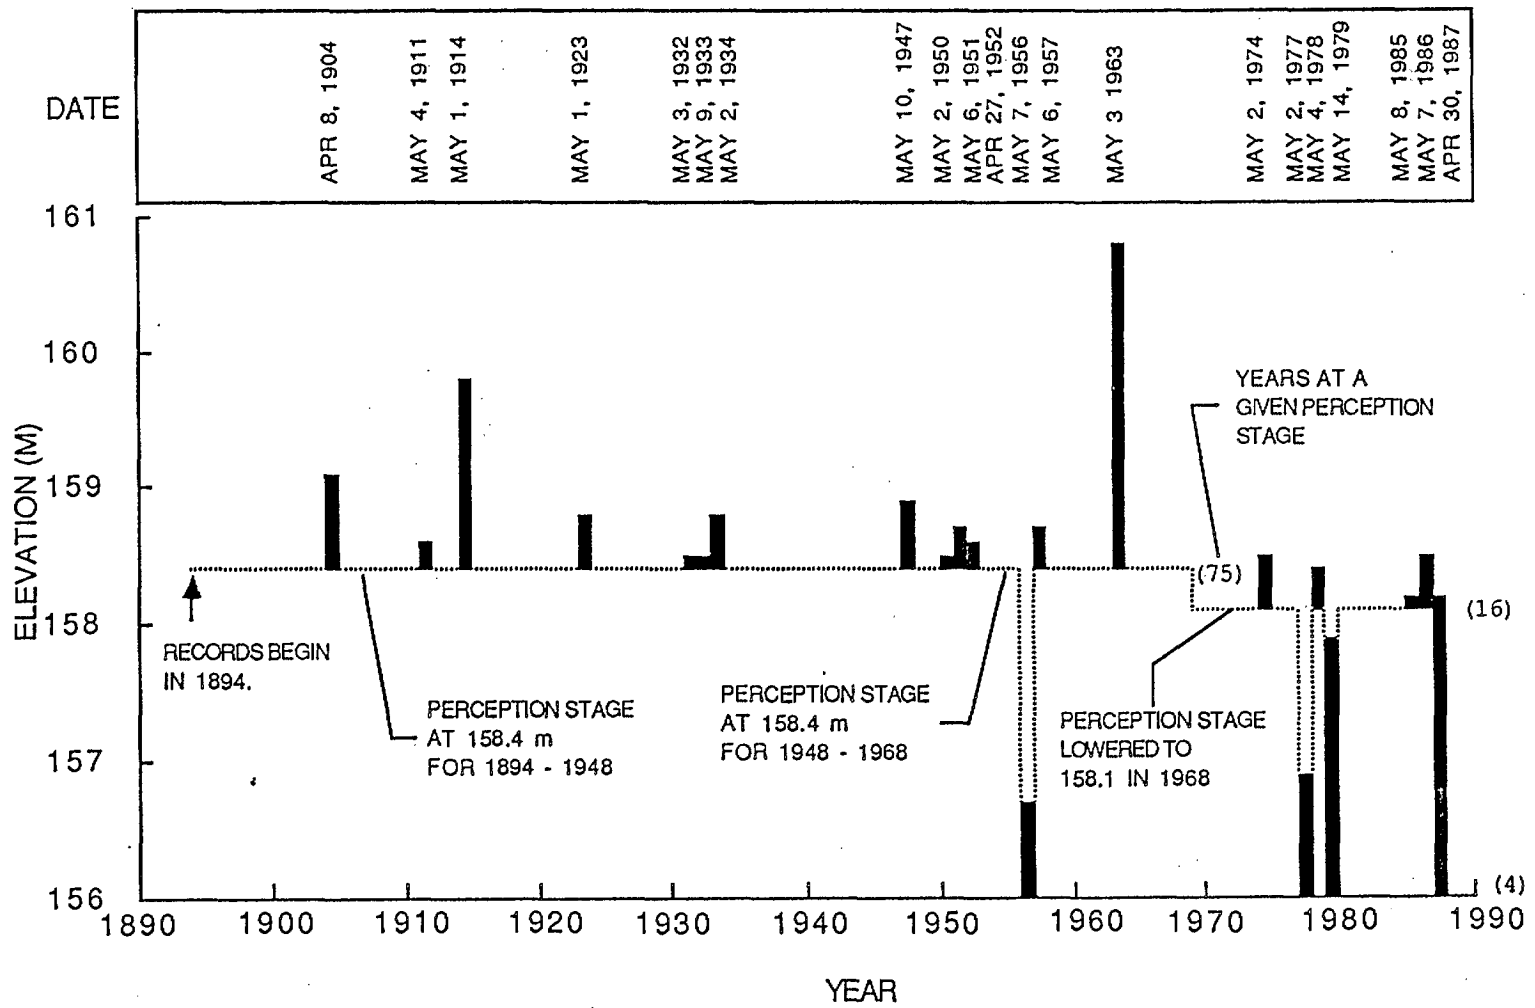
Figure 25 Flood and perception levels for the East Channel near the mouth (km 1113)

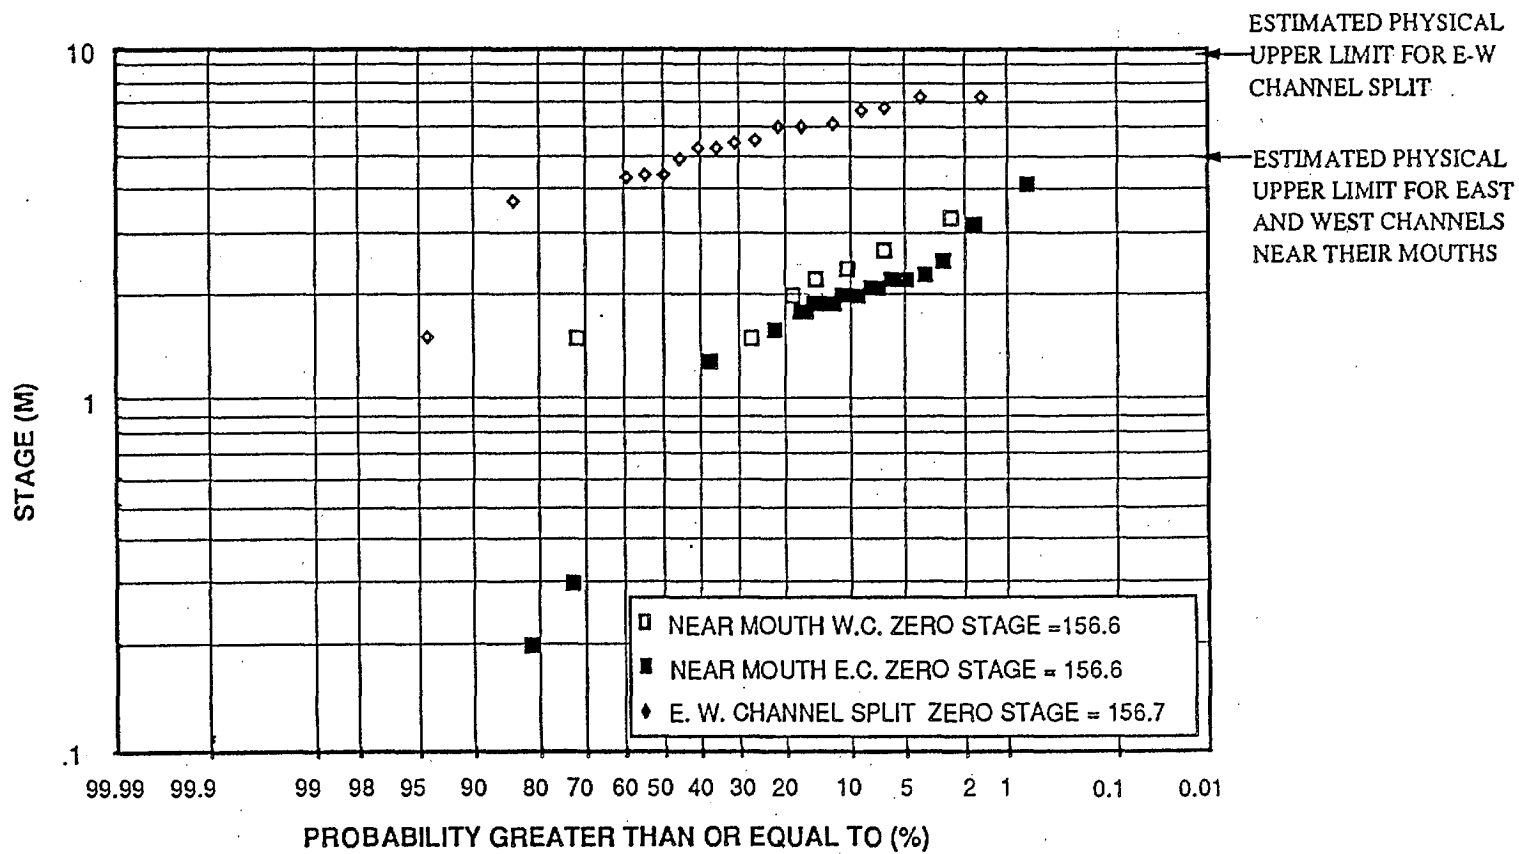
Figure 29(a) Water level exceedence probability distributions for the three reference locations in Hay River

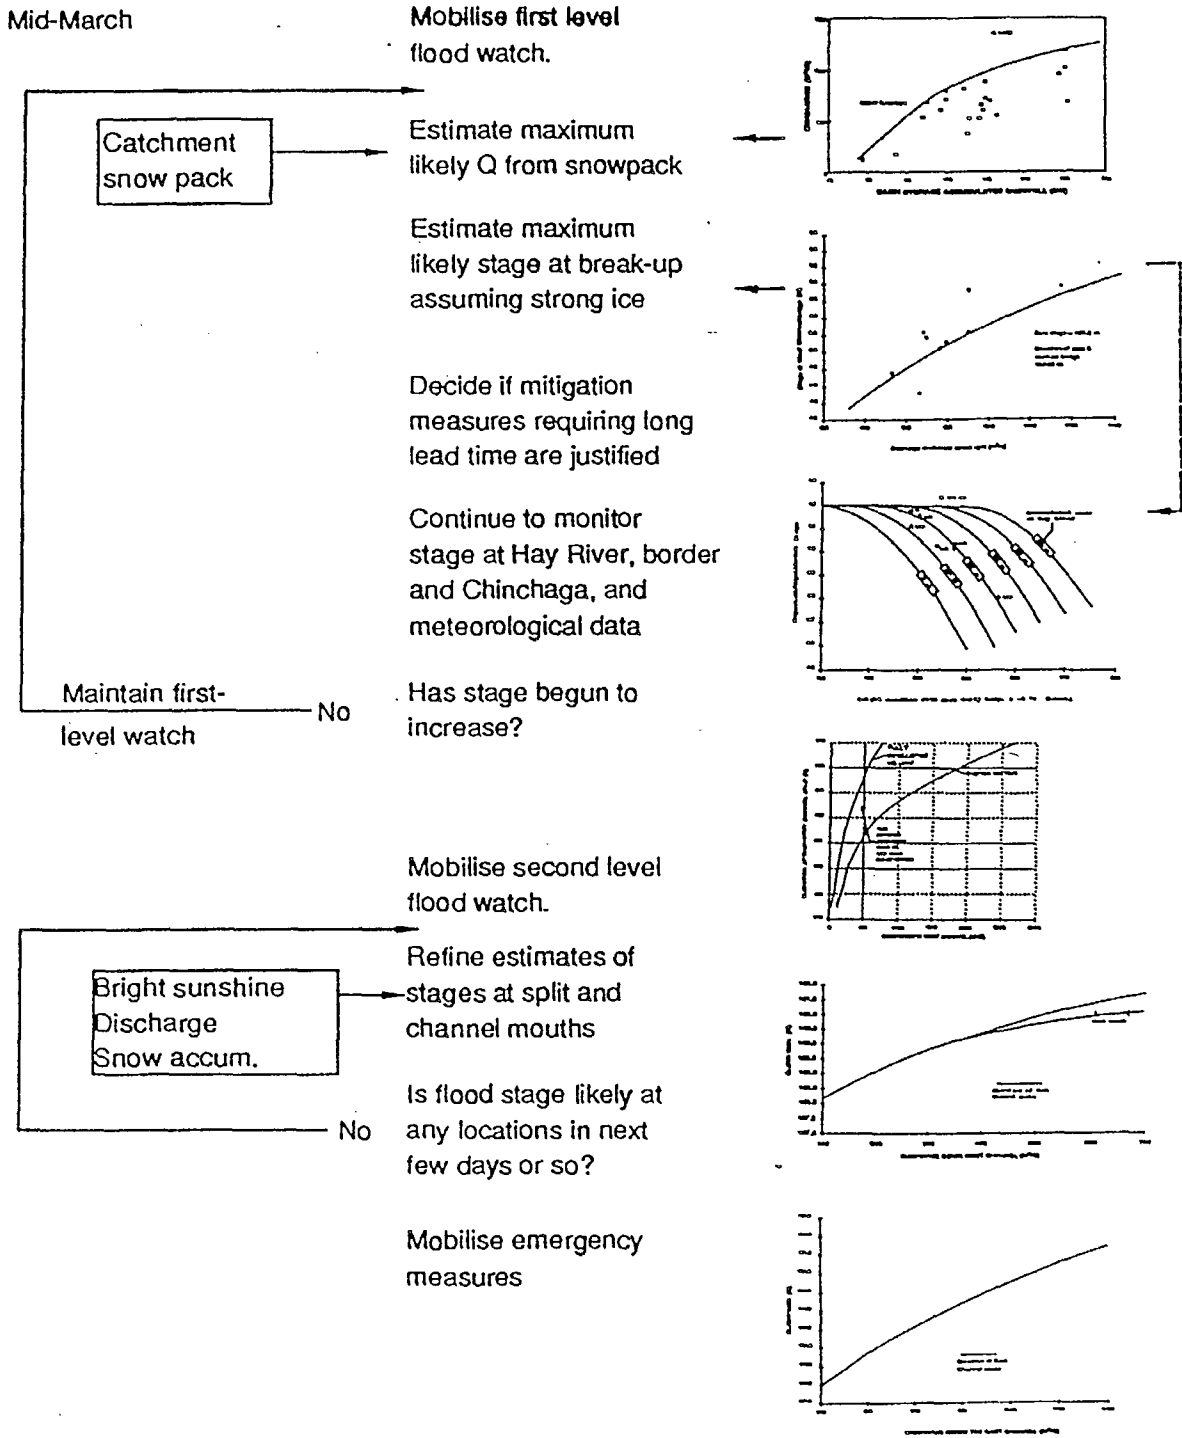
Figure 38 Flow chart for the ice jam flood forecast algorithm, Hay River at Hay River
