INSTALLATION OF A
TEMPORARY TIDE GAUGE
AT MOOSONEE, ONTARIO

1974

Dale Kimmett
Regional Tidal Office
Central Region

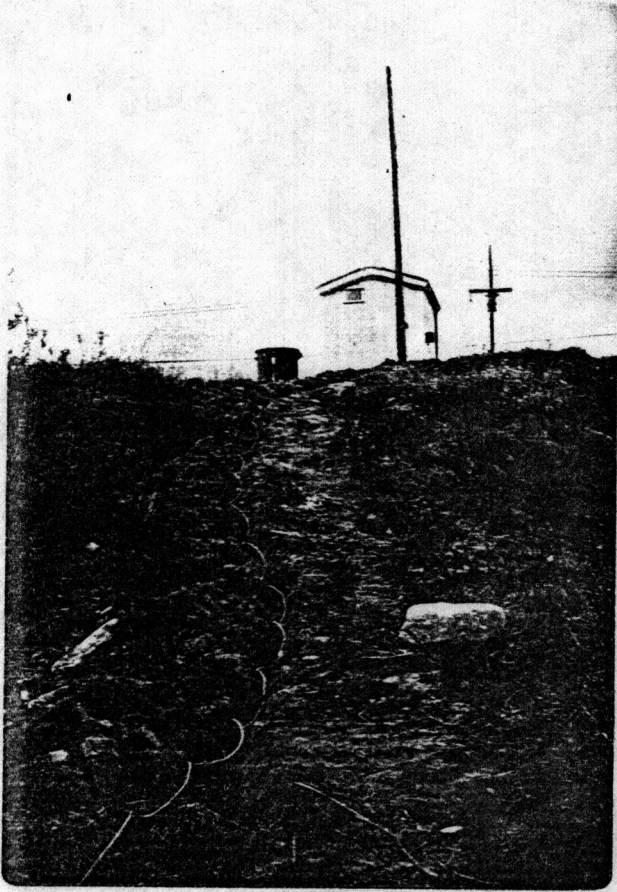
TRENCH FOR TUBING BELOW "GAUGEHOUSE"

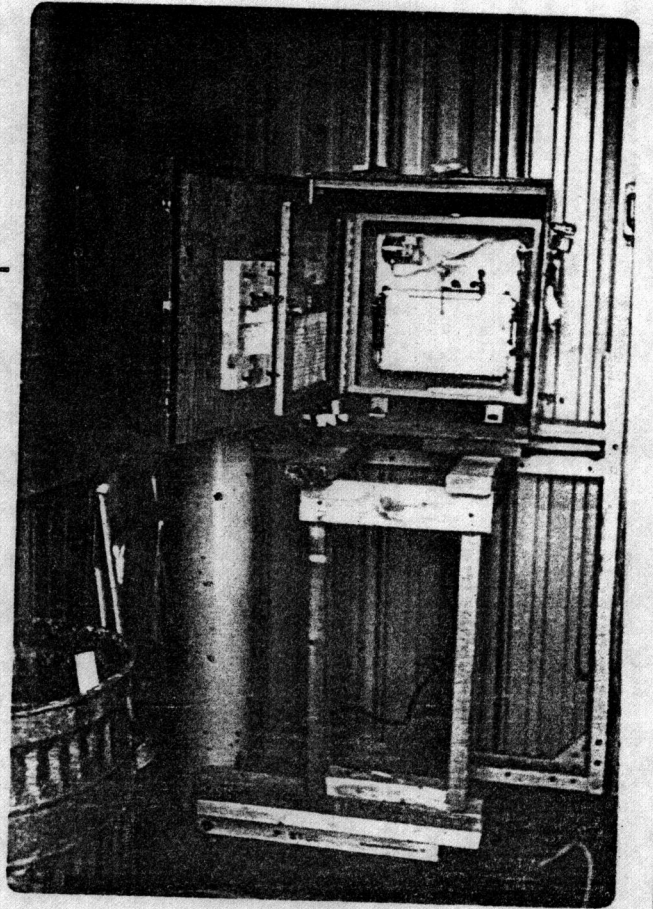
INSTALLED OTTBORO TIDE GAUGE

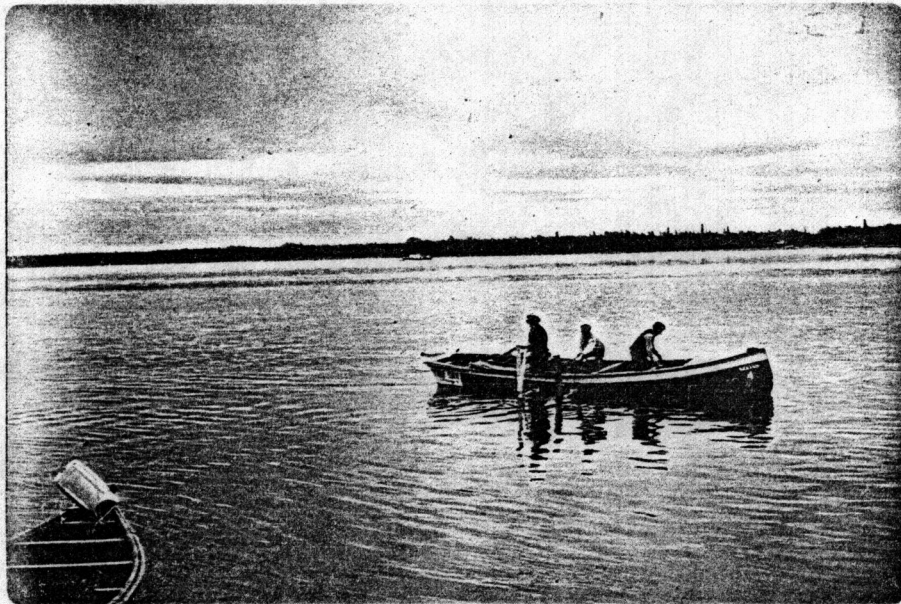
SUBMERSING ROCKFILLED CRIB

With little ado all necessary materials were obtained and construction was completed by mid-afternoon of Friday, June 14th. Low tide being predicted, a canoe and driver were employed to aid in submersing the structure. Voluntary help was also provided by Mr. Thomas Moore, a local technician, who later was employed as gauge attendant. Photographs of facilities and crib were taken as seen in "Photographs".

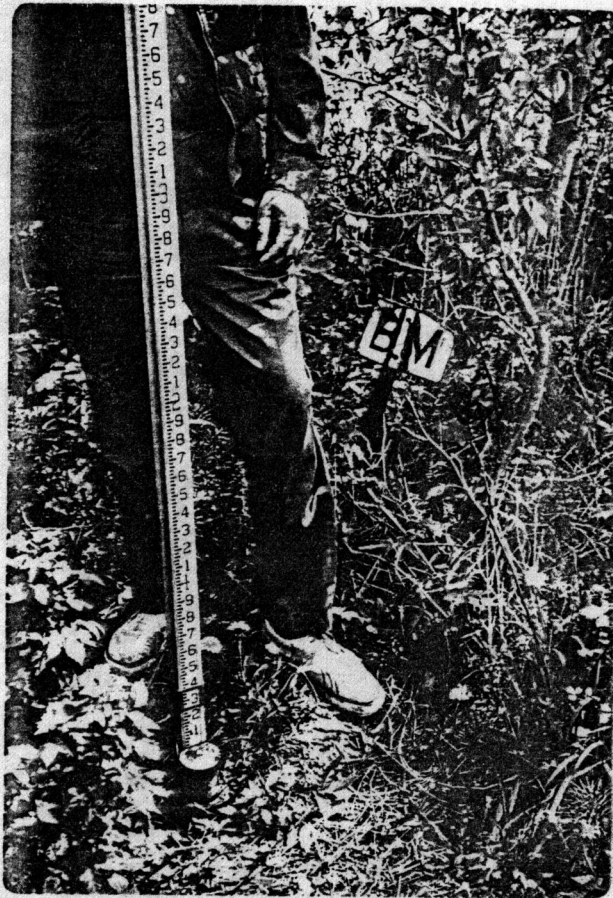
REFERENCE BENCH MARK
G.S.C.

On Saturday, June 15th, land survey work necessary to vertically tie in the water level gauge to existing Bench Marks began. Of the five Bench Marks on record, only two were found to be undamaged. A Geodetic Survey of Canada Bench Mark was chosen as a reference Bench Mark in establishing two tide staffs, and two temporary Bench Marks near the "Gaugehouse" as shown on Plan #2.

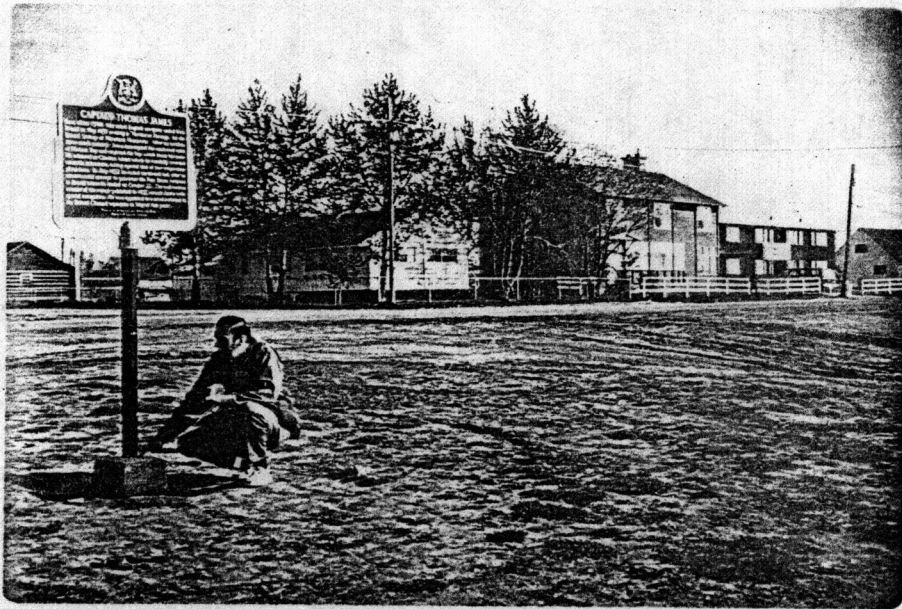
TEMPORARY BENCH MARK NO. 2
