TURKEY LAKES FOREST WATERSHED PROGRAM

ANNUAL ACTIVITY SUMMARY

1981/82

F.H. Don
Technical Operations Division
National Water Research Institute

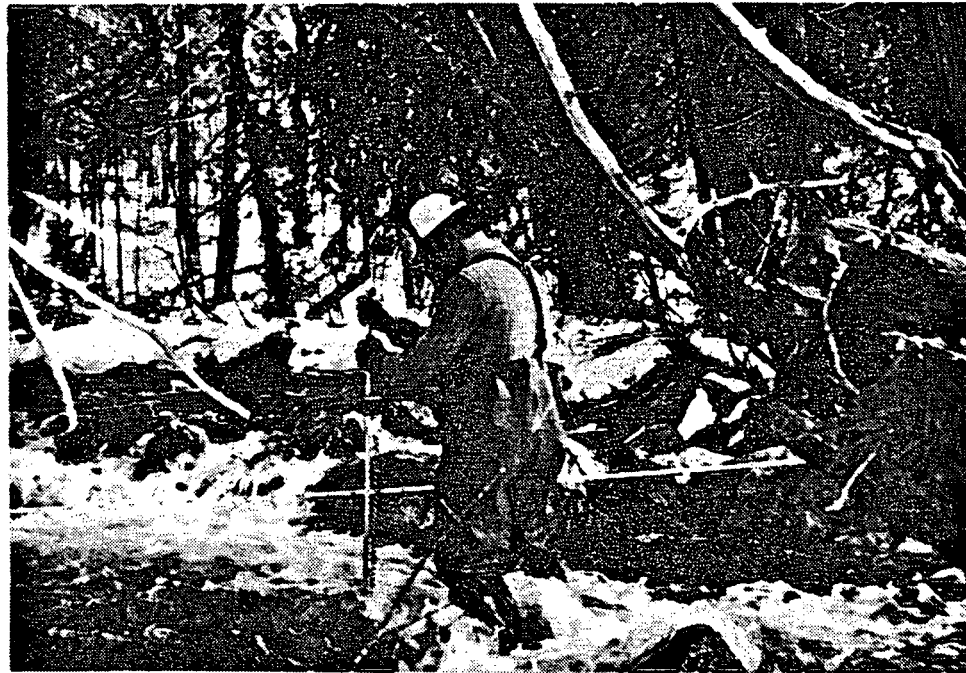
FIGURE 2: MEASURING STREAMFLOW AT ST3

Streamflows were measured at a minimum of twenty points equally spaced across the stream using a price or pygmy price hand-held current meter (figure 2). At each sampling point the number of revolutions of the current meter in 40 seconds was noted (chart 7). These readings were forwarded to the Water Survey Offices in North Bay where a computer was used to calculate the streamflows.

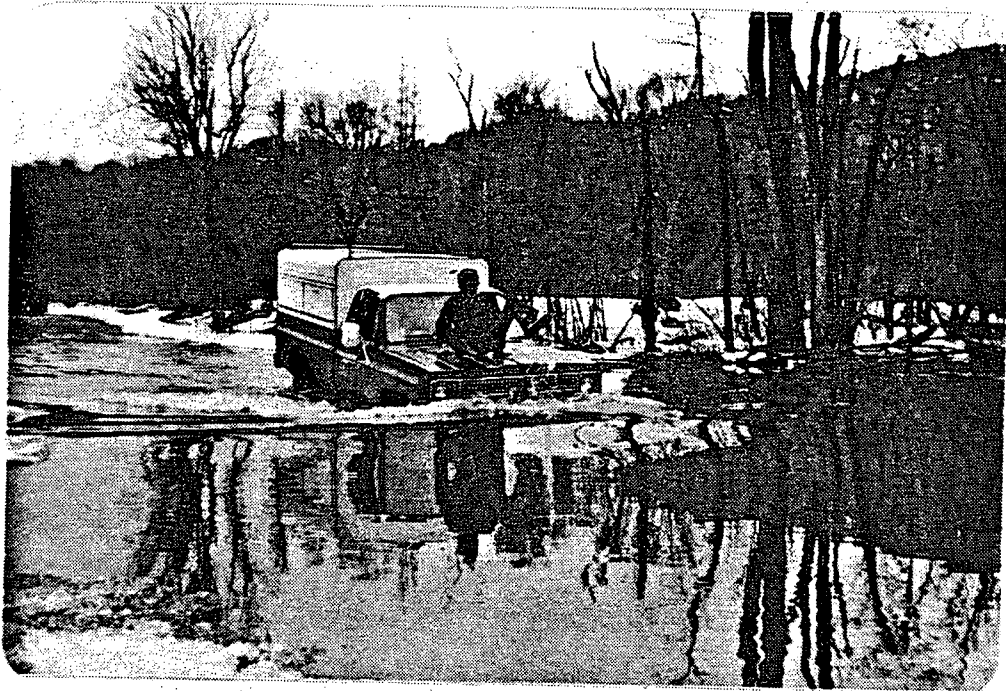
FIGURE 6: ROAD CONDITIONS DURING SPRING RUNOFF

The work required five people to complete the heavy workload (three Technical Operations). One team of two worked on lake stations while the other two-man team did the streamwork. The samples were returned to the trailer site where they were split and analysed by the remaining team member. Seven people (5 NWRI and 2 Forestry) stayed in a hunting cabin at the site for the duration of the program. This eliminated 3 1/2 hours of driving time per day when the roads could be travelled (during 4 days the road was under 4 feet of water in places (figure 6)).

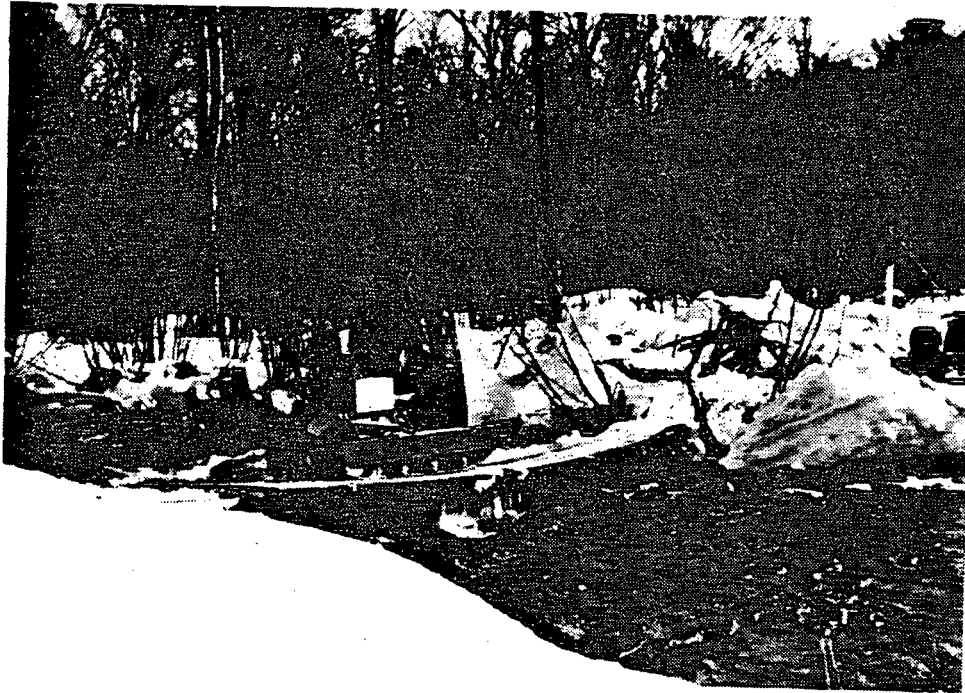
FIGURE 7: ALPINE SKIDOO TRAVELLING BETWEEN LAKES

Two Technical Operations personnel will fly to Sault Ste. Marie each month to support this portion of the project. Travel from lake to lake requires the use of the skidoos and Argo (figure 7).
