WATER INVESTIGATIONS
ALONG THE
ALASKA HIGHWAY PIPELINE ROUTE
IN THE YUKON TERRITORY

December 1978

**Inland Waters Directorate
Pacific and Yukon Region
Vancouver, B.C.**

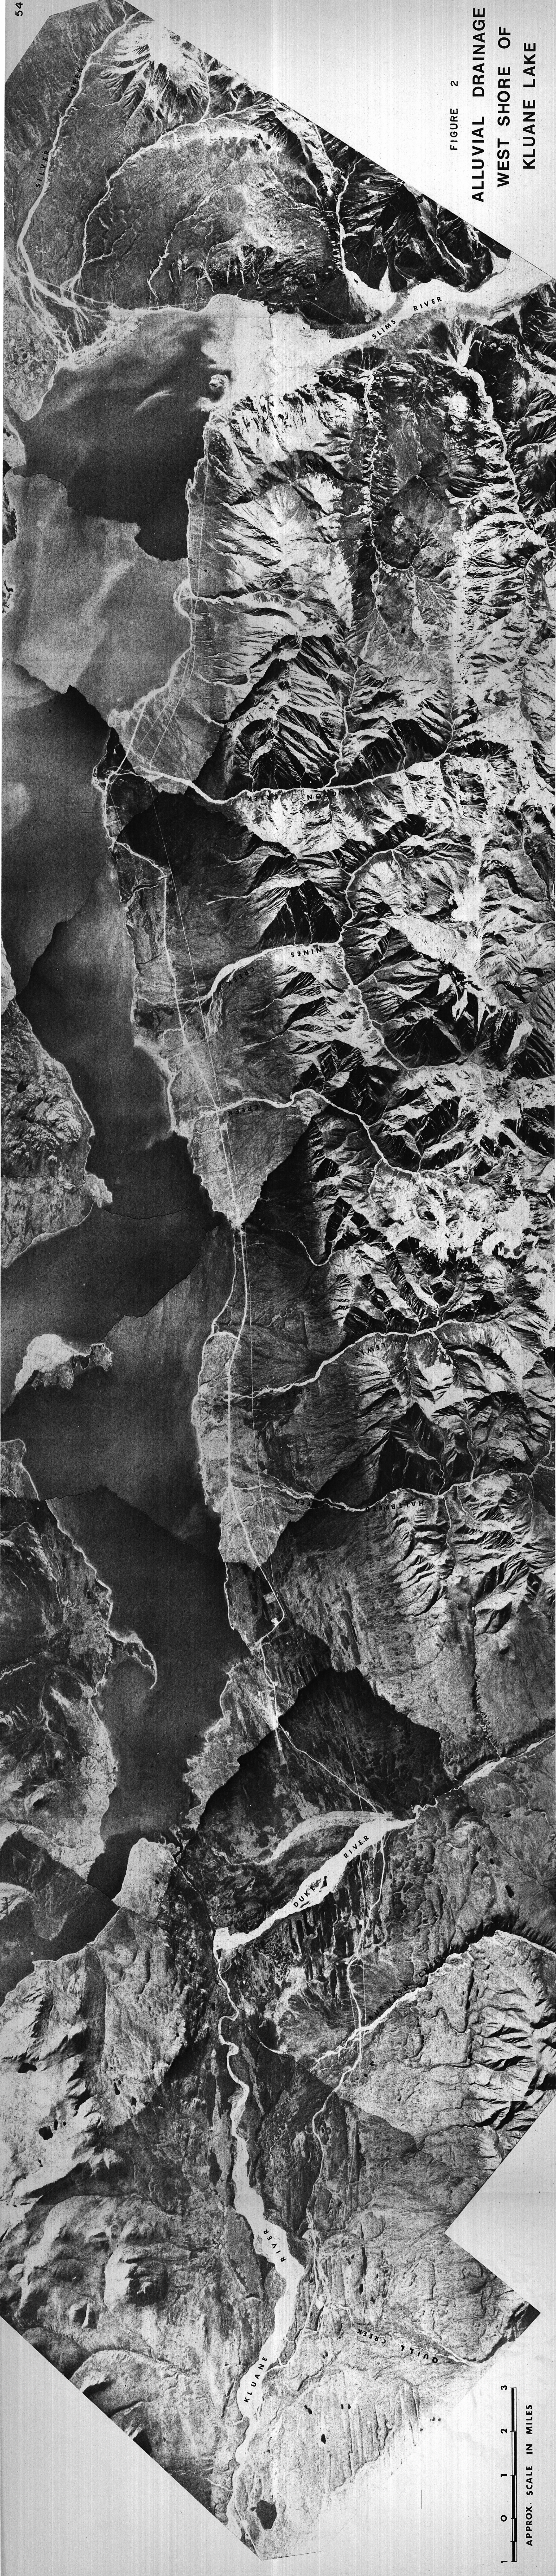
FIGURE 2

ALLUVIAL DRAINAGE
WEST SHORE OF
KLUANE LAKE

FLUVIAL FANS, WEST SIDE OF KLUANE LAKE

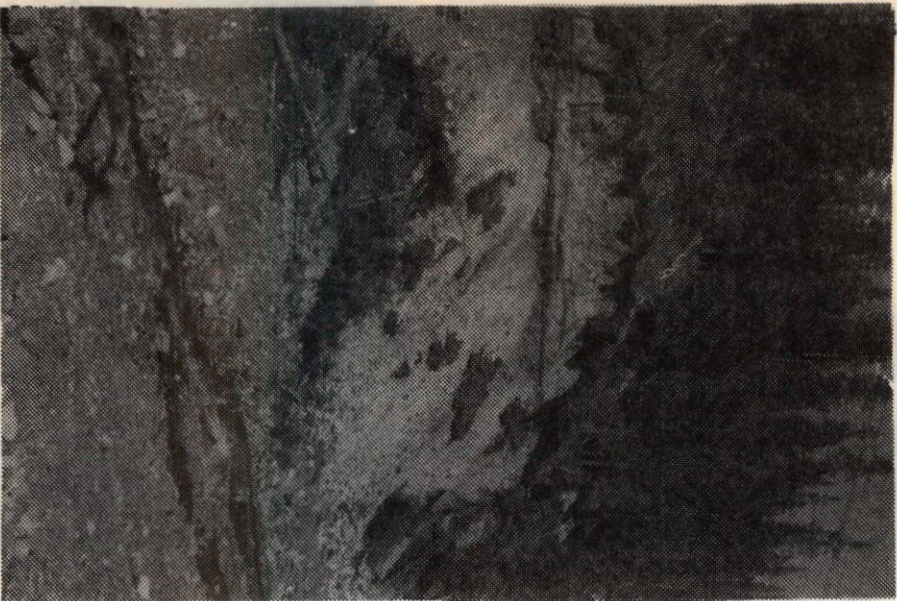
typical bank
condition

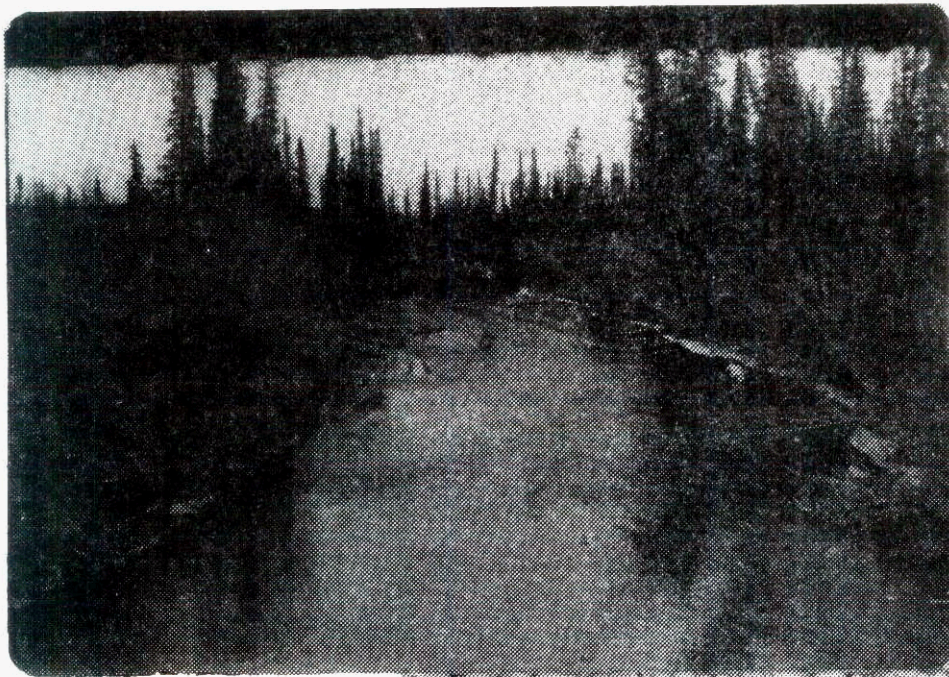
SNAG CREEK

- looking downstream
Sept. 1978

B.M. - 6" spike in d/s pile under bridge, right bank - 100.00' local datum.
