HISTORICAL FLOOD REVIEW:  
FORT SIMPSON, FORT NORMAN  
FORT GOOD HOPE, FORT McPHERSON,  
AKLAVIK, FORT LIARD, NAHANNI BUTTE

L.A. Kriwoken

Northern Hydrology Section  
Surface Water Division  
National Hydrology Research Institute  
Environment Canada  
Ottawa, Ontario  
K1A 0E7

March 1983

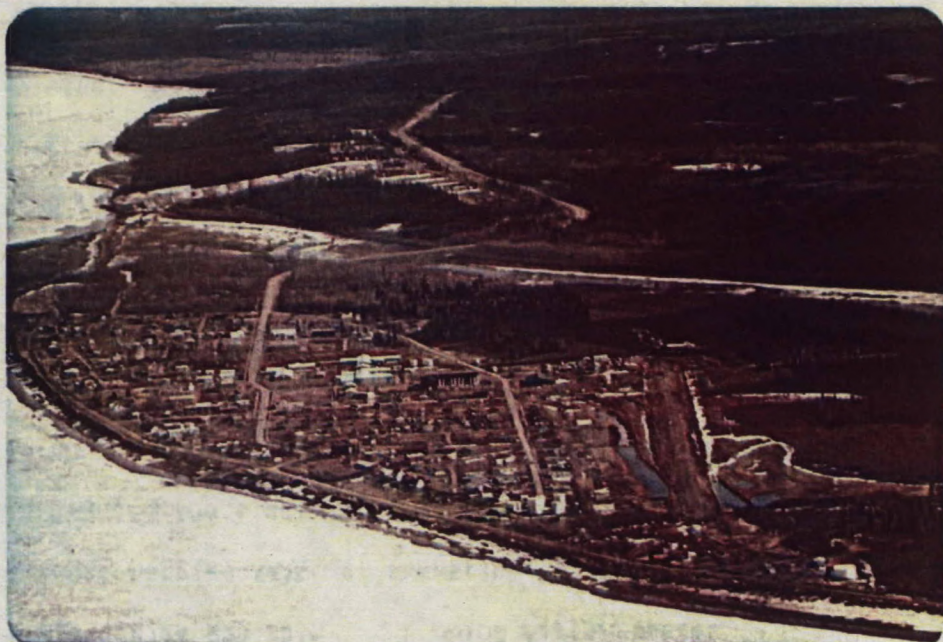
Photograph 1. Fort Simpson Island viewed southeast, upstream the Liard River, left bank of the Mackenzie River in foreground. 07 May 1982, 1745 MDT.

Prior to 1970, a low causeway linked the southeast end of the island to the mainland. The elevation of the causeway was too low and was frequently overtopped during spring break-up. As a result, the Liard water and ice would flow through the Snye and enter the Mackenzie at the downstream end of the island. In 1970, construction of a higher causeway was completed. Although the Snye continues to fill with backwater from the downstream end of the island during break-up, the new causeway has forced the Liard to enter the Mackenzie upstream of the island. Also common during break-up is the flooding of both ends of the island where the lower terrace merges with the shoal area.

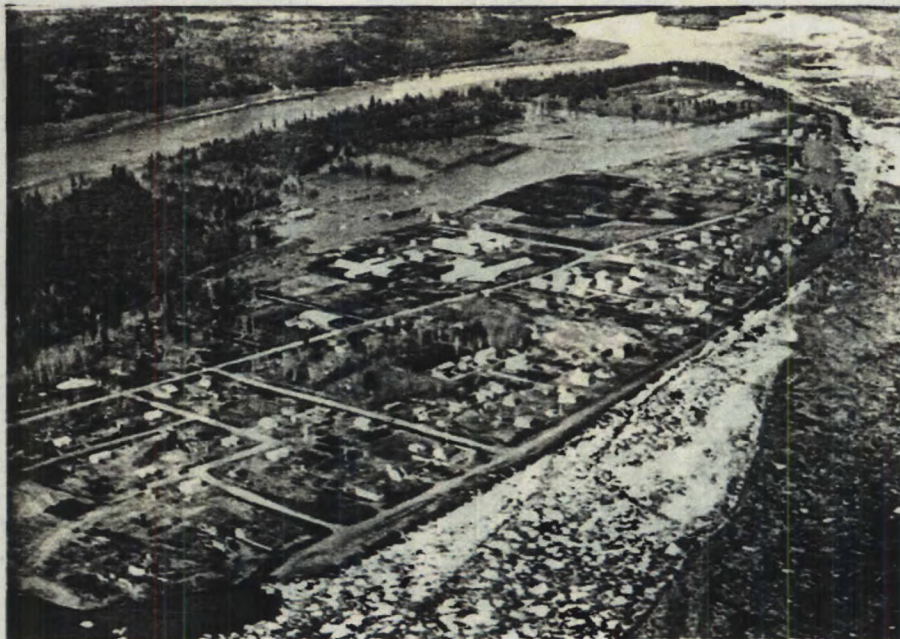
Photograph 2. 1963 Flood at Fort Simpson, viewed from upstream end of island (timing of photograph unknown; believed to have been taken on 01 May 1963, one day prior to peak stage). Note in foreground that water has reached upper terrace, cutting off road to low-lying flats.

1963 Extreme Floodline (126.1 m) delineated on Fort Simpson Flood Risk maps.

Extreme Ice Shove Limits: Observed limits of 1963 ice shove activity along Mackenzie Drive (126-127.5 m asl); ice shoved up to 6 m high on road, delineated on Fort Simpson Flood Risk maps.

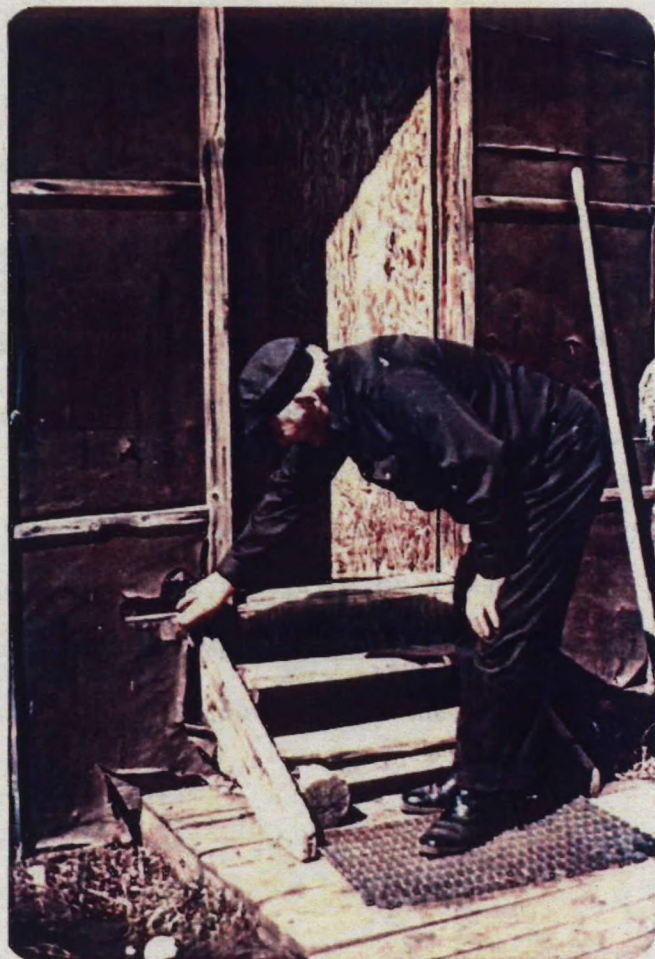
Photograph 4. Long-time resident of Fort Simpson, Joe Lafferty, indicating high water level (126.1 m asl) of 1963 flood.

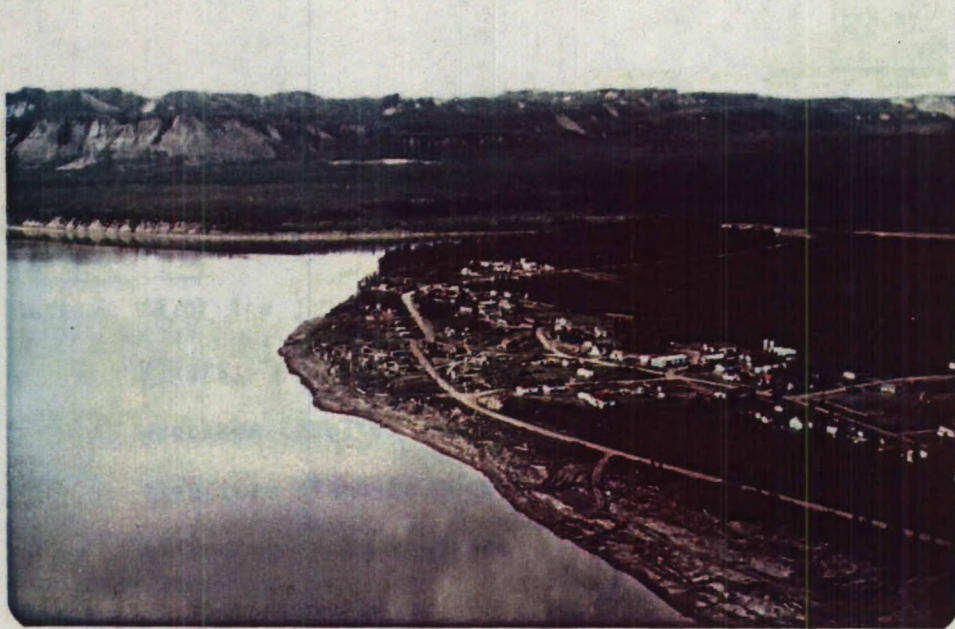
Photograph 5. Fort Norman settlement at confluence of Great Bear and Mackenzie Rivers, viewed downstream the Mackenzie with Great Bear entering from the north, 20 July 1982, 1700 MDT.

The confluence of the Great Bear and Mackenzie Rivers, where Bear Rock rises to 400 metres, is prone to ice jamming. At this site during spring break-up, ice is commonly obstructed by Windy Island, extensive shoals and the intact ice cover at the mouth of the Great Bear (MacKay and Mackay, 1973).

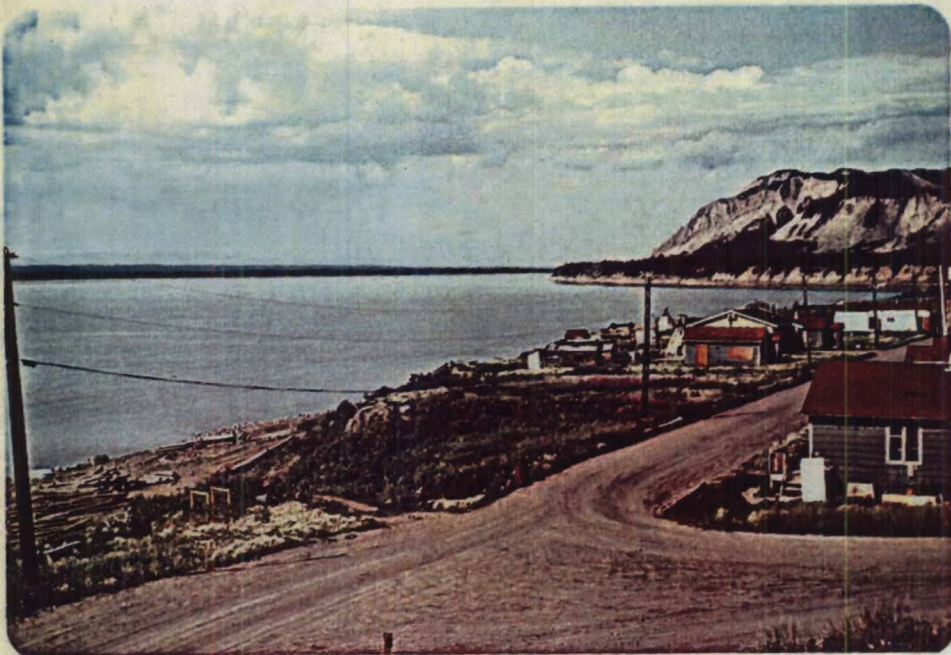
Photograph 6. Lower terrace of Fort Norman, viewed downstream the Mackenzie from old HBCo. yard on upper terrace, 21 July 1982, 1020 MDT. Offers a comparative view with photograph 7, taken from same vantage point.

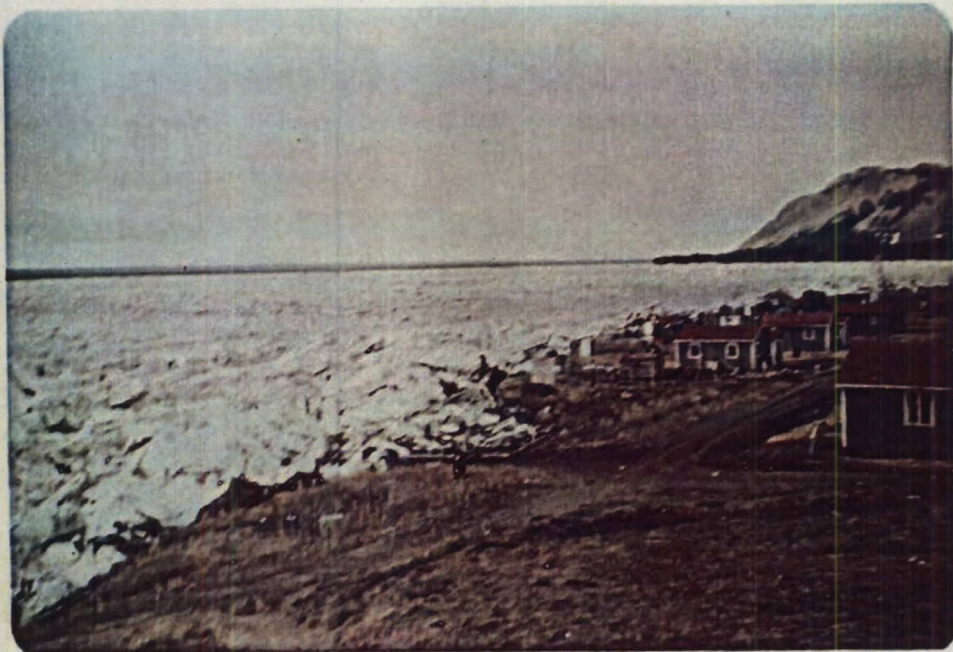
Photograph 7. Extent of ice shove (60.5-60.9 m) on lower terrace of Fort Norman settlement, 28 May 1964.

Extreme Ice Shove Limits: Observed limits of 1964 ice shove activity along lower terrace of settlement (60.5-60.9 m asl) delineated on Fort Norman GNWT community map (information provided from Photographs 7 & 9).

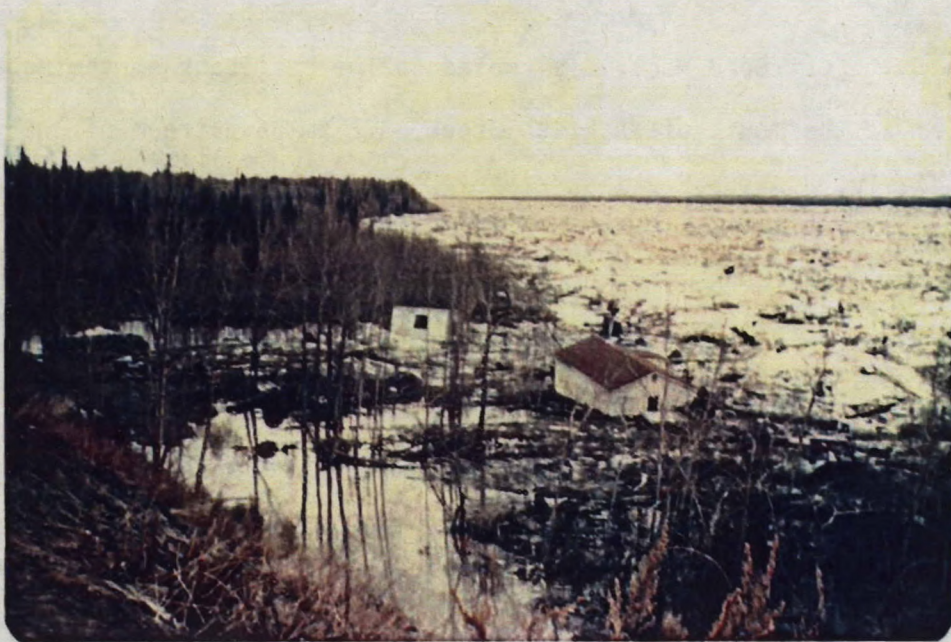
Photograph 8. 1964 flood at Fort Norman, viewed upstream the Mackenzie River to road below old HBCo. yard; 28 May 1964. Water level surveyed at 60.9 m asl.

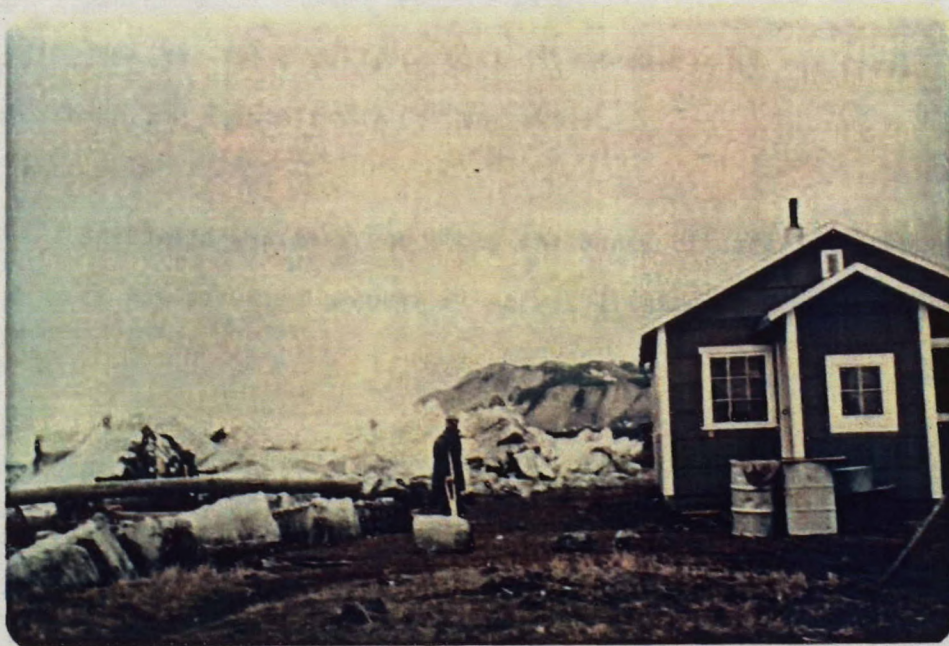
Photograph 9. 1964 ice shove on lower terrace of Fort Norman Settlement, 28 May 1964.

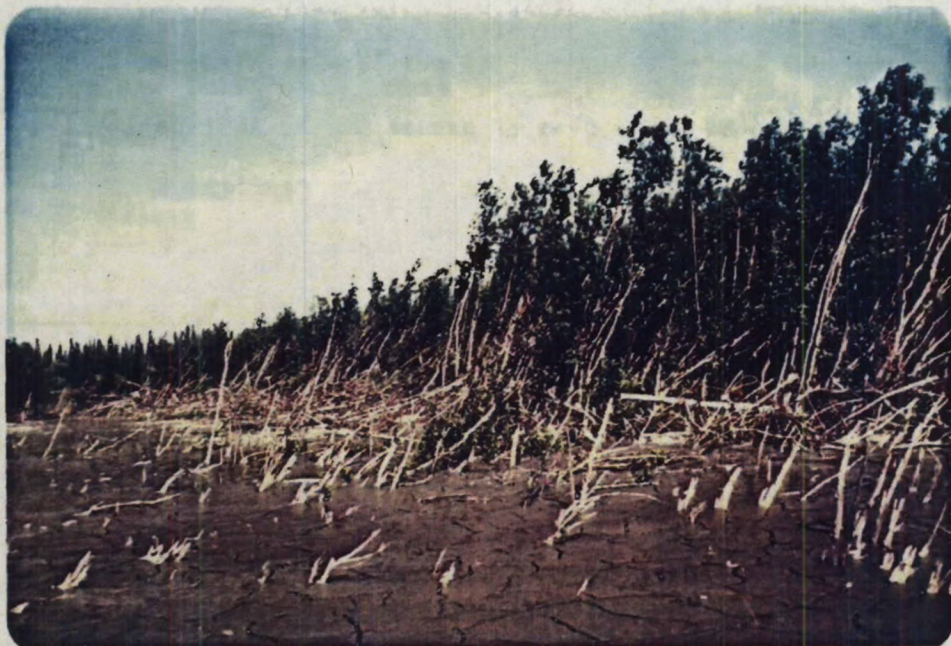
Photograph 11. Trees damaged by spring break-up ice shove on "Last Dock Road" - north of Fort McPherson settlement. 06 July 1982, 1800 MDT. Ice shove levels surveyed between 10.5-11.0 m asl.

Ice Shove Limits: Observed limits of 1982 ice shove activity along "Last Dock Road" (10.5-11.0 m asl) delineated on Fort McPherson Flood Risk map.

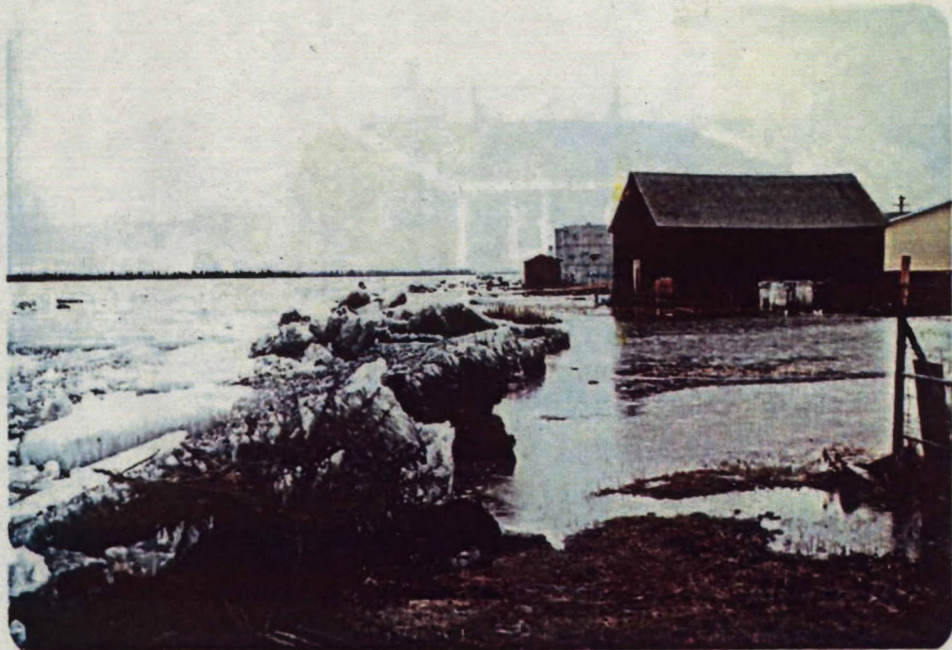
Photograph 13. 1982 flood at Aklavik, viewed upstream Peel Channel from in front of Roman Catholic Mission, 02 June 1982, 1400 MDT.

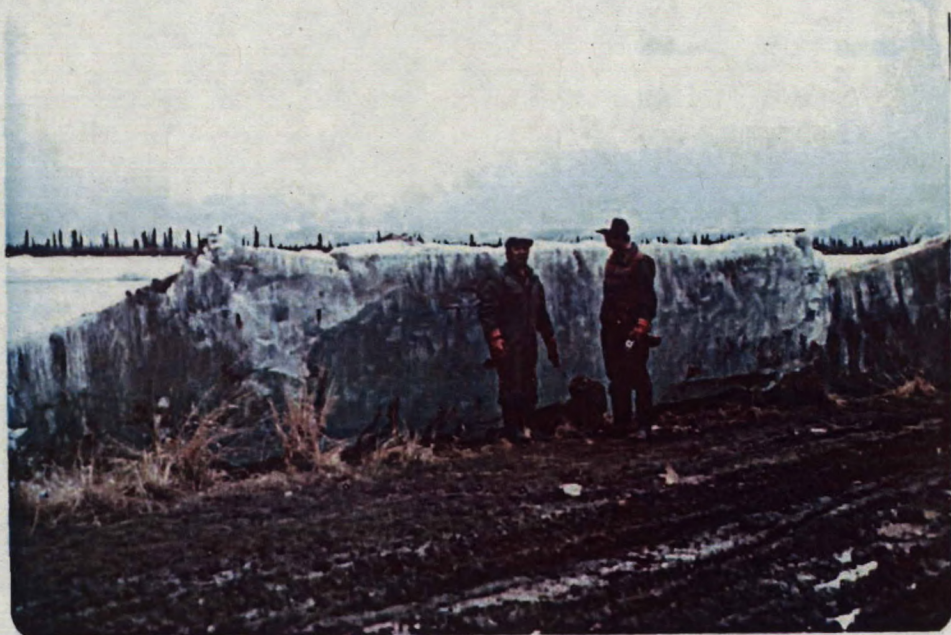
Photograph 14. Ice shove on road in front of old HBCo. store, Aklavik, 02 June 1982, 1350 MDT (black ice thicknesses between 1.5-1.8 m).

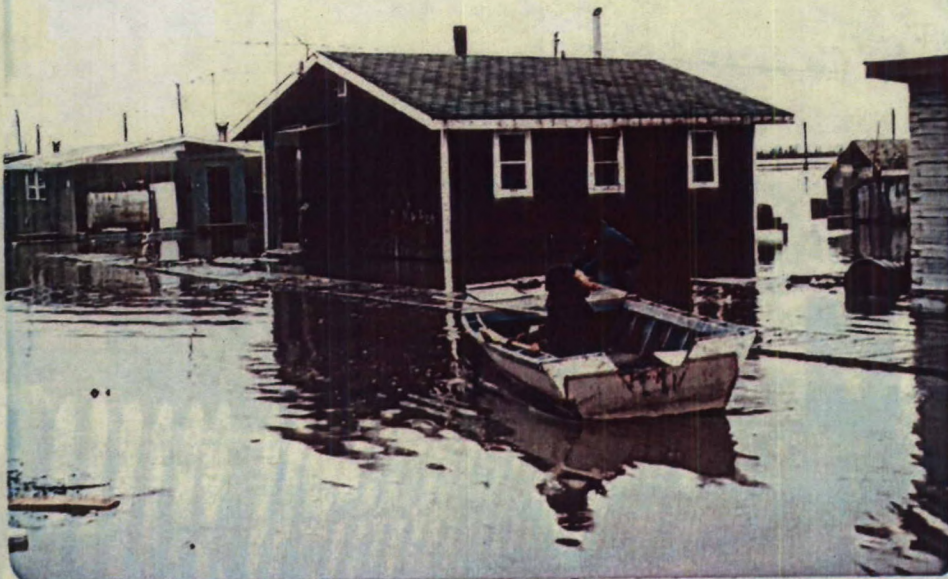
Photograph 15. Floodwaters inundating main road in Aklavik, viewed 1 block north of HBCo. store, 02 June 1982, 1305 MDT.

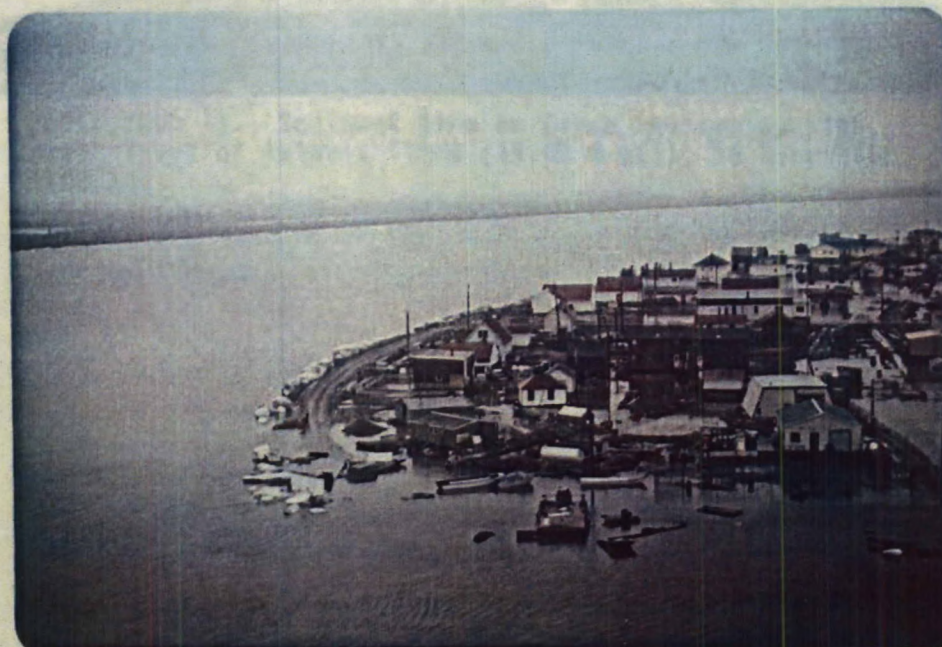
Photograph 16. 1982 Flood at Aklavik, viewed upstream Peel Channel, 03 June 1982, 1020 MDT, between 3 1/2 and 9 hours after peak stage.

03 June - Flood level peaks between 0130 and 0700 MDT  
1020 MDT - photograph 16 indicates extent of  
water in settlement
