**Atlas Specialty Steels
Welland, Ontario
and
Environment Canada
Toronto, Ontario**

**The Full-Scale Welland River
Reef Cleanup Project
Project Assessment Report
Technical Reference Document
Volume 1 of 3
Main Report**

December 1997

**Acres International Limited
Niagara Falls, Ontario**

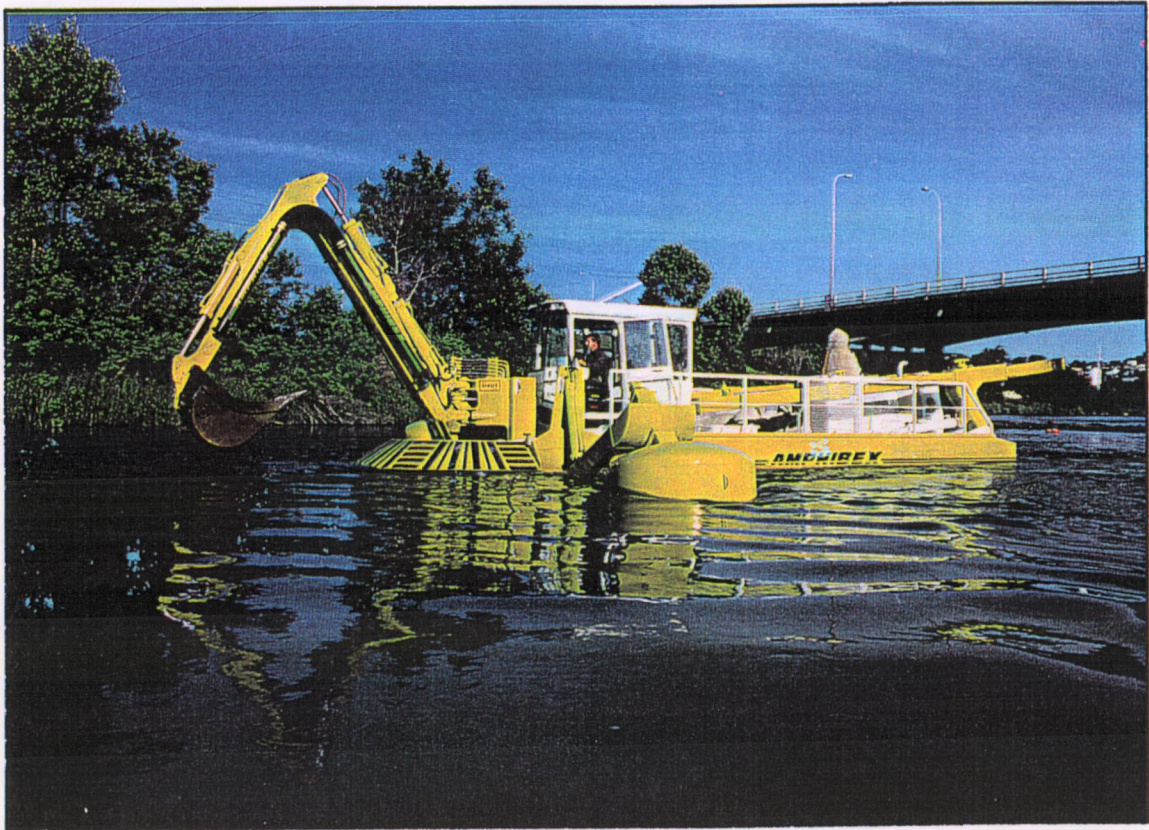
The Amphibex dredge is a combination mechanical-hydraulic suction dredge which requires no cables for anchoring or maneuvering. It has two spud legs at the rear of the dredge, and two stabilizer arms off either side near the front end of the dredge. The spud legs can be tilted, and in combination with the stabilizing arms and the excavating arm, can effect movement of the dredge both in the water and on land. It also has a rear mounted propeller which allows additional maneuvering capabilities in water. Technical features and specifications of the Amphibex are shown in Figure 5.1.

The forward backhoe-style arm of the dredge can be equipped with various attachments including a pump bucket, an excavating bucket, rake, hammer, etc. During operation, the main body of the dredge remains stationary and the attachment is extended over the front of the dredge for use.

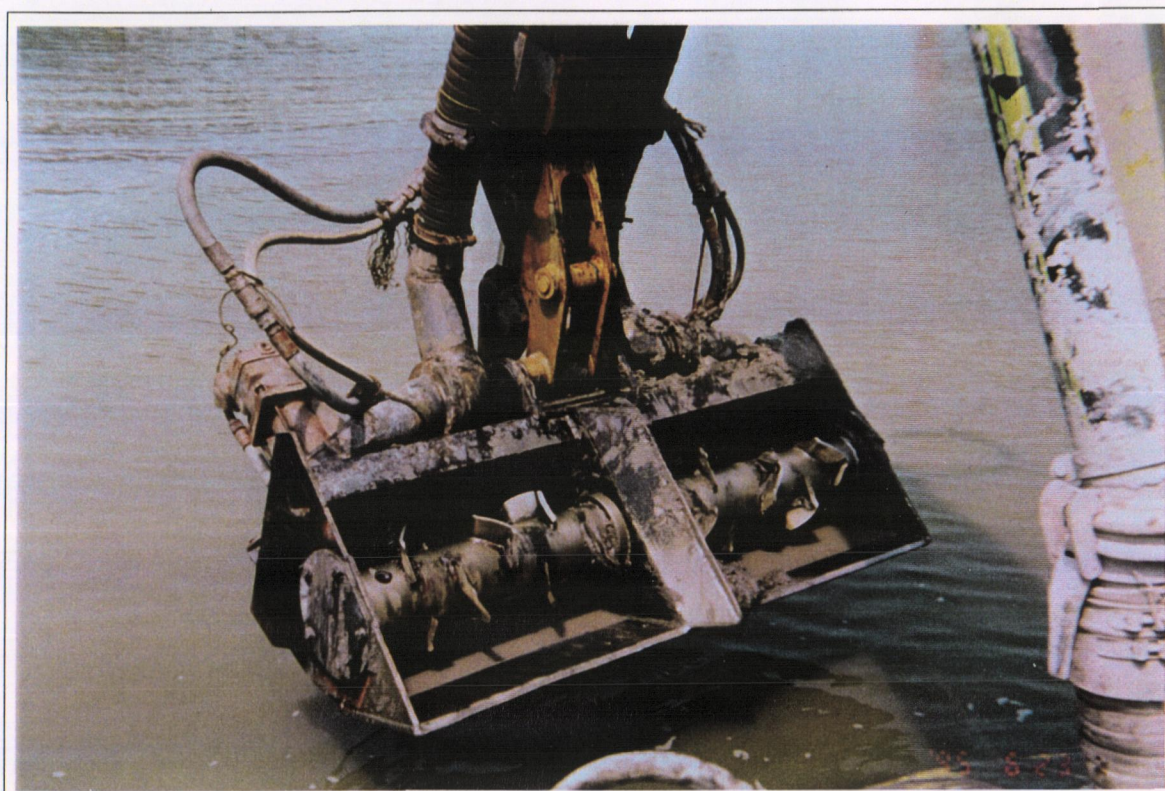
Dredge head showing augers, pumps and split bucket design.

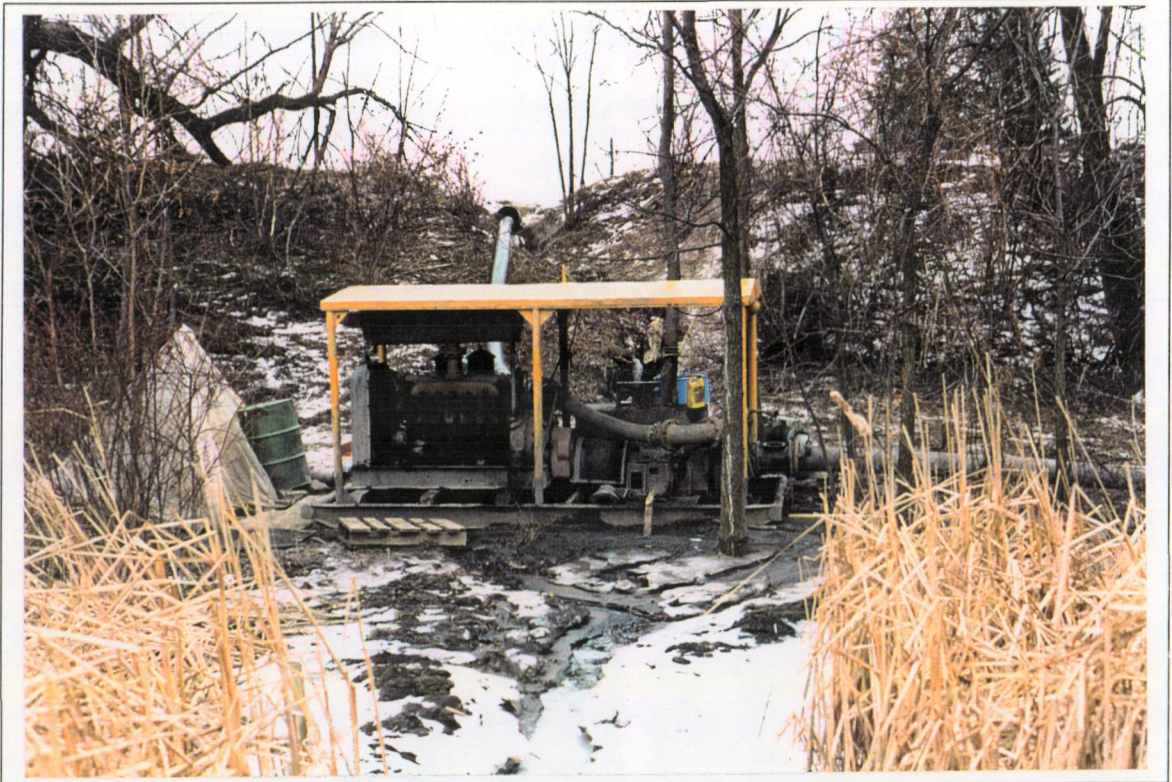
Booster pump located at edge of floodplain, midway between dredging and treatment sites.

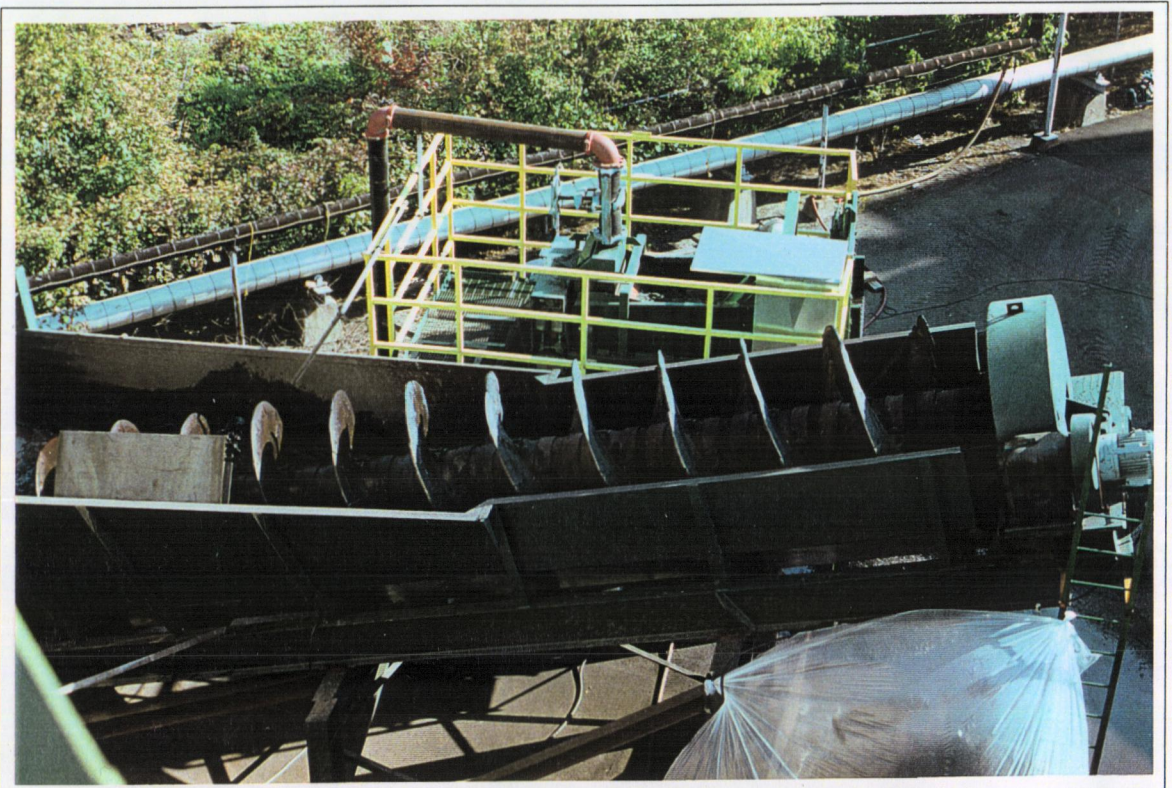
Aerial view of screw classifier (foreground) and scalping screen (background).

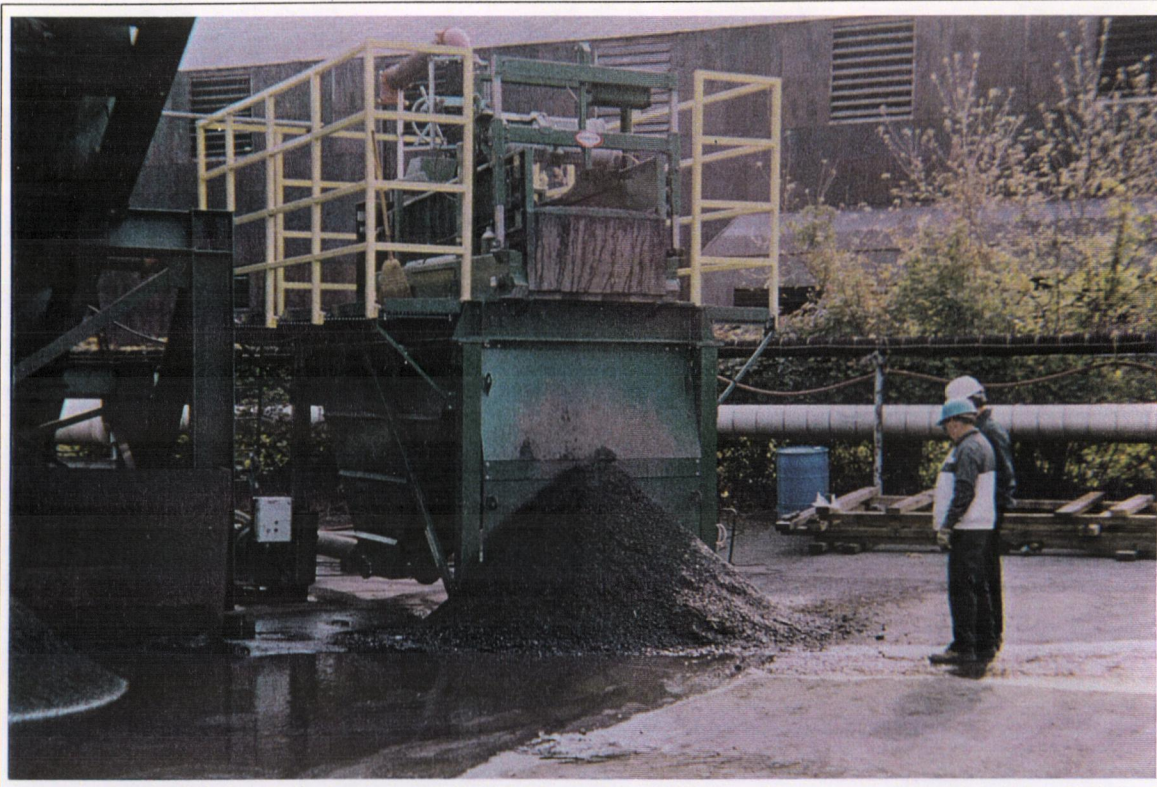
Front view of scalping screen and separated coarse materials (screw classifier to left).

During periods of high solids content in the dredged slurry, it was occasionally observed that the 2-mm mesh of the scalping screen would become blinded resulting in the discharge of much of the slurry flow onto the ground in front of the screen. To prevent this from occurring the 2-mm mesh screen was replaced with a coarser 9.5-mm mesh which allowed more and larger solids to pass through it. These solids were then removed from the slurry by the screw classifier.

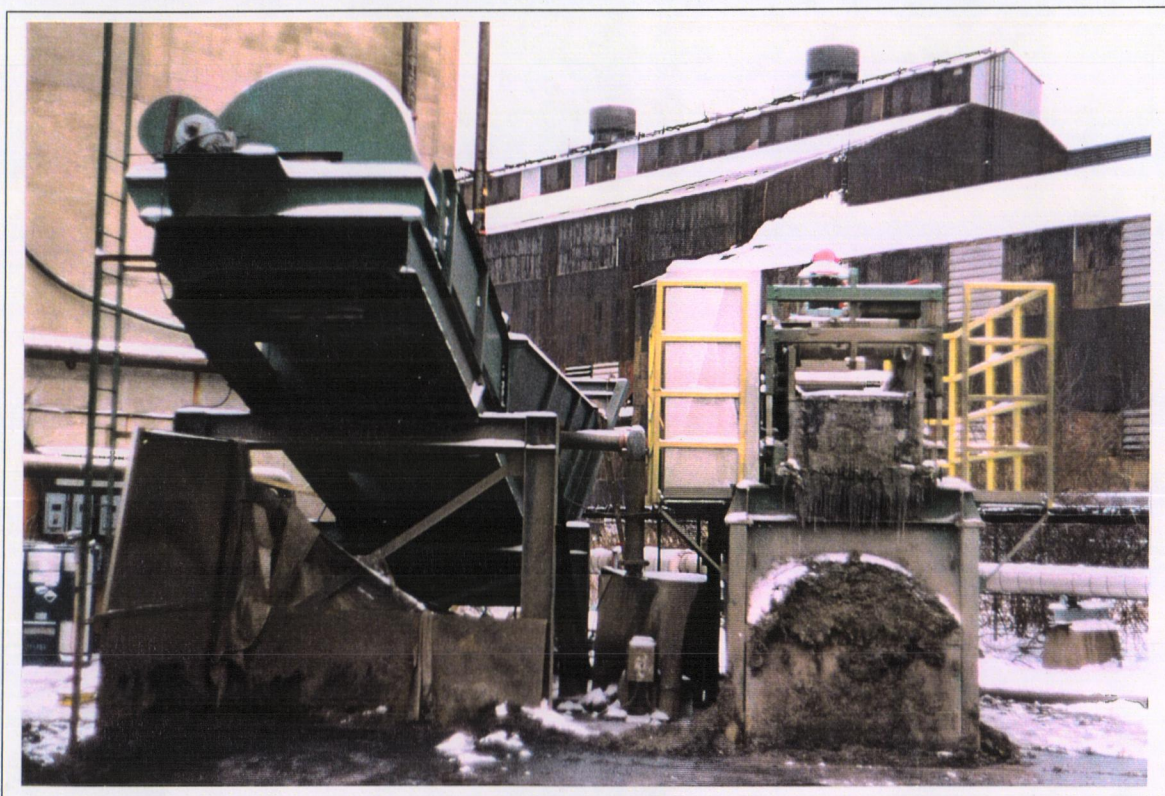
Front view of screw classifier (left) and scalping screen (right) during cold weather (December 19, 1995) operation.

The scalping screen generally functioned adequately in separating out the coarse particles and river debris. Occasionally, when the solids content in the slurry was high, the screens (2-mm opening) on the unit would blind resulting in a sudden discharge of wet slurry to the ground. Toward the latter part of the project the 2-mm screens were replaced by 9.5-mm screens which eliminated the blinding problem.

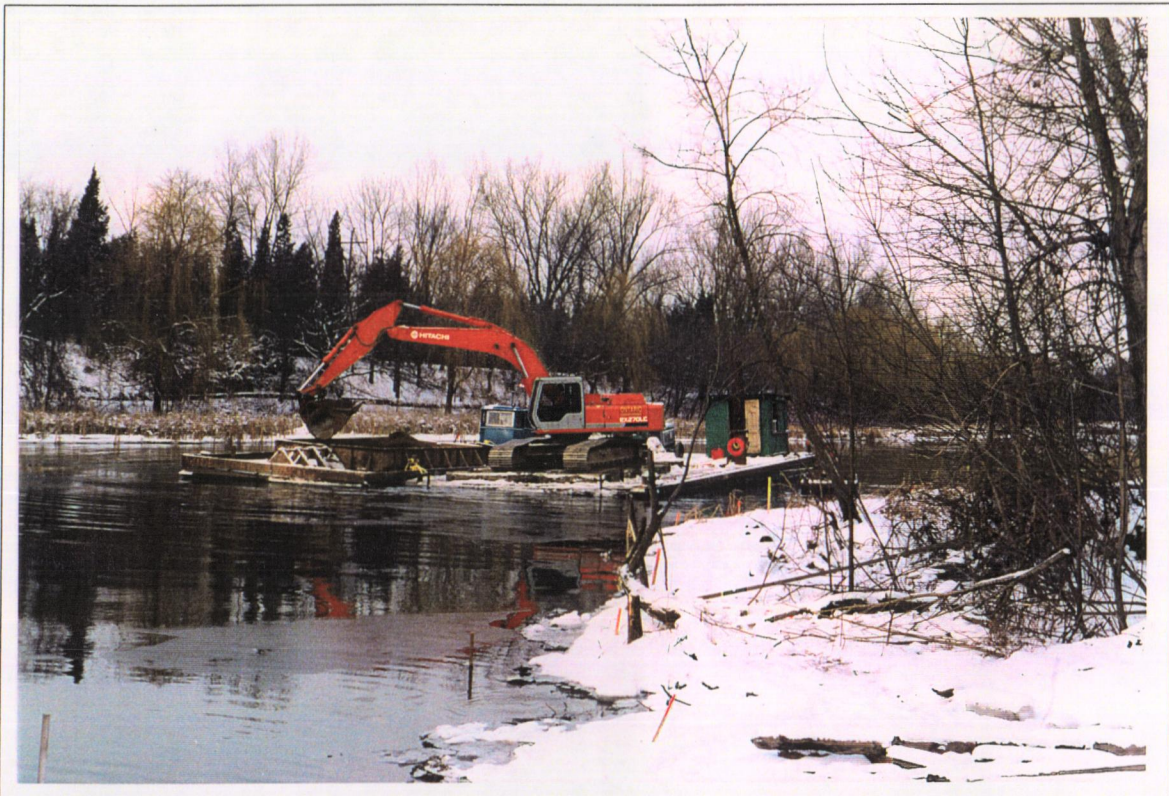
Backfilling of dredged areas to recreate river side slope using clean granular fill.

During the planning stages of the project it was noted that the Zones 1 and 2 granular fill, to be used to recreate the underwater side slope in the river after dredging, was different from the existing river bank materials (fine silts and clay), and a concern was raised that the selected material would provide a different type of habitat than would normally be expected in the Welland River system. Following further discussion with the MNR, it was agreed that a program would be initiated after the project was completed to assess the rate and degree of infilling of the granular material over time. The initiation of this program was identified as a responsibility of Atlas' as part of the full-scale clean-up project. The program, as outlined below, involved the installation of sedimentation samplers into the side slope at selected locations downstream from the McMaster Avenue and Atlas 42-in. outfalls. Following retrieval and assessment of the first set of samples (late spring 1996 after the spring flood event), the program would be turned over to the Welland River Wetland Working Group. The long-term goal of the program is to determine the suitability of this type of granular material for similar shoreline applications in the future.

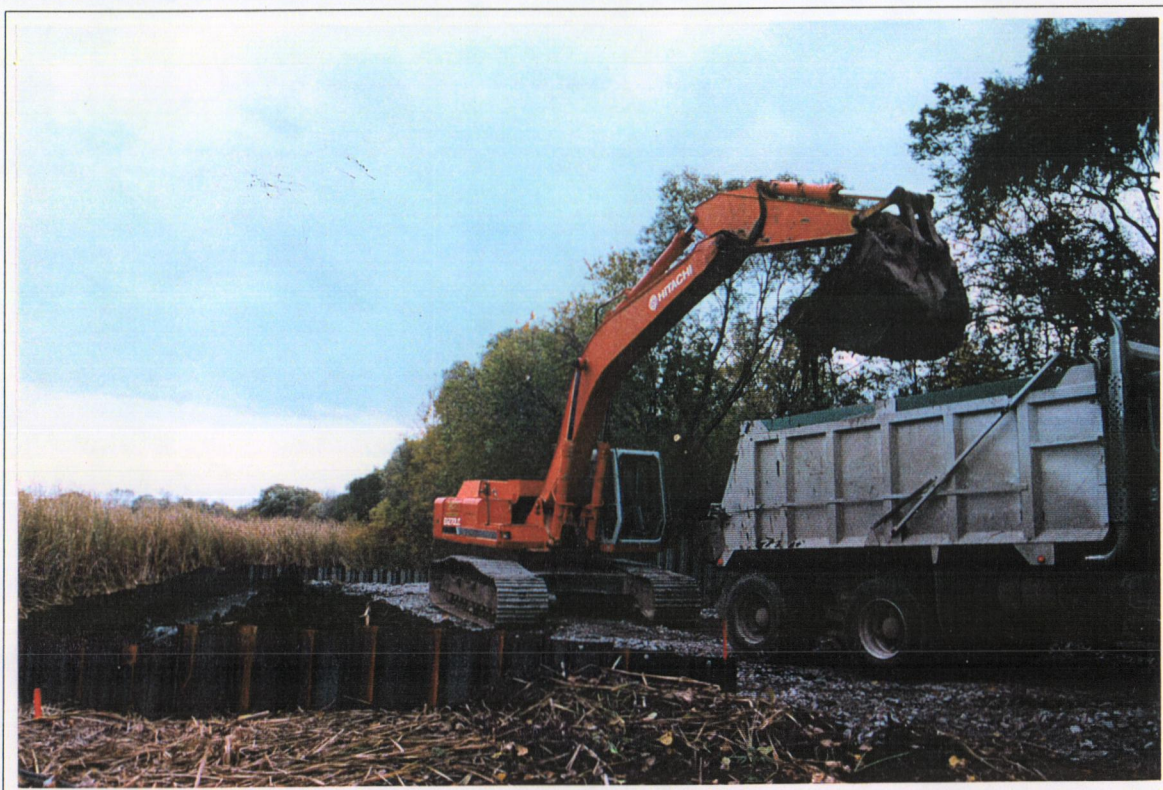
Initial excavation of floodplain millscale pocket north of Atlas 42 in. outfall.

It should be noted that, although mill scale has been removed from this area of the floodplain, the backfilled area will still retain some degree of contamination. This is due to contaminated floodplain sediments having been unavoidably mixed with the backfill materials and unrestricted groundwater flow from the surrounding contaminated area into the backfill.
