Digital Television Tests Results Phase I

*CRC Report No. CRC-RP-2000-11
Ottawa, November 2000*

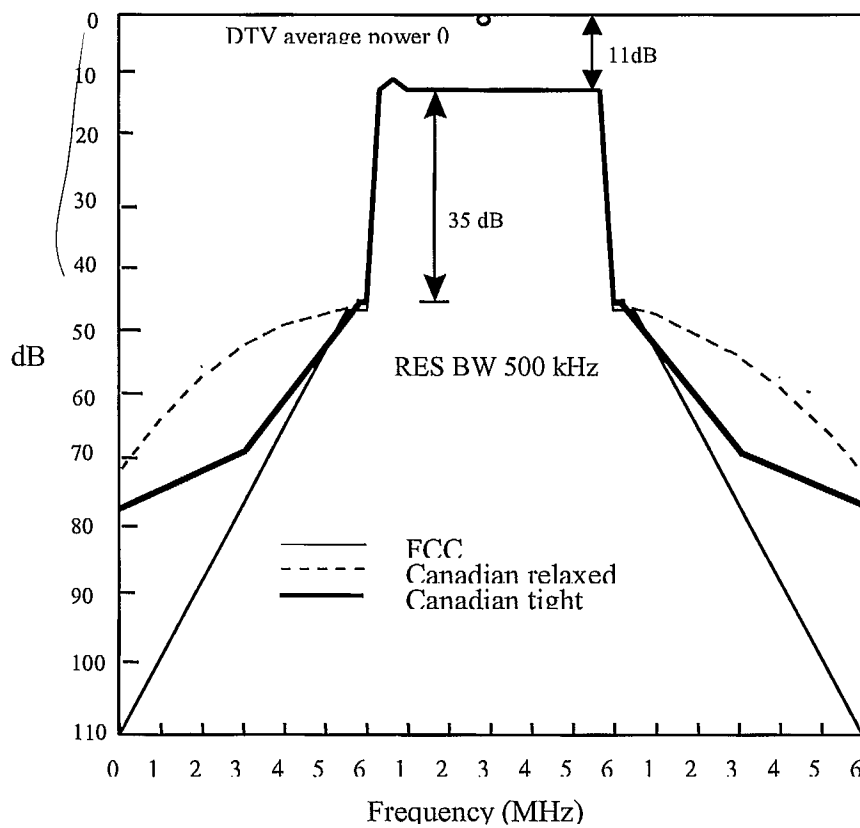
Figure 5. Digital Television Emission Mask (6 MHz)

The Canadian mask filter for the DTV emission is presented in Figure 5. The RF spectrum of the transmitter output is shown in Figure 6. It meets the relaxed RF spectrum mask specified for DTV transmission in Canada.

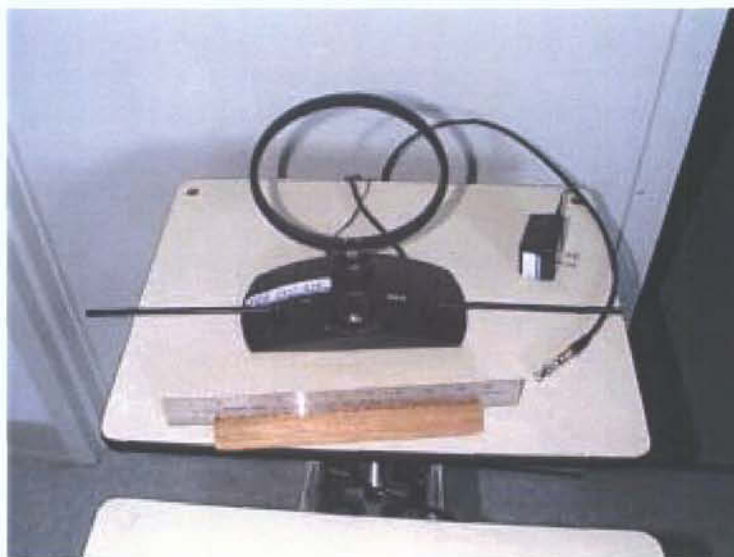
Figure 11. The RCA *CANT 200* active loop antenna.

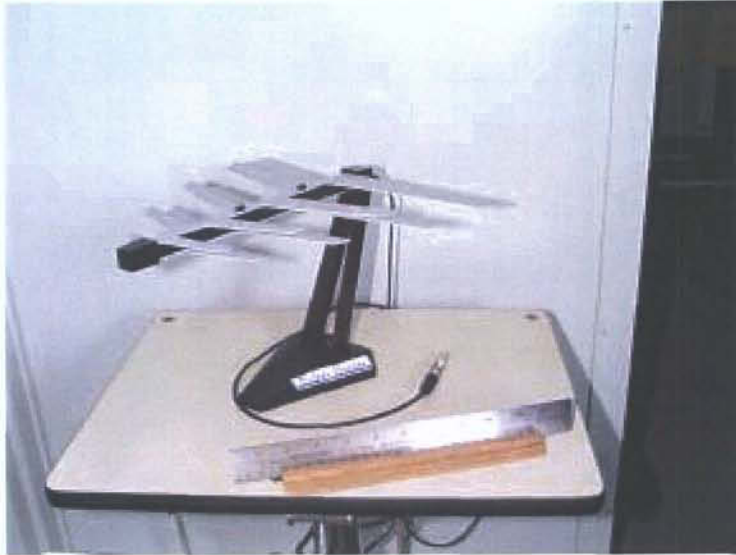
Figure 12. The Antiference *Silver Sensor* passive antenna.

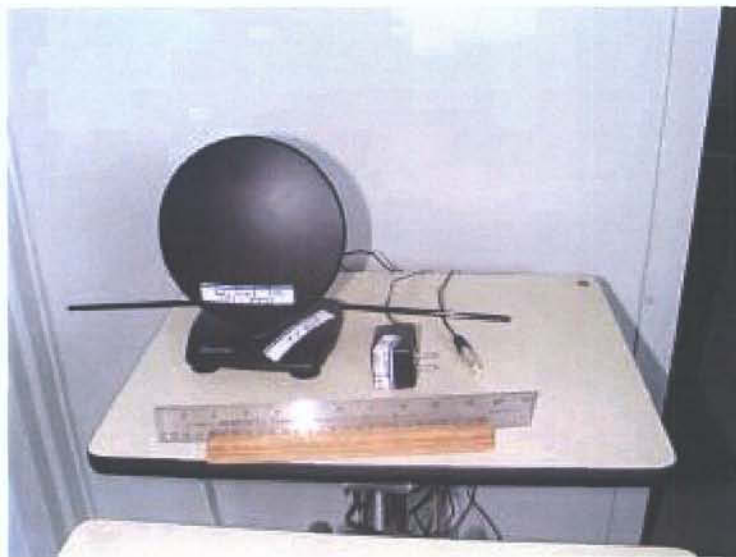
Figure 13. The Recoton Power Wave Model *TV 800* active antenna.

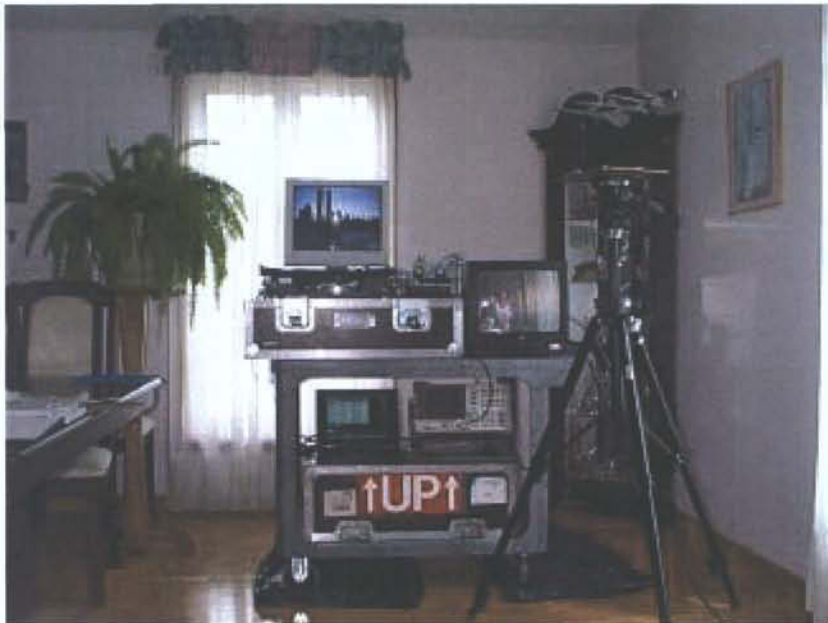
Figure 14. Complete setup used for DTV indoor reception tests. Left monitor (LCD): DTV reception; right monitor: NTSC receiver.

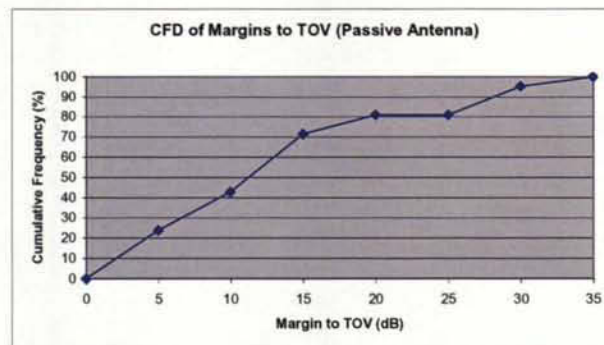
Figure 18. The CFD of the margins to TOV for the *Silver Sensor* antenna (reliable sites only). The median was about 11 dB.

For the passive antenna (Fig. 12), these margins ranged from 1 to 31 dB. Fig. 18 shows that 50% of those 21 sites had a margin to TOV of more than 11 dB with the *Silver Sensor* antenna.

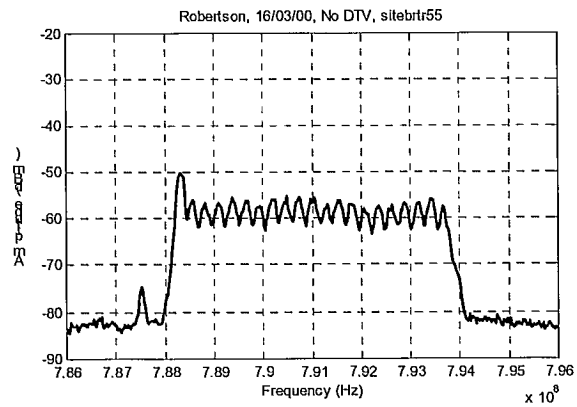
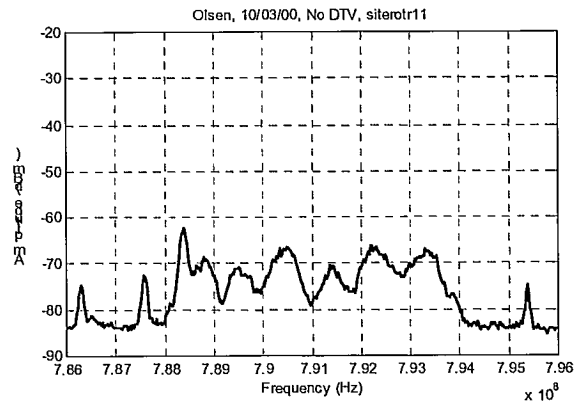
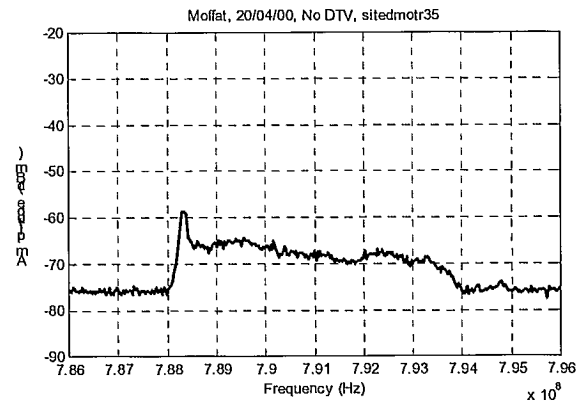
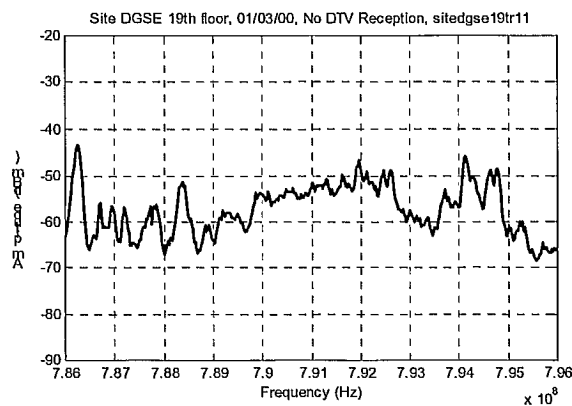
- **A) Reliable DTV reception:**
(*High field strength and a close-in ghost*)
($C/(N+I) \approx 50$ dB)
(NTSC: 4)

- **B) No DTV Reception:**
(*Multipath only*)
($C/(N+I) \approx 25$ dB)
(NTSC: 0.5)

- **C) No DTV Reception:**
(*Low field strength and multipath*)
($C/(N+I) \approx 7$ dB)
(NTSC: 0.5)

- **D) No DTV Reception:**
(*Low field strength and multipath*)
($C/(N+I) \approx 8$ dB)
(NTSC: 2)

- **E) No DTV Reception:**

(Low field strength, in-band multipath distortion and out-of-band intermodulation distortion)

- **F) Sensitive DTV Reception:**

(Multipath and tone interference)

Figure 21. Some typical RF spectrum plots (resolution bandwidth: 100 kHz, video bandwidth: 1 kHz, no averaging), with the corresponding picture quality for NTSC (Channel 65). All these plots were taken using an active antenna, except Fig. 21D.

At site #9 (Kanata), surprisingly, the DTV spectrum was *flatter* with the *RCA* antenna, yet one could only achieve sensitive DTV reception in these conditions: *tone interference* can very likely explain these results (see Fig. 21F). A strong tone @ 794.4 MHz (approximately) and two weaker ones (about 12.5 dB below) @ 786.5 and 787.5 MHz are clearly visible on this plot. These tones were not visible with the passive antenna and were likely caused by a strong out-of-band transmitter (e.g. a pager) overloading the antenna's preamplifier, thus creating intermodulation products falling within (therefore not visible on the spectrum analyzer) and in the vicinity of Channel 67.

Because of the wide variety of scatterers found in the paths between the transmitter and the indoor sites, the 8-VSB spectrum plots on Channel 67 have quite different shapes. The following figures (Figs. 21 below) show typical RF DTV spectra observed during the field tests (center frequency: 791 MHz, span: 10 MHz, resolution bandwidth: 100 kHz, video bandwidth: 1 kHz, no averaging). An assessment of the picture quality of NTSC transmissions (see Table 7) on Channel 65 at these locations is also indicated.
