Fisheries and Oceans
Canada

Basin Head Marine Protected Area: 2019-2020 Operational Management Plan Implementation Progress Report

Gulf Region Basin Head Management Series 2021/02

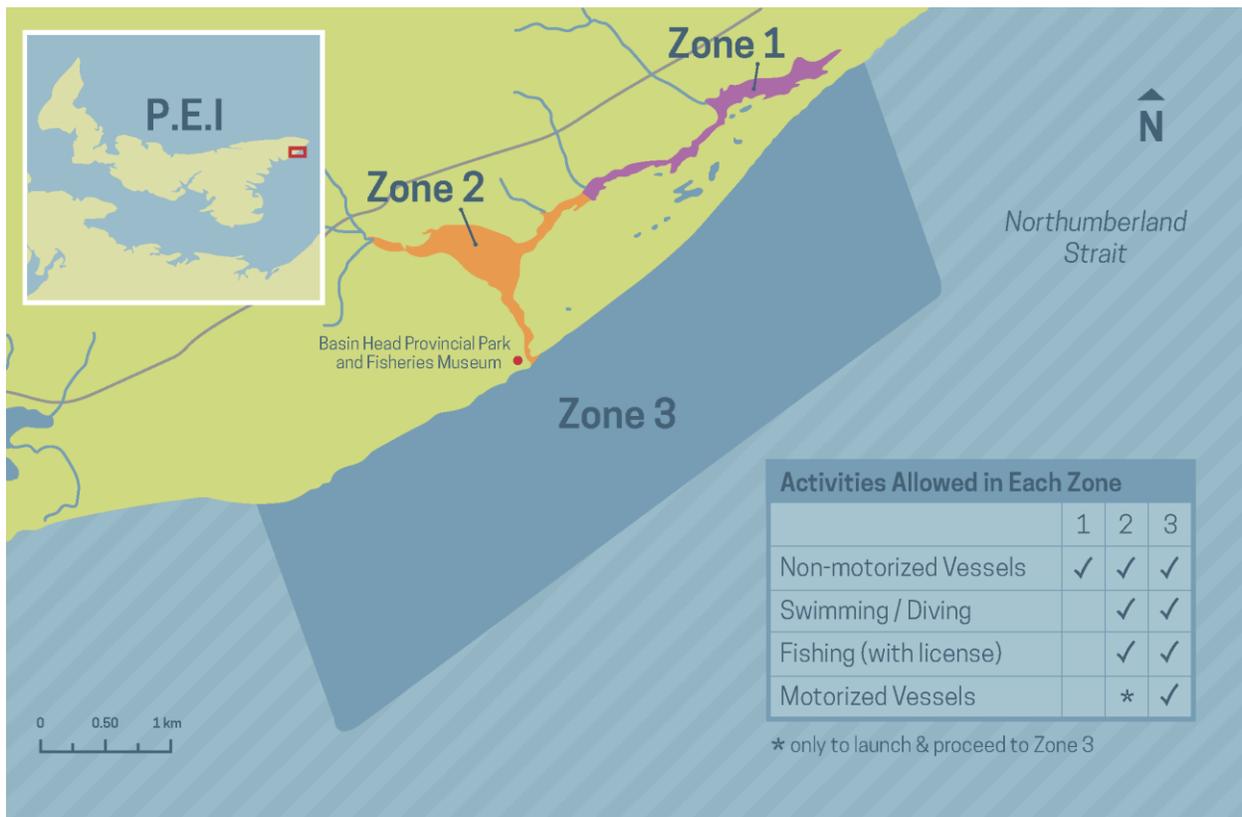
Figure 1: Basin Head Marine Protected Area and its three management zones.

The MPA encompasses Basin Head Lagoon and an adjacent offshore buffer zone in eastern Prince Edward Island within the Northumberland Strait (Figure 1). The MPA was designated by regulations to conserve and protect a distinct form of an otherwise common marine alga, Irish moss (*Chondrus crispus*). This form of *Chondrus*, also known as the giant moss, is thought to exist only within the confines of Basin Head. It reproduces only by fragmentation, does not reproduce sexually or by producing spores (Tummon Flynn et al. 2018), and has no holdfast but is held in place by byssal threads of Blue mussels (*Mytilus edulis*). Sheltered habitats often influence morphology of algae; this has resulted in relatively expanded blades for the giant Irish moss in Basin Head. However, spriggy outer coastal plants (i.e. narrow blades) sharing the habitat are attached to hard objects by holdfasts and have not developed into the giant form. The exploration of genetic differences between this and the other Irish moss population is a logical next step to try to understand the uniqueness of this strain. The use of microsatellite genomes to compare Irish moss strains may provide further insight on the differences among populations (see studies by Krueger-Hadfield et al. 2011, 2013, 2015). What is especially interesting and requiring management and protection is the giant Irish moss dependence on mussels for attachment.

Basin Head's Northeast Arm extends from the main basin to the east for approximately three kilometres. This inner channel has been given the highest level of protection because this is where the unique form of Irish moss is found. Because of its vulnerability, motorized vessels are not permitted in this zone; there is no commercial or recreational fishing, nor any other potentially destructive activities allowed. Swimming and diving are also not permitted in this zone, except under a scientific research activity plan.

This zone includes the main basin of the lagoon, the western end of Northeast Arm and the channel leading to the entrance to Northumberland Strait. This zone acts as a buffer for the more sensitive inner reaches of Northeast Arm. The zone can tolerate minor disturbance; therefore swimming, diving, and non-vessel based fishing activities are allowed. It includes a boat slip from which motorized vessels may be launched, but these vessels must proceed directly to the open water (zone 3).

The outer coastal area protects the integrity of Basin Head's sand dune structure. This zone extends seaward from the mouth of the lagoon for one nautical mile and covers an area of coast three nautical miles long (southwest to northeast) adjacent to the entrance channel. In this zone, the only restrictions are on those activities that could alter the coastline in such a way as to endanger the fragile dune system, and therefore the lagoon itself. All other activities are allowed.

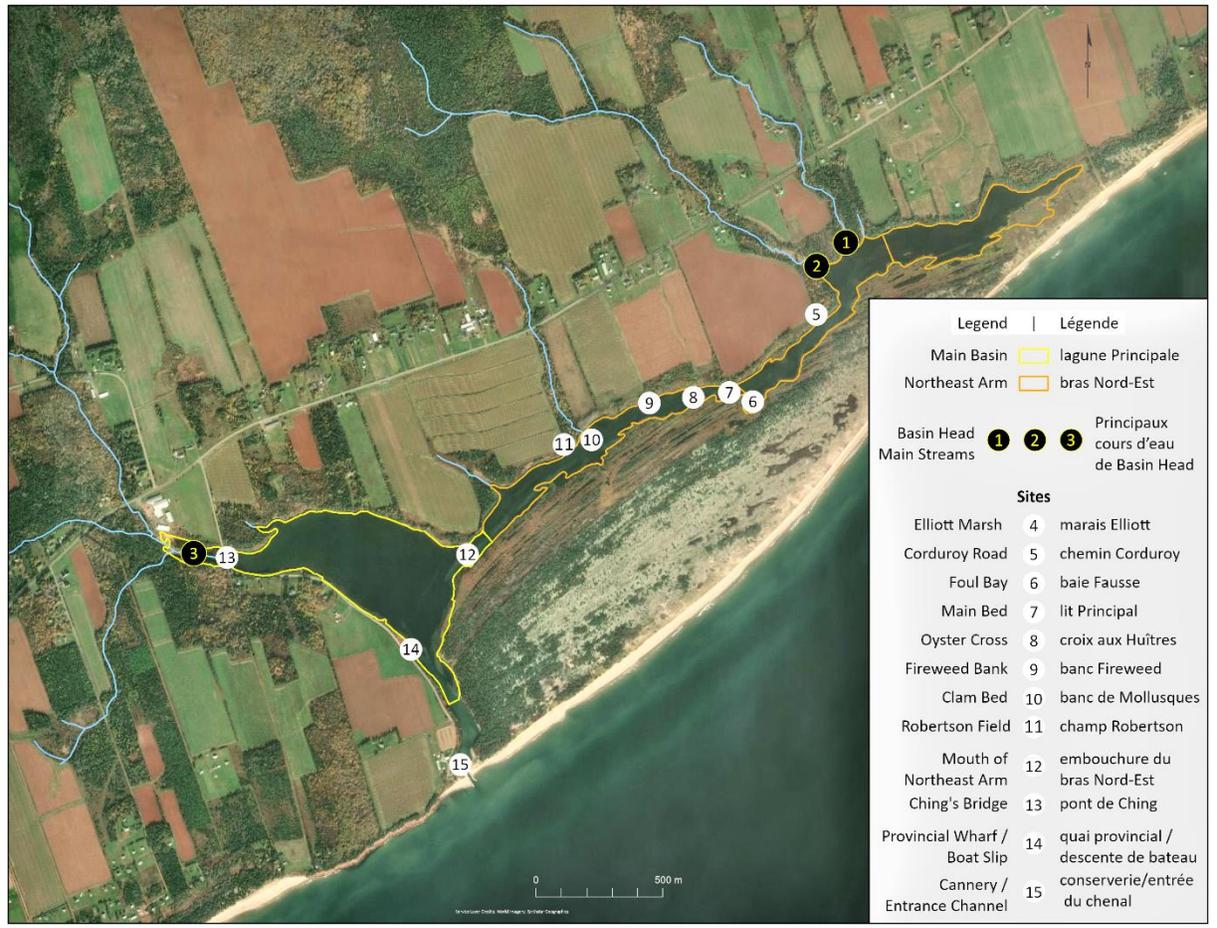
Figure 2: Map of Basin Head Marine Protected Area with lettered streams and numbered sites.

(refer to the map of Basin Head MPA Fig. 2 for locations of the areas named below)

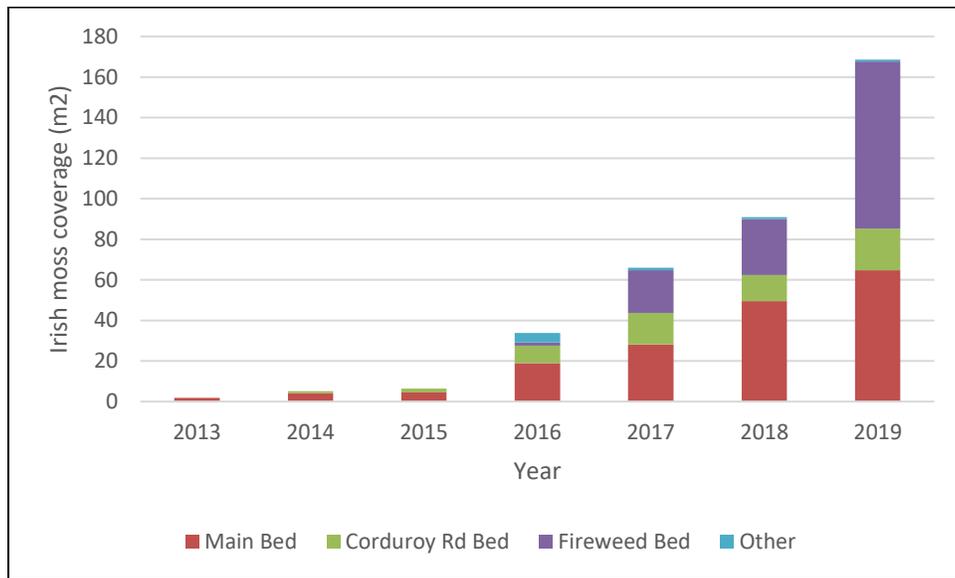
Figure 3: Chondrus cover (m²) in Northeast Arm from 2013-2017 (determined by comprehensive surveys) and in 2018-2019 (estimated from surveys of 2-m wide permanent transect swaths and tallies of planted clumps).

- In 2019, 2964 clumps were planted in Main Bed, Corduroy Road and Fireweed Bank for a total of 12,668 clumps planted during the five-year span (2015-2019) bringing the estimated area covered by Irish moss at the end of 2019 up to 169 m² compared to 91 m² at the end of the 2018 season (see Figure 3).

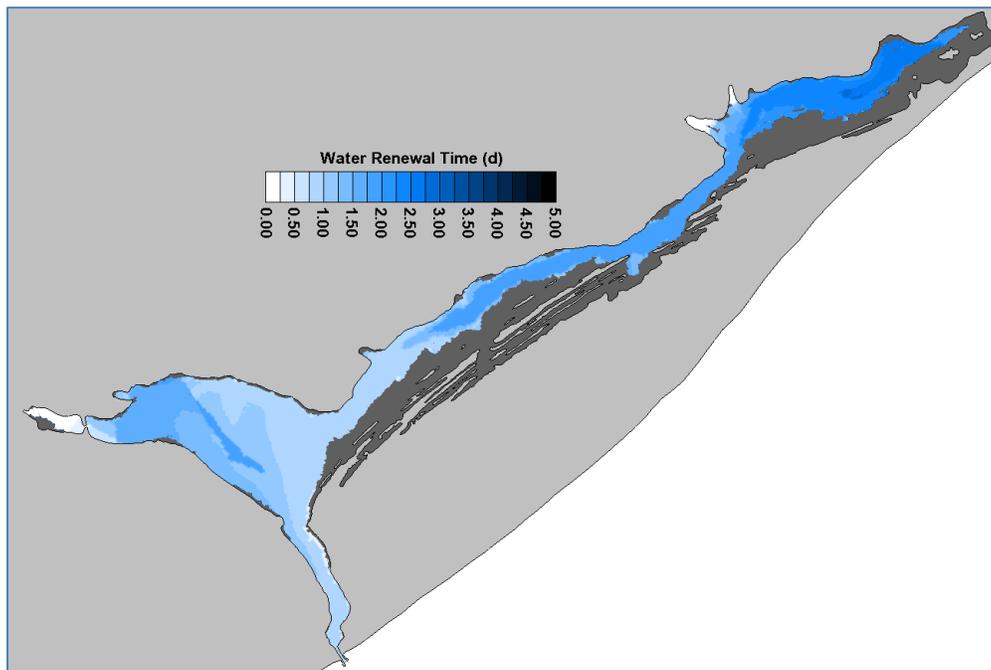
Figure 4. Estimated water renewal time in days in the Basin Head MPA.

- Water renewal time was estimated using the updated hydrodynamic model. A typical distribution for coastal lagoon is observed in Basin Head with renewal times shorter close to the opening to the ocean and increasing in areas further away, up to more than 3 days at the head of the Northeast Arm. Compared to other coastal systems in the region, Basin Head waters are renewed fairly quickly which is due in part to the overall small volume of water to be exchanged (see Figure 4).
