OPEN FILE 8735

Understanding prairie landslides: current research in the Assiniboine River valley, Manitoba-Saskatchewan (2019-2020)

D. Huntley, P. Bobrowsky, D. Rotheram-Clarke, R. Cocking, and J. Joseph

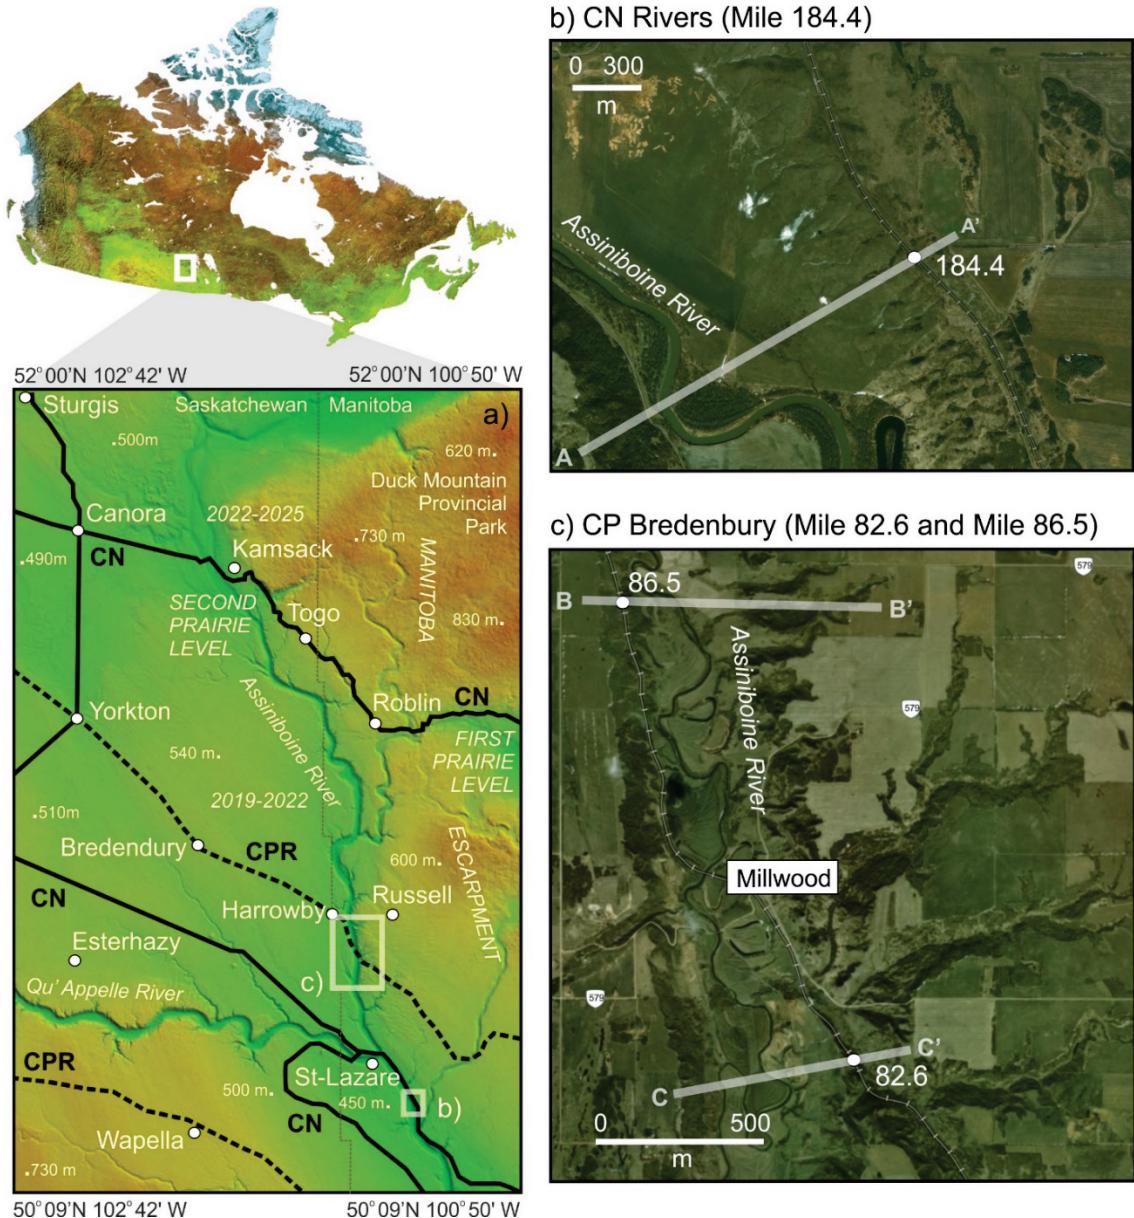
Figure 1-1 New study areas showing railway routes and major landforms and areas of interest to CN and CPR: a) major geomorphic elements (after Klassen 1972; Christiansen 1979) crossed by the CN and CPR tracks (source DEM: SRTM); b) Worldview image for CN area of interest (Rivers Subdivision, Mile 184.4) (base map source: [arcgis.com](#)); c) Worldview image for CPR area of interest (Bredenburg Subdivision, Miles 82.6 and 86.5) (base map source: [arcgis.com](#)); Digital elevation model derived from SRTM data and processed in Global Mapper™.

Rail is the dominant method for moving Canada's import and export commodities to marine terminals on the east and west coasts, and into the USA. Service efficiency and capacity are vital for a sustainable national railway system transporting Canadian grain, coal, oil, potash, and other natural resources to the global market, a significant portion of which must cross the landslide-prone Assiniboine River valley on the border of Manitoba and Saskatchewan (**Figure 1-1**).

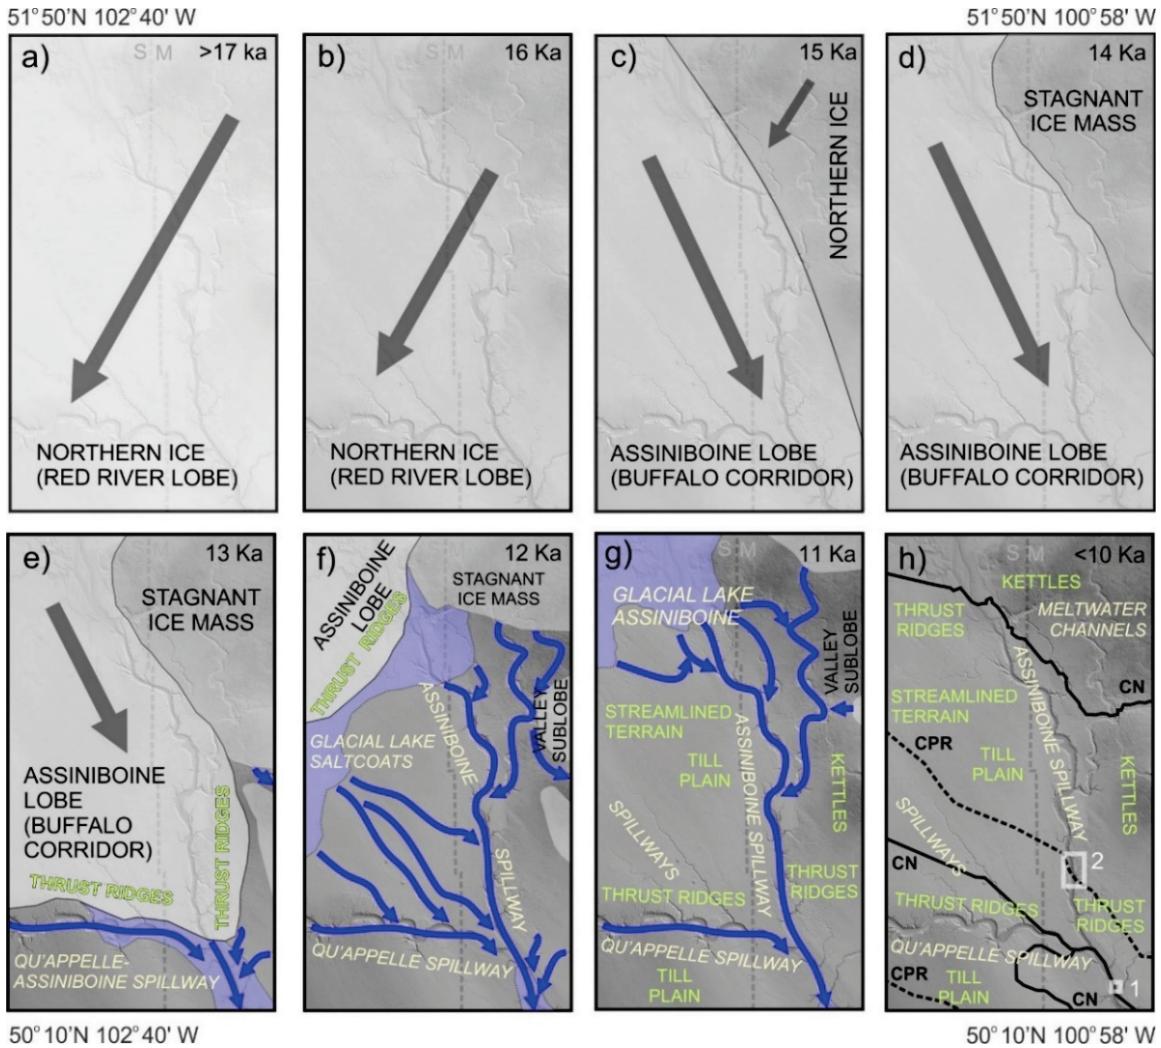
Figure 2-1 Postulated Late Wisconsinan glacial history of the study area: a, b) At the close of the last glacial maximum, from before 17 Ka (>21,000 calendar yBP) to 16 Ka (~19,000 calendar yBP), the Red River lobe of the western Caribou Dome of the Laurentide Ice Sheet flowed southwest over the region, eroding weakly consolidated Cenozoic and Mesozoic bedrock, and deranging pre-existing drainage networks; c) after 15 Ka (~18,000 calendar yBP), the northern ice mass stagnates while the Assiniboine Lobe becomes active, flowing to the southeast; d) deglaciation *ca.* 14 Ka (~16,000 calendar yBP) with the Assiniboine Lobe forming thrust moraines along the margins of ice-free terrain that is locally inundated by higher stages of glacial lake Agassiz and incised by ice-marginal spillways draining retreating ice; e) further retreat of the Assiniboine Lobe is accompanied with the formation of an ice-marginal proglacial lake system connected to glacial lake Agassiz by spillways dissecting deglaciated terrain, *ca.* 13 Ka (~14,000 calendar yBP); f) glacial lake Assiniboine forms with further retreat of the Assiniboine Lobe, *ca.* 12 Ka (13,000 calendar yBP) and is drained by overflow spillways feeding the Assiniboine and Qu'Appelle spillways; g) glacial lake Assiniboine drained by overflow spillways feeding the Assiniboine and Qu'Appelle spillways, *ca.* 11 Ka (12,000 calendar yBP); h) by 10 Ka (~11,000 calendar yBP), the study areas, indicated by the two white rectangles, are ice-free but glacial deposits and landforms are subject to periglacial modification until vegetation cover is established in post-glacial times, and later by anthropogenic activities.

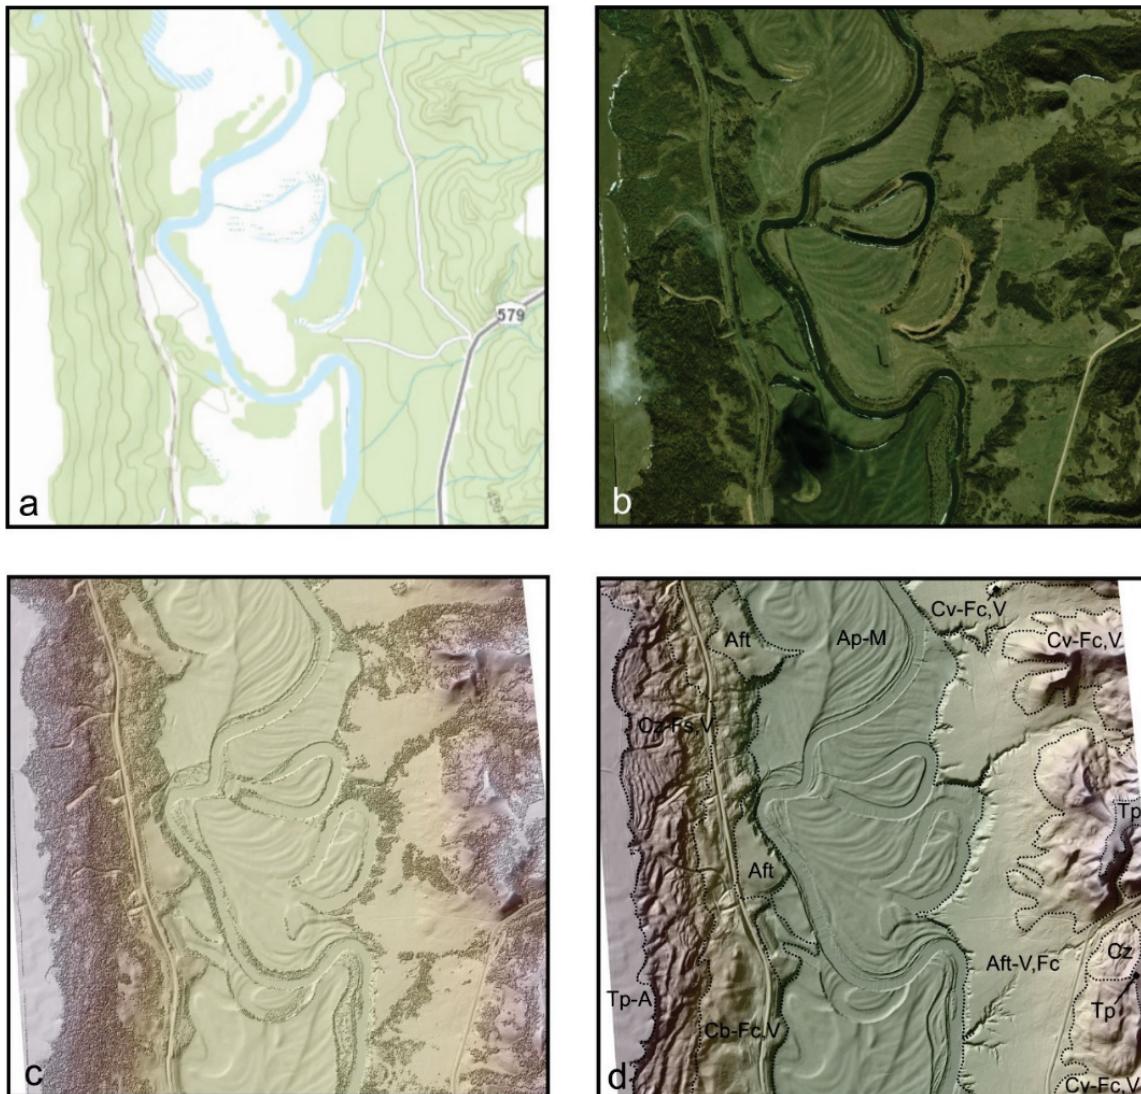
Figure 2-2 Contrasting views of the terrain in the vicinity of Millwood (Harrowby study area c) as depicted on: a) a topographic map (source, arcgis.com); b) Google Earth image; c) LiDAR imagery (1 m resolution) with vegetation and surface features; d) the LiDAR bare earth model with preliminary terrain classification (after Howes and Kenk 1998). Ap-M = alluvial flood plain, modified by meandering Assiniboine River. Aft-V, Fc = alluvial fan terraces, modified by gully erosion and hillslope creep. Cv-Fc,V = colluvial veneer (<2 m thick), modified by hillslope creep and gulley erosion. Cz-Fs,V = active landslide, modified by slow rotational slumping and gulley erosion. Tp-A = till plain, modified by anthropogenic activity (farming, road cuts, railway cuts and embankments). The linear feature on the left is the rail line (image processing by R. MacLeod).

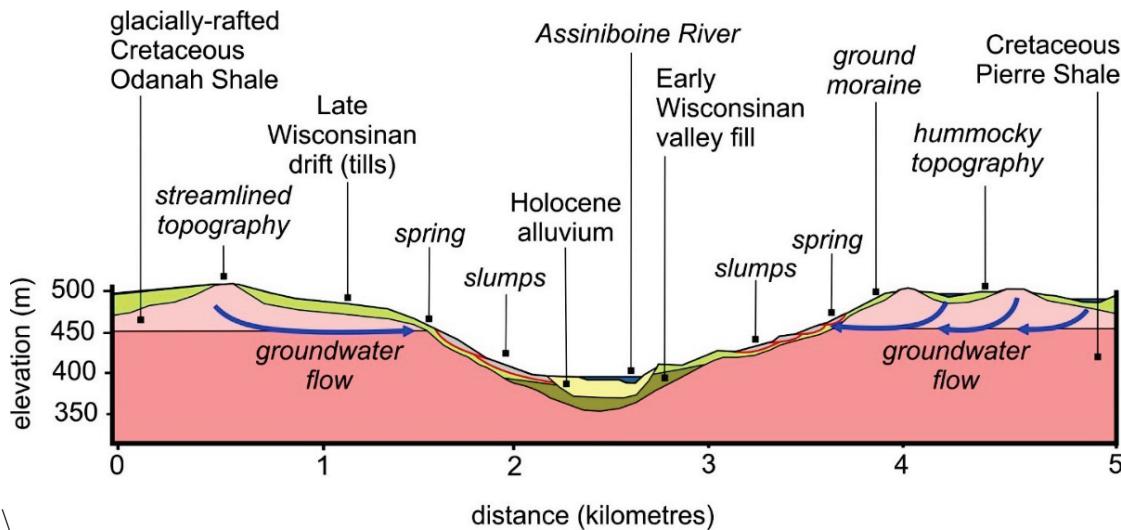
Figure 2-3 Simple stratigraphic model of the Assiniboine and Qu'Appelle river valleys showing hypothetical relationship of landslides to groundwater flow paths through earth materials in the study area (after Klassen 1972; Sauer 1978).

The geological and geomorphological settings of the Assiniboine and Qu'Appelle River valleys are markedly different from those of the Thompson River valley. Whereas slope failures at the British Columbia test site occur within clay-rich glaciolacustrine deposits, landslides in the Saskatchewan-Manitoba border region occur in both weak (clay-rich) shale beds and glacial valley deposits. In the Thompson River valley, small ice-rafted blocks and glacially sheared sediments contribute to slope instability (Huntley and Bobrowsky 2014; Huntley et al. 2019a, b). For the Assiniboine and Qu'Appelle river valleys, ice-rafted megablocks of weak, glacially deformed shale are prone to failure, in addition to glacial valley fill (**Figure 2-3**).

The rôle played by glacially-rafterd terrain in controlling groundwater flow and regional landslide distribution and behaviour will be addressed in this study (**Figure 2-3**). Pre-sheared, brecciated, folded, faulted and jointed shale beds are expected to be more porous and permeable than undeformed (underlying) shale and (overlying) clay-rich morainal deposits. A new understanding of the regional stratigraphy can be provided through detailed terrain mapping (using UAV imagery with ground control), combined with geophysical surveys (e.g., ERT, borehole gamma, induced polarity and magnetic susceptibility), and laboratory investigation of geotechnical properties (e.g., hydraulic conductivities, shear strength) at the UA and USASK. In addition to field mapping (led by the GSC and MGS), monitoring groundwater and shear surfaces in well-logged boreholes with piezometers and slope inclinometers (led by UA and USASK partners) will be essential for characterizing hydrogeological units, and observing how river and weather conditions recharge aquifers and influence slope stability.

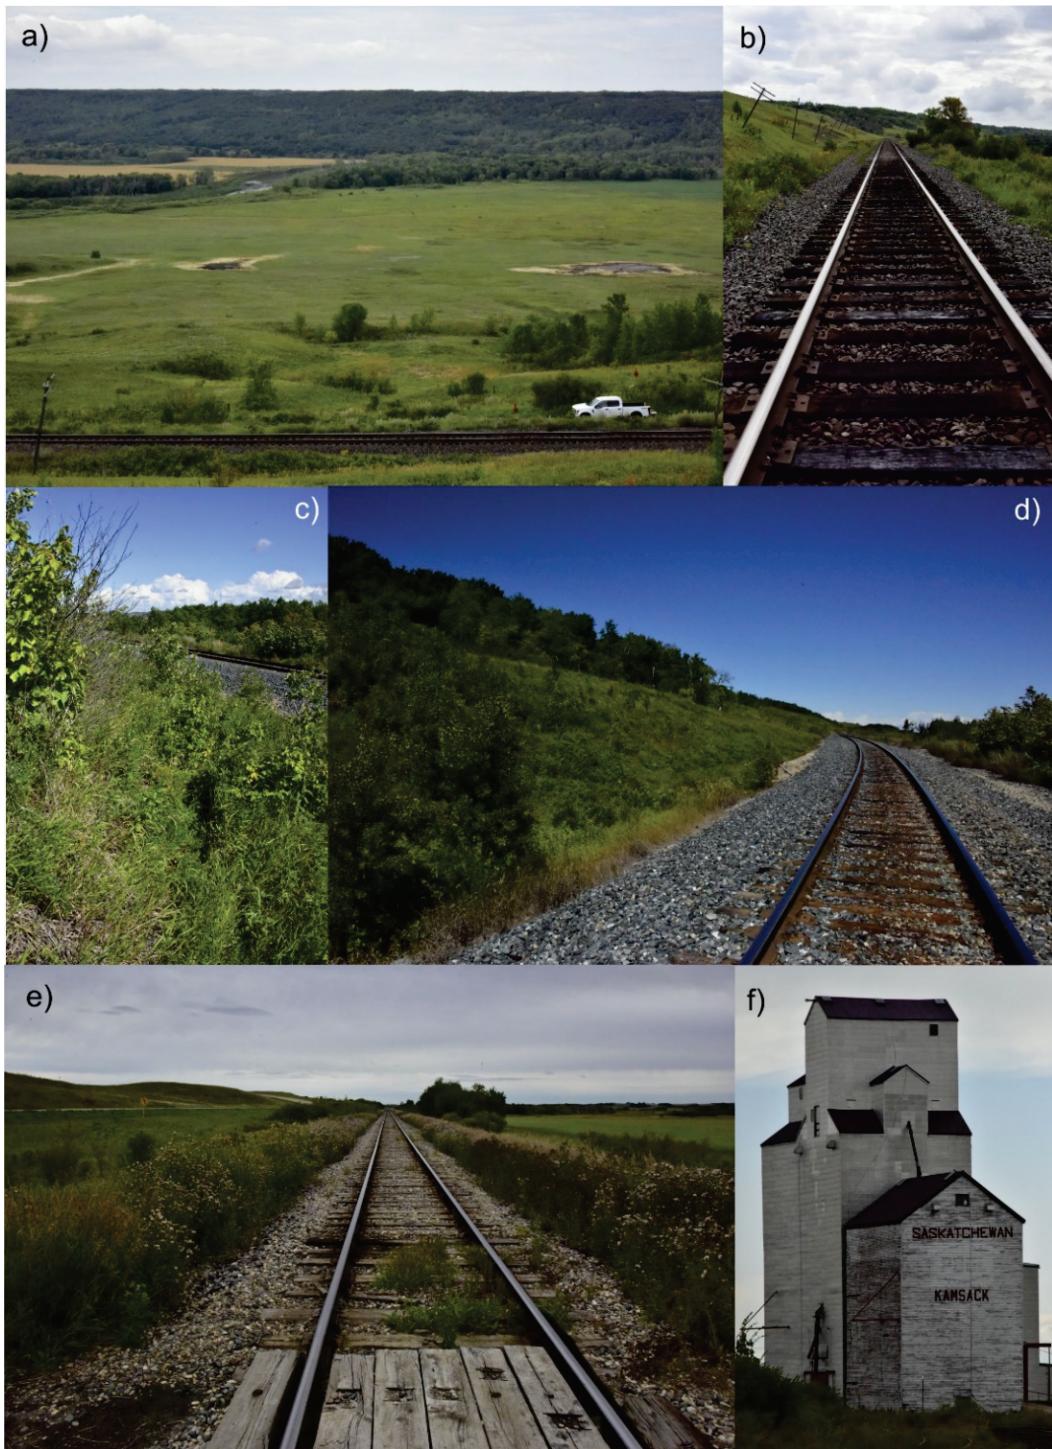
Figure 3-1 Reconnaissance views of study sites: a) CN Mile 184.4, Rivers Subdivision, view west (NRCan photo 2020-271); b) CN Mile 186.2, Rivers Subdivision, view south (NRCan photo 2020-272); c) CPR Mile 82.6, Harrowby Subdivision, view north (NRCan photo 2020-273); d) CPR Mile 86.5, Bredenbury (Harrowby) Subdivision, view north (NRCan photo 2020-274); e) CN tracks outside of Kamsack, Togo Subdivision, view east (NRCan photo 2020-275); f) Grain elevator at CN siding in Kamsack – a key role for both CN and CPR is the transportation of agricultural produce to global markets (NRCan photo 2020-276).

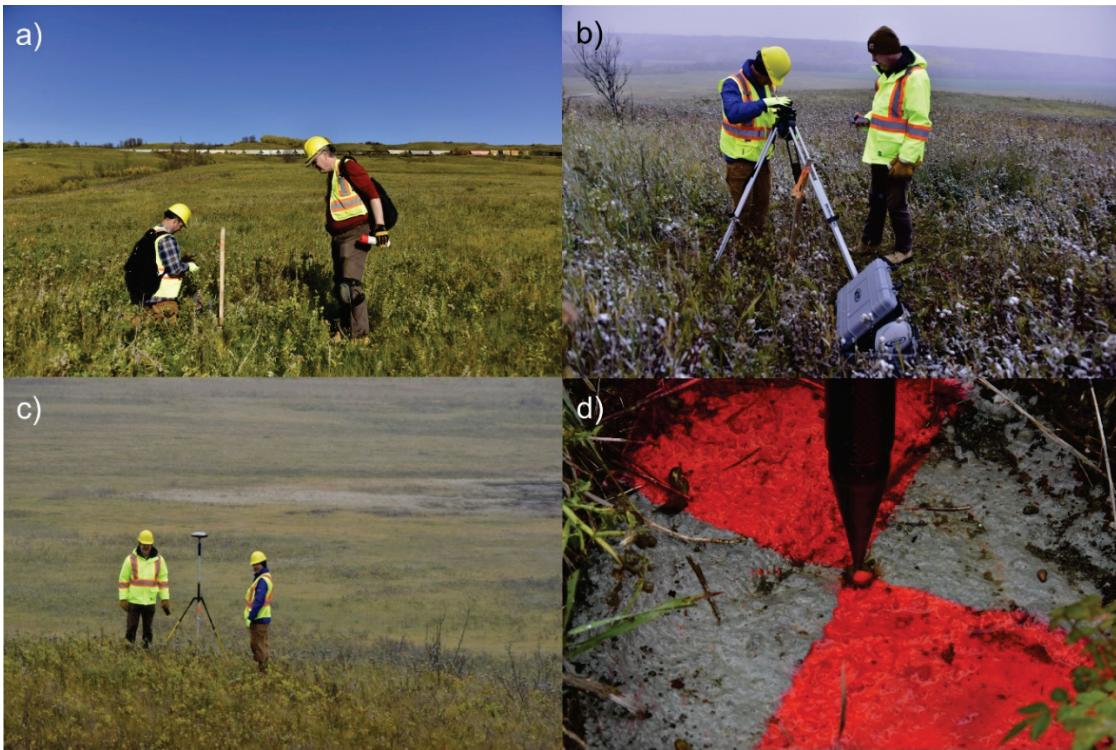
Figure 3-2 RTK-GNSS base survey at CN Mile 186.2: a) identification of GCPs (NRCan photo 2020-277); b) establishing base station (NRCan photo 2020-278); c) collection of location points for GCPs with RTK rover unit (NRCan photo 2020-279); d) detail of concrete GCP with fluorescent target marking (annual clearing of vegetation and soil will be required) (NRCan photo 2020-280).

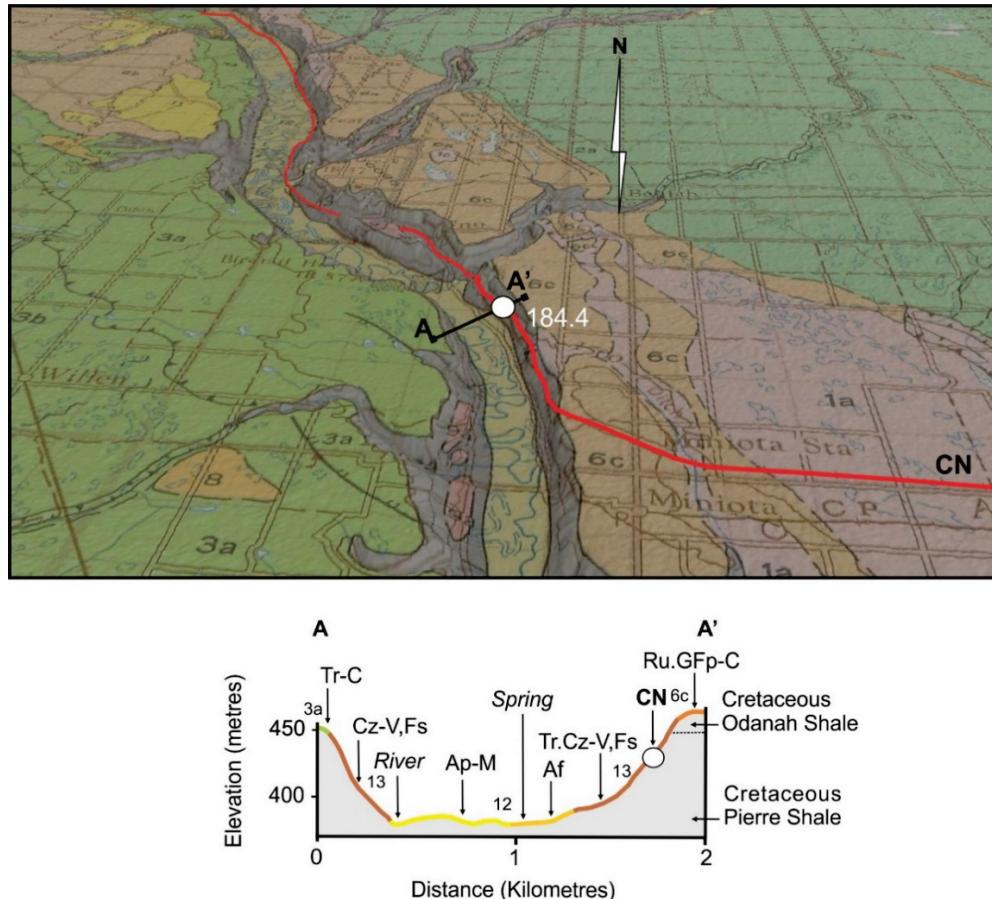
Figure 3-3 Cross-section across the Assiniboine River valley in the vicinity of the landslide site at CN Rivers Mile 184.4. Terrain units from Klassen (1979): 1a (Rp-C) – bedrock plain, modified by meltwater erosion; 3a (Tr-C) – corrugated till, modified by meltwater erosion; 6c, 8 (GFp-C) – glaciofluvial outwash, modified by meltwater erosion and deposition; 12 (Ap-M, Af) – alluvial floodplain and fan deposits, modified by meandering channels; 13 (Cz-V, Fs, Fc) – undifferentiated colluvium, modified by gulley erosion, slow-moving rotational slumps in drift and shale, and soil creep on moderate to steep slopes (>18°).

East of Assiniboine River, a single CN track with sidings crosses a glaciofluvial spillway comprising an undulating bedrock plain (Ru-C) draped by gravel-rich glaciofluvial outwash (GFp-C). Both surficial units are extensively modified by meltwater erosion and ice-marginal depositional processes. At the Assiniboine River, the track turns north and descends the eastern valley side wall, crossing two coulees before encountering the floodplain. Valley sidewalls are draped in clay-rich till and colluvium (Tr.Cz-V, Fs, Fc) modified by gully erosion, slow-moving rotational slumps, and soil creep on moderate to steep slopes ($>18^\circ$). The CN track crosses the Assiniboine River at the confluence with Qu'Appelle River, encountering silty sand-rich alluvial floodplain and fan deposits, modified by meandering channels (Ap-M, Af). At St-Lazare, the track continues westward along the north side of the Qu'Appelle River valley (**Figure 3-3**).

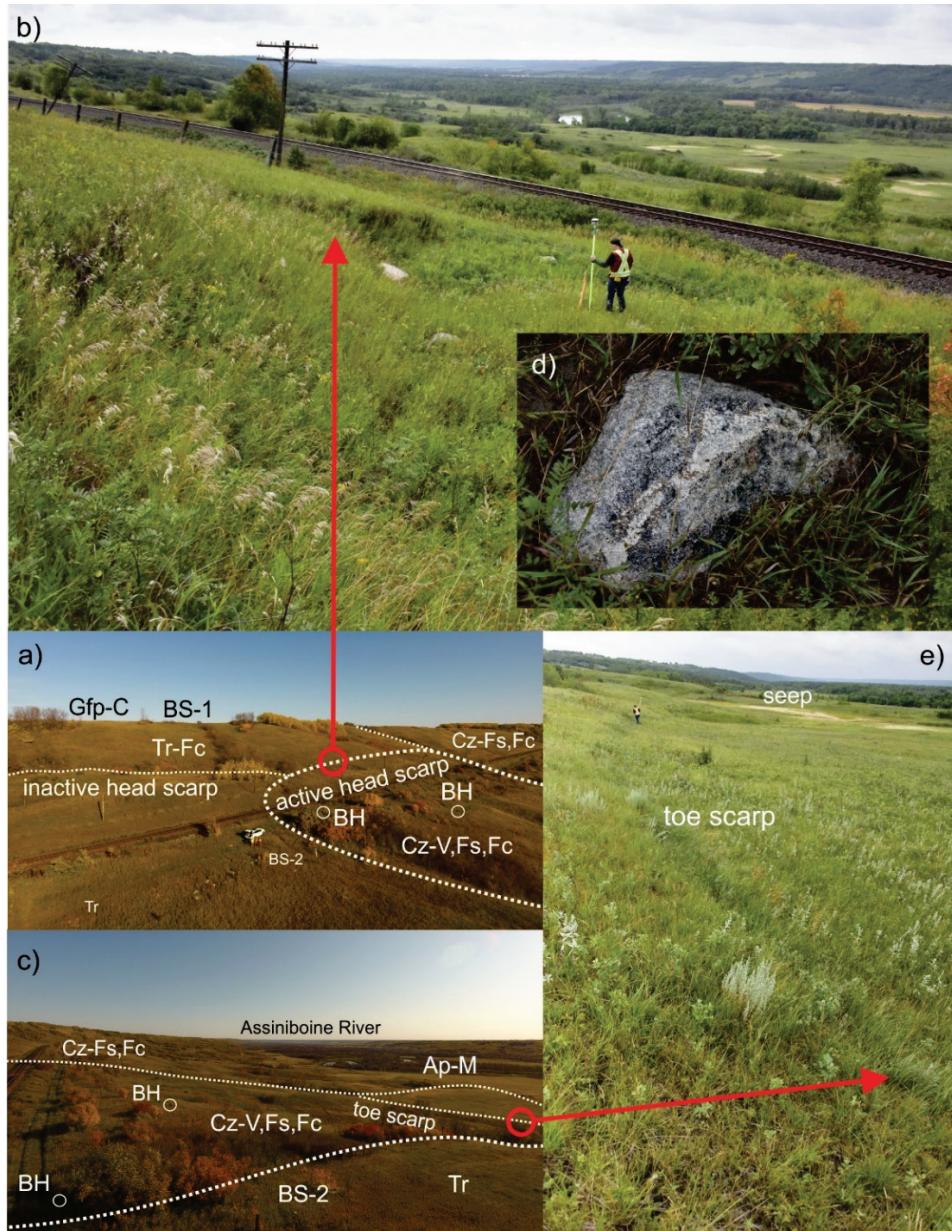
Figure 3-4 Oblique aerial and ground views of the slump-slide complex of Rivers Subdivision CN Mile 184.4: a, b) head scarp features and upper valley wall with CN track traversing the middle slope (bedrock exposed in railway cutbanks), view to southeast (b, NRCan photo 2020-281); c) middle and toe slope, view to south with Assiniboine River valley; d) granite-gneiss erratic boulder interpreted as a Laurentide erratic (NRCan photo 2020-282); e) toe scarp and shallow detachment above the modern flood plain, saturated ground conditions are observed here and perennial seeps are also observed at the break of slope (NRCan photo 2020-283).

At Mile 184.4, the CN track is cut into a moderate valley slope of $<18^\circ$ (**Figure 3-4 a, b, c**). Exposures of clay-rich mudstone and siltstone facies of the Cretaceous Odanah Shale (R) are confined to the 2-3 m-high railway cutbank upslope of the track. Although the contact with underlying Pierre Shale units is not exposed, saturated soils observed below the track may be an indication of groundwater seepage along the upper geological contact (cf. **Figure 2-3**). These weakly consolidated and poorly cemented bedrock formations were incised during the last glaciation to form a broad south-draining trough, then blanketed by subglacial and ablation tills composed of clay-rich diamicton containing Laurentide erratics (**Figure 3-4**).

d). Valley-side till deposits (**Figure 3-4 a, c, d**) are <20 m in thick, and have corrugated or lobate surface expressions reminiscent of recessional moraine ridges modified by solifluxion processes (Tr-V, Fs, Fc).

Till slopes are actively modified by gulley erosion, slow-moving rotational slumps in drift and shale, and soil creep (Cz-V, Fs, Fc). Unstable terrain is bounded by ephemeral gullies that incise the valley side and drain to alluvial fans (Af) that prograde over the floodplain (Ap-M). The numerous shallow rotational slumps remobilizing boulder clay-rich till and underlying clay-rich bedrock from above the track to the valley floor produces a hummocky or lobate surface expression where ground displacement is active (**Figure 3-4 a-e**). Characteristically, the head scarps of shallow slumps are arcuate in planform, listric in cross-section, and up to 3 m deep (e.g. **Figure 3-5 a**). Slump toes form lobes up to metre in height that are observed overriding grassy slopes, forest soils, and tree boles (**Figure 3-5 b**). A distinctive feature at Mile 184.4 is a linear scarp at the toe slope, ranging in height from 0.5 m at the north end to 1.5 m high in south, which runs the width of the slide zone (**Figure 3-4 c, e**). Riverwards, the toe slope is saturated from at least

late August to early October, and zones of seepage are observed along the upper margin of the active floodplain (**Figure 3-4 e**).

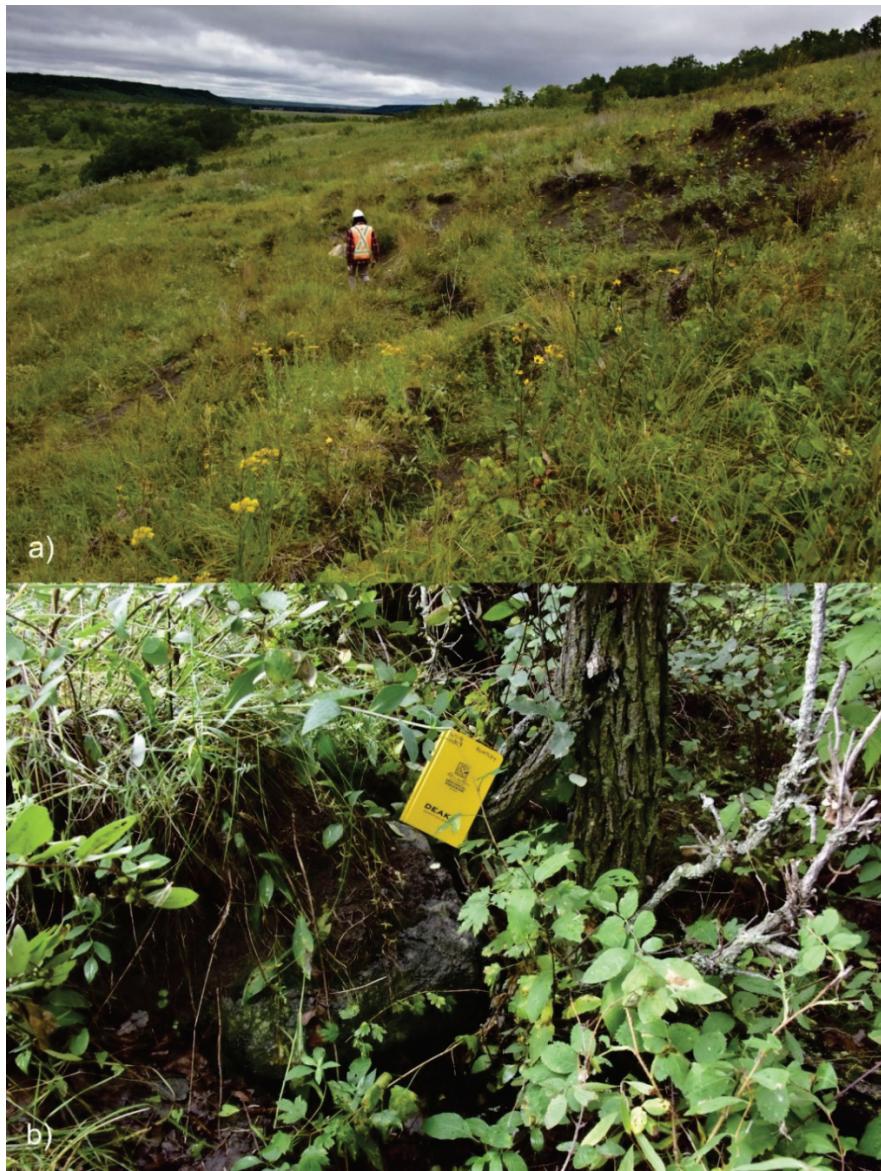
Figure 3-5 Details of: a) a rotational head scarp (NRCan photo 2020-284); b) toe slope lobe at CN Mile 186.4 (NRCan photo 2020-285).

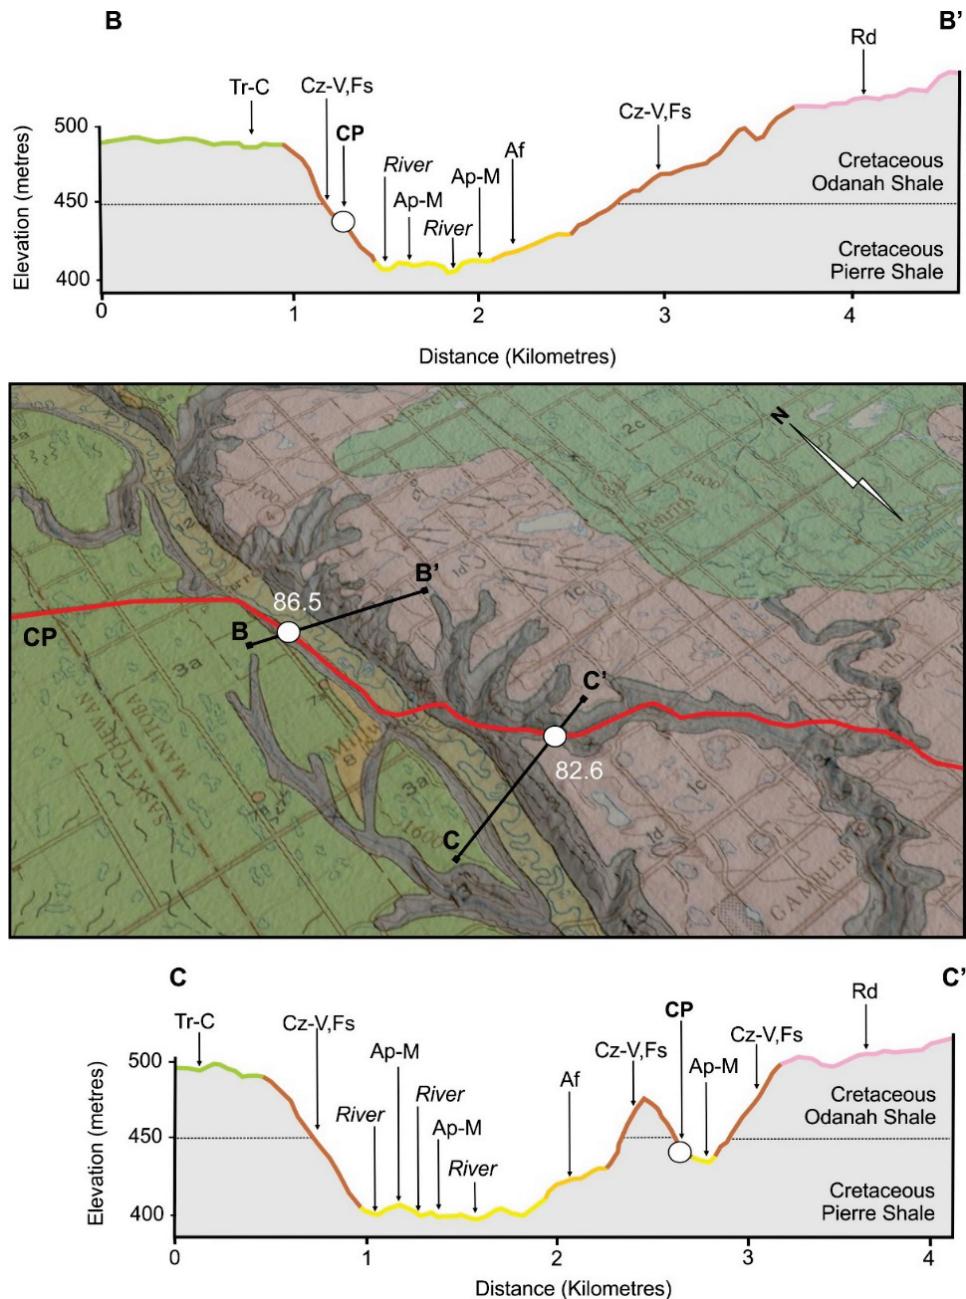
Figure 3-6 Cross-section across the Assiniboine River valley in the vicinity of the landslide sites at CP Bredenbury Miles 82.6 and 86.5. Terrain units from Klassen (1979): 1a, b (Rd) – bedrock plain, drumlinized; 3a (Tr-C) – corrugated till, modified by meltwater erosion; 12 (Ap-M, Af) – alluvial floodplain and fan deposits, modified by meandering channels; 13 (Cz-V, Fs, Fc) – undifferentiated colluvium, modified by gully erosion, slow-moving rotational slumps in drift and shale, and soil creep on moderate to steep slopes ($>18^\circ$).

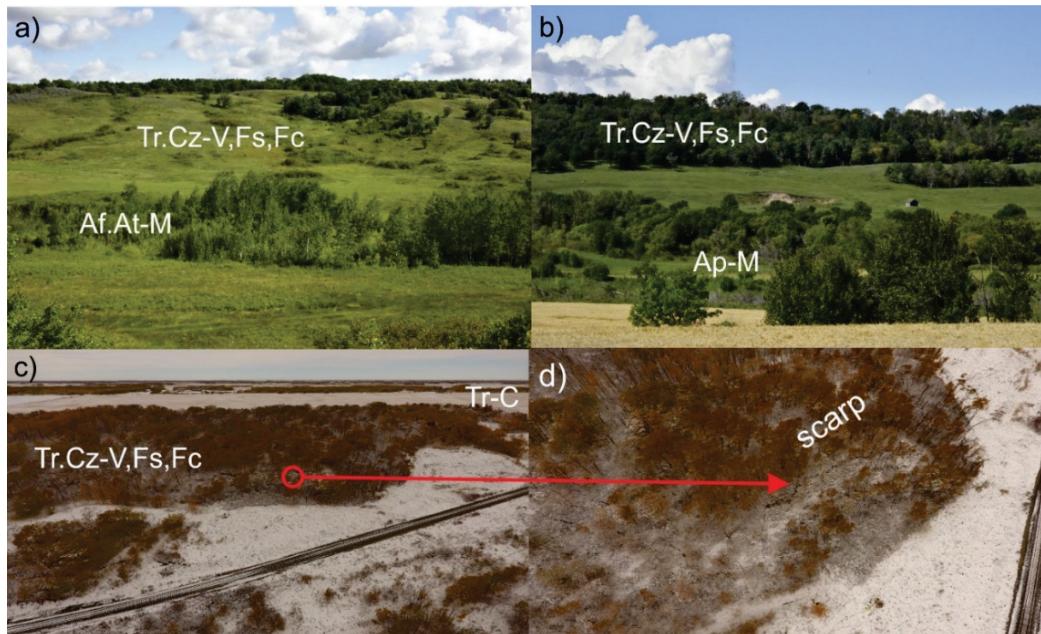
Figure 3-7 Oblique ground and aerial views of terrain in Bredenbury Subdivision: a) east side of coulee viewed from CPR Mile 82.6 (NRCan photo 2020-286); b) Assiniboine River valley at Millwood (NRCan photo 2020-287); c) oblique UAV aerial view of geoengineered slope and slump feature at CPR Mile 86.5; d) oblique UAV aerial view of back scarp of the CPR Mile 86.5 slump.

At Binscarth, a single CPR track with sidings runs northwest, descending a steep grade along a tributary coulee, into the Assiniboine River valley. At Millwood, the track crosses the actively meandering river, makes a northerly ascent up the west side of the valley, then turns west for Harrowby (**Figure 3-6**). East of Assiniboine River, the CPR track crosses glacially streamlined (drumlinized) bedrock plain (Rd). Descending a coulee with moderate to steep side slopes ($>18^\circ$), the track is incised into clay-rich till modified by gully erosion, slow-moving rotational slumps, and soil creep (Cz-V, Fs, Fc; **Figure 3-7 a**). Crossing at Millwood, the track encounters silty sand-rich alluvial fans, and terraced floodplain deposits modified by meandering channels (Af, Ap-M, **Figure 3-7 a, b**). On the west side of the valley the track is

again incised into clay-rich till modified by gully erosion, slow-moving rotational slumps, and soil creep (Cz-V, Fs, Fc; **Figure 3-7 c, d**).

Although Cretaceous Odanah and Pierre shales (R) are not well exposed on valley sidewalls, saturated soils above the track may be an indication of groundwater seepage along their contact (cf. **Figure 2-3**). The numerous shallow rotational slumps remobilizing till and underlying bedrock produces a hummocky or lobate surface expression where ground displacement is active from above the track to the valley floor (**Figure 3-7 a**). West of the Assiniboine River valley, an undulating till blanket with moraine ridges is modified by meltwater erosion (Tr-C; **Figure 3-7 c**). Logistical constraints and weather conditions precluded ground observations of the rotational slumps impacting the CPR track at Bredenbury Mile 82.6 & Mile 86.5 in 2019. During summer, heavily forested east-facing slopes obscure ground conditions and limited observations trackside, and from the CPR hi-rail (**Figure 3-7 a, b**). Ground conditions were still not possible to assess due to early snow cover during fall fieldwork (**Figure 3-7 c, d**).

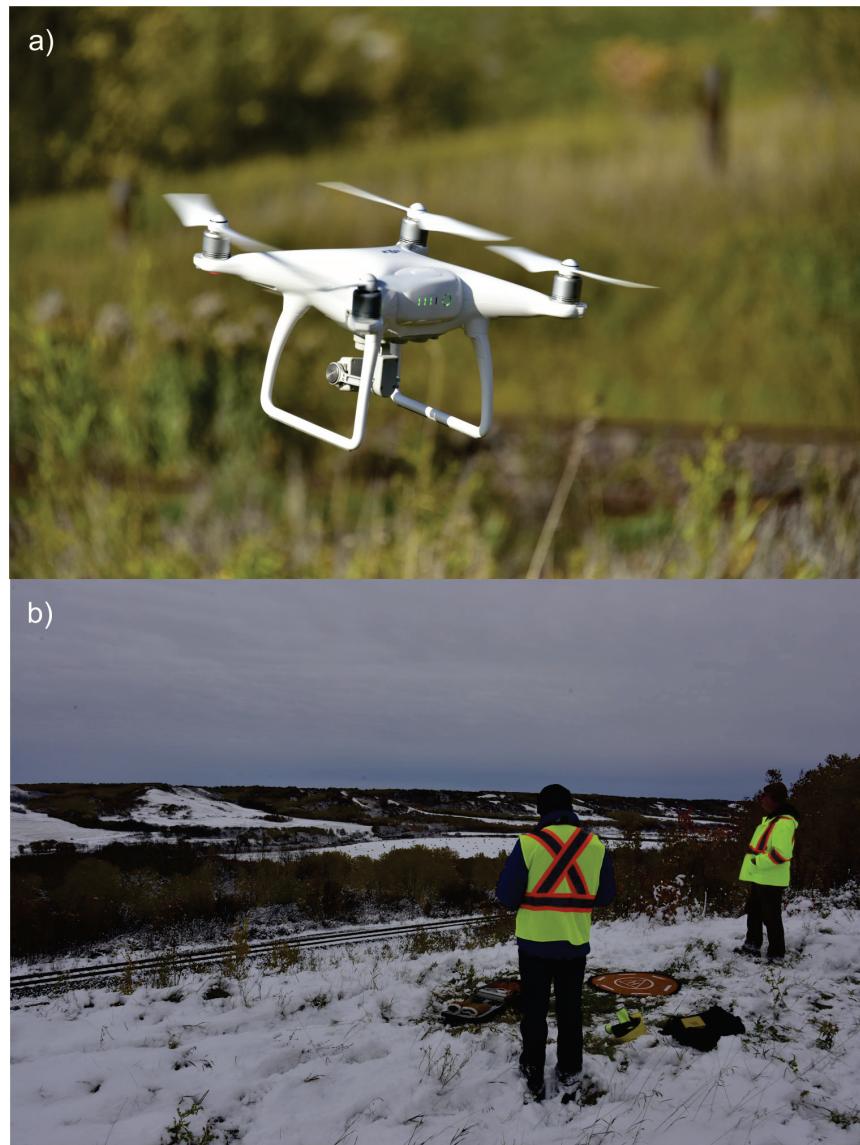
Figure 3-8 UAV surveying in the Assiniboine River valley under varying weather conditions: a) CN Mile 186.2, Rivers Subdivision, October 9, 2020 (NRCan photo 2020-288); b) CPR Mile 86.5, Harrowby Subdivision, October 10, 2020 (NRCan photo 2020-289).

The new study sites in the Assiniboine River valley are similar in areal extent to those in the Thompson River valley, BC. Consequently, UAV photogrammetric surveys offer an excellent opportunity to generate high-quality repeat Digital Surface Models (DSMs) that can be compared to characterize surface change of active landslides along the transportation corridor. Started in the fall of 2019, UAV surveys aim to capture changes in landslide morphology in the valley. Baseline survey flights were conducted from October 7-10, 2019 using the GSC's DJI Phantom 4 with a 12.4 MB RGB camera (**Figure 3-8 a**), with one operator and two observers (**Figure 3-8 b**).

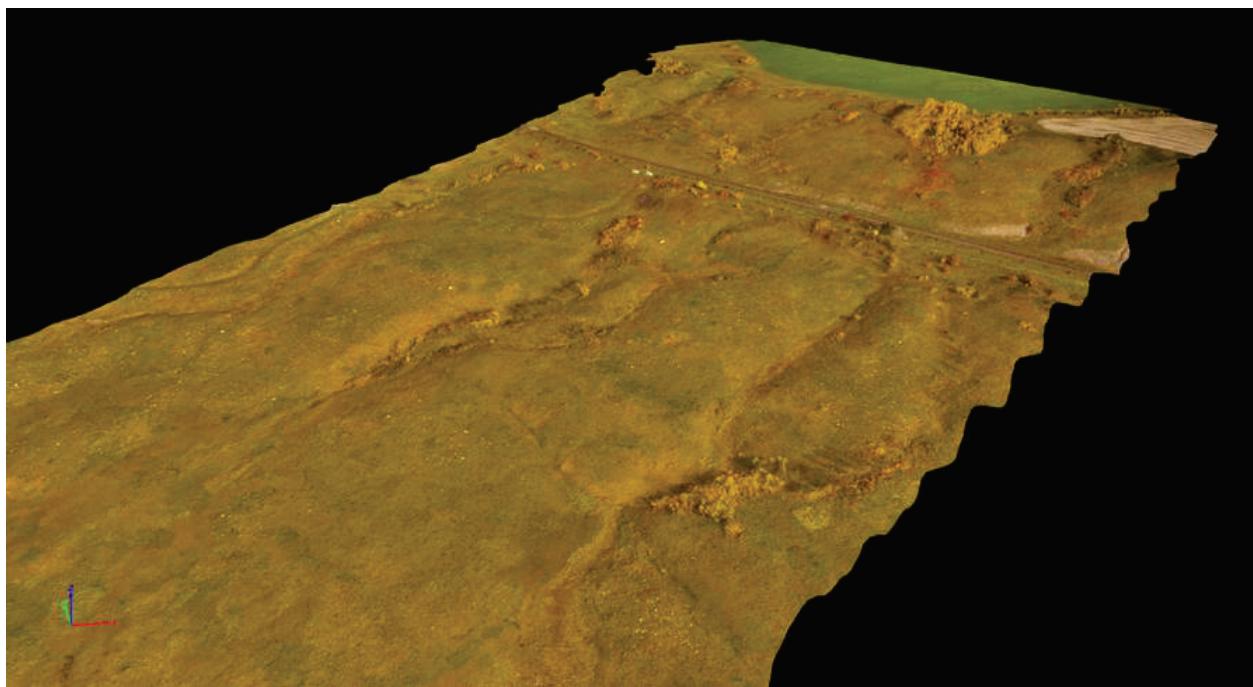
Figure 3-9 Overview SfM digital surface model (DSM) generated from October 2019 overflight of CN Mile 186.2, Rivers Subdivision (view NE).

The arrival of snow and sub-zero temperatures during October 2019 fieldwork curtailed detailed overflights of the CPR Bredenbury sites. UAV surveys focused on capturing the CN Mile 184.4 for Structure from Motion (SfM) modelling (Figure 3-9, Figure 3-10, and Figure 3-11).

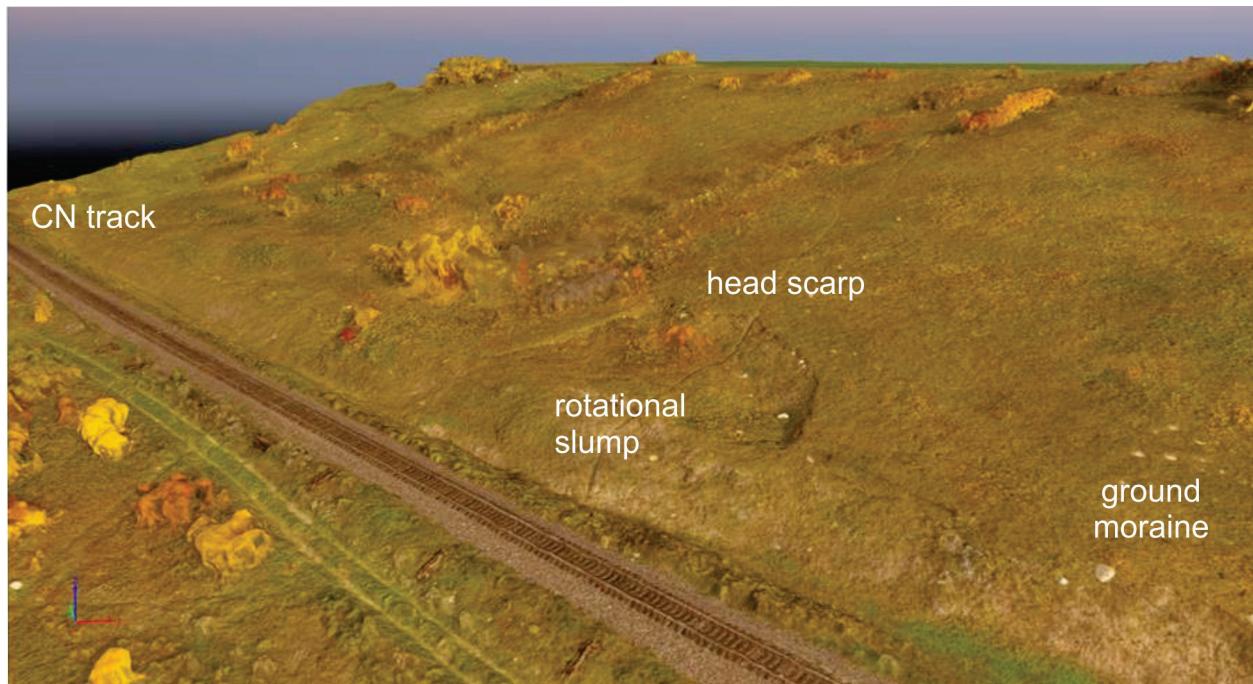
Figure 3-10 SfM digital surface model (DSM) of headscarp slump above CN track generated from October 2019 overflight of CN Mile 186.2, Rivers Subdivision (view NE).

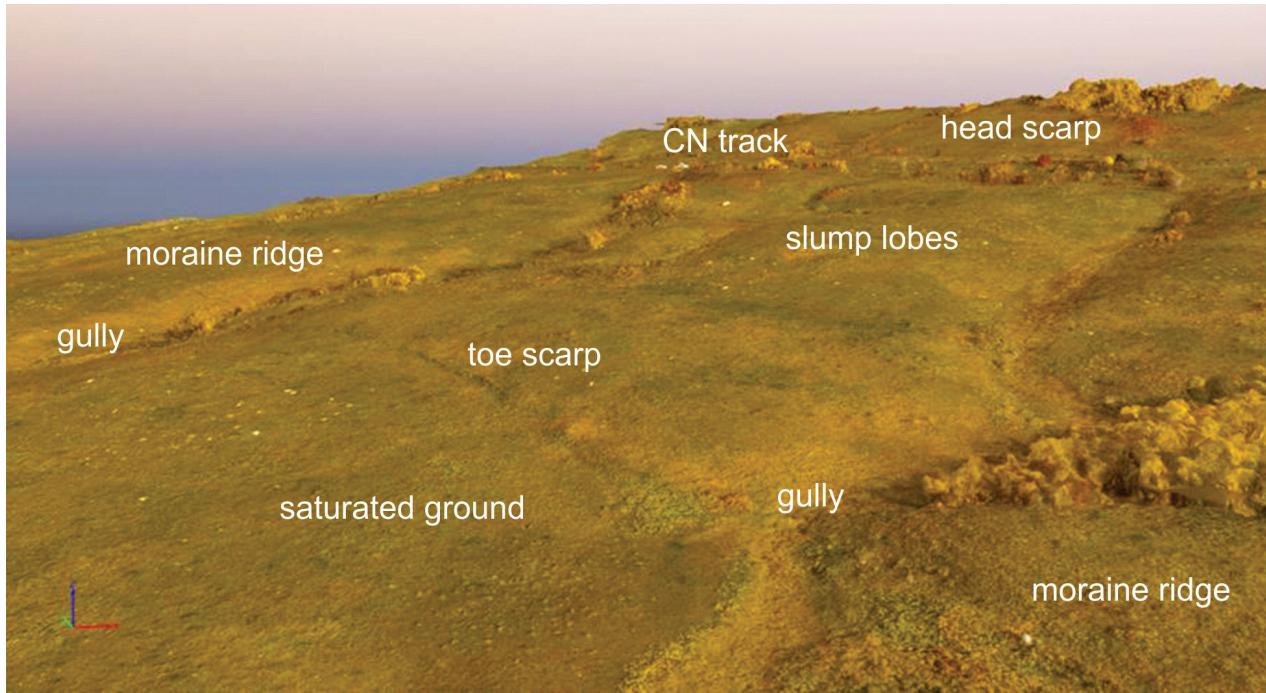
Figure 3-11 SfM DSM of slide toe and linear scarp feature, generated from the October 2019 overflight of CN Mile 186.2, Rivers Subdivision (view NE) downslope from **Figure 3-10**.

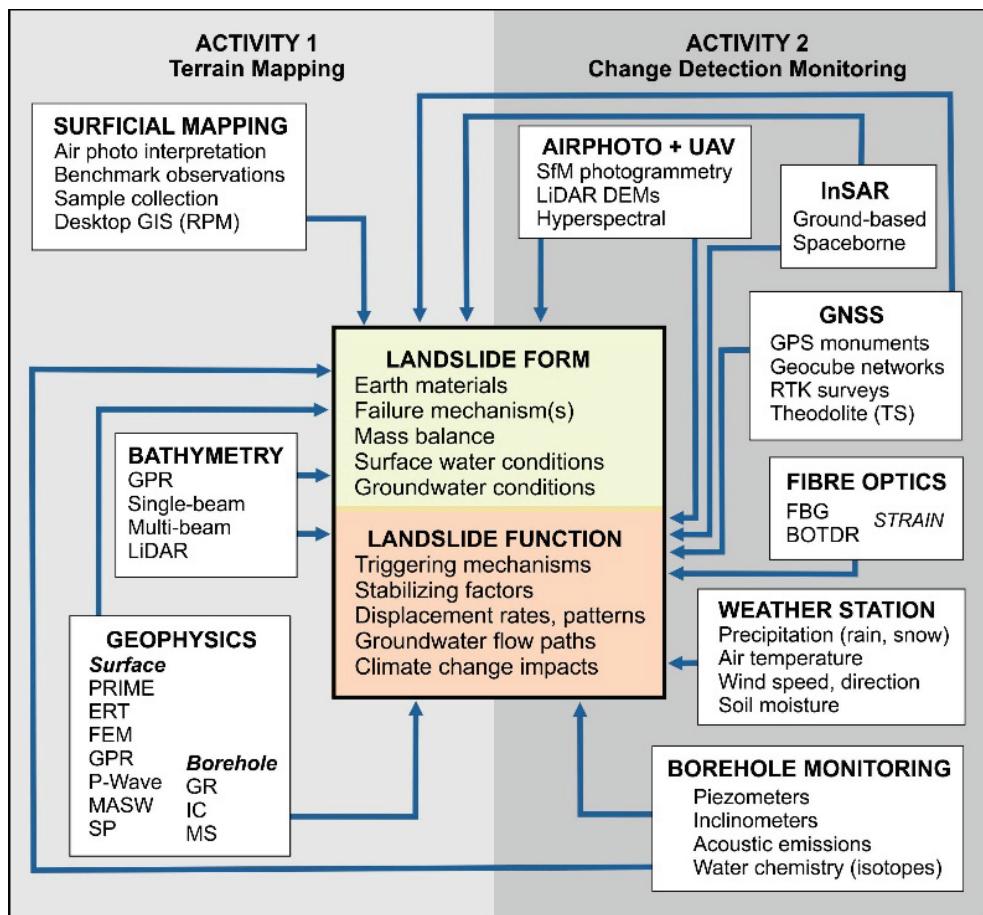
Figure 4-1 Best practices for terrain mapping and change detection monitoring of landslide systems, based on experience in the Thompson River valley, British Columbia (2013-2020), and to be applied to the Assiniboine-Qu’Appelle river valleys, Manitoba-Saskatchewan (2020-2025).

The primary mandate of IDLA-4755 was to gain a better understanding of landslide hazards impacting Canada's railway network through: 1) *Terrain Mapping* described landslide form, adjacent stable slopes and water bodies using surficial geology mapping, bathymetric and geophysical surveys, and real-time monitoring of movement, groundwater, and geophysical properties in boreholes (**Figure 4-1, Table 4-1**). 2) *Change Detection Monitoring* described landslide function using emerging airborne and spaceborne platforms, ground-based GNSS systems, fibre optics and climate variables (**Figure 4-1, Table 4-1**).
