Indoor Air Quality Survey of Northwest Territories Housing

INDOOR AIR QUALITY SURVEY OF NORTH WEST TERRITORIES HOUSING

Final Report

Appin Associates
In association with Dr. A. Yassi

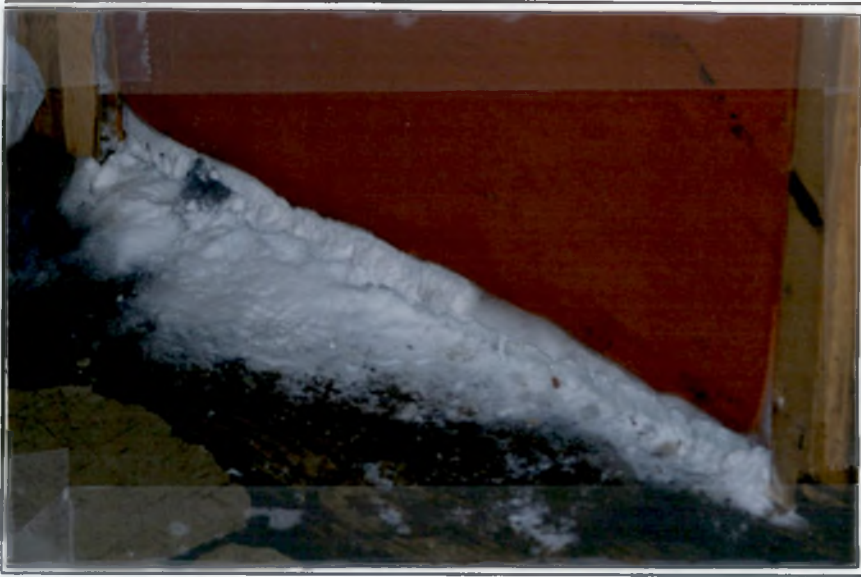
Photo 1.

1. Snow drifting under porch door and tiles lifted from floor.
2. Oil furnace and electric DHW tank in back porch area.

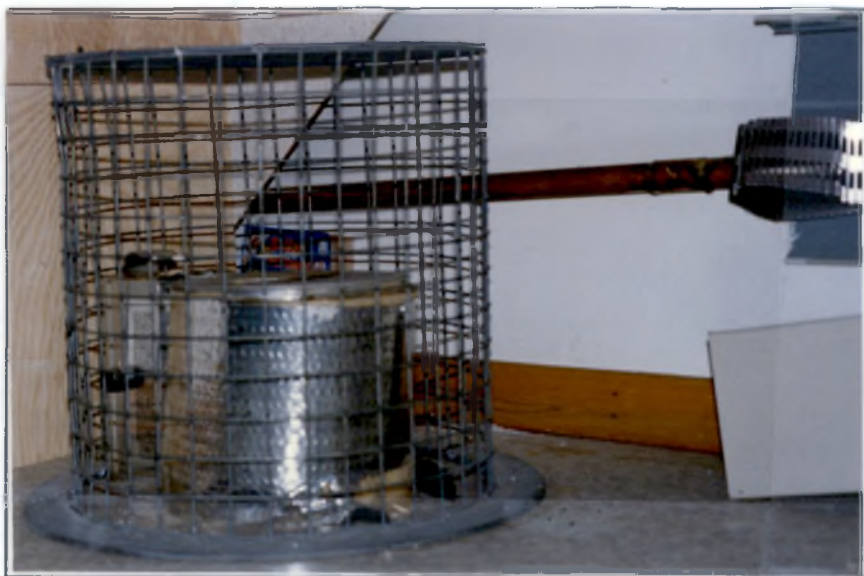
Photo 1.

1. Combustion air damper (disconnected and closed)
2. Barometric damper (no weight) and flue damper above (not wired) but open.

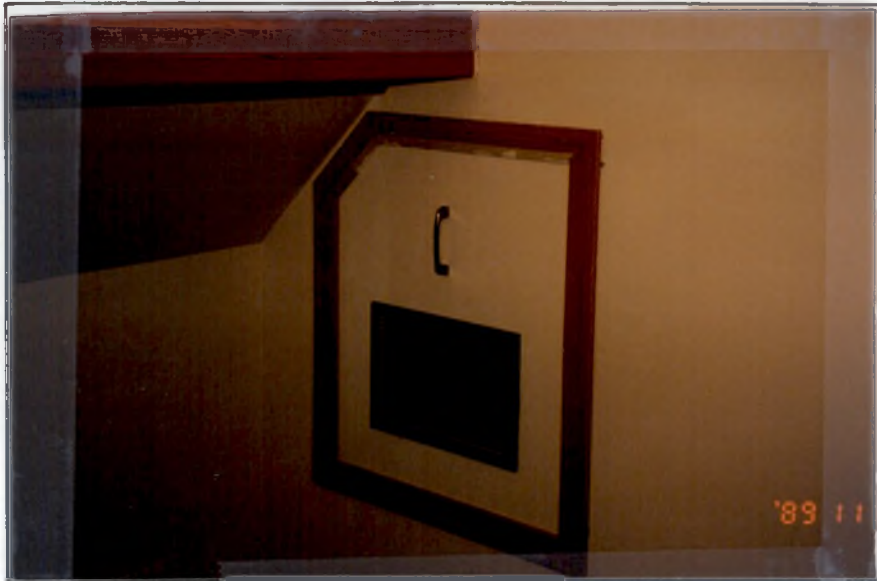
Photo 1.

1. Vent to warm attic storage space off stairs.
2. Vent to upper warm attic space.
3. Paint peeling above combustion air inlet.
4. Boiler room.

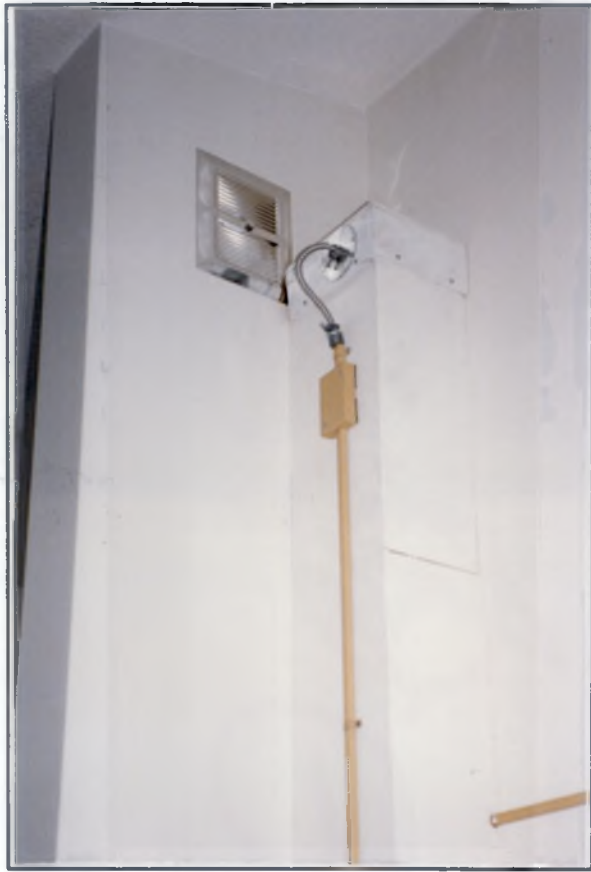
Photo 1.

1. Additional new exhaust fan in living room on top of box.
2. Exhaust fan outlet.
3. Passive vent in living room.
4. Passive vent hood outside living room.
