# CCGS Cygnus – Hull and Propeller Cleaning

Unclassified  
OCRE-TR-2018-036

**Report Number: OCRE-TR-2018-036**

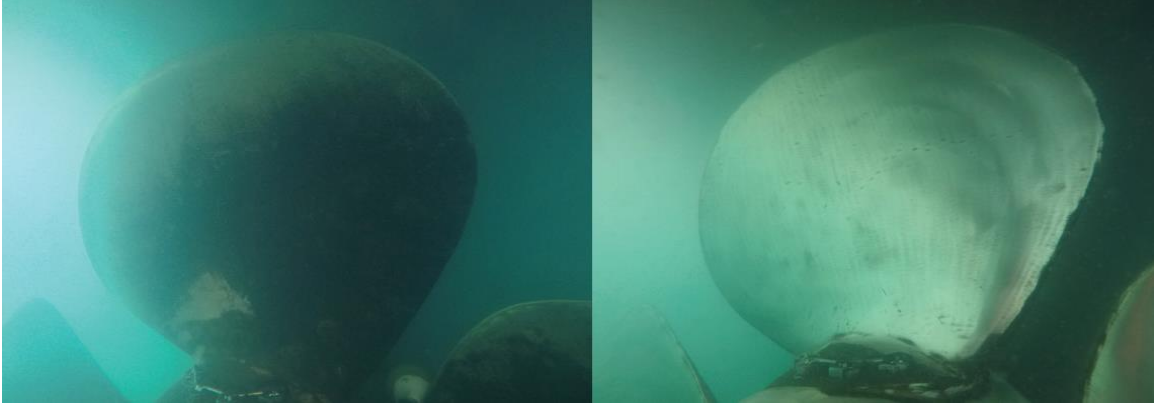
Figure 2. Typical propeller pressure face pre (left) and post (right) cleaning

The propeller was also assessed by divers to quantify the level of fouling present. All propeller blade faces were covered in a light to moderate slime which was heavier at the root and tapered towards the tips. Under the slime the propeller blades were covered with a heavy calcium buildup. The level of propeller fouling was measured using a ship propeller roughness gage which characterizes the propeller roughness per the Rubert Comparator scale. The propeller fouling was rated as Rubert scale E. Once polished, the propeller was rated at a Rubert scale A/B. Post polishing trials were conducted at this polished state. Figure 2 illustrates the pre cleaning and post cleaning condition of a typical propeller pressure face of the CCGS Cygnus propeller. The diver’s report on propeller polishing is also included in Appendix A for ease of reference. This report includes a number of images of pre and post cleaned propeller surfaces.

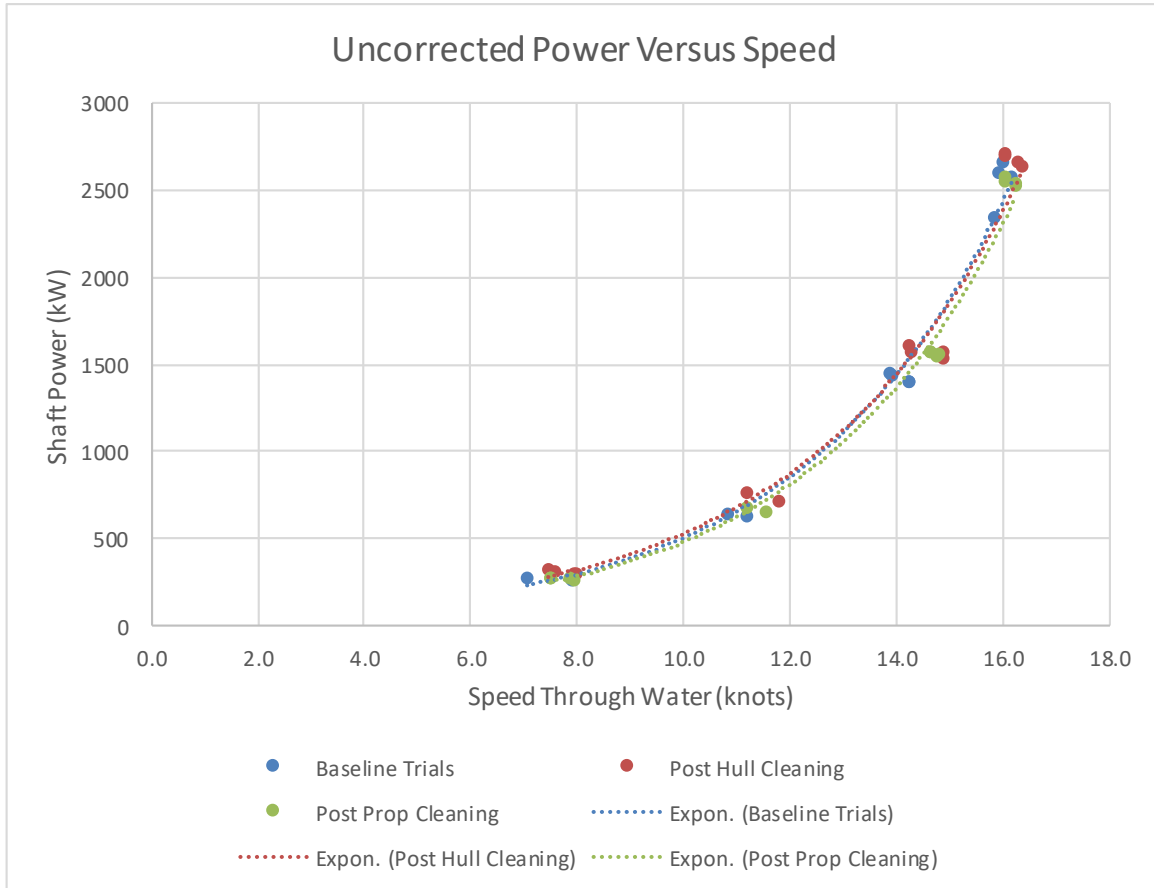
Figure 5. Uncorrected power versus speed

The measured shaft power versus speed through water for each test during each trial were plotted on the same plot for ease of comparison (see Figure 5). All data points align to the same general curve relatively well. There appears to be less variability in the post propeller trials data when compared to the other trials results for a given engine setting. This was expected since the wind and sea conditions during the post propeller polishing trials were lower than those for the other two trials.

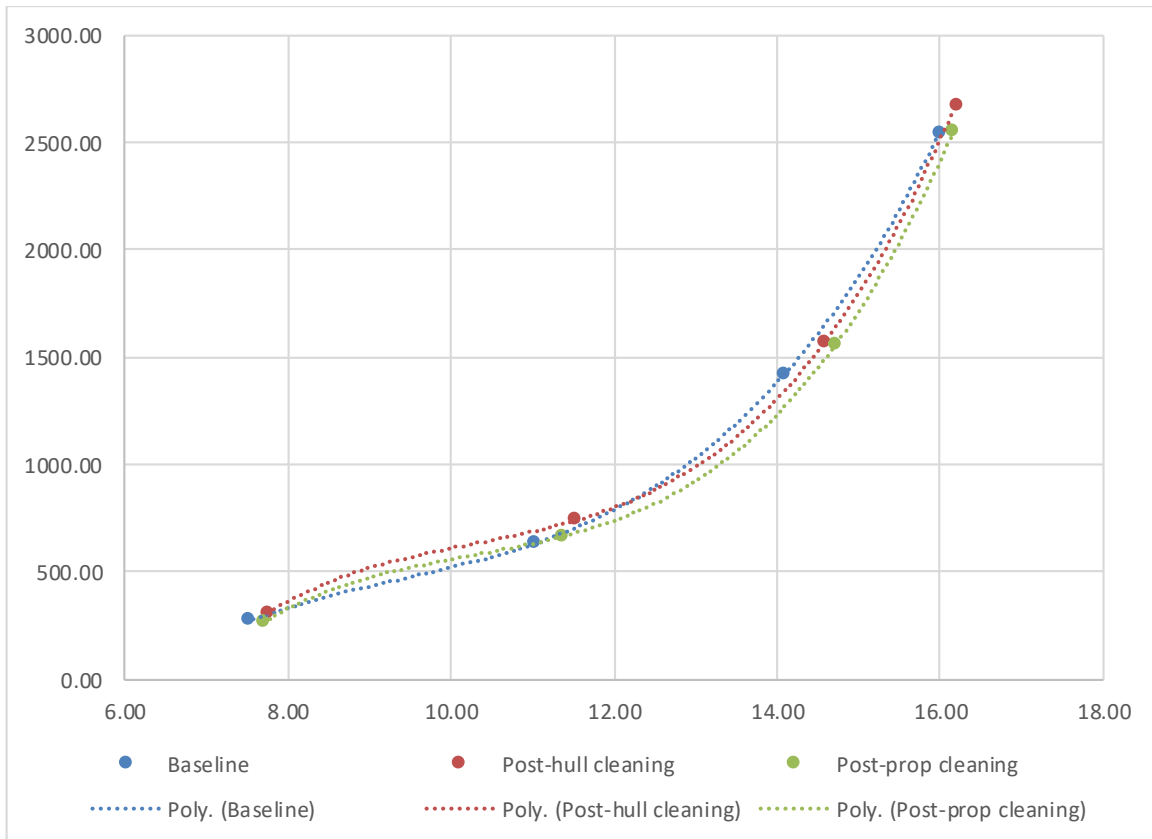
Figure 6. Means of Measured Data - Shaft Power versus Speed through Water

The measured data was analyzed first using the mean of means method to provide further insight towards data trends between trials. The mean of means method involves taking the mean of consecutive double runs at a given engine setting and then taking the mean of those means to represent the speed and power values at that engine setting. The intent of this method is to eliminate the unidirectional effects of wind and current under the assumption that these effects will average to zero. The mean of means for all trials completed at a given engine setting, within each sea trial, were calculated. The results of shaft power and vessel speed through water for each sea trial were plotted (Figure 6). Trend lines were fitted through the data for each sea trial.

The differences in the relationships between power and speed for the three sea trials is clearer here. The trend line relationships between trials change across the speed range. The post-hull cleaning trials trend line requires on average **4.1%** less power to attain speeds between 12.5 and 16 knots. In this same speed range, the post-propeller cleaning trials trend line indicates that on average **5.0%** less power is required to attain a given speed when compared to the post hull cleaning trials. These results indicate that a total of approximately **9%** less power is required to attain a given speed (in speed range between 12.5-16 knots) as a result of cleaning both the hull and propeller. For speeds less than approximately 12 knots, more power is required to attain a given speed for the post hull cleaning trials when compared to the baseline trials. This result is unexpected and may be influenced by the higher level of uncertainty involved in the lower engine setting trials.

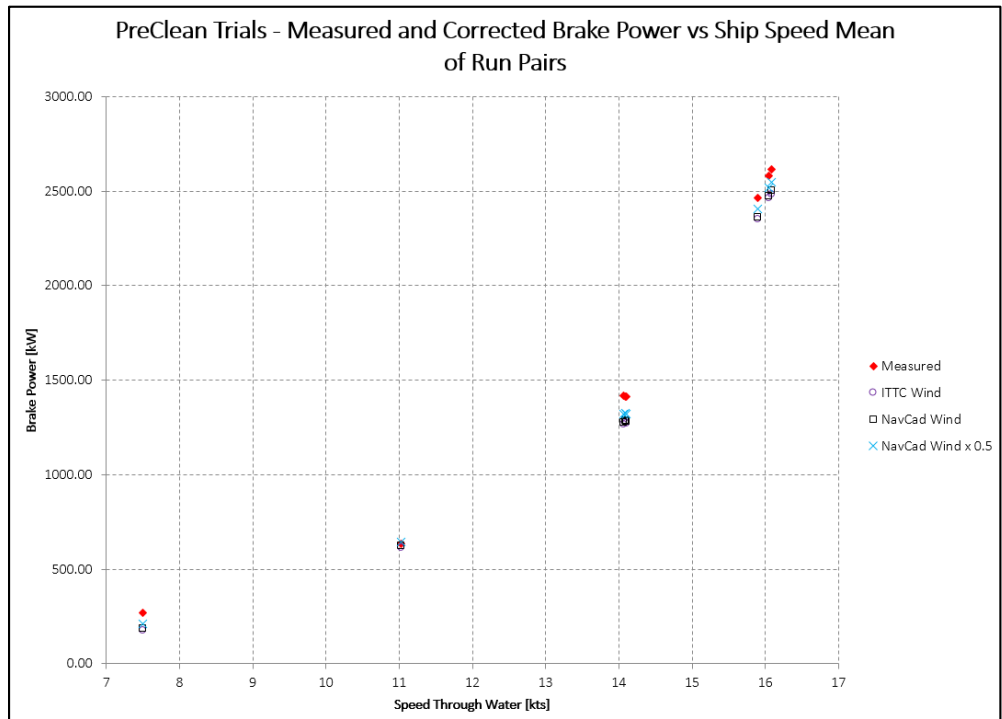
Figure 7. Corrected Speed and Power Results for Baseline Trials

The results of the three analysis methods for the baseline trials data is summarized in Figure 7. The measured (uncorrected) data is also included to reference the extent to which the measured data is modified as a result of the wind, wave and sea temperature corrections.

The measured trials data have higher power per speed than the corrected data for all test cases except the 11 knot speed. It is expected that the measured power would be higher since the power is being corrected to a calm condition and less power would be required to attain a given speed in calm seas. The measured data is very close to the corrected values at 11 knots which suggests that the wind and wave conditions during these tests were relatively mild. There is not much difference between the corrected results using the ITTC wind correction and the NavCad (Fujiwara) wind correction, for all tests. The corrected data using half the Fujiwara wind correction, lies in between the measured data and the other corrected data. A summary of the measured power and corrected power values from each analysis method are provided in Table 7 for each test during the baseline trials.

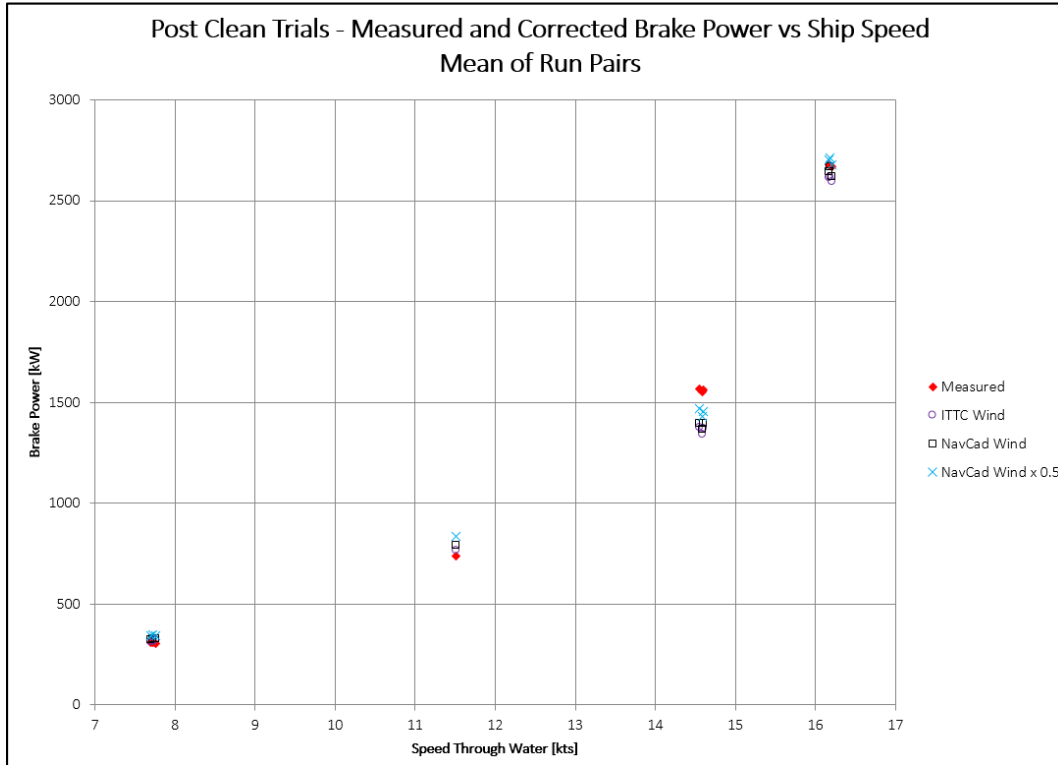
Figure 8. Corrected Speed and Power Results for Post Hull Clean Trials

The results of the three analysis methods for the post hull cleaning trials data is summarized in Figure 8. The measured (uncorrected) data is also included to reference the extent to which the measured data is modified as a result of the wind, wave and sea temperature corrections.

The data corrected using the ITTC wind correction and the NavCad wind correction are very similar. The spread between the measured and corrected data increases with speed for the post hull cleaning trials. A summary of the measured power and corrected power values from each analysis method are provided in Table 8 for each test during the post hull cleaning trials.

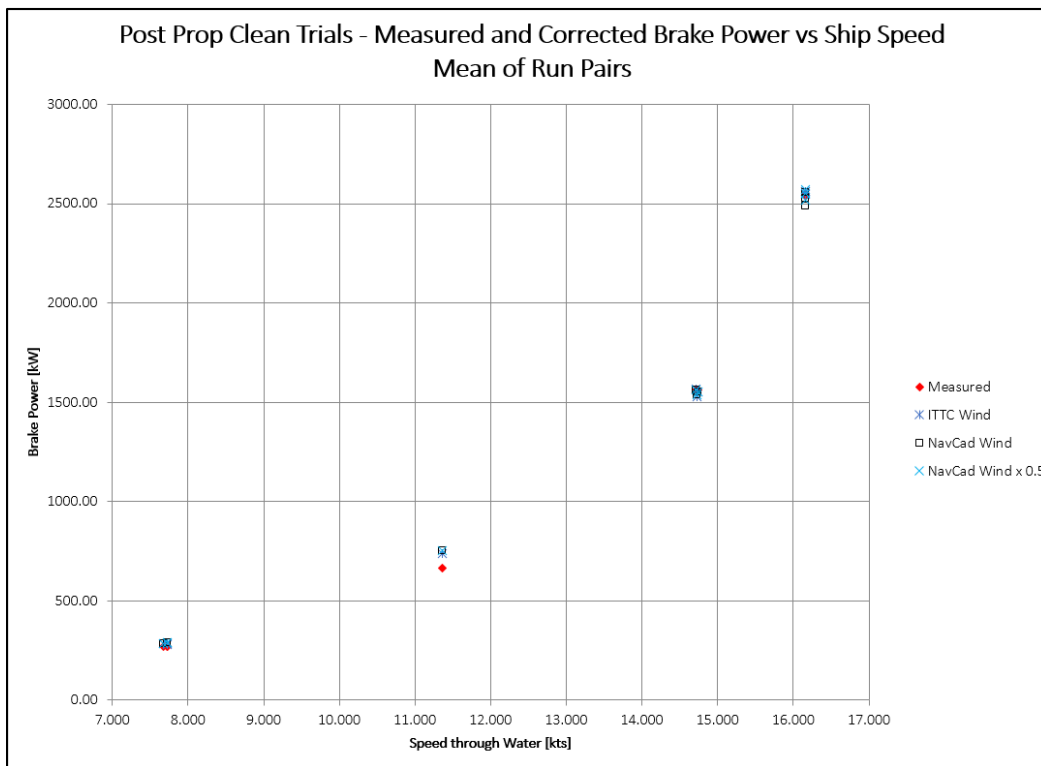
Figure 9. Corrected Speed and Power Results for Post Prop Clean Trials

The results of the three analysis methods for the post propeller cleaning trials data is summarized in Figure 9. The measured (uncorrected) data is also included to reference the extent to which the measured data is modified as a result of the wind, wave and sea temperature corrections.

The measured data is very close to the corrected data for the post propeller cleaning trials due to the mild environmental conditions during the trials. There does appear to be one outlier for the tests at speed between 11 and 12 knots for which the measured power is below the corrected power values. A summary of the measured power and corrected power values from each analysis method are provided in Table 9 for each test during the post propeller cleaning trials.

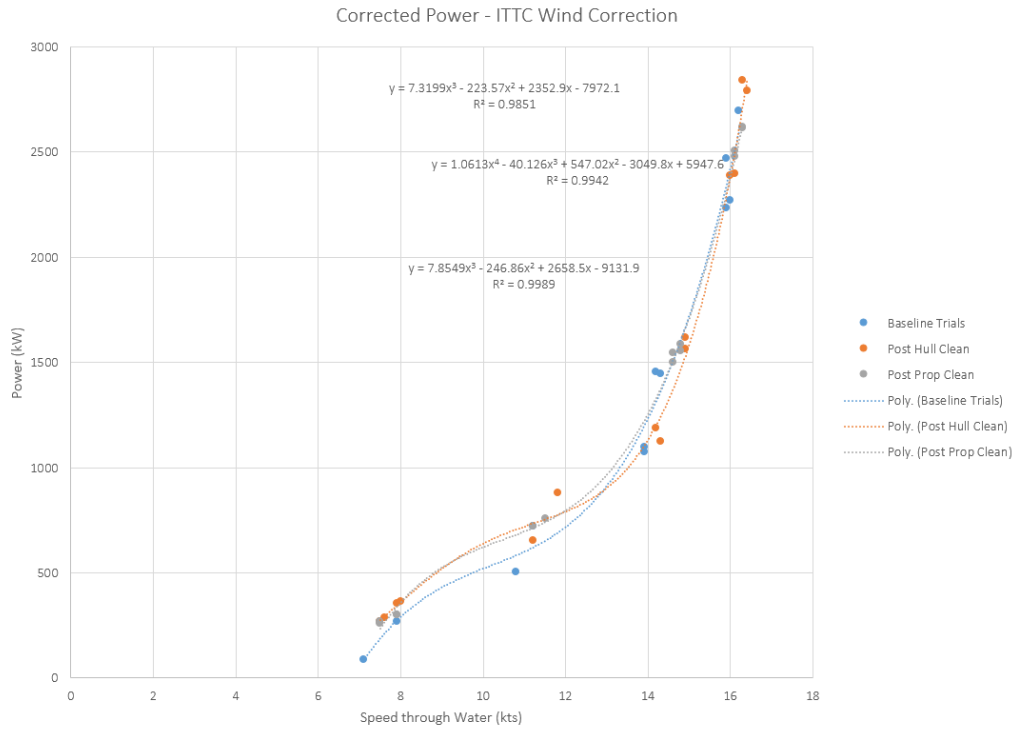
Figure 10. Corrected Power Results for All Trials – ITTC Wind Correction

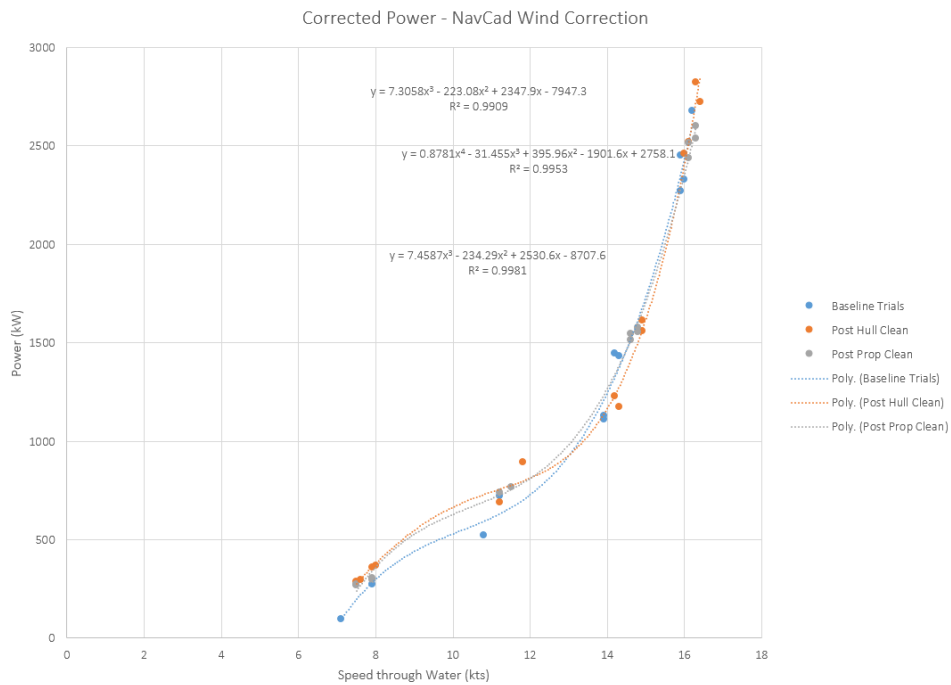
Figure 11. Corrected Power Results for All Trials – NavCad Wind Correction

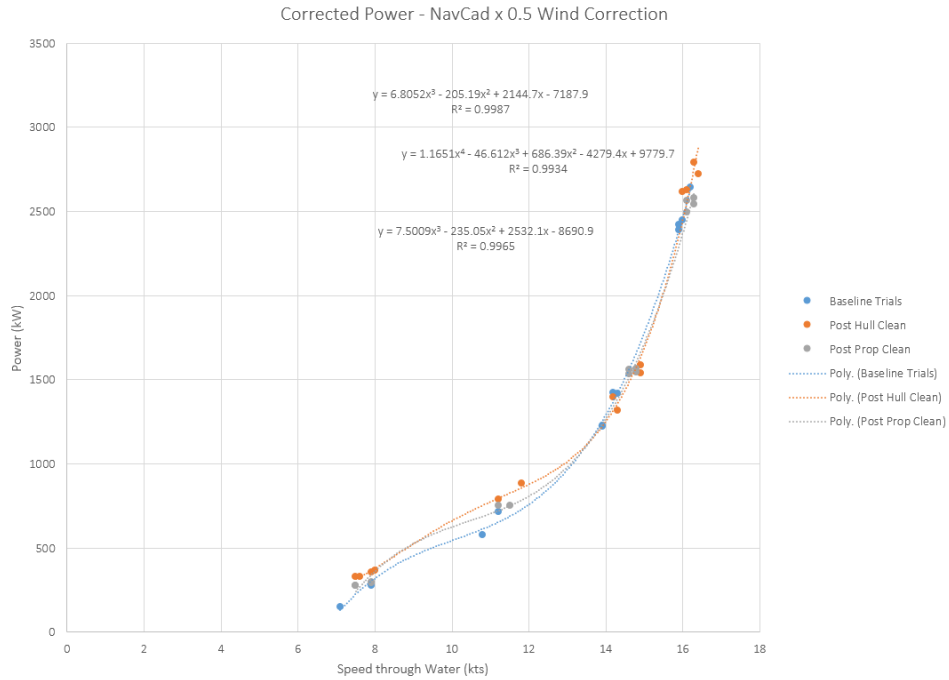
Figure 12. Corrected Power Results for All Trials – NavCad x 0.5 Wind Correction

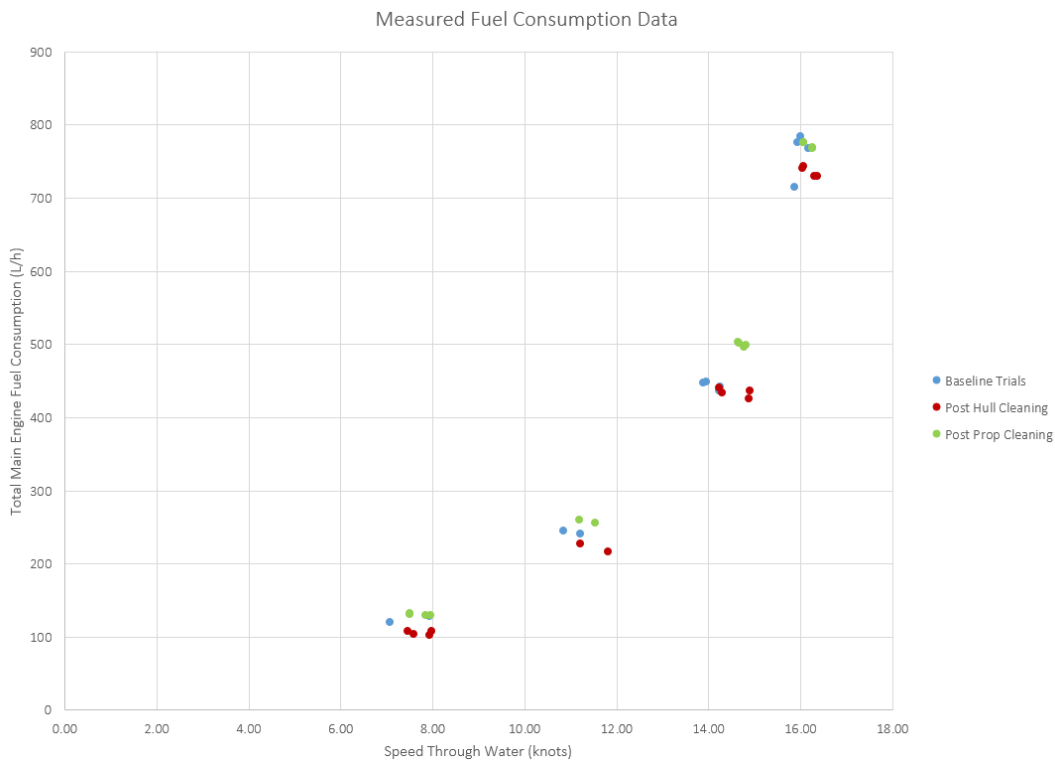
Figure 13. Uncorrected fuel consumption versus speed

The measured total fuel consumption rate of both main engines was plotted against the speed through water for each test during each trial. The results from all trials were added to a single plot to allow comparison between the data sets. All data aligns relatively well to a single fuel consumption versus speed curve, though there is variability in the data sets. The post propeller cleaning trials have the least variability amongst the data points at a single engine setting, particularly at the higher engine settings tested. This was expected since the wind conditions during the post propeller cleaning trials were milder than the other two trials. The post hull cleaning points are slightly lower in terms of the fuel consumption rate that is required to attain a given speed when compared to the results of the other two trials. However, the post propeller cleaning points appear to be in line with the baseline trials results in terms of fuel consumption requirements for a given speed.

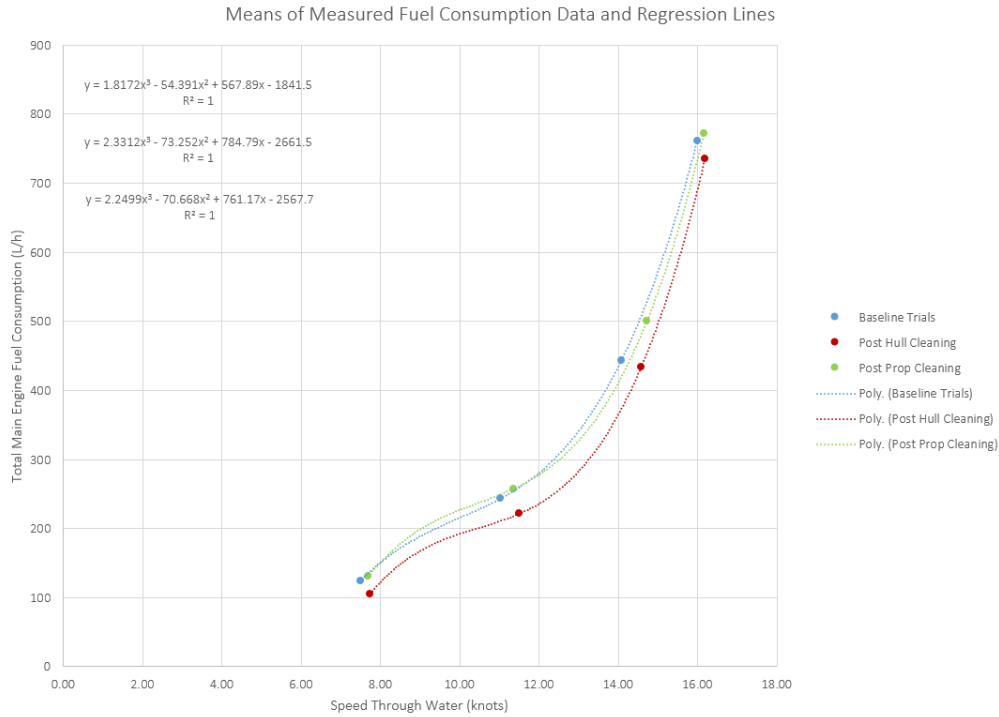
Figure 14. Means of Measured Data – Fuel Consumption versus Speed through Water

The mean speed and fuel consumption rate at each engine setting was computed for each of the three trials. The mean fuel consumption values were plotted against the mean speed values and regression lines were fit through the data representing each trial. The results of this analysis is provided in Figure 14. The differences between the data sets from each trial, in terms of the relationship between fuel consumption and power, are clearer here. The fuel consumption savings as a result of cleaning the hull alone is larger than the fuel consumption savings resulting from cleaning the hull and propeller, which was unexpected.

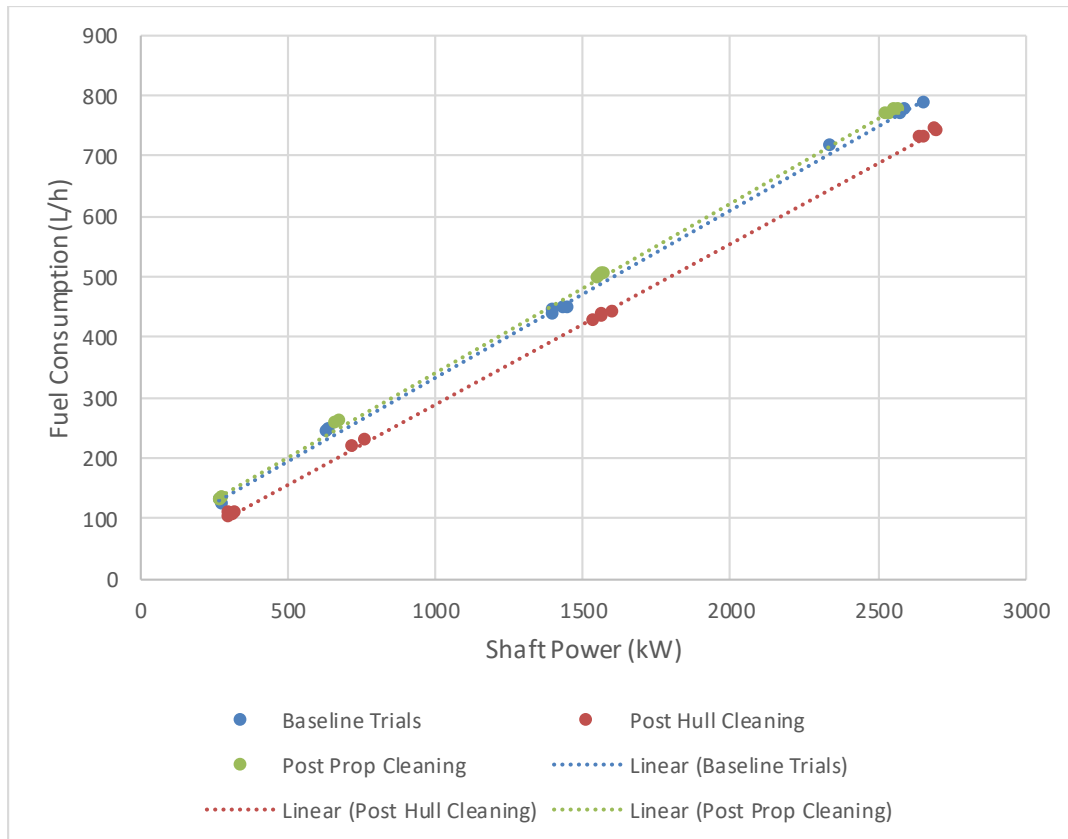
Figure 15. Uncorrected total main engine fuel consumption rate versus shaft power

To investigate this further the total main engine fuel consumption versus shaft power was plotted for each trial. The fuel consumption versus power curve should be consistent for all trials since both fuel consumption and shaft power are not affected by external parameters such as environmental condition or hull and propeller condition. The speed attained however, does change as a result of variation in these external parameters. The measured total main engine fuel consumption versus power curve for all trials is shown in Figure 15. For each engine setting tested during trials, the baseline trials and post propeller cleaning trials data aligns well. However, there is an offset when it comes to the post hull cleaning trials data. For these trials there is less fuel required for a given power setting, particularly at higher power values. It is expected that there was some mechanical difference in the fuel measurement system that led to the discrepancy in the post hull cleaning fuel versus power data. A possibility is that one (or more) of the fuel flow meters surrounding one of the main engines was bypassed or partially bypassed or blocked during the post hull cleaning trials. However, the OpDAQ system bypass indicator did not highlight a complete bypass during this, or any of the trials.

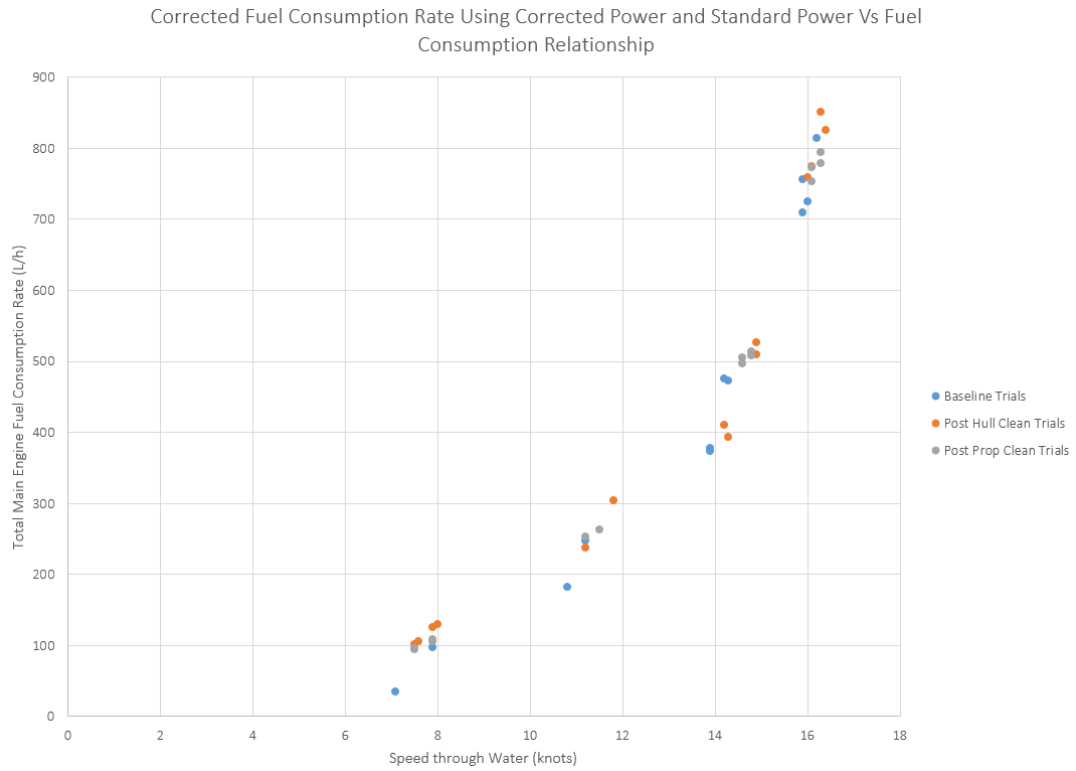
Figure 16. Corrected total main engine fuel consumption rate versus speed

The baseline and post propeller trials data for fuel consumption versus power was used to define the general fuel versus power curve for the Cygnus main engines. The post hull cleaning trials data was not used for this purpose due to the discrepancy from the other trials data. The general fuel versus power regression equation (regression equation listed in Figure 15) was used to calculate the “corrected” fuel consumption by adding the corrected power values at each engine setting for each trial. The power values corrected using the NavCad wind correction were used in this analysis. Once the “corrected” fuel consumption rate was identified for each test, the corrected fuel consumption versus speed was plotted for each specific trial so that the data could be easily compared (see Figure 16). There is no quantifiable difference between the fuel consumption rate and speed through water for the different sea trials. This is due to the level of variation in data at single test condition within a given trial and how data from different trials fall within this variability range. For example, at a throttle setting of 8.0, the baseline trials speed through water ranges from 13.9-14.3 knots and the corrected fuel consumption ranges from 373-475 L/h. At this same throttle setting, the post hull cleaning trials speed through water ranges from 14.2-14.9 knots and the corrected fuel consumption ranges from 393-526 L/h. There is overlap in the speed and fuel consumption variability ranges between trials for each engine setting.

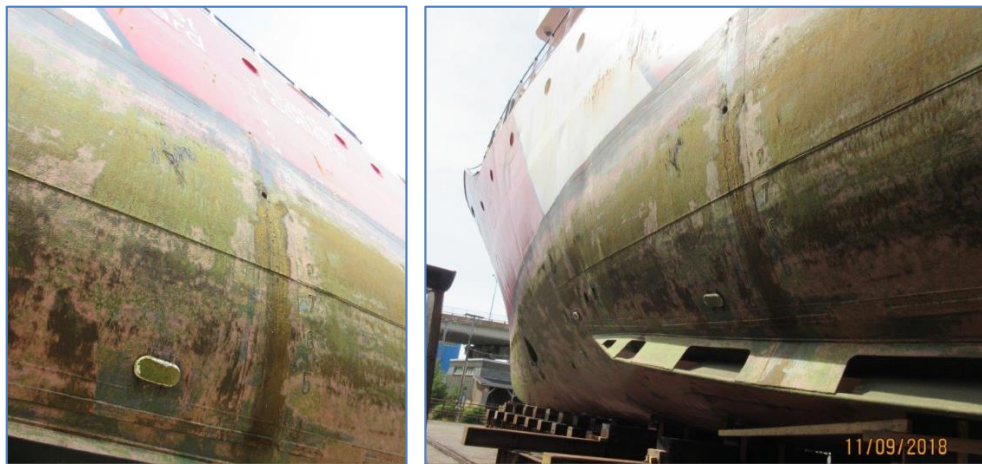
Figure 17. Images of port side of hull during September, 2018 dry dock

The CCGS Cygnus was taken into dry dock on September 11, 2018 to perform vessel maintenance. When in dry dock, the hull was observed to have a relatively high level of fouling on one side in particular (port). The level of fouling present on the port side was similar to the amount that was present during the underwater survey conducted in May, 2018, prior to cleaning the hull. Specifically, there was slime and sea grass covering a large portion of the underwater hull (see Figure 17). These observations were unexpected for two reasons. The first relates to the speed of fouling taking place on the Cygnus hull. Prior to the May hull cleaning, the Cygnus hull had not been cleaned in two years. It was anticipated that the level of fouling present in September, just 3.5 months post hull cleaning, would be much less than that observed during the May survey. Some reasons that could have led to rapid fouling growth during this short period include the relatively warm temperatures during summer 2018 in the region and a depletion in anti-fouling coating.
