# A Literature Review of the Fire Performance of Floor Assemblies Commonly used in Houses

Volume: Research Report

Report No.: A1-018027

Authors: Alex Bwalya, Joseph Su, Nouredine Bénichou

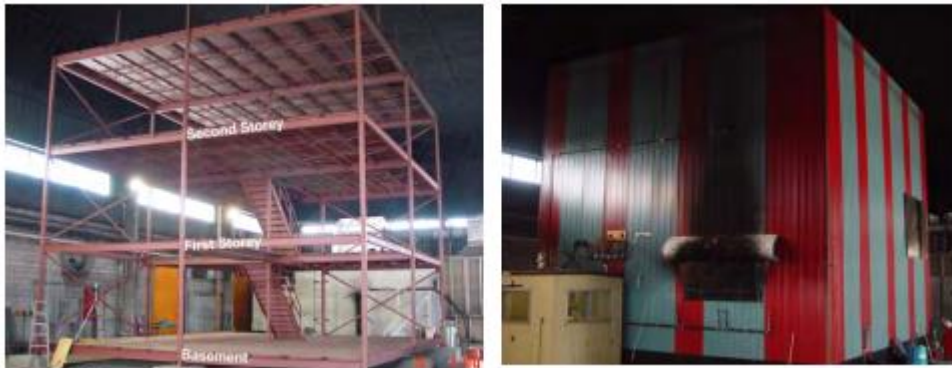
Figure 1. FPH test facility

The fire tests were conducted in a test facility that was designed to represent a typical two-storey detached single-family house with a basement, which is shown in Figure 1.

Each of the three levels of the test facility had a floor area of 95 m<sup>2</sup> and a ceiling height of 2.4 m. The basement was partitioned to create a fire room representing a 27.6 m<sup>2</sup> basement living area. The layout of each of the three storeys is shown Figures 2 – 4. For the basement fire room, a rectangular exterior opening measuring 2.0 m wide by 0.5 m high and located 1.8 m above the

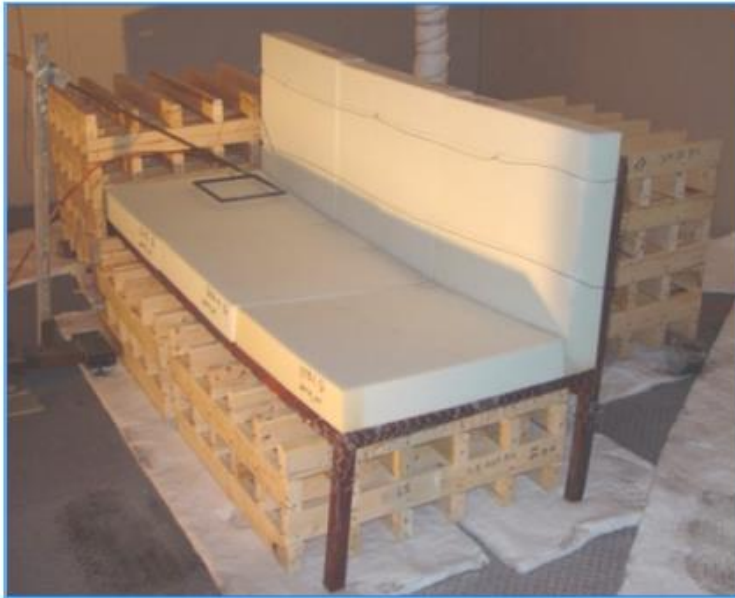
The fuel package consisted of a mock-up sofa that was constructed with 9 kg of exposed polyurethane foam (the dominant flammable constituent of upholstered furniture) and 190 kg of wood cribs that was arranged as shown in Figure 5. The design of the fuel package took into consideration the fact that the floor assembly would contribute to the fuel load. The fuel package was placed at the centre of floor space of the basement fire room. The fire was started by igniting the mock-up sofa with a square gas burner that was positioned as shown in Figure 5.

Figure 5. FPH Fuel package

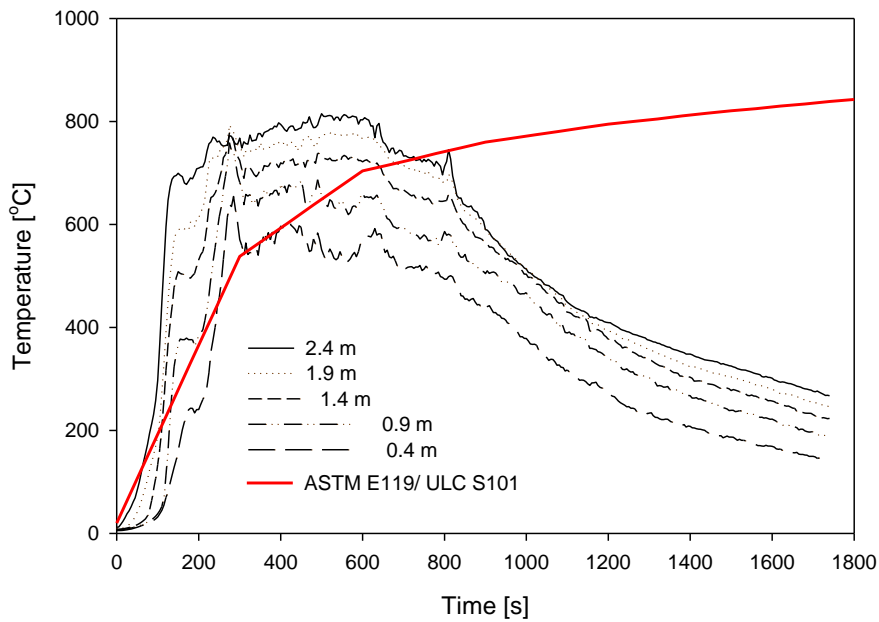
Tests were conducted with the basement doorway either in the open or closed position. Figure 6 shows the average temperatures at five elevations that were obtained during an experiment in which all of the walls and ceiling in the fire room were lined with a non-combustible sheathing and the basement doorway was left open during the characterization test, FS-1. Figure 6 also shows the difference between the standard CAN/ULC S101 temperature-time curve and the actual temperatures in the fire room for a duration of approximately 1800 s (30 min). The temperature rise was more rapid than that of the S101 curve during the initial 720 s (12 min), indicating a more severe fire exposure. Figure 7 shows that when the characterization test was conducted with the basement door closed, the peak temperature in the room was substantially lowered (less severe fire) due to the limited supply of combustion air to the fire room.

Figure 6: Temperature evolution in an actual room fire test (with non-combustible room linings and basement doorway open) compared to the ASTM E119 / ULC S101 standard temperature curve.

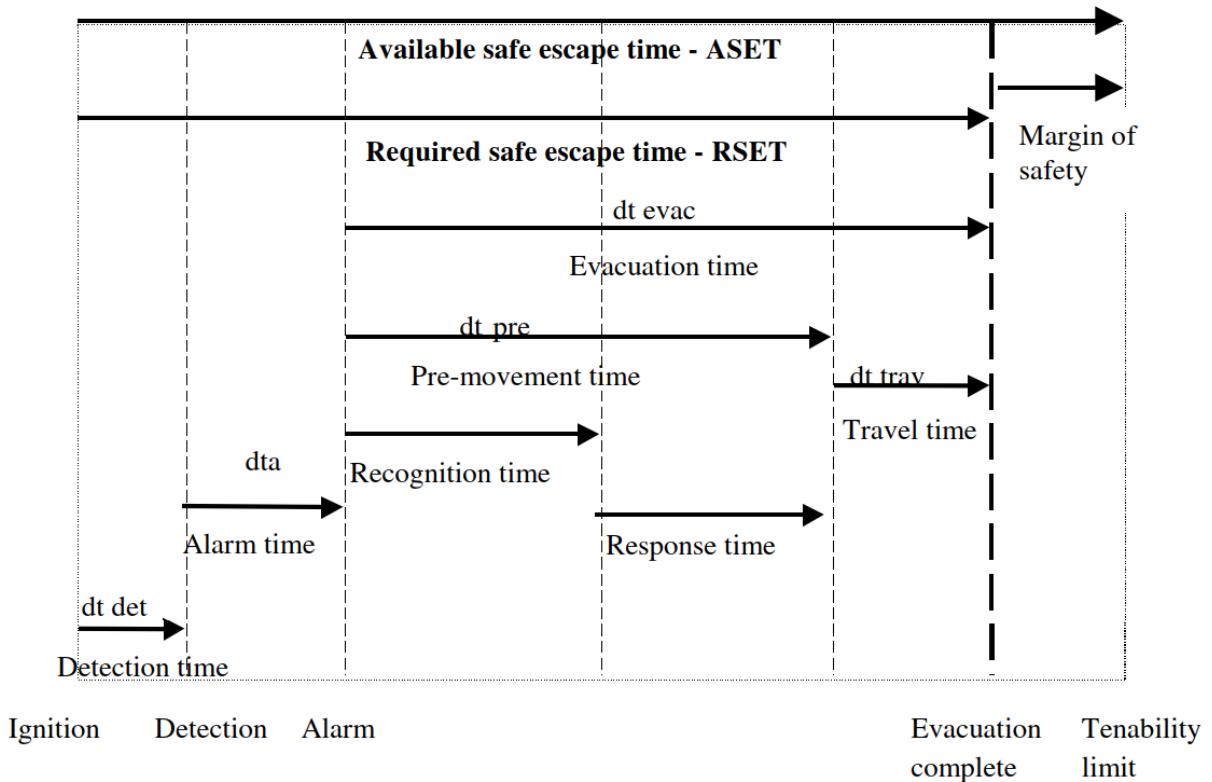
assessment, the evacuation time is often calculated using the ASET/RSET model illustrated in Figure 8. The ASET is the available safe escape time calculated from the time of ignition of a fire until the time at which the occupant tenability criteria are exceeded in the means of egress. The RSET is the required safe escape time, which is the time calculated from ignition until occupants can reach an area of safety. The timing of each phase of the evacuation process depends on a wide range of factors, such as fire location, combustibles in place, detector placement, space layout, and the characteristics of the occupants.

Figure 8. Egress time model [16]

It was noted that the ASET/RSET approach could not account for certain kinds of fire scenarios, for instance, those in which occupants who are intimate with fire ignition experience ignition of their own clothing or bedding such that their ASET is essentially nonexistent. Another scenario considers a lone occupant who has a disability or is immobile, such that their RSET will be unlimited as they cannot evacuate unaided. These scenarios are not considered in this analysis.

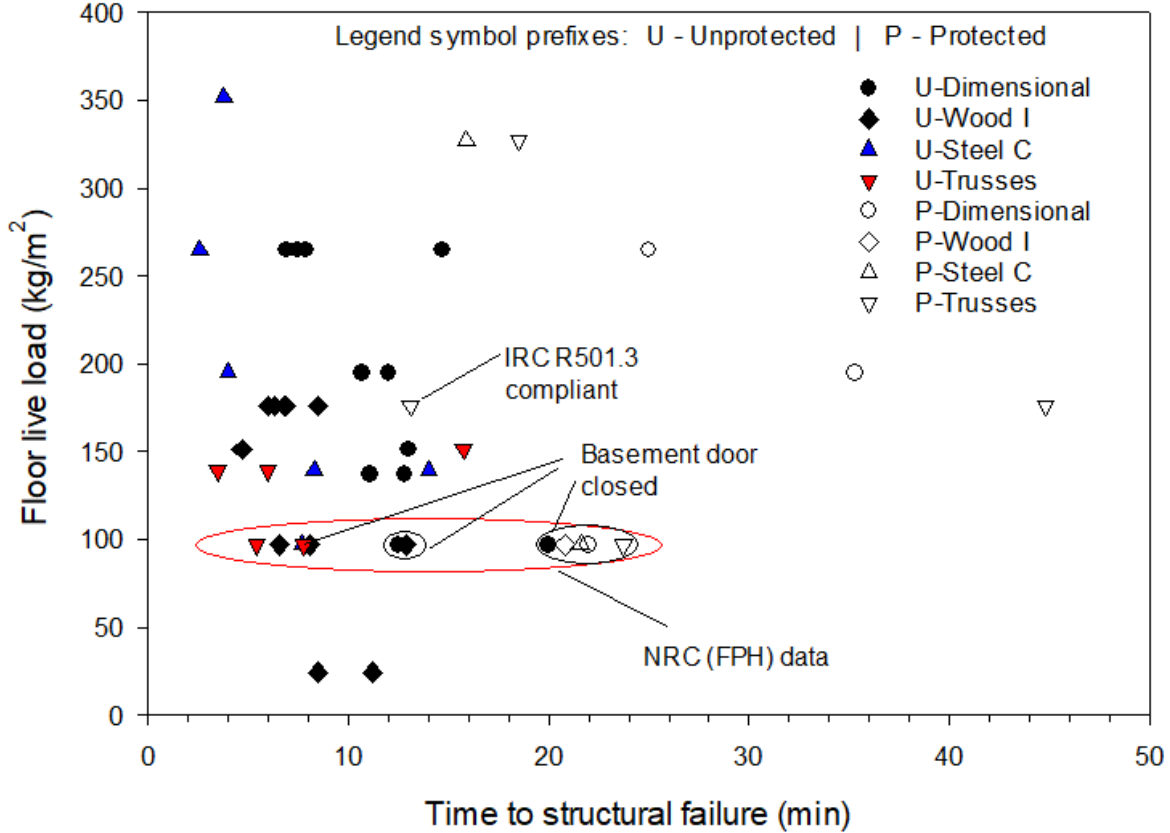
Figure 9 shows the results of the time to structural failure for all of the non-standard experiments conducted with unprotected and protected assemblies. The results from the NRC FPH project are also included in Figure 9 to give a complete picture of all of the available data. There are variations in the results obtained for similar assemblies due to the many experimental variables that were used. One of the key variables that has a strong influence on the time to structural failure is the live load applied to the test assemblies. Other main variables in non-standard compartment fire tests included ventilation conditions and the fire load (quantity and composition), which creates differences in fire severity. However, the fire performance trends for the various assemblies and effect of protection measures are clearly discernible. For dimensional lumber assemblies, the lowest time to structural failure was 6.9 min (Test 7-3 in Table 8). The test was conducted in a fire resistance furnace using a non-standard temperature-time exposure that was derived from compartment fire tests, in which the same assemblies had a failure time of 12 min (Test 6-2 in Table 8). This result is similar to that obtained in the NRC FPH project (failure time of 12.5 min in Test UF-01) although the live load was different. Another FPH test (UF-02) with the same assembly had a failure time of about 20 min under the reduced fire severity resulting from reduced ventilation when the basement door was closed.

The results shown in Figure 9 also collaborate the findings in the FPH study, which found that assemblies using trusses and steel C joists had significantly reduced structural fire endurance compared to dimensional assemblies. The lowest performing assemblies in the tests presented in Table 8 were a steel C-joist and metal-plate connected truss with failure times of 2.6 min (Test 7-10) and 3.5 min (Test 10-10), respectively. The effect of adding ceiling protection (typically 12.7 mm regular gypsum board) is also evident in the results.

Figure 9: Non-standard experiments

Figure 9 also shows the performance of a test (No. 11-4) which evaluated the performance of a metal-plate connected truss assembly that complied with the new provisions that were introduced in the International Residential Code (IRC) in the USA that essentially required unprotected engineered assemblies to demonstrate fire performance equivalent to dimensional lumber assemblies. In the USA, the main codes are the International Building Code or International Residential Code, electrical codes and plumbing, and mechanical codes. It is reported that about fifty states have adopted the I-Codes at the state or jurisdictional level. Since 2012, the International Residential Code Section R501.3 “Fire protection of floor”, required floor assemblies that are not required to be fire-resistance rated to be provided with a 12.7 mm gypsum membrane, 15.9 mm (5/8 in.) wood structural panel membrane or equivalent on the underside of the floor framing. In the 2015 and 2018 IRC, the provision was moved from Section R501.3 to Section R302.13 and new language was added to allow for penetrations or openings in the fire-protection membrane. Therefore, the 2018 IRC R302.13 reads as follows:

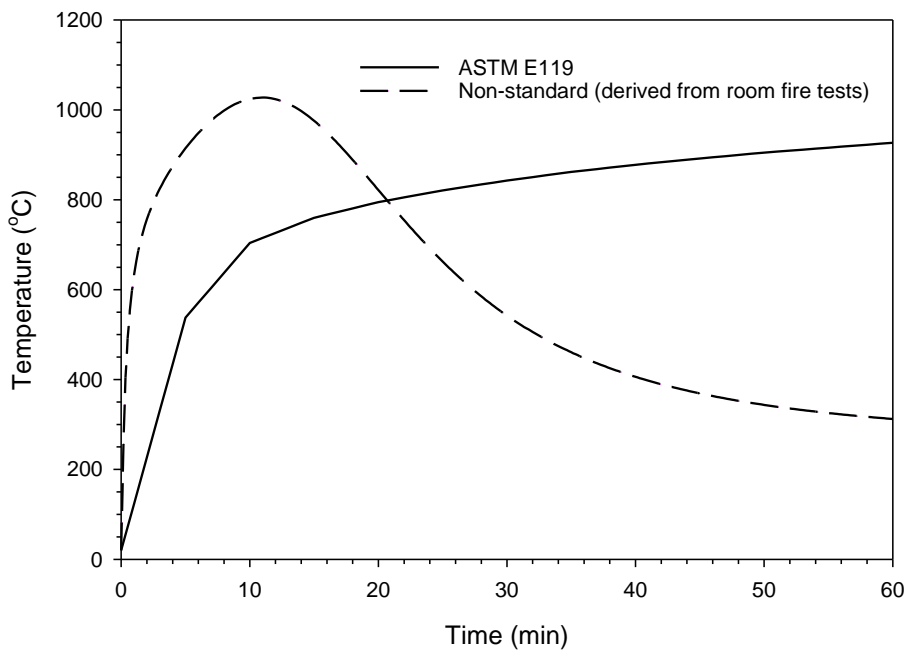
The first part of the project involved seven experiments (see Tests 6-1 to 6-7 in Table 8) with floor assemblies that were conducted in a simulated basement room with actual furnishings. In the second part of the project, 10 experiments (Tests 7-1 to 7-10 in Table 6) were conducted in a standard fire resistance furnace using two different fire exposures: the ASTM E119 temperature-time exposure and a non-standard temperature-time exposure (see Figure 10) that was developed using the temperature data from the experiments in the first part of the project. An additional variable introduced in the furnace tests was the excess air, which was controlled to simulate the limitation in ventilation that occurs in post-flashover room fires.

Figure 10: Non-standard temperature-time curve developed using data from full-scale room tests [22] compared with the ASTM E119 curve.

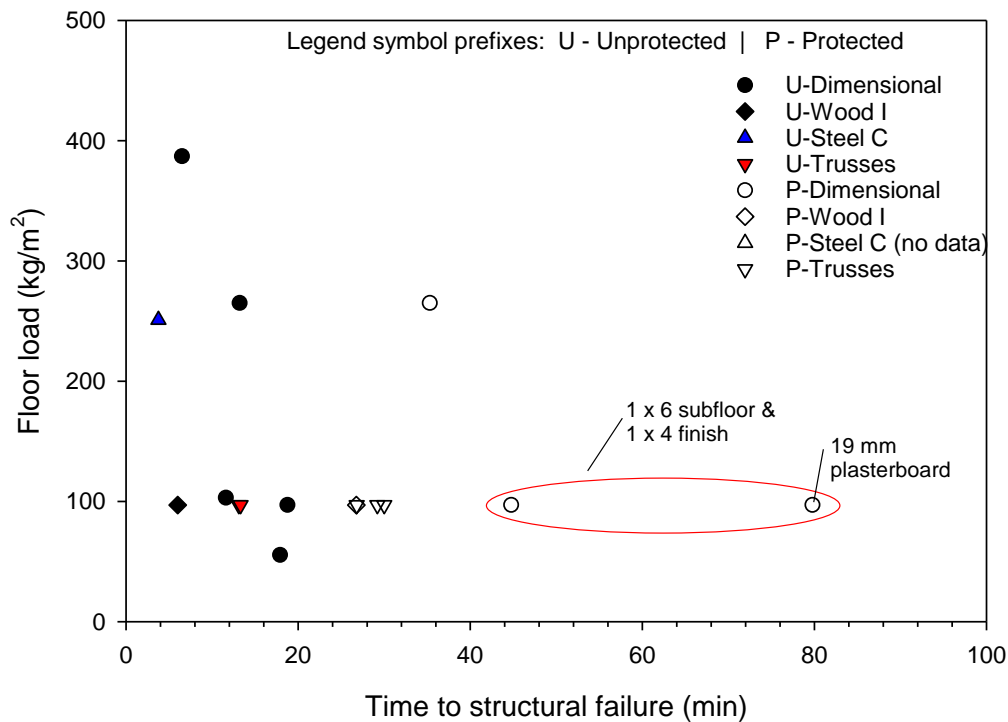
Figure 11 shows the results of structural failure times for 15 experiments (including the seven UL tests discussed previously) that were conducted with the floor assemblies subjected to the standard ASTM E119 temperature-time exposure. As was the case with the non-standard tests, the applied load affects the structural fire endurance of the assembly. The one test with an unprotected steel C-joist assembly recorded the lowest failure time of 3.75 min. A wood I-joist assembly also had a relatively short time to failure of 6 min under an applied load of 97 kg/m<sup>2</sup>. The effect of the applied load is clear from results for the dimensional lumber assembly; the failure time was as short as 6.5 min under a high applied load of 387 kg/m<sup>2</sup>, while this was significantly extended to 18.8 min at a loading on 97 kg/m<sup>2</sup>, which is similar to the live load that was applied in the NRC FPH fire tests. As previously found in the non-standard tests, the application of a ceiling protection resulted in a significant improvement in structural fire endurance. Two tests are highlighted in Figure 11, in which the failure time was greatly increased (beyond 40 min) likely due to the type of ceiling, sub-floor and finish materials (19 x 140 mm (1 x 6) subfloor, (19 x 89 mm (1 x 4) floor finish and 12.7 mm regular gypsum board in one case; and 19 mm plasterboard in the second case).

Figure 11. Failure time of 15 experiments based on the ASTM E-119 standard test method
