LAKE ONTARIO CANADIAN NEARSHORE Assessment

2019 HIGHLIGHTS
REPORT

Nearshore Assessment Lake Ontario 2019

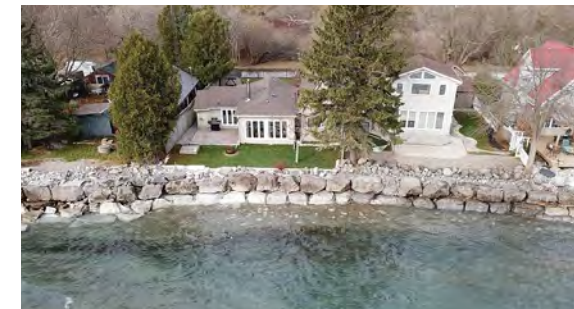
Shoreline armoring reduces natural resiliency

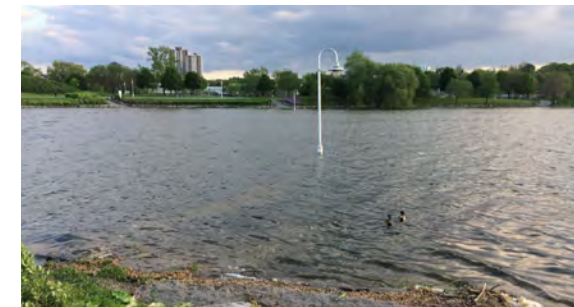
High water levels damage and limit access to public spaces
