LAKE HURON CANADIAN NEARSHORE Assessment

2021 HIGHLIGHTS
REPORT

Nearshore Assessment Lake Huron 2021

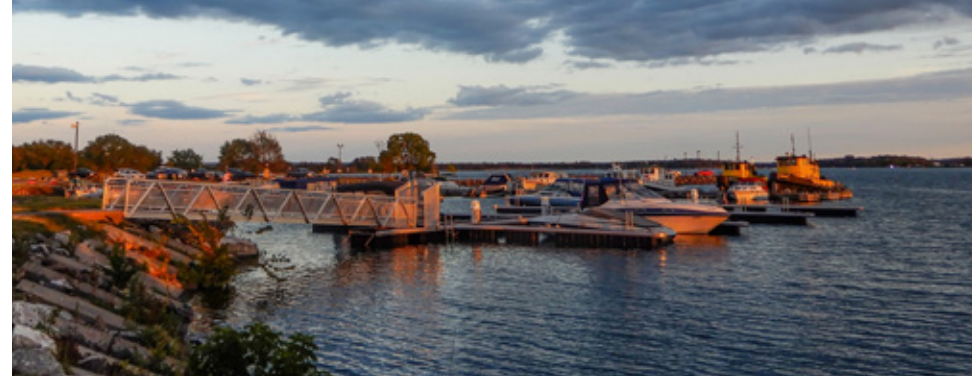
The St. Marys River is under moderate stress from the cumulative impact of poor benthic community quality and beach postings. Benthic communities were taxonomically distinct from all other Regional Units with the lowest richness and evenness. The one monitored beach was posted an average of 12.5% of the swimming season. There are no ambient monitoring data for water or sediment quality in the river, although more localized information will be available for ongoing efforts in the binational St. Marys River Area of Concern. Canada and Ontario have drafted a contaminated sediment strategy which outlines actions to manage specific locations on the Canadian side and community engagement is ongoing. At 8 meals per month for Smallmouth Bass, Walleye and Yellow Perch, fish consumption is a source of low stress.

- Large areas of intact natural shoreline
- Major conduit between Lake Superior and Lake Huron: relatively short length (approx. 120 km) and high flow volumes create a variety of habitats
- Upper River: rapids with facilities and channels for navigation, hydropower, water regulation
- Diverse fish community supported by large areas of coastal habitat
- Critical habitat and corridor for lake sturgeon
