HYDROMETEOROLOGIC CONDITIONS  
PREVAILING DURING THE 1984 RIVER ICE  
BREAKUP, FORT SIMPSON REGION, N.W.T.

T.D. Prowse

March 1985

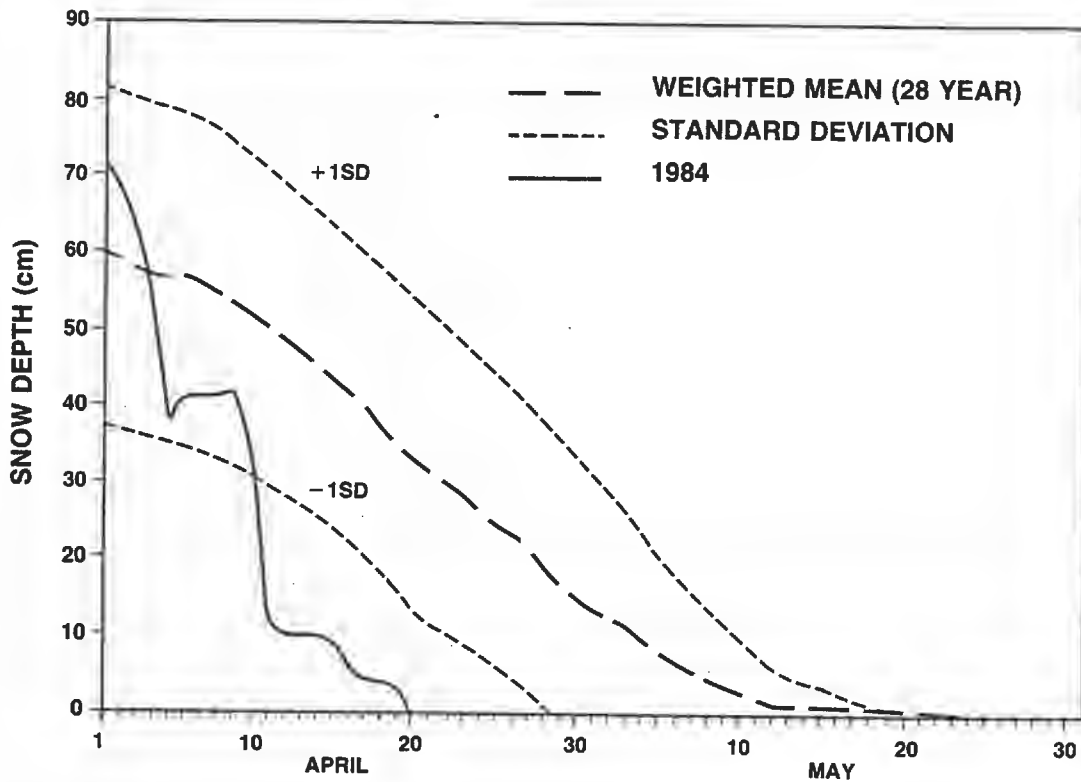
Figure 3. SNOW COVER DEPLETION. Atmospheric Environment Station : Fort Simpson 'A'.

Snow depths were slightly above normal at the beginning of April, but warm conditions rapidly depleted the snowpack to below normal levels within a matter of days (Fig. 3). Snowmelt was interrupted by the brief cold period, mentioned above, and a light snowfall (4.4 mm W.E.) in the middle of the first week of April (Fig. 2), but with a return to warm conditions, snow depth was reduced to only a trace by April 20 - over 20 days earlier than the long term average date.

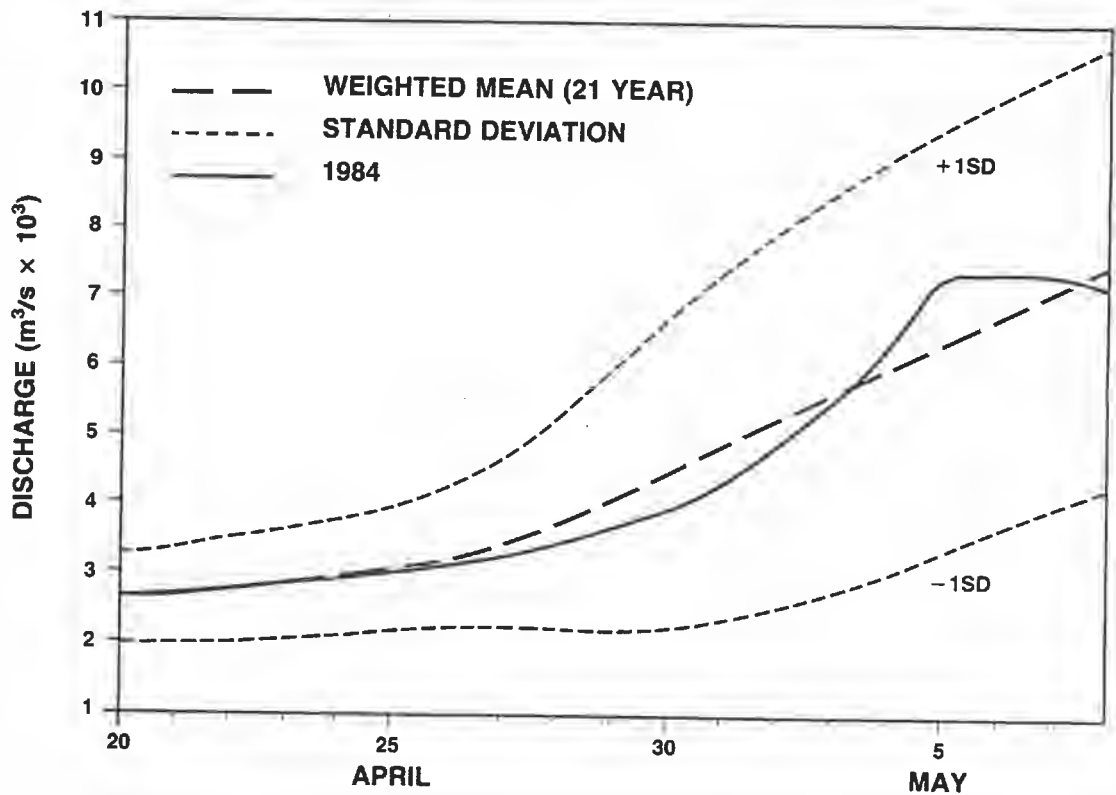
Figure 5. DISCHARGE OF MACKENZIE RIVER AT FORT SIMPSON. Weighted mean derived from record 1960-1982 (excluding 1961). Source: Water Survey of Canada.

On April 20, flow on the Liard River was 36% above normal at 658 m<sup>3</sup>/s (Fig. 4) and near normal on the Mackenzie River at 2600 m<sup>3</sup>/s (Fig. 5). Until the main breakup period (April 30-May 4), discharge remained above normal on the Liard and below normal on the Mackenzie River. Notably, discharge on the Liard River on the day before breakup was almost exactly the same as that in 1983, a year of spectacular ice jamming. (The date of breakup was also the same in both years: April 30). During the main breakup period, however, the Liard River discharge remained relatively constant, rising at maximum rates of only 150 m<sup>3</sup>/s/dy to 1810 m<sup>3</sup>/s and never producing a true spring flood wave. In contrast, during the 1983 breakup, discharge rose very quickly at rates of 600 m<sup>3</sup>/s/dy to a much higher maximum of 4200 m<sup>3</sup>/s. Despite below normal discharge on the Mackenzie River, breakup of the river upstream of the confluence was almost concomitant with that of the lower Liard River. More detailed

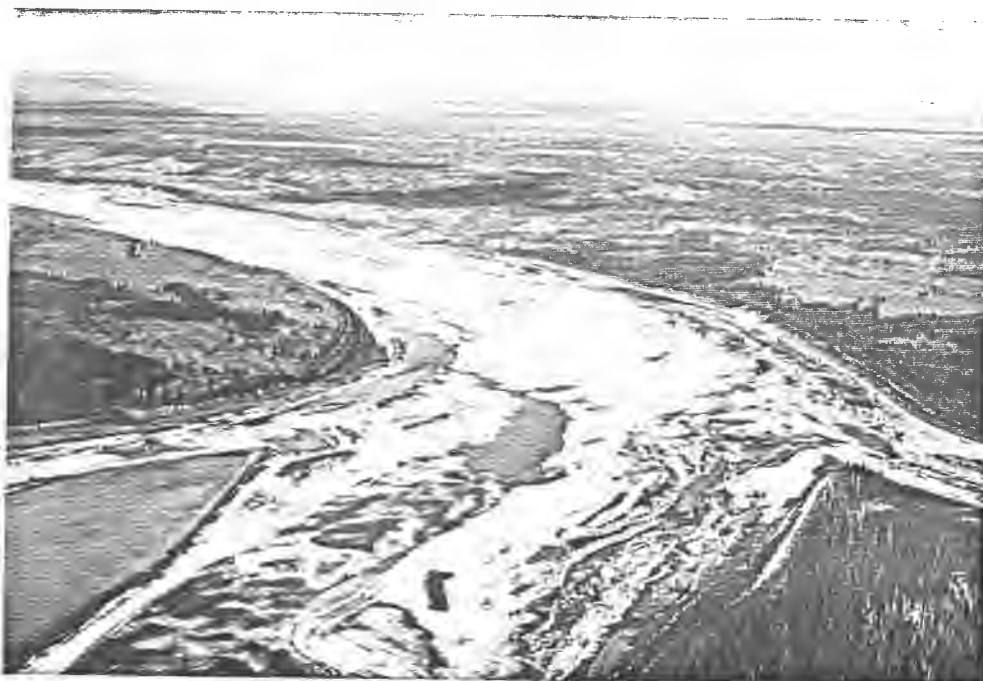
Photograph 1: DECAYED LIARD RIVER ICE COVER, APRIL 26. View downstream the Liard River from Sawmill Island (bottom right) towards the ferry crossing. Note the large areas of exposed shoal and the zones of open water in the central portions of the ice sheet.

April 26-27: Zones of open water continued to grow at many locations near the centre of the ice sheet. Typical river ice conditions are shown in Photograph 1. Velocity experiments were discontinued and meteorological instrumentation was removed from the Liard River because the ice surface was considered unsafe for travel. Photograph 2 shows the degree of

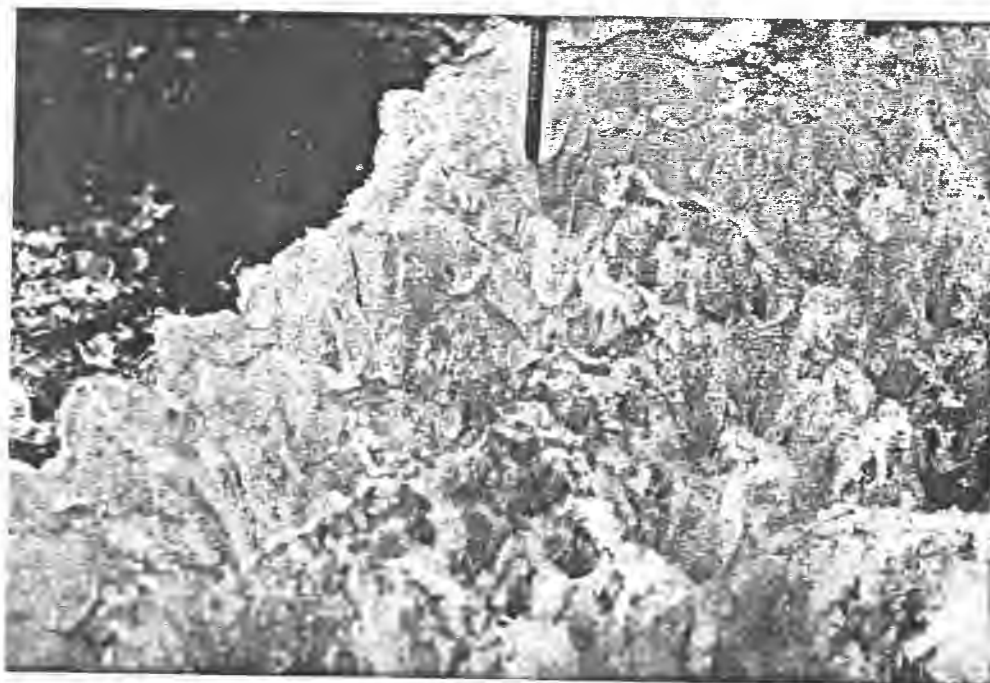
Photograph 2. THERMAL MELT OF THE ICE BOTTOM. The bottom surface of recently upturned ice was pockmarked by holes approximately 2-4 cm wide and 5-8 cm deep. Note the pencil inserted into one of the holes for scale.

hydrothermal melt which had already occurred at the bottom of the ice sheet. Water was now beginning to flow in the shore leads.

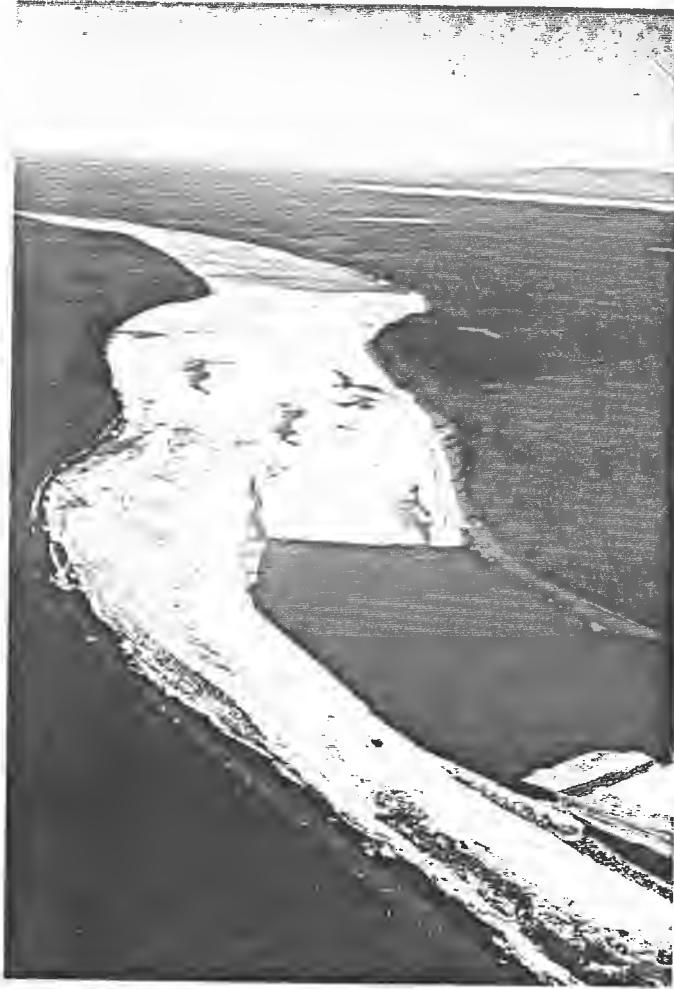
Photograph 3: ICE COVER RELEASE, APRIL 29. View upstream the Liard River from Sawmill Island. Large sections of the ice sheet began to separate and pull away from the remaining intact ice. Note the large expanse of open water in the background.

April 29: Large sections of ice on the lower portions of the Liard River began to separate from the main ice sheet (Photo. 3). In many areas only black ice was exposed at the surface and was beginning to show the effects of candling to a considerable depth (Photo. 4).

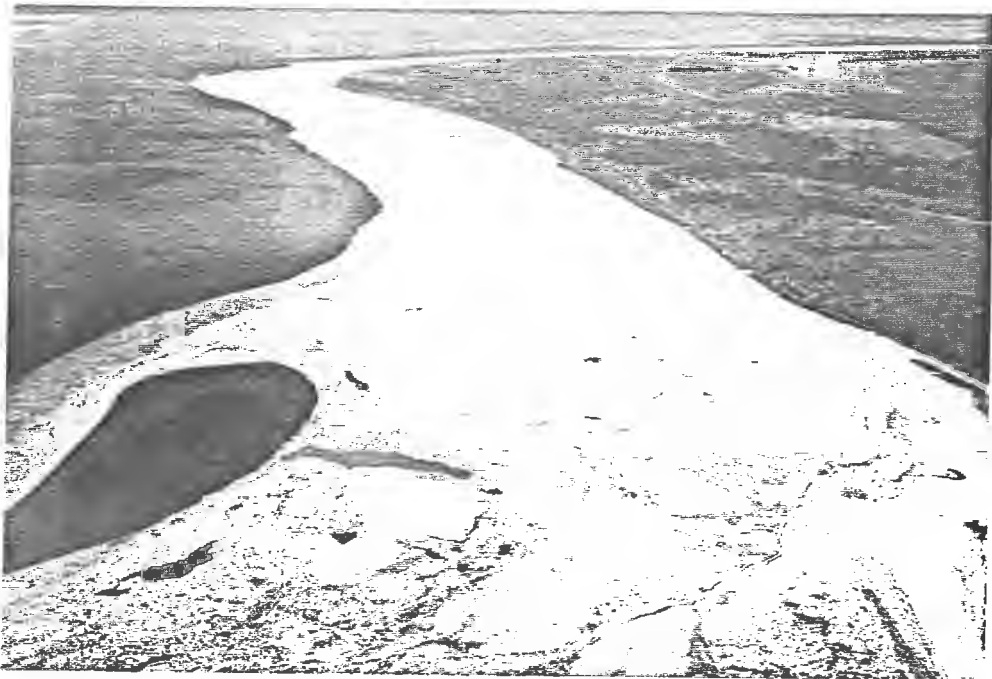
Photograph 5: TOE OF THE LIARD RIVER ICE JAM, MAY 1. View upstream the Liard from Franklin-Clarke Island shown on the left. The toe of the jam (foreground) was comprised of large floes, some 200 m or more in diameter, while the upstream portion (background) was filled in with small diameter brash ice.

May 01: By early morning, a considerable amount of new ice had been added to the Liard River jam (Fig. 8). The toe, still comprised of large ice pans, had moved further downstream to Franklin-Clarke Island (Photo. 5). The position of the jam head continued to fluctuate during the day with further additions of upstream ice, although the jam did not appear to compact and thicken.

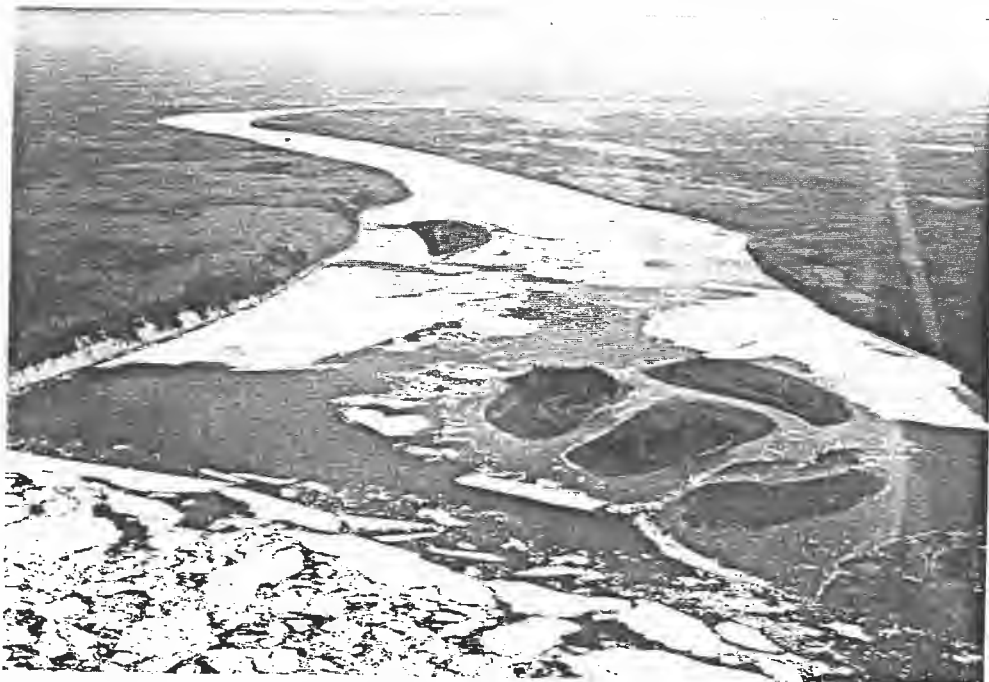
Photograph 6: LIARD RIVER MOUTH, MAY 3, 07:00. View upstream the Liard River from the confluence with the Mackenzie River. Large areas of open water have developed in the river mouth around the Truesdell Island group (foreground) but considerable ice is still jammed further upstream (background).

May 03: The head of the Liard River ice jam began to move downstream. The toe of the jam, however, remained at Franklin Clarke Island, despite the presence of a large open water zone at the Liard mouth (Fig. 10; Photo. 6).

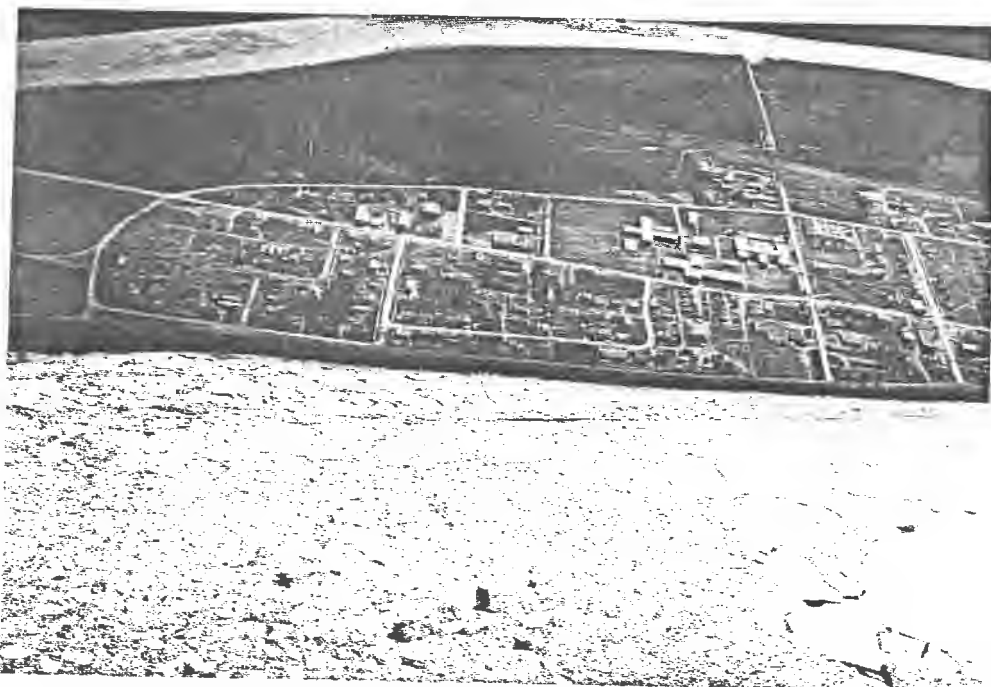
Photograph 7: ICE RUN, MACKENZIE RIVER AT FORT SIMPSON, MAY 3, 17:25. Note the large diameter ice floes in the ice run and the water within the snye behind Fort Simpson island. Although the Liard River ice moved downstream with this ice run, the major run which ultimately cleared the Mackenzie River at Fort Simpson began approximately four hours later.

At 11:40 large sections of the Mackenzie River ice cover began to shift downstream and cover over some of the open water zones downstream of Fort Simpson island. The Mackenzie River ice cover continued to shift throughout the day in small ice runs (Photo. 7). Water levels steadily increased throughout the day, by as much as 50 cm/hr. Upstream of the confluence, open water now reached as far downstream as MKP 328 (Photo. 8 and 9).

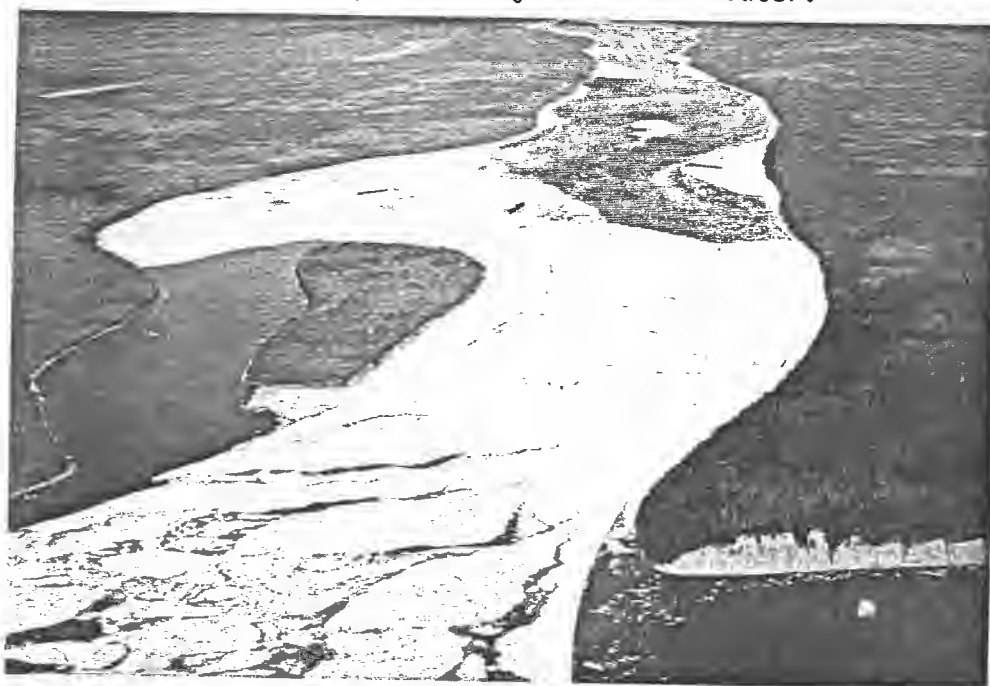
Photograph 8: UPSTREAM MACKENZIE RIVER, MAY 3, 17:26. View upstream the Mackenzie River from the Liard confluence to Green Island. The upstream portions of the Mackenzie River began to clear at approximately the same time that the Liard River ice began to spill into the Mackenzie River at Fort Simpson. Note the large ice island in the centre of the open water reach (background).

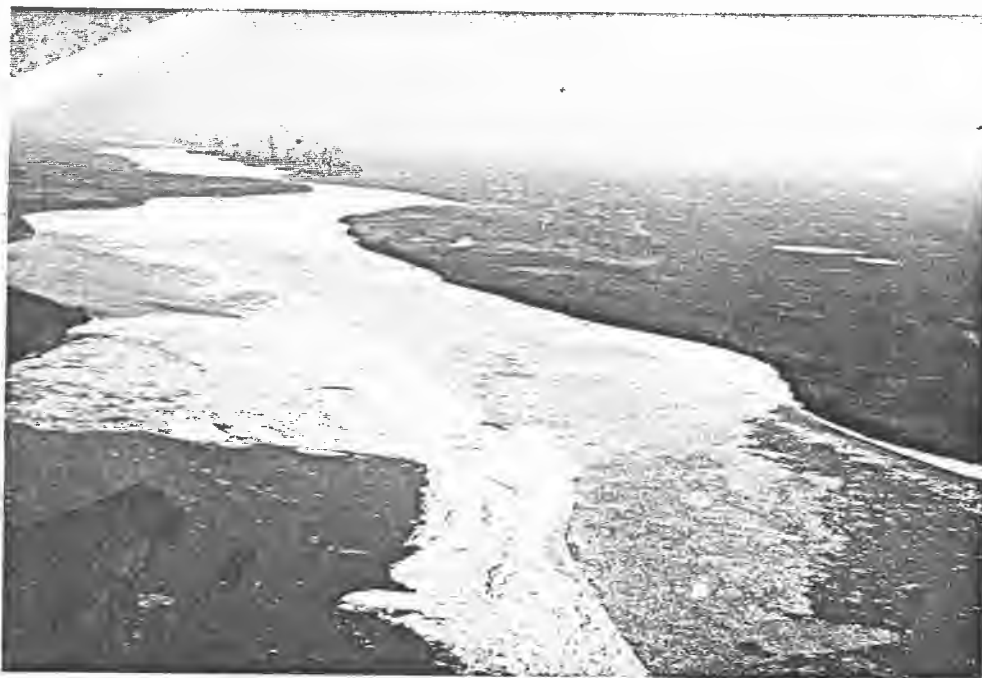
Photograph 10: MACKENZIE RIVER BELOW FORT SIMPSON, MAY 4, 06:41. Ice temporarily jammed at the large bend (background) downstream of Fort Simpson. Note the difference in ice colour between the moving ice (dark) and the relatively stationary ice (white) along the margins.

May 04: Mackenzie River water levels temporarily decreased during the night, but by the morning of May 4 the stage was again rising. Although the river opposite Fort Simpson was only partly ice covered (brash ice accumulation), a jam had formed downstream near the bend at MKP 355 (Photo. 10; Fig. 11). At 11:15 the Mackenzie River breakup water levels peaked at 118.89 m. At a discharge of 6300 m<sup>3</sup>, over 3.9 m is attributable to backwater.
