LIARD AND MACKENZIE RIVER ICE BREAK-UP,
FORT SIMPSON REGION, N.W.T., 1982

J.C. Anderson

Northern Hydrology Section
Surface Water Division
National Hydrology Research Institute
Environment Canada
Ottawa, Ontario
K1A 0E7

September 1982

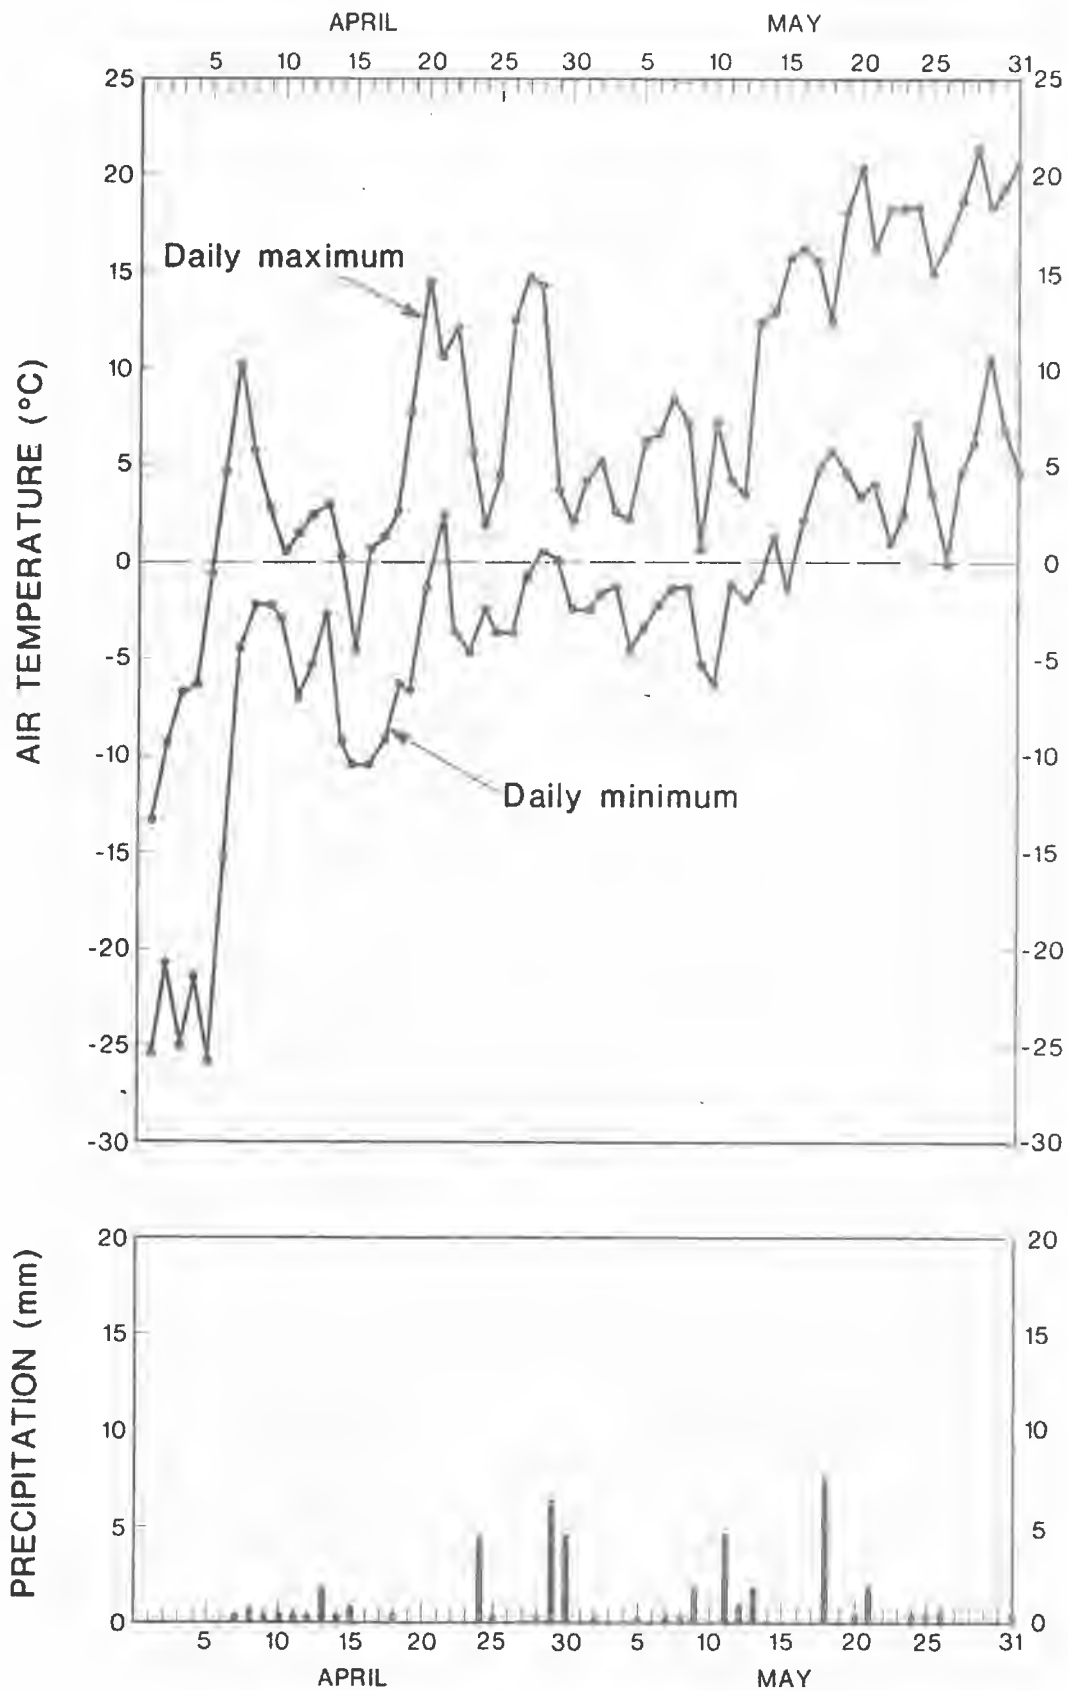
FIGURE 4. Air temperature and precipitation data, Fort Simpson airport, N.W.T., April 1 - May 31, 1982.

At Fort Simpson, daily maximum temperatures rose above 0°C on April 6 and remained positive with the exception of April 15 (Figure 4). However the maxima from April 29 to May 12 were less than 9°C, and daily minima were primarily negative until May 17. Fort Simpson had only 70 and 86% of its normal sunshine in April and May respectively, and precipitation was not excessive. Thus atmospheric conditions did not favour rapid deterioration of the ice cover prior to break-up in the Simpson region.

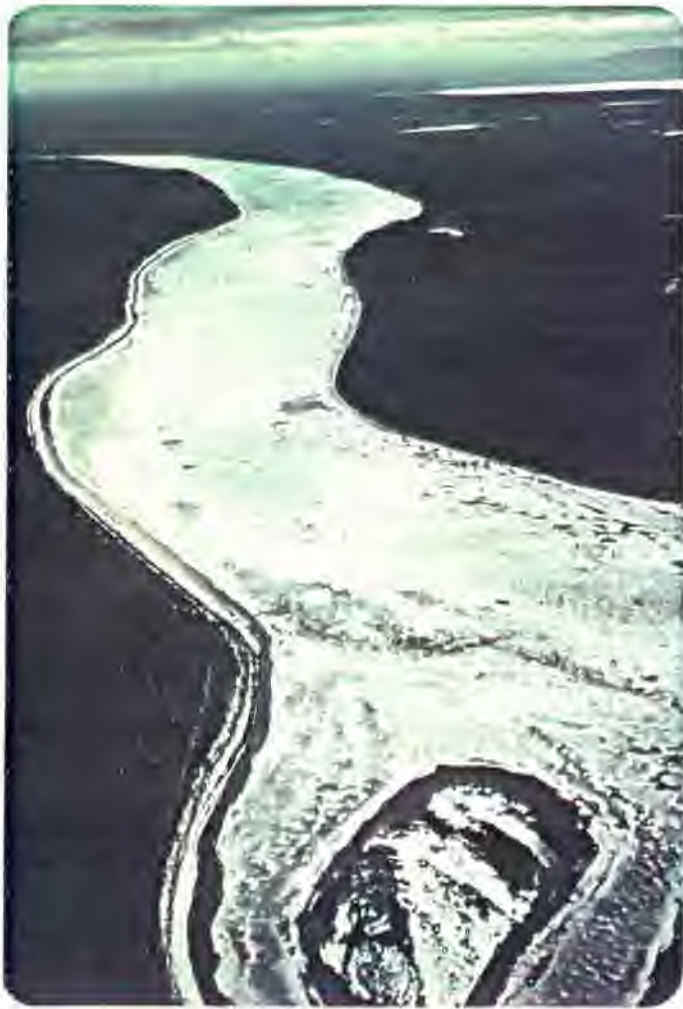
PHOTOGRAPH 1. Liard River viewed upstream from LKP 21, May 7, 1982, 1540 MST, showing pre-break-up ice conditions. Note the deteriorating but continuous ice cover, shore leads, and bottomfast ice along right bank.

2. May 7, 1540-1650 MST: (Figure 5). The ice cover was continuous with shore leads (e.g. Photograph 1) with the following exceptions:

Liard ice appeared weaker than Mackenzie ice, overall (compare Photographs 4 and 1).

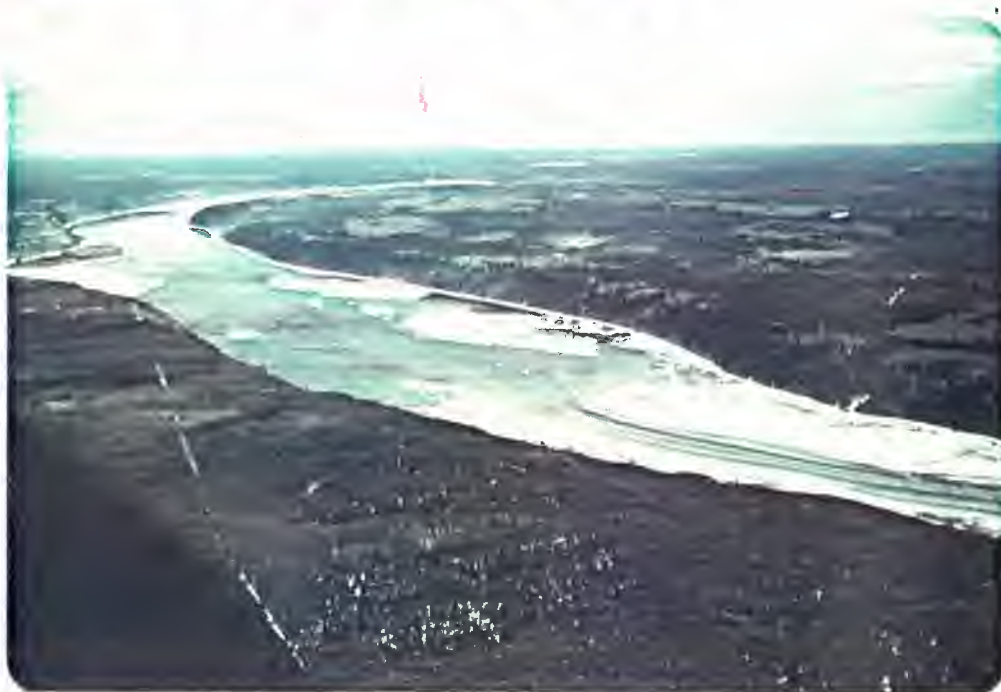
PHOTOGRAPH 2. Liard River viewed downstream, showing open water from LKP 77 to LKP 67, May 7, 1982, 1600 MST. Note the contrast in ice cover upstream of the open water, with the dark ice marking the high velocity portion of the channel.

- (a) LKP 79 (Liard kilometre-post 79): Poplar River open and breaking into Liard;
- (b) LKP 77 to 67 (Photograph 2): open water above rapids at "Beaver Dam" (LKP 59);
- (c) Beaver Dam to LKP 53: a few small open water areas;
- (d) MKP 302; MKP 356, 357: small open water areas;
- (e) MKP 318 to 320: open water at Green Island rapids, with broken ice below (Photograph 3).

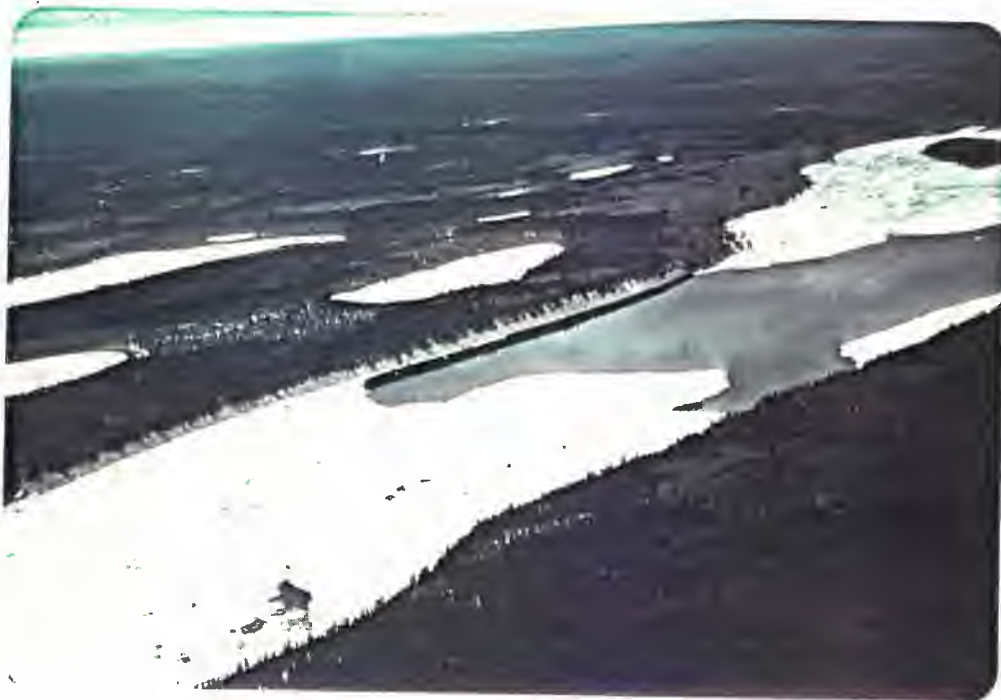
PHOTOGRAPH 3. Mackenzie River, MKP 324 to MKP 317, view northeast, showing open water at Green Island rapids, May 7, 1982, 1630 MST.

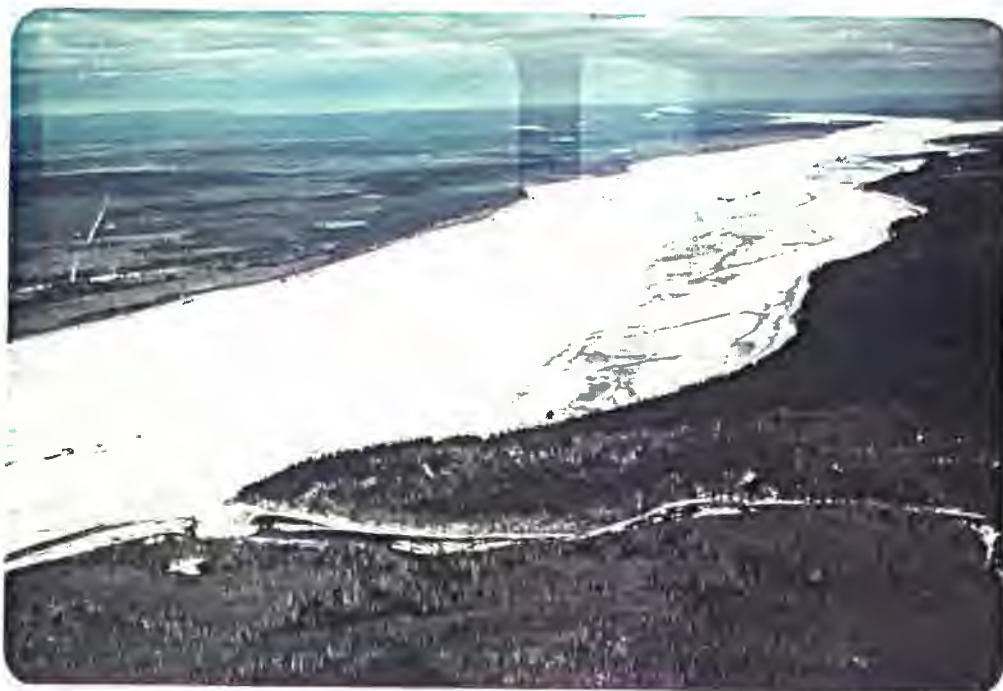
PHOTOGRAPH 4. Mackenzie River, viewed upstream from Martin River through Liard River confluence, May 7, 1982, 1635 MST. Note shore leads around shoals and islands downstream of Fort Simpson island.

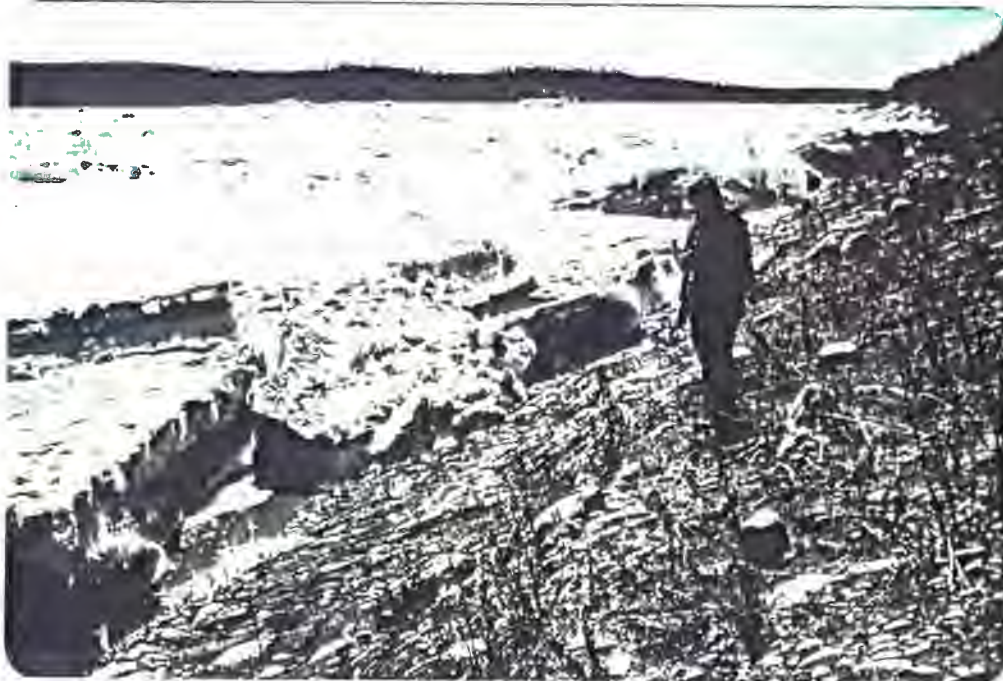
PHOTOGRAPH 6. Ice jam at Liard ferry crossing viewed upstream from left bank at the crossing, May 9, 1982, 1320 MST. Note ice shove on both shores.

4. May 9, 1500-1615 MST: (Figure 6). The Liard was broken downstream to the ferry crossing where a jam had formed by noon (Photographs 5, 6). At the ferry crossing, discharge was evident along

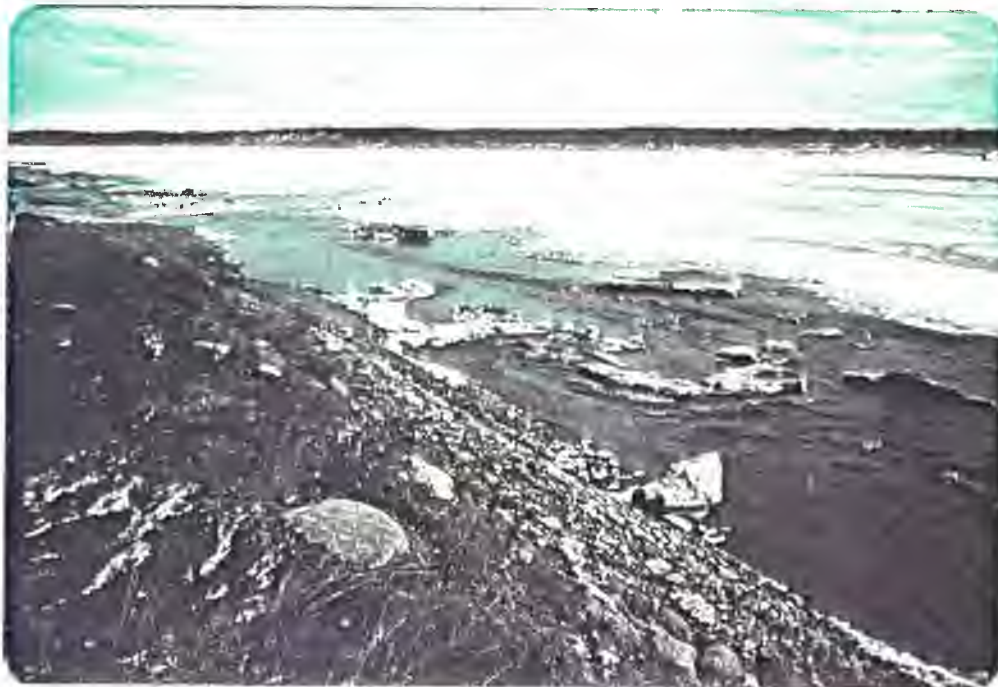
PHOTOGRAPH 7. Liard ferry crossing viewed downstream from left bank during ice jam, May 9, 1982, 1245 MST. Note discharge along bank and overflow atop ice at right.

both shores and atop the ice cover near midstream (Photograph 7). Excluding a couple of small openings, there was solid pack ice from the ferry crossing upstream to near LKP 40, and floe sizes decreased upstream. More open water was appearing on the Liard below the ferry crossing, but there was little change on the Mackenzie.

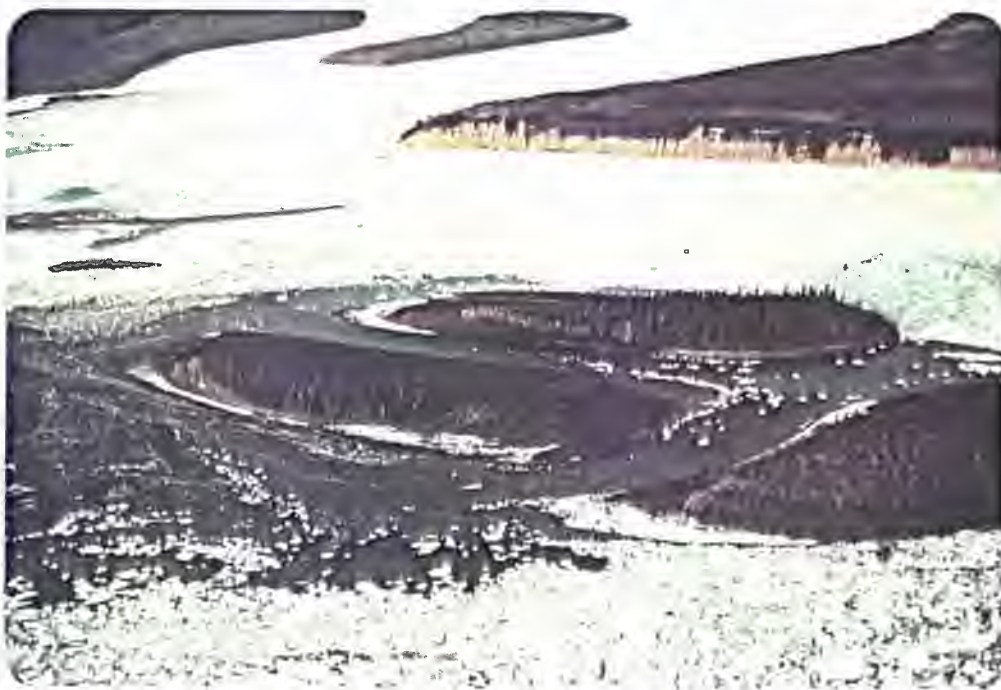
PHOTOGRAPH 8. Liard - Mackenzie River confluence showing Liard ice thrust into Mackenzie River, May 9, 1982, 2101 MST. The Liard flows from right to left, with Truesdell Island in the foreground. Note intact ice on Mackenzie River around Martin Island, at top of photo.

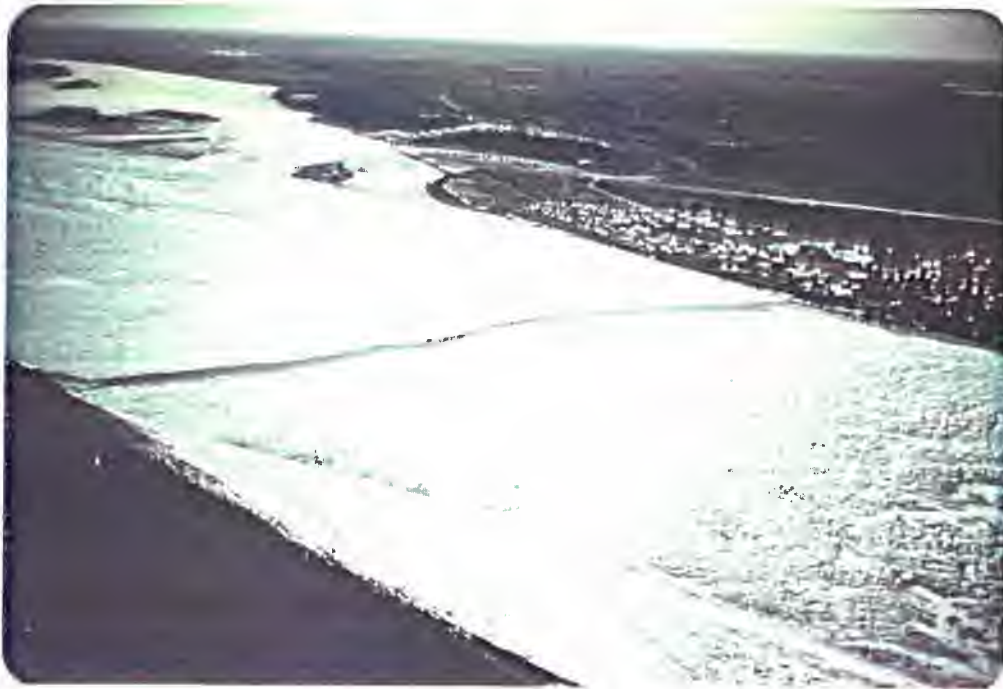
PHOTOGRAPH 9. Liard ice thrust into Mackenzie River, viewed southeast from right bank of Mackenzie, May 9, 1982, 2116 MST. Note transverse lead in Mackenzie ice at Fort Simpson.

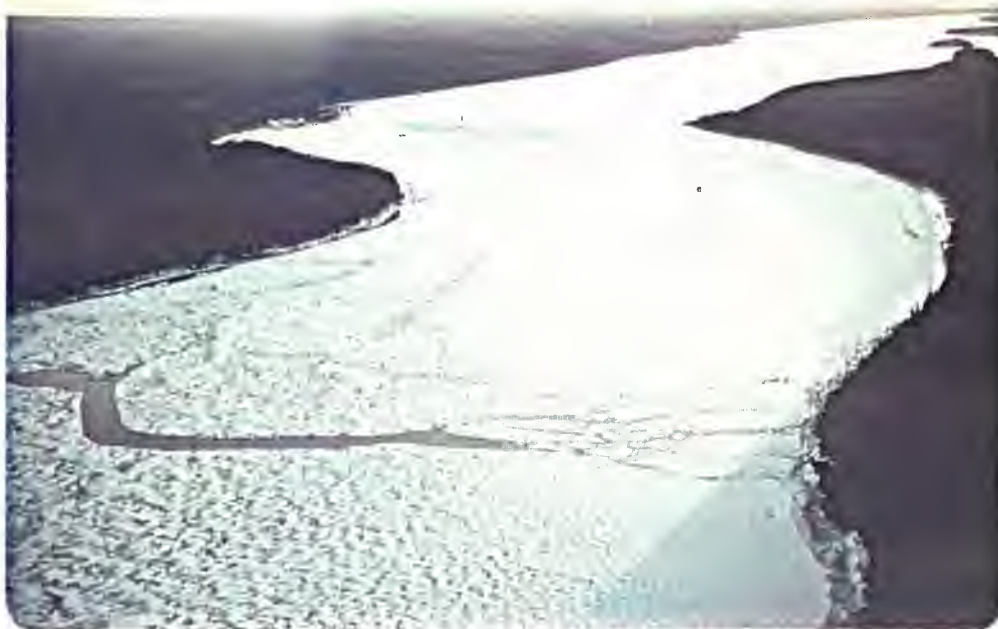
PHOTOGRAPH 10. Mackenzie River viewed downstream from MKP 355, showing transverse cracks and leads at MKP 355 and MKP 357, May 9, 1982, 2109 MST.

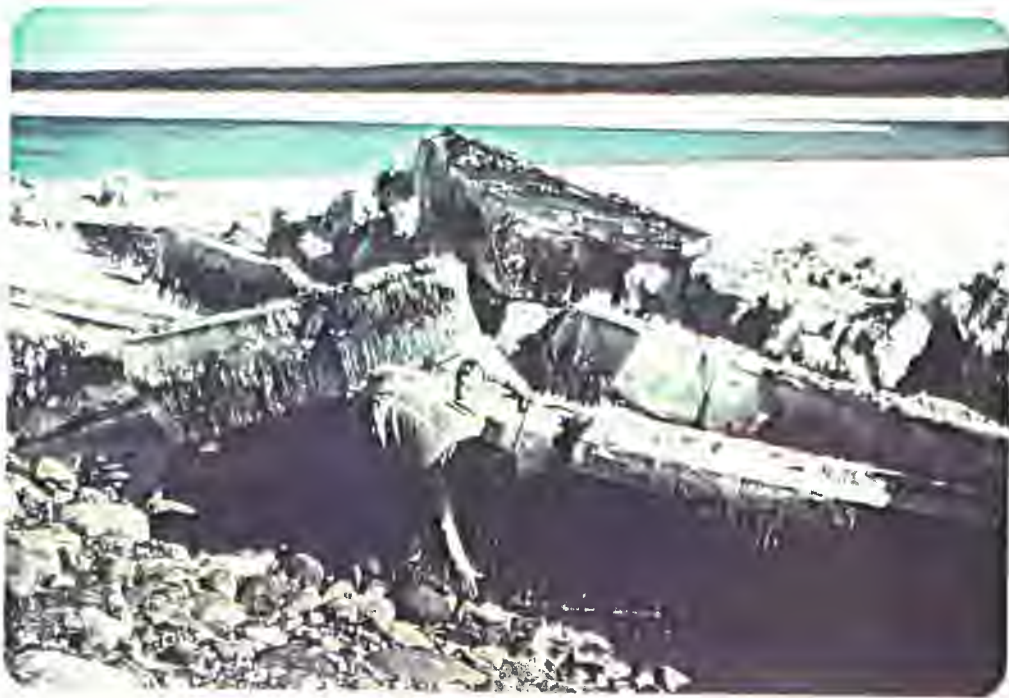
PHOTOGRAPH 11. Initial ice thrust, left bank Mackenzie River near Water Survey of Canada gauge, Fort Simpson, May 10, 1982, 0905 MST. Note ice thickness and structure, and transverse lead in background.

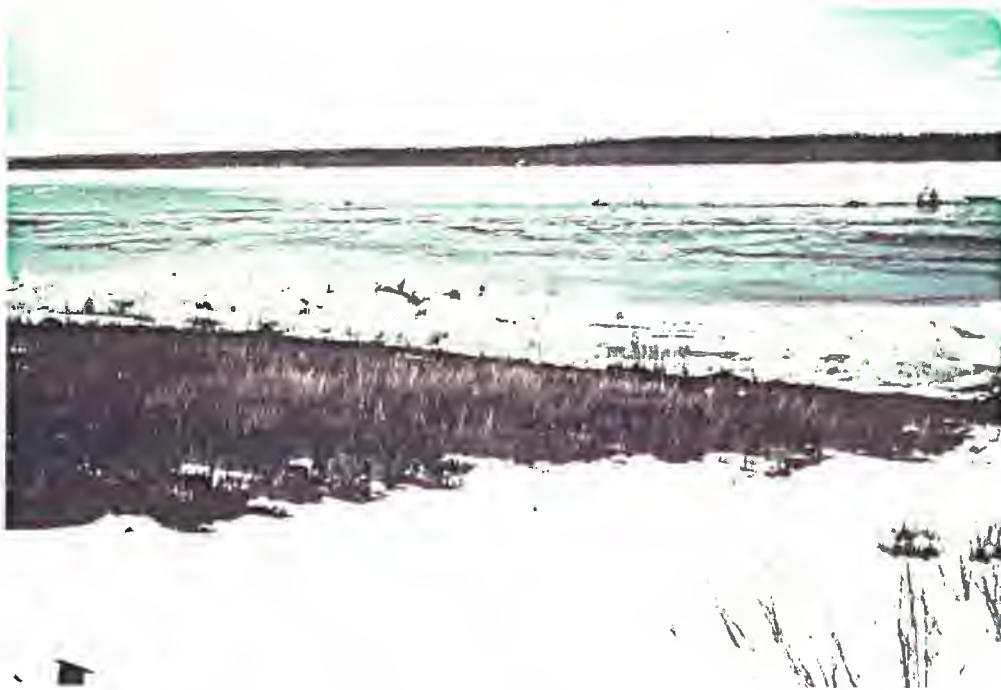
PHOTOGRAPH 15. Mackenzie ice thrust on shoal at downstream end Fort Simpson island, viewed from the island, May 10, 1982, 1557 MST. Note discharge along shore.

Aerial reconnaissance between 1150 and 1305 h revealed an ice jam developing at the downstream end of Fort Simpson island (Photographs 13, 14, 15). Mackenzie ice was grounding on the shoals which run obliquely downstream from the end of the island, and discharge was observed alongside the island at that point. Downstream of this, a large floe was unable to pass through a channel narrowing near MKP 354, and ice thrust was occurring on the right bank at MKP 354 and the left bank at MKP 352-353.

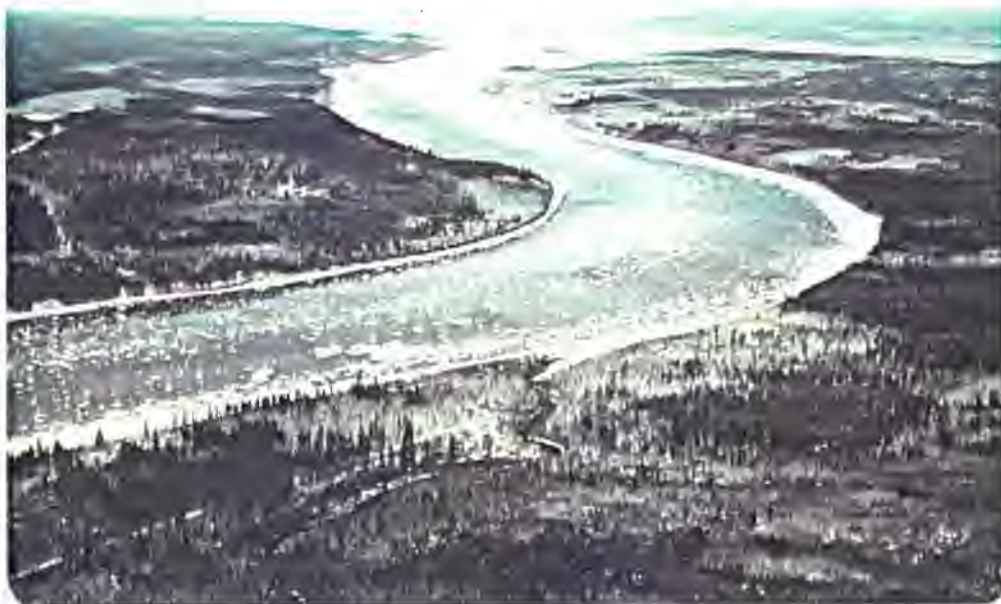
PHOTOGRAPH 16. Lower Liard River viewed toward Mackenzie River, with leading edge of open water near LKP 7, May 10, 1982, 1259 MST.

Upstream, backwater had cracked the Mackenzie ice cover for two or three kilometres above Martin Island. The leading edge of open water on the Liard was near LKP 7 (Photograph 16), with pack ice below this to the jam at MKP 340. Backwater from this jam caused a rise in water level of approximately four metres, and the water elevation at Fort Simpson peaked at approximately 121.7 m a.s.l.

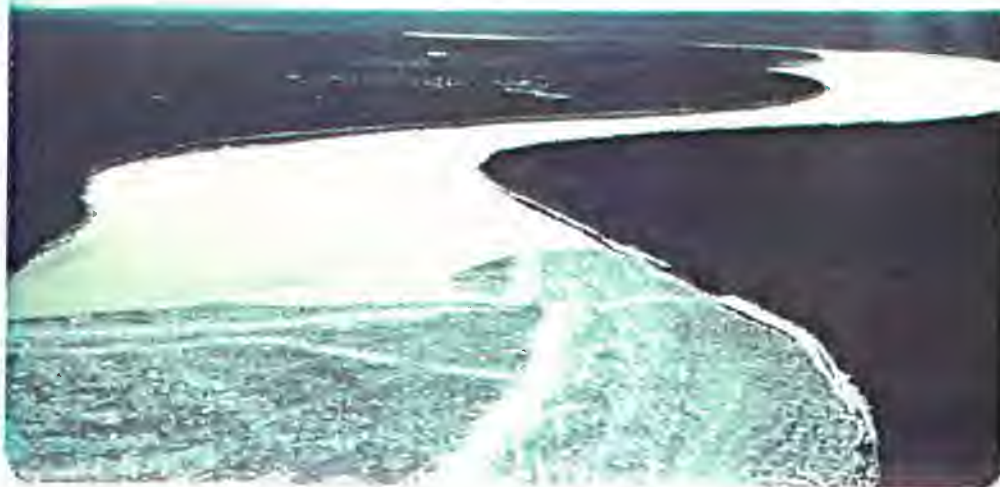
PHOTOGRAPH 21. Large floe jammed at MKP 297, with ice thrust on right bank; view downstream, May 15, 1982, 1847 MST.

At MKP 297, a large floe was caught in a narrow river bend (Photograph 21) producing a jam with ice floes upstream to MKP 280. From there to Jean Marie River (MKP 270) the river was primarily open, while above MKP 270 the ice was cracked but stationary as far as one could see.

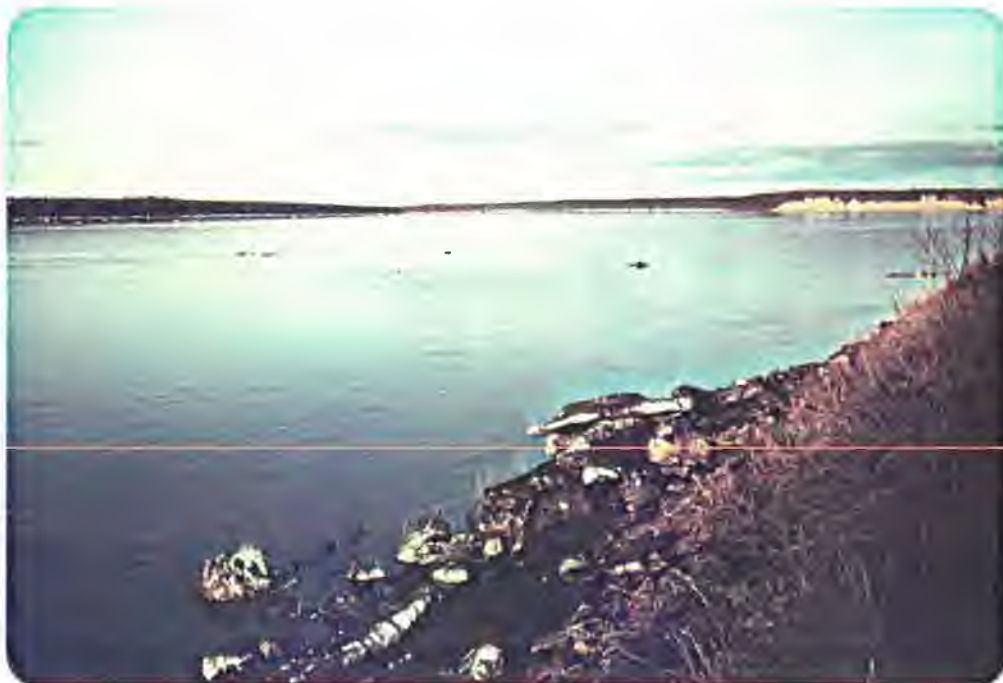
PHOTOGRAPH 23. Mackenzie River at Fort Simpson looking upstream toward Gros Cap, May 21, 1982, 2105 MST. Note minimal ice run and depletion of stranded ice along shore.

17. May 21: Water levels continued to rise, but the ice run at Fort Simpson was minimal since much of the stranded ice was now gone (Photograph 23).
