Flight Comment

ISSUE 3, 2022

**SPECIAL SERIES:
NECK AND BACK PAIN**

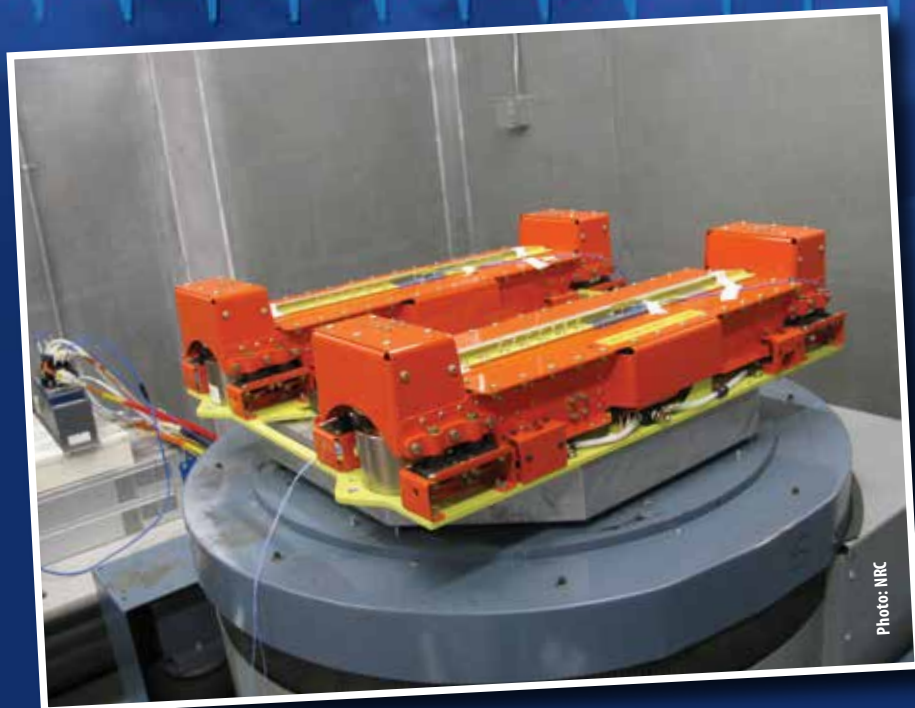
"Our human-rated shaker table is a very useful tool for studying the effects of vibration on occupants. Basically, the shaker table is a platform that can vibrate precisely in the primary direction of vibration, which is up and down, to simulate what you feel in the helicopter" says Dr. Viresh Wickramasinghe, Team Leader of NRC-FRL. "Because we have precise measurements of vibration across various RCAF aircraft, with a click of a button, we can make the occupant feel like they are

sitting in the Chinook on the ramp, or flying at maximum speed, as well as feel like they are sitting in the side-facing seat of a Griffon during a transition to the hover. We can then instrument the occupant with various sensors including accelerometers to measure vibration transmission through the body, electromyography (EMG) to measure muscle activity on the back and neck, pressure plates to measure “hot-spots” on the thigh and buttocks, and motion tracking to track dynamic postures. It’s a wonderful engineering tool.”

verified in NRC’s shaker table to significantly reduce whole body vibration of seated occupants. The seat cushions were recently submitted to an Initial Operational Assessment (IOA) by the Land Aviation Test and Evaluation Forces (LATEF) to assess how the seats could integrate with existing Tactical Aviation and Search and Rescue/Combat Support Squadron (SAR/CSS) missions and aircraft configurations and provide improved comfort to non-pilot aircrew. The results of the assessment showed that the seat cushions were comfortable, however, several deficiencies were identified related to material selection, craftsmanship and compatibility with other mission kits that are being assessed by DTAES and NRC-FRL. The intent is to address the deficiencies through design changes and resubmit the article to IOA.

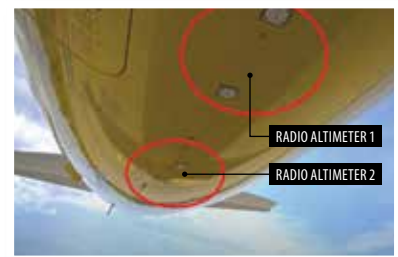
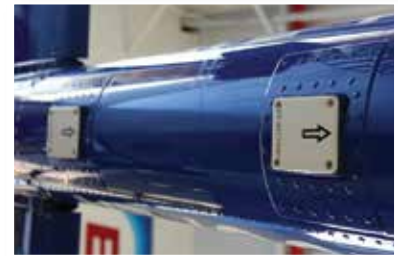
Picture 1 and 2. Location of a RADALT on an airframe: on the top picture it is located near the rear of the tail of a large jet, and on the bottom picture it is located on the underside of the tail boom of a helicopter. (Picture credit: Quora for the Jet, Aero Access for the helicopter)
