**Cruise Report:
Geoforce DTS
C.C.G.S. Vector
PGC2021-004**

**Submitted by:
Tom Fralic
Geoforce Group Limited
60 Thornhill Drive – Unit 10
Dartmouth, Nova Scotia
B3B 1S1**

**Date:
Sept 14, 2021**

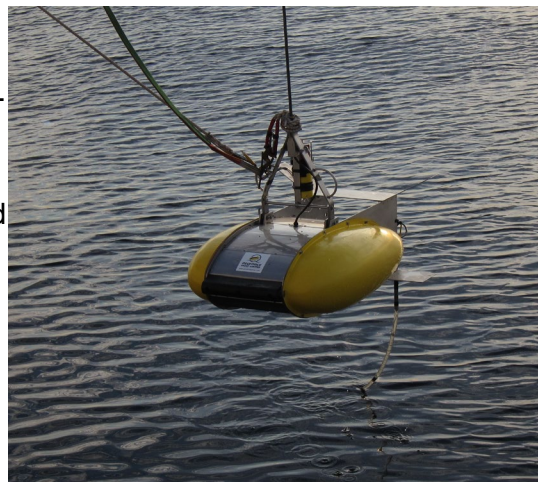
Figure 1: Geoforce DTS

The DTS system is a deep towed, high resolution, sub-bottom profiling system complete with two acoustic sources (Boomer/Sparker), high-voltage Energy Storage Unit (ESU), Digital Acquisition Unit (DAU), and two receiving hydrophones housed in an underwater tow fish. This system is complimented with a custom data acquisition software known as Geoforce Cerebella and a purpose-built Topside Control Unit (TCU) for both receiving DTS telemetry and providing low voltage and high voltage to the DTS.

DTS SN3004 system was primarily used on this mission. The maximum transmit power output of this system is 1000 Joules with an ED10F/C Boomer and a twenty-tip mini Sparker source. For this mission, the internal single element GF16 hydrophone was recorded as “Internal Channel”. The externally towed Geoforce GF15/10P streamer hydrophone was recorded as “External Channel” (overall streamer length 15 feet, single channel with a combined 10-foot active section, total of 10 AQ-16 elements with an effective spacing of 12 inches).

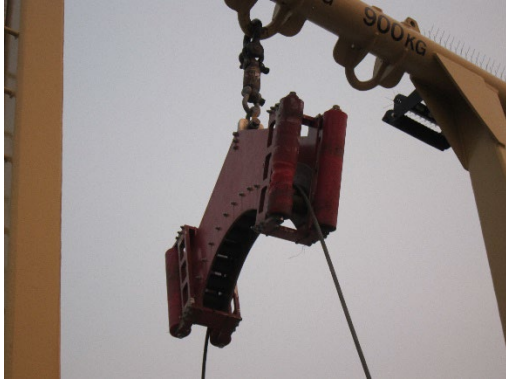
Figure 4 - Roller Block

The deck equipment consists of an oceanographic winch, which includes a Focal multi-way slip ring and a 400-meter, fourteen-conductor, armored tow cable. The tow cable is handled by a 36-inch diameter roller cluster rigged on the center position of the aft A frame.

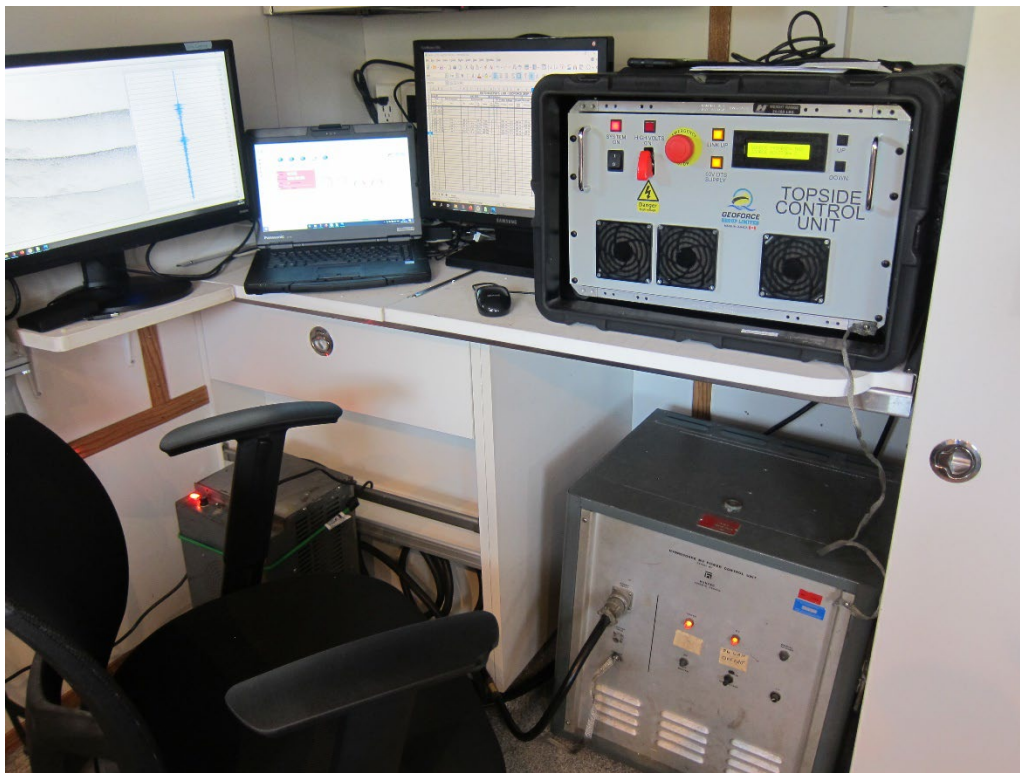
Figure 6 - DTS Topside equipment in operation

The lab instrumentation consists of a Windows 10 PC running Geoforce Cerebella logging software, a Geoforce TCU, a Hunttec Mk III PCU, and a Hunttec low pass filter unit.

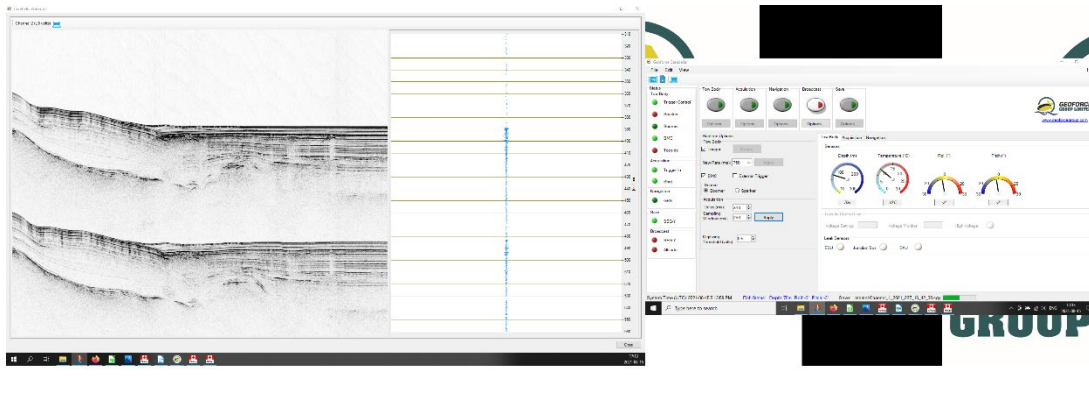
Figure 7 - Geoforce Cerebella software in operation

A Geoforce Cerebella acquisition system was used as the digital recording device. This software is designed specifically to communicate with the Geoforce DTS and was a large portion of the BCIP contract. This software incorporates a waterfall view which can be viewed on a separate screen with a primary purpose of providing data quality assurance to the operator, but in certain scenarios can also be used to interpret on the fly. The software also includes displays showing the DTS depth, attitude (pitch and roll), ambient water temperature, leak sensor indicators, trigger options, and TCU status.

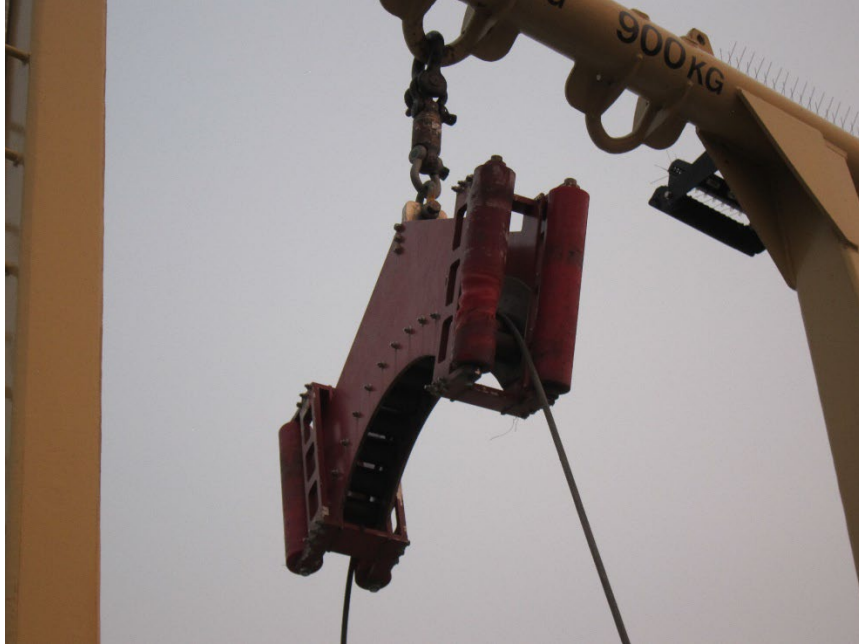
Figure 9 - Roller Block in operation

- The Roller block suffered damage on one of the vertical rollers due to cable bouncing during cable payout
