**DEVELOPMENT & TESTING
OF FLOOR DRAIN WITH A
VALVE TO BLOCK SEWER
GAS FOR RESIDENTIAL
APPLICATIONS**

by: Bert Phillips, UNIES Ltd
for: Dranjer Corporation

June 1997

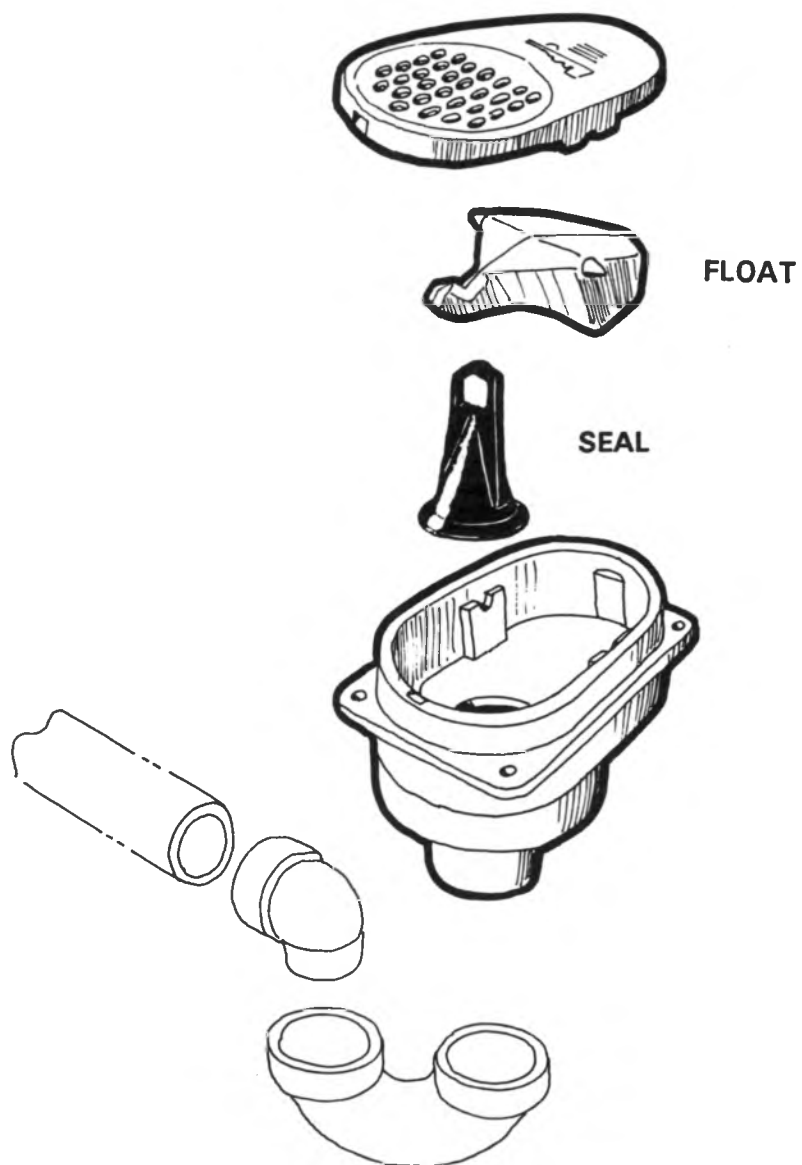
FIGURE 1

The Dranjer model XN-3 shown in Figure 1 has a float/counterbalance, designed to ensure a smooth flow of water through the device when the drain is in active use. As water fills the catch basin the float forces the valve to open, releasing air pressure that has built up under the valve (allowing it to glub). The float/counterbalance and valve seal assembly are easily removed to give access to the trap. The all plastic construction avoids problems with corrosion.

NOTE: WHEN ASSEMBLED, THE SEAL SEATS THROUGH THE UNDERSIDE OF THE HOUSING - IN THE NORMAL POSITION FOR A BACKWATER VALVE.

THE FLOAT ACTS TO ENSURE THE SEAL OPENS PROPERLY FOR A SMOOTH FLOW OF WATER.

THE FLOAT ALSO ACTS AS A COUNTERWEIGHT TO KEEP THE VALVE CLOSED WHEN THE DRAIN IS NOT IN USE - PREVENTING SEWER GASSES FROM ENTERING THE HOME IN THE EVENT OF A DRY TRAP. THIS "SEWER GAS CHECK VALVE" FEATURE IS PROMOTED AS AN ALTERNATIVE TO A TRAP PRIMER. THE SEAL ACTS DIRECTLY TO KEEP OUT SEWER GASSES AND INDIRECTLY BY PREVENTING EVAPORATION FROM THE RESIDENTIAL SIDE OF THE TRAP.

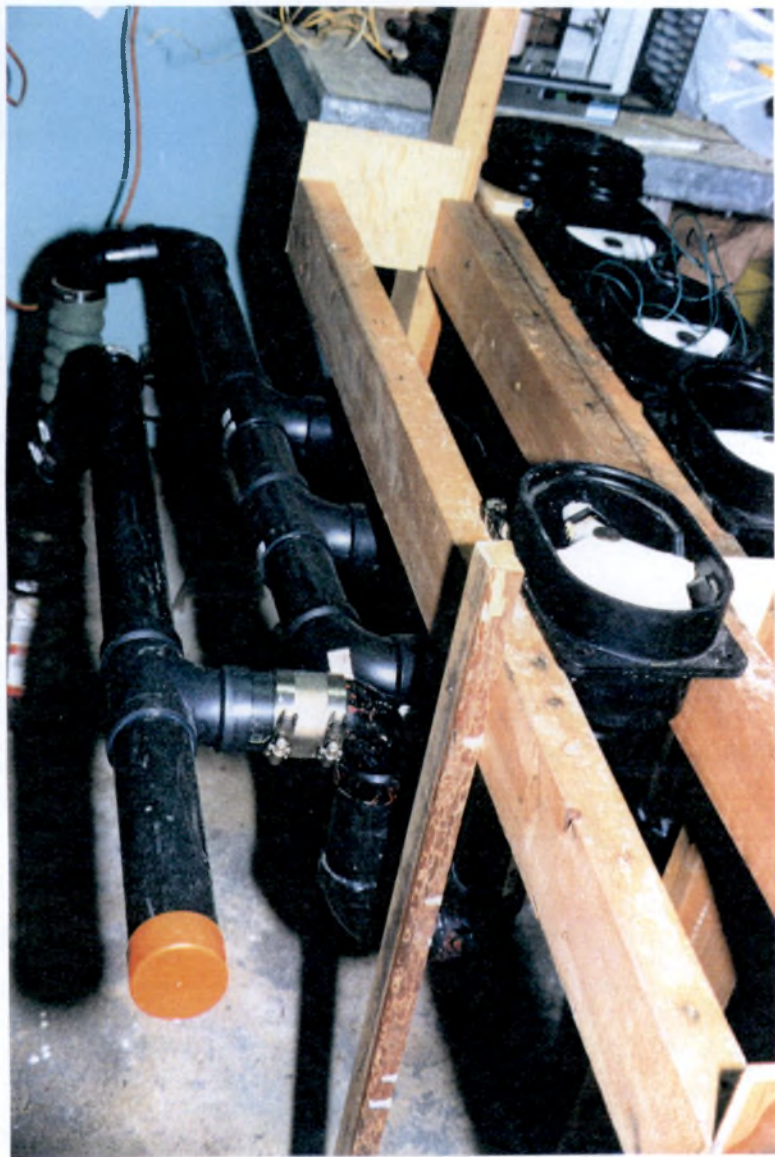
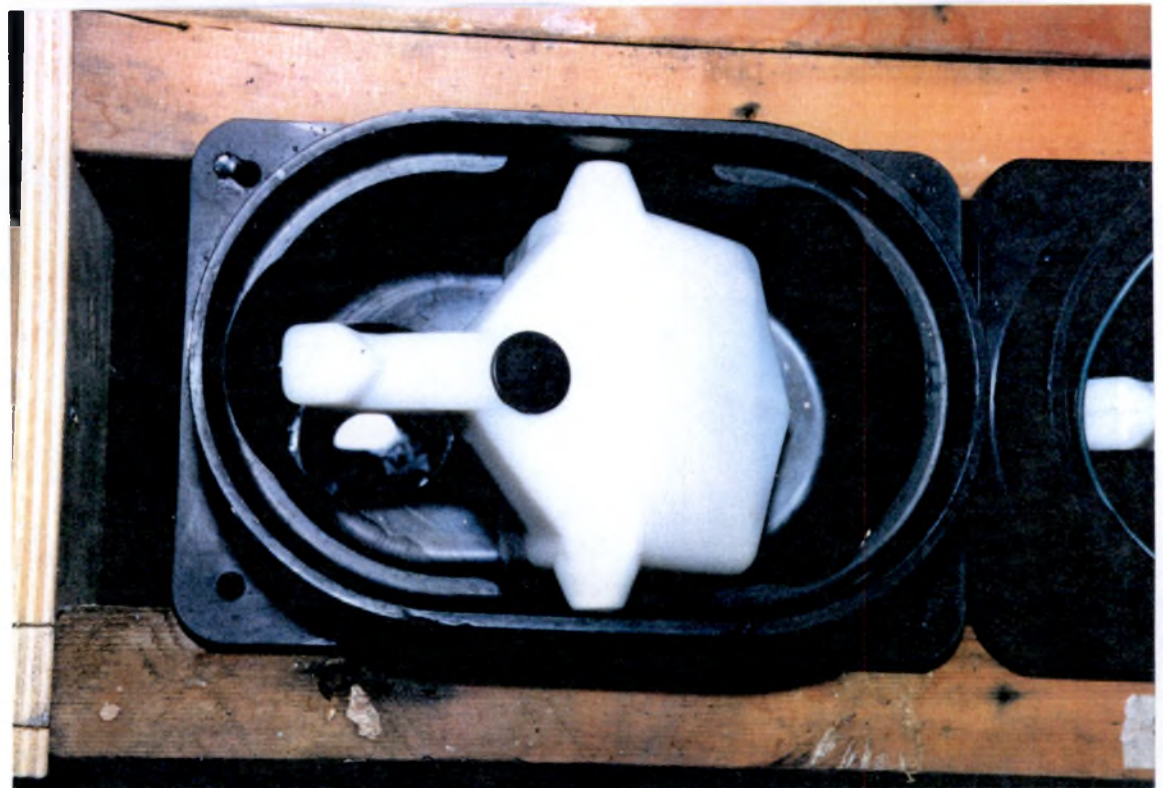
Figure 2

Above - Test rig set-up

Above right - Transparent drains
with level gauges

Right - Dranjer with valve removed

On July 7, 1996 four Dranjer floor drains with deep traps were connected to a sealed manifold which was attached to an extension on the sewer clean-out of a house connected to the municipal sewer system. Photos of this setup are presented in Figures 2, 3 and 4 (the colour photos from an earlier report). Each Dranjer floor drain was set up to represent a different operating condition:

Each Dranjer was connected to a wet trap with a transparent tailpiece. A scale with the initial water level marked on it was secured to the outside of each tailpiece to allow visual inspection and measurement of water level depression. The set-up allowed each operating condition to be tested simultaneously. The downstream side of the traps were exposed to the air in the sewer lines, as would the floor drain in a normal installation. The traps were above grade and as such were warmer than an in-ground installation.

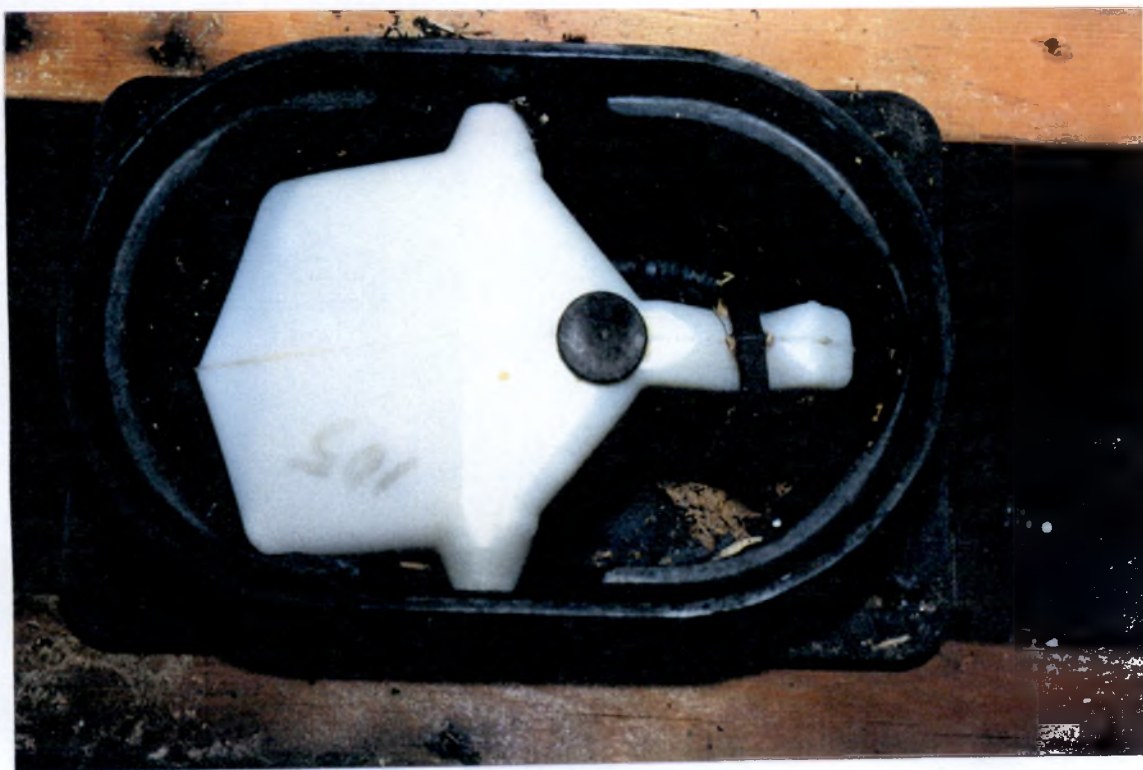
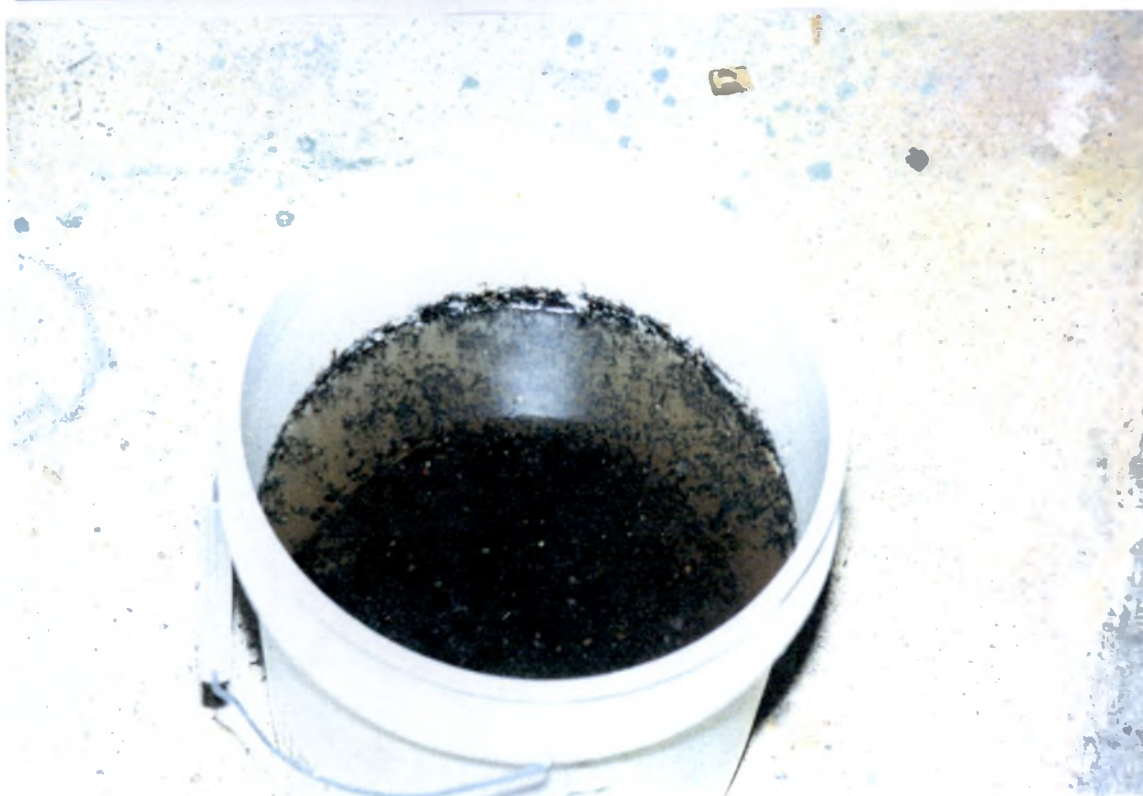
Figure 4

Above - Dranjer treated with household and workshop dirt

Below - Household and workshop dirt mixed with water which was poured into above Dranjer

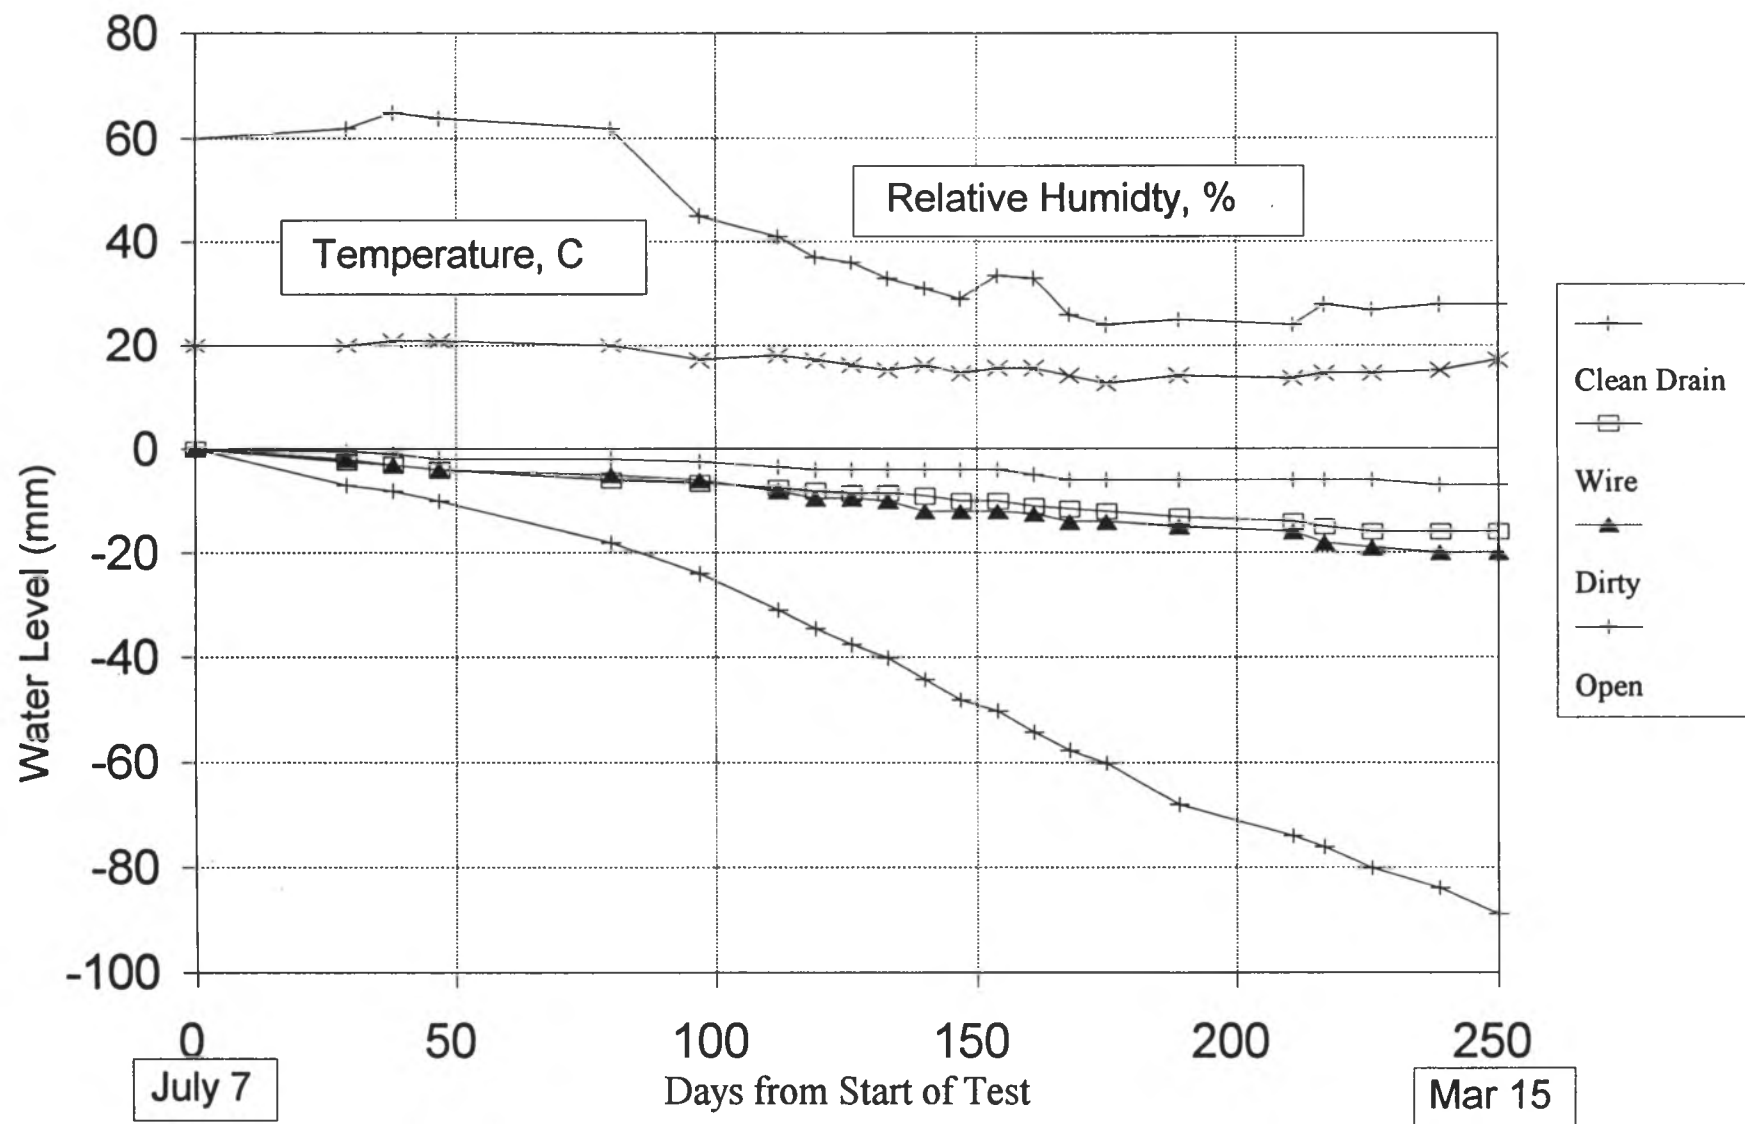
Figure 5
Data from Evaporation Rate Tests

Evaporation rate readings were taken on a regular basis between July 7, 1996 and March 17, 1997. Figure 5 (figure showing levels against time) shows depression of water levels due to evaporation in each of the drains over the test period, along with average space temperatures and humidities for those time periods. Over this period evaporation was:

- 89 mm (3.5 inches) from the open drain (i.e., control unit)
- 7 mm (0.27 inches) from the clean drain
- 16 mm (0.63 inches) from the drain with the wire
- 20 mm (0.79 inches) from the dirty drain

The results show that evaporation from the conventional (open) drain is four to five times that from those with dirt or a wire obstructing the seal and 12 times that of a clean, properly functioning unit. The properly functioning, clean trap had the lowest rate of evaporation. Evaporation rates increased during the winter months, with a fall in humidity levels in the basement.

Between the December 30 readings and January 6, 1997, a blockage in the plumbing stack caused water levels in the test drains to drop 50 mm below the initial (i.e., July 7, 1996) water level. It is the writer's opinion that a combination of heavy snowfalls and extremely cold temperatures in December and early January caused the plumbing vent to freeze over. After that, a major water flow in the house's sanitary drainage system (e.g., toilet flush) caused 100 mm of water column negative pressure in the drains, which resulted in the observed drop in water levels.
