**Field Investigation Survey of  
Air Tightness, Air Movement and  
Indoor Air Quality in  
B.C. High-Rise  
Apartment Buildings**

**FINAL REPORT**

Bob Landell  
**AVALON MECHANICAL CONSULTANTS LTD.**  
#4-1322-A Government Street  
Victoria, B.C.  
V8W 1Y8  
(604) 384-4128

**July 15, 1991**

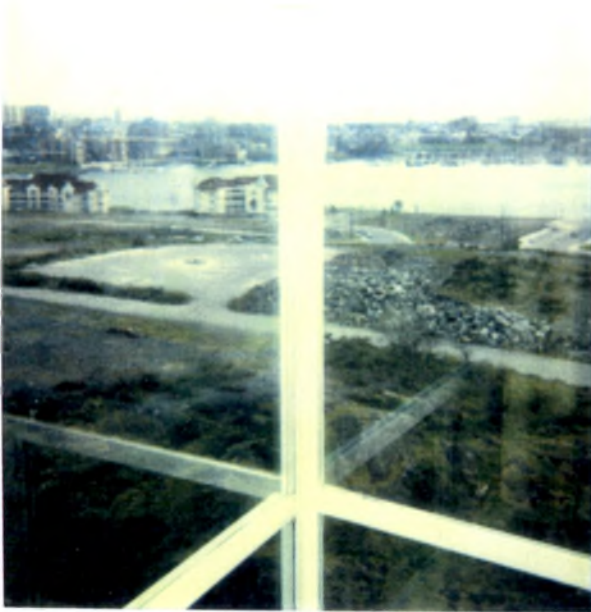
BLDG 'A' AIR & WATER  
LEAKAGE

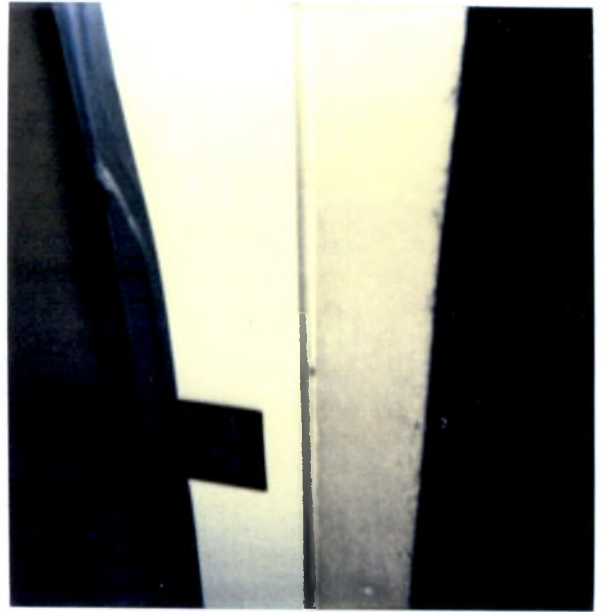
BLDG 'A' ELEVATOR  
DOOR

Excluding infiltration through the elevator shaft, the greatest source of air leakage was through the bathroom and kitchen exhaust fans. Each of these fans is ducted directly outdoors through separate ducts equipped with backdraft dampers. These dampers were obviously ineffective, since a draft could be easily felt by hand at each fan.

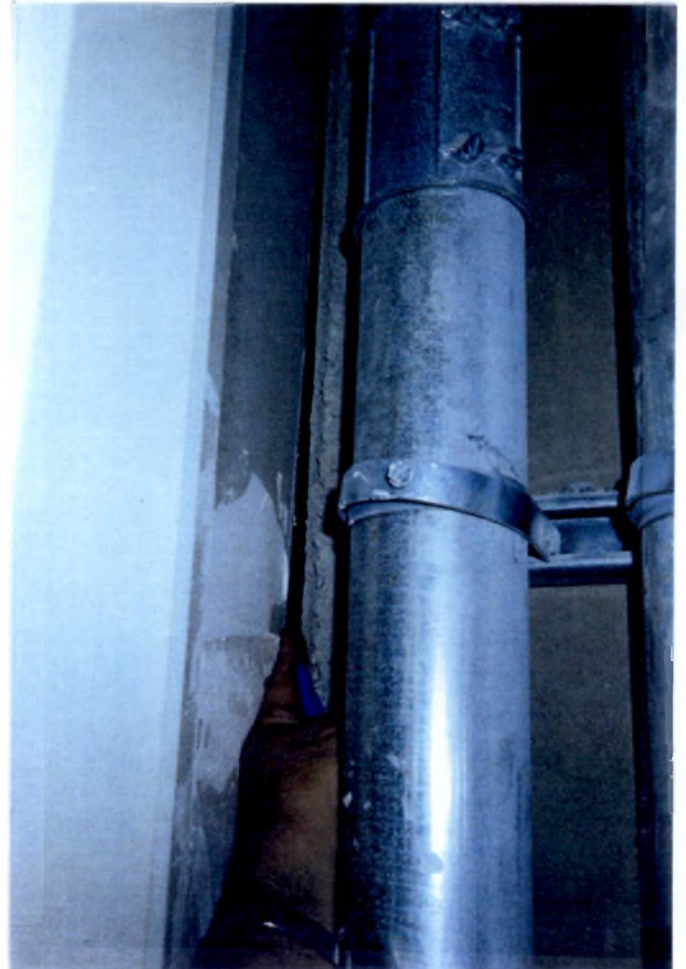
BLDG. 'B' ELECT. RM / ELEVATOR

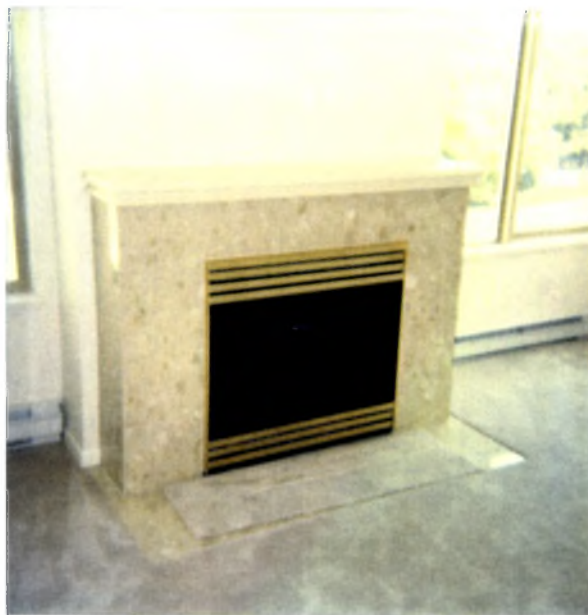
BLDG "B"  
GAS FIREPLACE

The gas fireplaces are sealed units, receiving their combustion air directly from outdoors via a co-axial vent and chimney. Very little air entered the suite through the gas fireplaces, but there was noticeable leakage at the junction of the fireplace unit and the wall, and where the gas supply pipe came in through the wall.

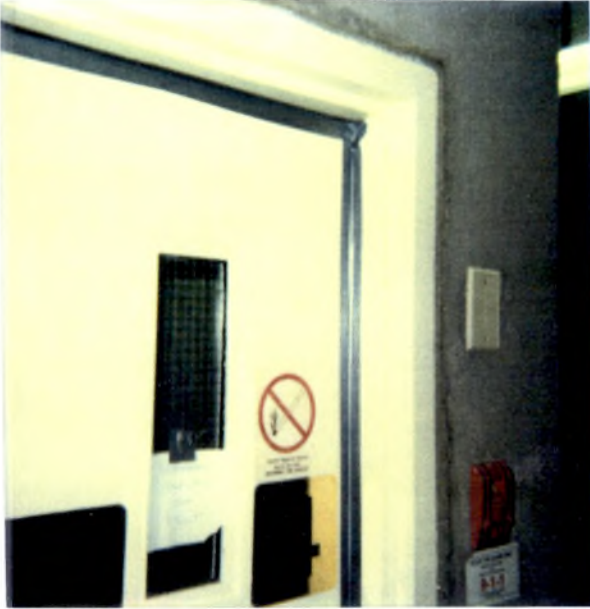
BLDG "A"  
STAIRWELL SEALING

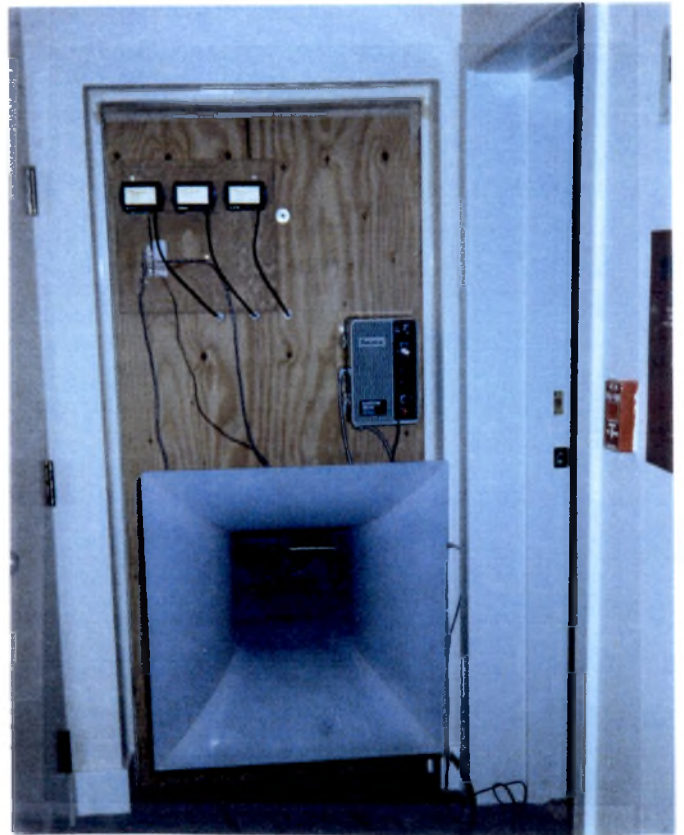
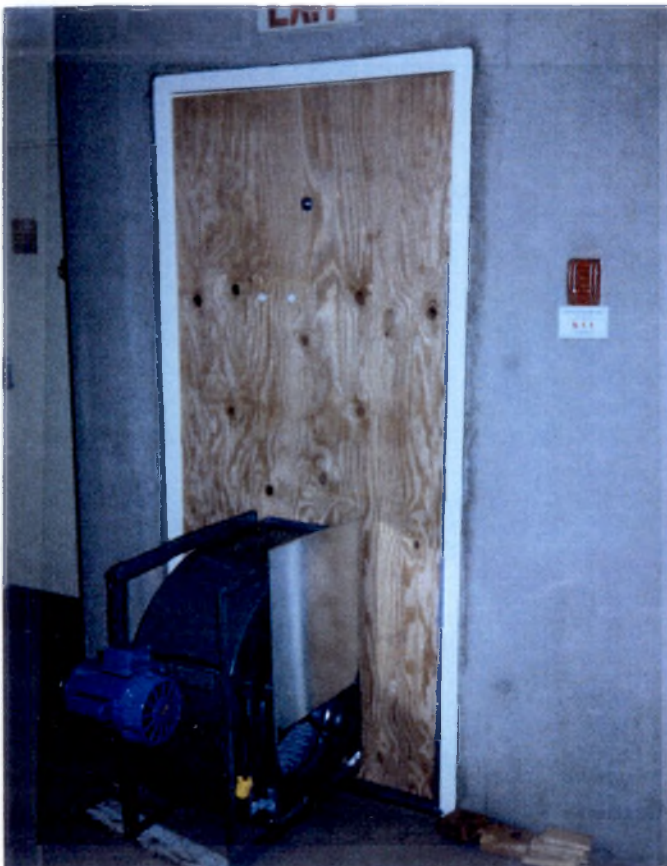
BALANCE FAN

operated from the standard 0-10 volt output signal generated by the micro-processor controller. It was decided to use this to drive the main test fan. Because they are relatively light and efficient and are readily available, it was decided to use forward-curved single inlet centrifugal fans for the main test fan and the balance fans.

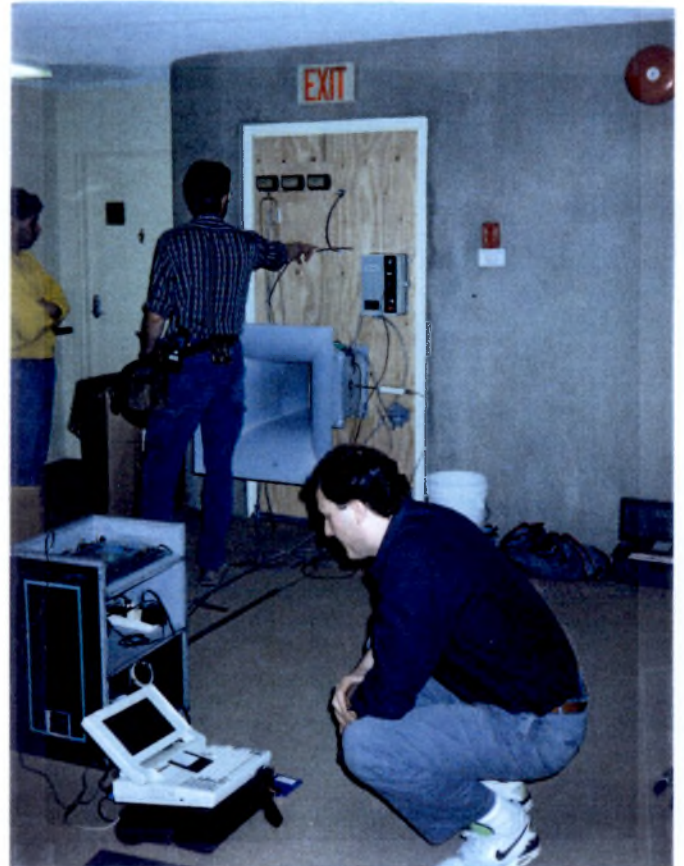
CONTROL / DATA
