**EVALUATION OF EXTERIOR DOOR ASSEMBLIES FOR
RESISTANCE TO FORCED ENTRY**

Prepared for
CANADA MORTGAGE AND HOUSING CORPORATION

by
**FORINTEK CANADA CORP.
Eastern Laboratory
800 Montreal Road
Ottawa, Canada
K1A 3Z5**

May 1982

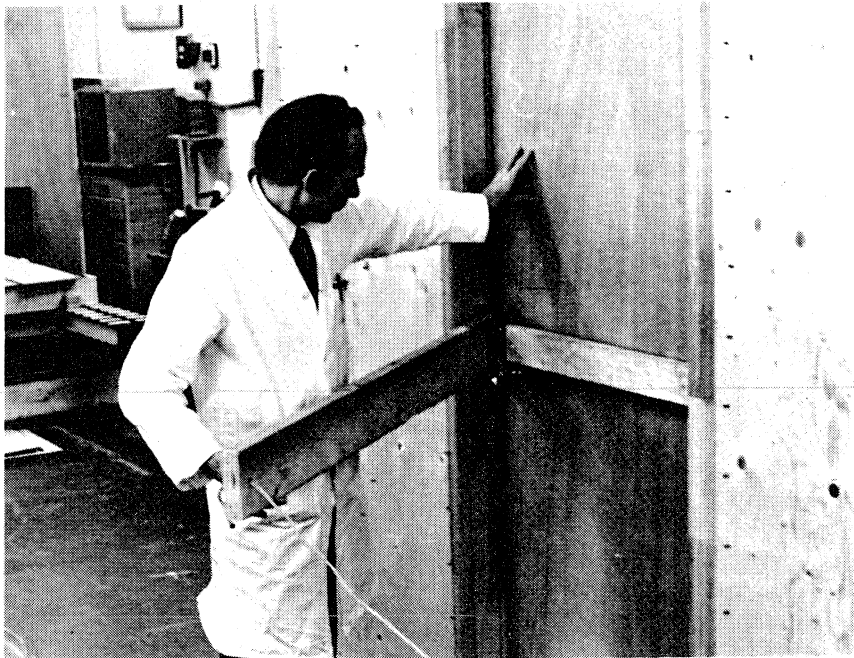
The jamb-spreading device and the test fixture are shown in

Figure 2. Apparatus for jamb/wall stiffness test.

The tests were carried out not only to determine the stiffness of the door frames, but also to determine the importance of shim location, the addition of a drop-deadbolt lock set as a secondary locking system, and the incorporation of horizontal members between studs adjacent to the door.

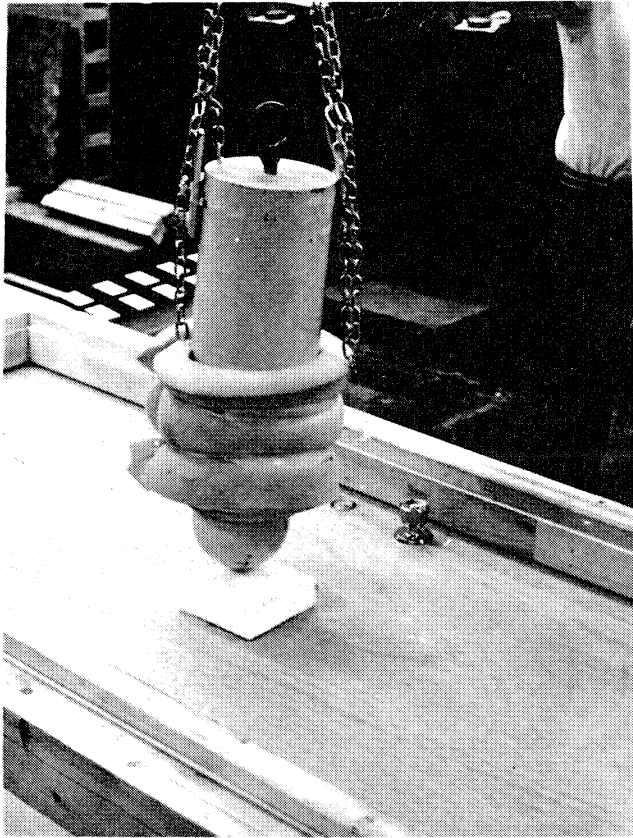
The test results in part 1 indicate that the door sample will meet the requirements of a grade 20 door when impacted in the center only (Figure 10). When the door was impacted twice at grade 30 level, the jamb split near the lock, the strike plate came off, and the door opened up. The failure was noted as a jamb failure.

Figure 10.
Test set-up.

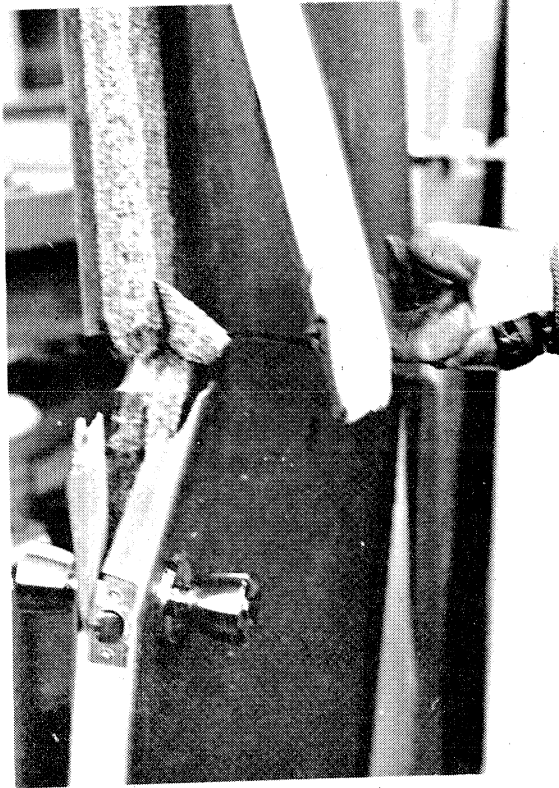
The spring-loaded latch came off the striking plate at grade 10 level on the first impact near the lock area leaving only the vertical deadbolt lock set engaged. The door finally failed on the first impact near the lock at grade 20 level. The stile was broken in half at lock height and separated from the core material (Figure 26). The deadbolt cylinder came off the door as it sheared through the particleboard core (Figure 27). Figure 28 shows the interior face of the door, following test.

Figure 26.
Damaged stile.

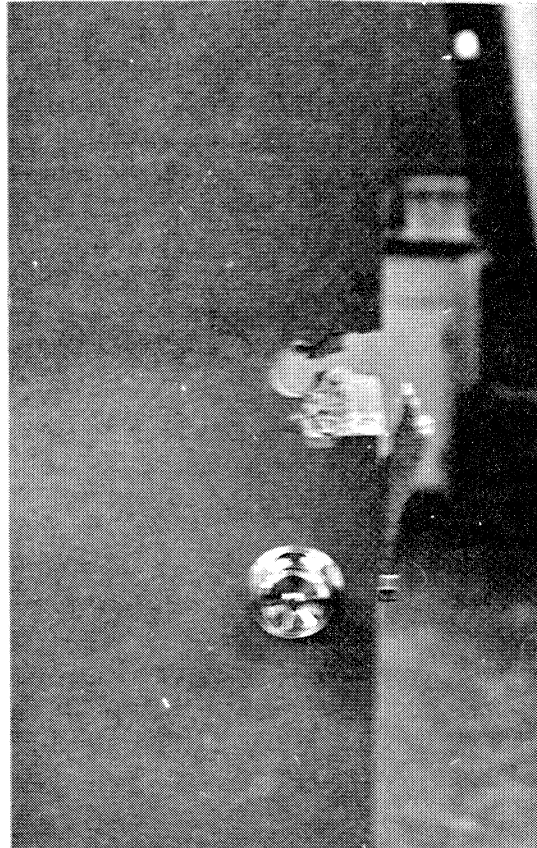
Figure 28.
Cylinder sheared through particleboard.

The two solid-core doors with a particleboard interior (IV & V) demonstrated a similar level of protection but failed when the drop-deadbolt cylinder was pulled out of the door (shearing through the particleboard) as the stile was damaged at lock height.

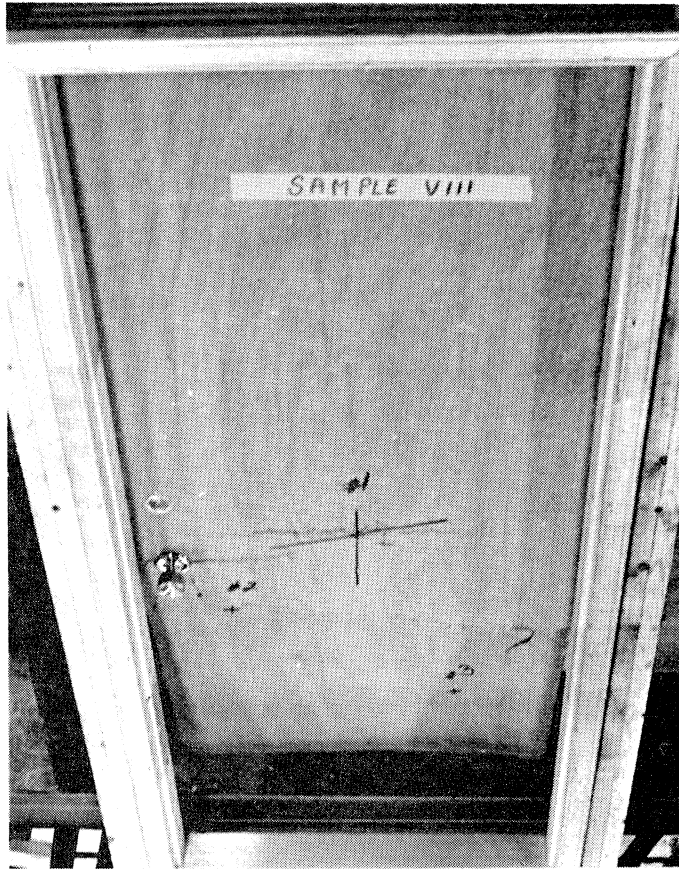
Figure 36.
Door No. VIII.

The sample tested was an insulated flush-faced plywood door 810 x 2030 x 45 mm (2'8" x 6'8" x 1 3/4"). The door framework was made of clear softwood lumber. The rails and stiles were 38 x 40 mm. This door is shown in Figure 36.

This sample met with the security requirements of a grade 10 door when impacted on all three critical areas. It also met with grade 20 requirements when tested in the centre of the door and near the lock area. However the door was badly damaged following the last series of grade 20 tests near the lower door hinge. The bottom hinge was pulled from the door on the first impact (Figure 37). Both stiles were transversely broken at lock height, literally splitting the door in half on the second impact, since the lower part of the door was left unsupported (Figure 38). Entry could then be gained through the bottom part of the door.

This sample tested met with the security requirements of a grade 10 door. It failed to meet with the grade 20 requirements by a single blow. In all, twelve impacts were needed to cause failure to the door, for a total accumulated impact force of 1200 joules (838 ft. lb).

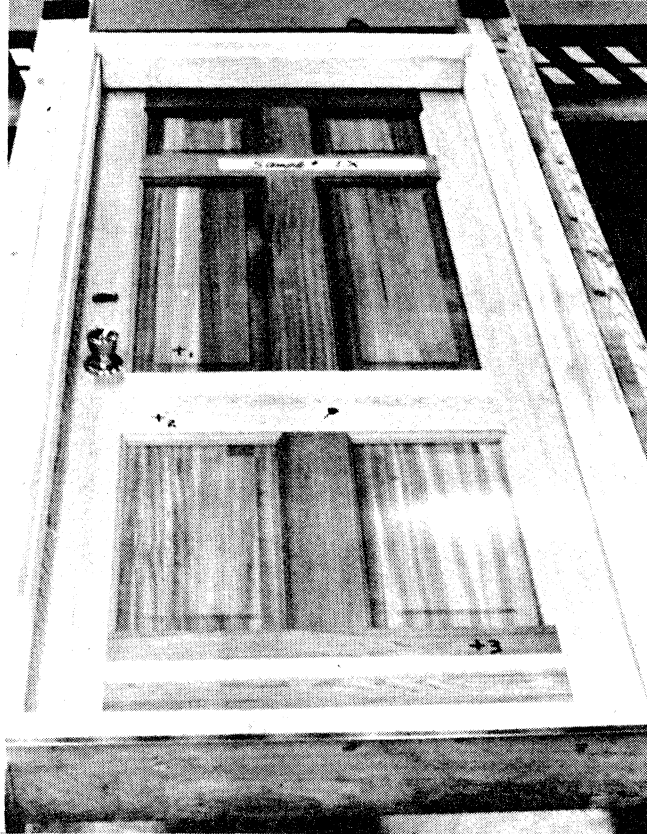
Figure 39.
Door No. IX before test.

This door is shown in Figure 39.

The door sample failed on the very first impact at the lowest grade level. The impact was directed at a point on the corner of the recessed panel closest to the lock, 75mm in from the vertical and horizontal edges of the panel. The entire panel and part of the cross rail (Figure 40) came off the door, it was then possible to open the door by reaching through the opening and unlocking the door from the inside.

The sample tested failed to meet with the minimum security requirements for an exterior door when tested for resistance to impacts. A single impact of 80 joules (59 ft. lb.), was sufficient to allow entry to be gained.

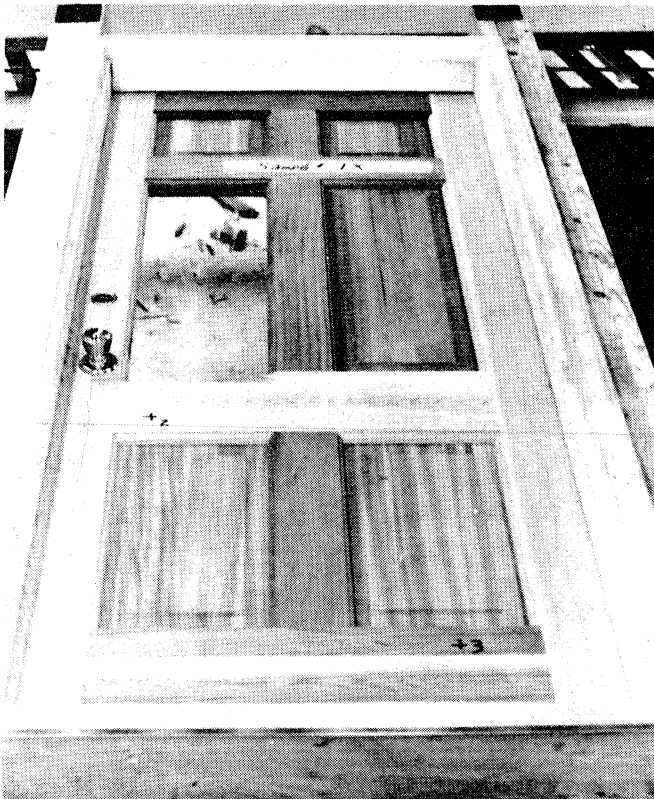
Figure 40.
Door after test.

Both panel doors tested (IX, a cedar door; and X, a used old-type pine door), were found to offer the weakest level of resistance to attacks of any door type tested. This is largely due to the thin panels that could be easily broken, or knocked off from the door at their weak tongued-and-grooved joint.

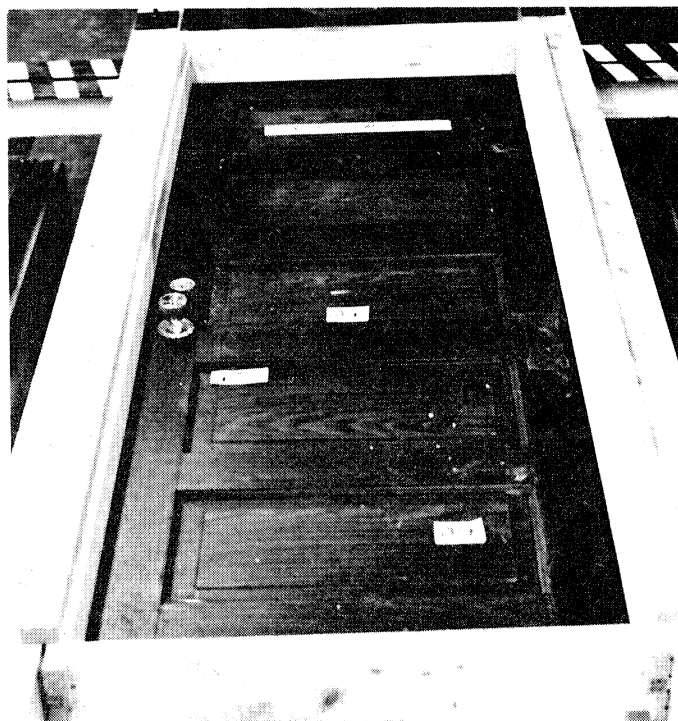
Figure 41.
Door No. X before test.

The sample tested was an old stile used panel door 755 x 2030 x 35 mm (2'6" x 6'8" x 1 2/5"). All five panels were 540 mm wide and 275 mm high and had a minimum thickness of 10 mm. The stile and rail were 115 mm wide. The hardware was mounted on the reverse side of that found in the original installation.

This door is shown in Figure 41.

The door failed on the very first impact at the lowest grade level. The impact was directed in the centre of the door, which coincided with the centre of the middle recessed panel, near a lower cross rail. The impact almost tore the whole panel off the door (Figure 42), making it possible to open the door by reaching through the opening and unlocking the door from the inside.

The used door tested failed to meet with the minimum security requirements for exterior doors. A single blow of 80 joules (59 ft. lb.) was all that was required to allow entry to be gained.

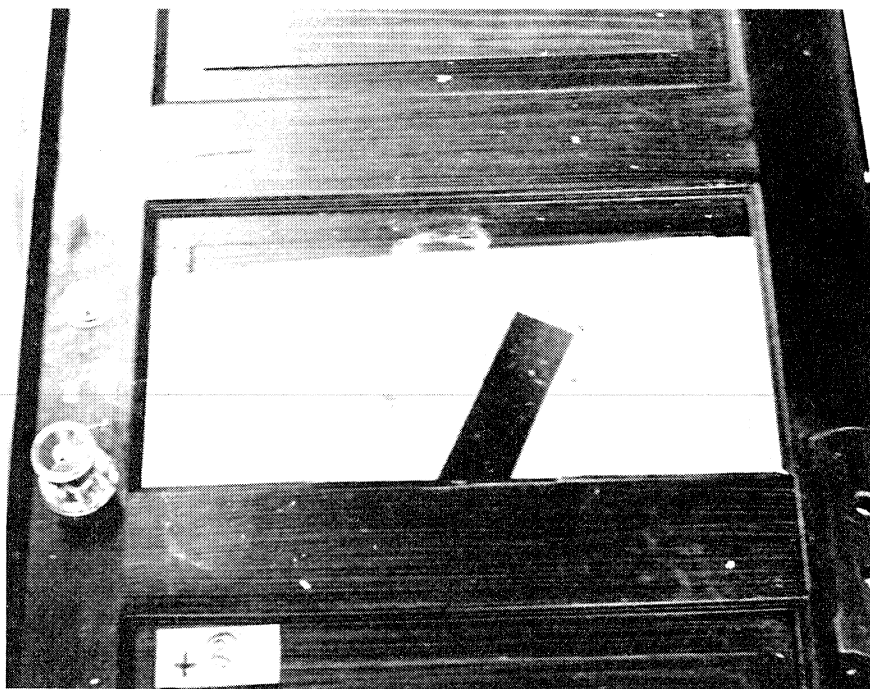
Figure 42.
Door after first impact.
