## **Characterization of Microstructure, Tensile (23°C to 850°C) and Charpy Transition Curves of a Current Tank Car Steel (TC128B) Circumferential Weld**

**Report No. CMAT-2018-WF 34540443**

January 2019

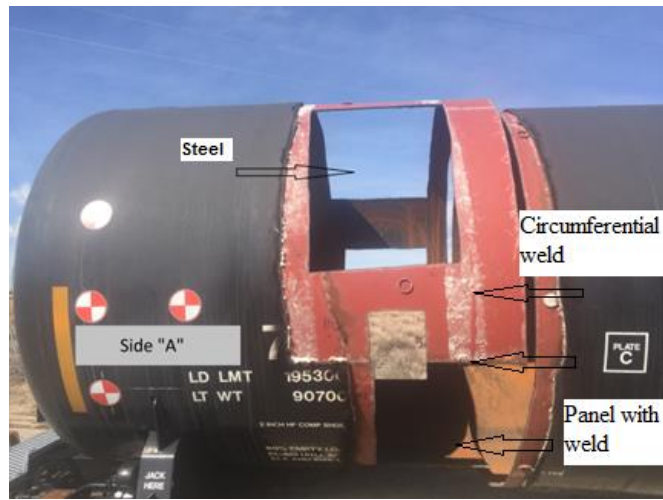
Figure 1. US Federal Railroad Administration impact-tested tank car, showing location of TC128B panel used in this work. Photo provided by Nolan Hanson of the Transportation Technology Center, Inc.

The tank car TC128B weld samples were taken from a tank car conforming to DOT 117 specifications, fabricated in 2015 and subjected to a side-impact test in September 2016. The tank car was purchased and the impact test was sponsored by the United States Department of Transportation (DOT). The shell has a nominal thickness between 12.7 mm (9/16") to 15.9 mm (10/16"). The tank car was fabricated using a submerged arc welding process. From locations sufficiently far away from the impact location, plates with and without welds were sectioned and provided to CanmetMATERIALS for testing. Figure 1 shows post-impact-test photograph of the tank with plate sections. The plate rolling direction (RD) is normal to the axis of the tank. A circumferential weld used in this work is shown in Figure 2. Cross-weld tensile specimens were taken transverse to the weld length and at transverse direction (TD) of the steel plate. The steel thickness was approximately 14.8 mm close to the weld.

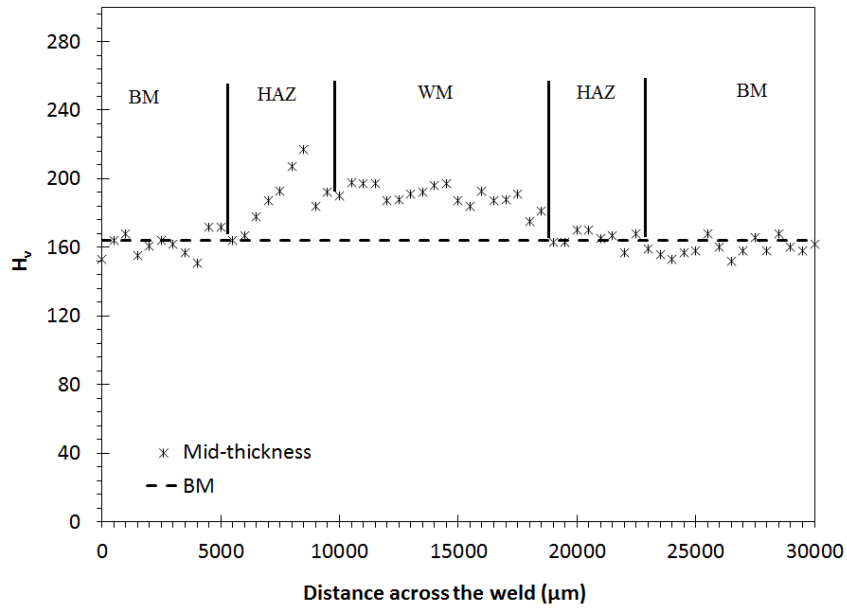
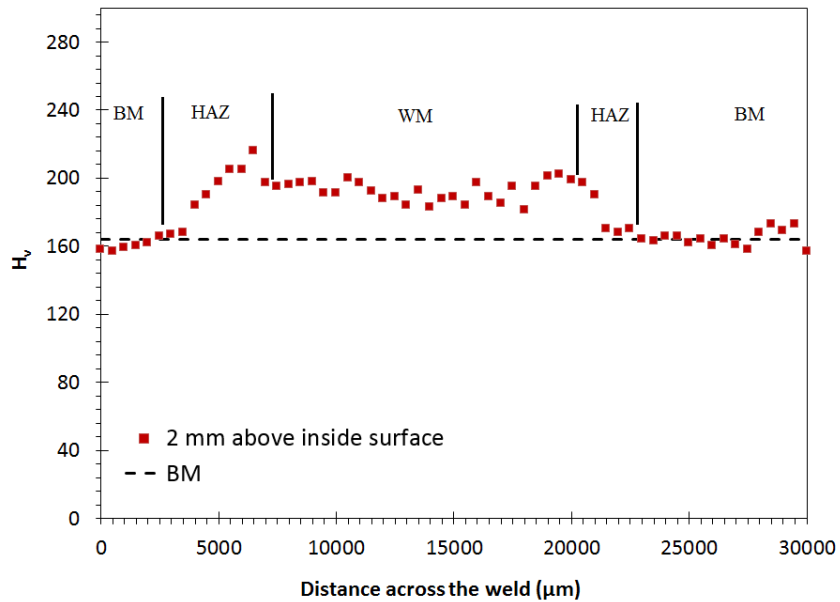
(a) Micro-hardness measured at 2 mm below outside surface

(b) Micro-hardness measured at mid-thickness

(c) Micro-hardness measured at 2 mm above inside surface

(d) Combined micro-hardness profile

Figure 8. Micro-hardness across the TC128 weld.

Micro-hardness measurements were made across the weld specimen and the hardness indentations (black dots) are shown in Figure 7. Twenty through-thickness micro-hardness tests were also performed on a section of tank car base metal (BM) and showed good consistent results  $164 \pm 8$  (from 152 to 182; the ratio of standard deviation to average was 4.6%). Cross-weld micro-hardness measurements are shown in Figure 8 and the average BM hardness (164) is shown as a horizontal dash-line for comparison. The regions of BM, HAZ and WM were illustrated in Figure 8a-c based on the indentation locations in Figure 7. The origin of X-axis in Figure 8 corresponded to the first hardness measurement on the right side in Figure 7. Since fusion line and HAZ boundaries at the three through-thickness positions are different these boundaries in Figure 8d are not illustrated. The average and standard deviation of micro-hardness of HAZ as measured in three through-thickness positions were  $191 \pm 17$  (from 151 to 217) and these of WM were  $194 \pm 9$  (from 163 to 217). The highest hardness values in the weld and HAZ were 217. The six hardness measurements in the RH-WM close to WM centerline yielded values of  $185 \pm 3$  (from 181 to 191), which are higher than the BM (avg. 185 vs. 163) but slightly lower than WM (avg. 185 vs. 194) and HAZ (avg. 185 vs. 191) hardness values. The main observation from the measurements was that the hardness values in the weld and HAZ were considerably higher than those of BM, i.e., demonstrating desired weld strength over-matching. The hardness values in the HAZ at 2 mm below the outside surface close to the second-pass weld fusion line (so-called the bay region in Figure 6) were slightly higher than those in the other two thickness positions (Figure 8d). The bay region close to the fusion line in the final weld pass usually displays coarse grained microstructure due to fast cooling rate after welding (e.g., [8]).

- The hardness values in the weld and HAZ were considerably higher than those of BM, i.e., demonstrating desired weld strength over-matching. The average and standard deviation of micro-hardness of BM, HAZ and WM were  $164 \pm 8$  (from 152 to 182),  $191 \pm 17$  (from 151 to 217) and  $194 \pm 9$  (from 163 to 217), respectively.

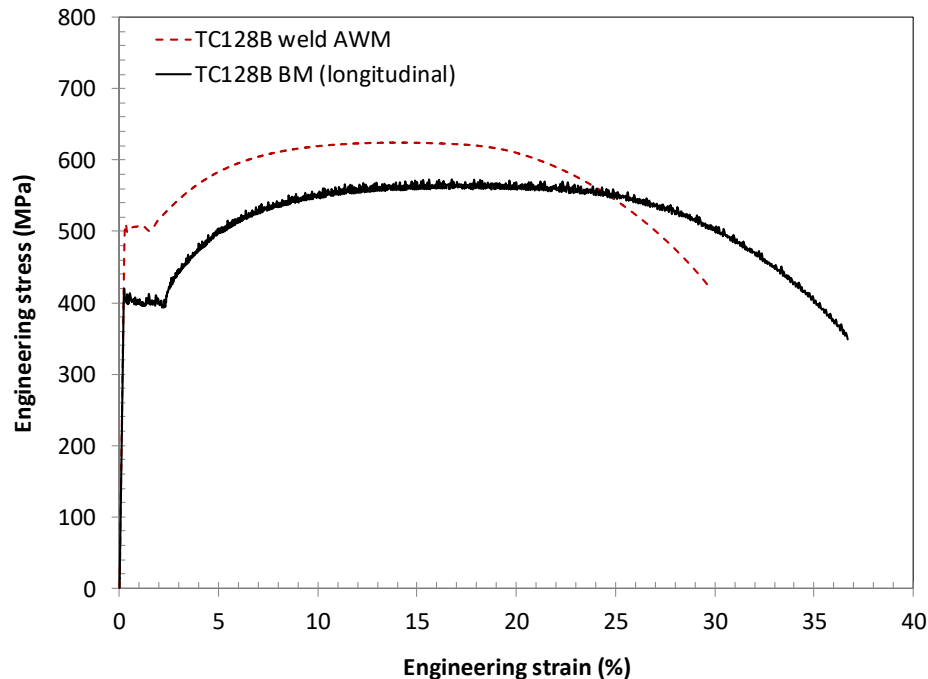
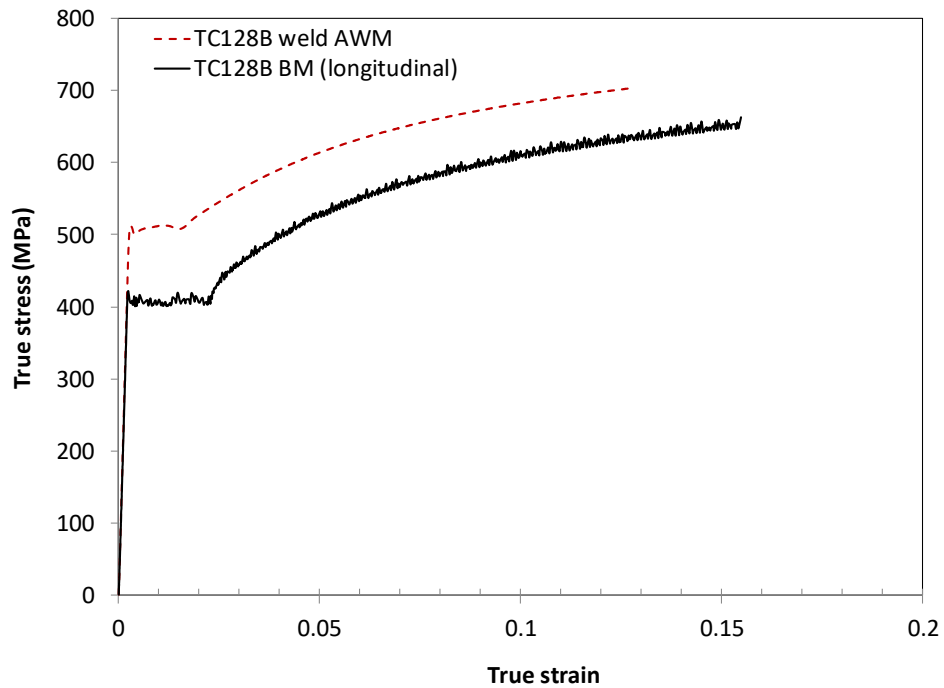
(a) Engineering stress-strain curve

(b) True stress-strain curve

Figure 15. Stress-strain curve of TC128B AWM and BM.

Two AWM tests showed very repeatable results. Representative stress-strain curves of the TC128B AWM and BM specimens are shown in Figure 15. AWM specimens showed higher flow stresses and lower elongation than those of the BM specimens and also displayed discontinuous yield up to approximately 1.5% strain.

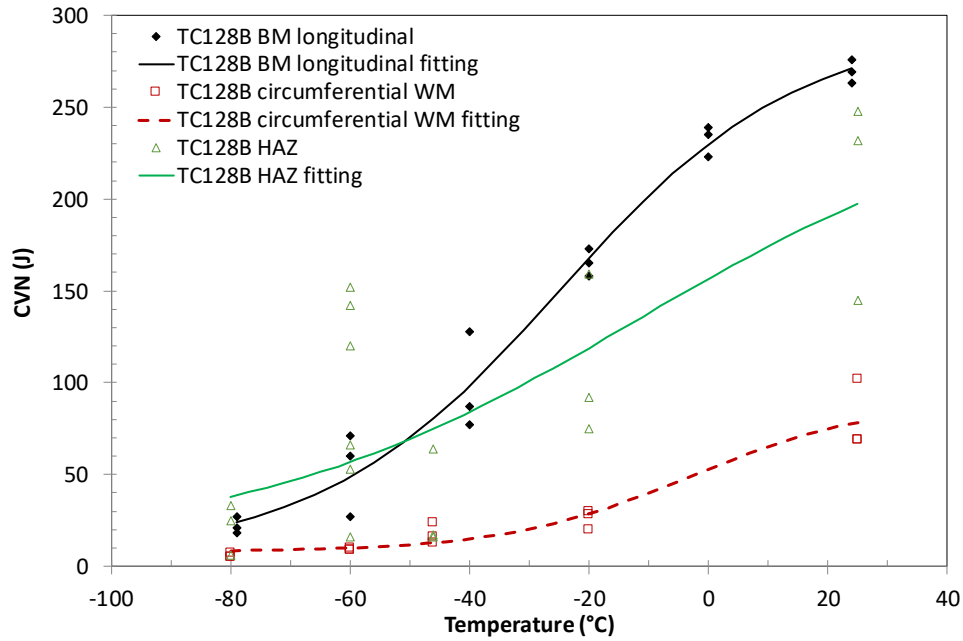
Figure 19. Charpy transition curve of TC128B BM, WM and HAZ.

Charpy impact toughness is the only toughness requirement included in the AAR tank car steel specifications. Charpy impact tests are also used to evaluate welding procedures for low-temperature applications [3]. The objective of this work was to establish Charpy transition toughness curves of a current TC128B circumferential weld joint and to compare the weld toughness to base steel toughness. Charpy absorbed energy (CVN) values of TC128B circumferential weld are given in Table 3. Charpy transition curves including that of the BM are shown in Figure 19 and the fitting curves are of the form

significantly lower than those of BM. CVN of HAZ specimens were between those of BM and WM at temperatures above -40°C, and displayed larger scatter than those of BM and WM because the HAZ specimens sampled inhomogeneous materials (Figure 5b and Figure 6).

The CVN energy of the WM is much lower than that of the BM across all temperatures, as shown in Figure 19. This means that in an accident involving impact the weld is most likely the failure location. Improving the toughness of the weld metal would reduce the chance of fracture/rupture under all service conditions. Weld toughness can be improved by adjusting the welding process, the filler metal, and the post weld heat treatment. It is recommended that a study be conducted to develop an improved weld process that increases weld toughness. The study should be conducted using equipment and processes consistent with what is currently used by industry. It may be possible to greatly improve the weld integrating with no, or little additional cost to the manufacturer.
