Observations on the Environmental Monitoring and Surveillance of the Alyeska or Trans-Alaska Pipeline

June 1978

Fisheries & Marine Service Manuscript Report No. 1451

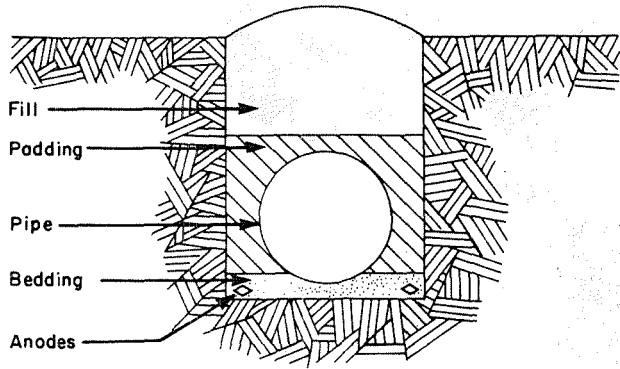
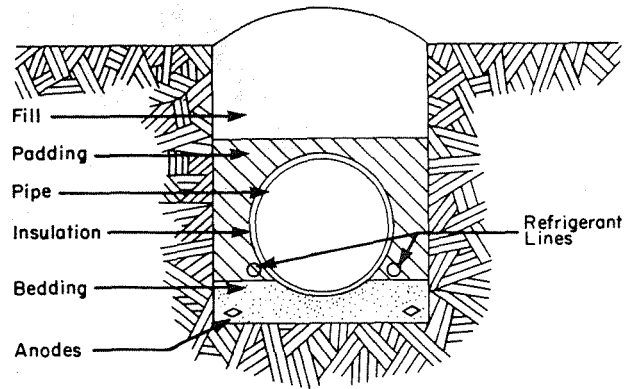
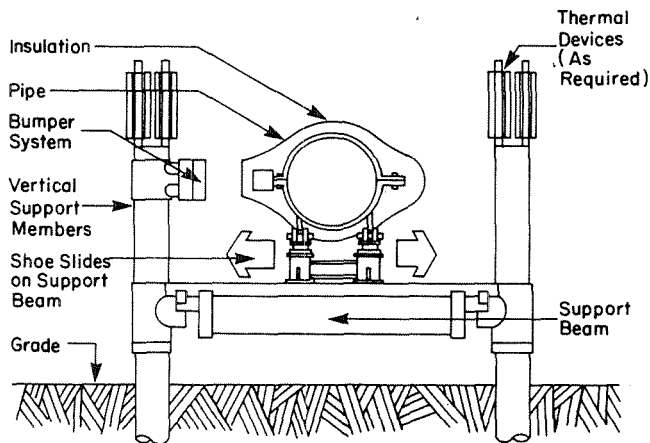
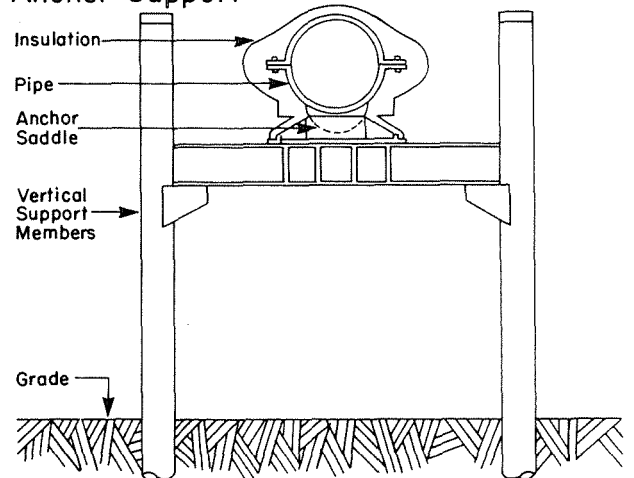
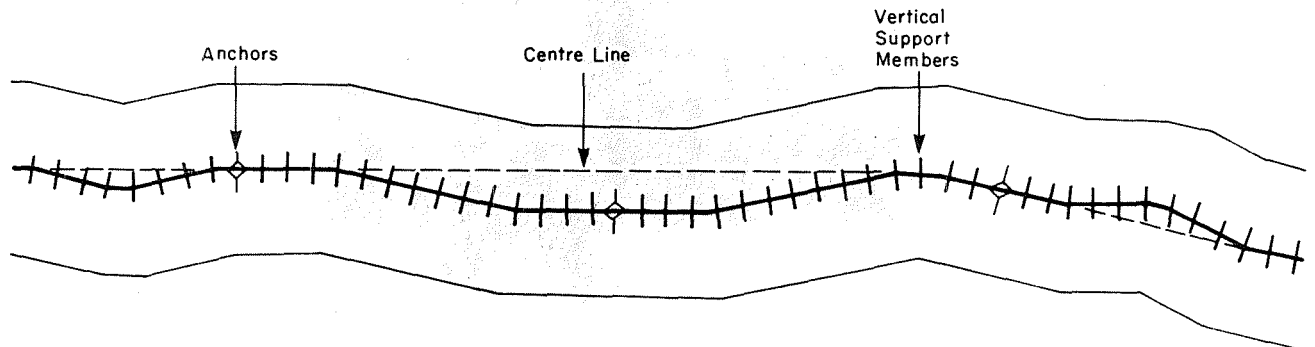
Fig. 4. Modes of construction used on the Alyeska Pipeline.

Oil comes from the ground at temperatures of up to 82° C. Heat generated by pumping and friction within the pipeline maintains the oil temperature at between 54 and 60° C. Since the pipeline traverses a considerable amount of permafrost and since a conventionally constructed hot oil pipeline could melt the permafrost and result in severe damage to the environment and ultimate failure of the pipeline, the pipeline has been built in three modes: conventional burial; above ground; and refrigerated burial (Fig. 4).

To compensate for expansion and contraction of above-ground pipe, the line has been built in a flexible zig-zag configuration which converts expansion of the pipe into sideways movement (Fig. 7). In these sections, the pipe has been secured in a shoe and saddle assembly, allowing it to freely slide on the cross beam (Fig. 4).

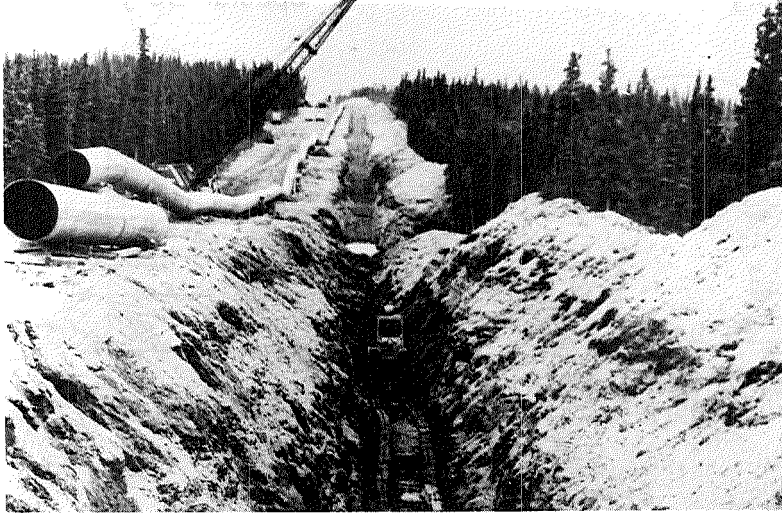
Fig. 5. Preparation of trench for buried segment of the pipeline.

In areas where the substrate consists of bedrock, thaw stable or thawed soil, the pipe is buried in a conventional manner, as is done with most pipelines throughout the world (Fig. 5).

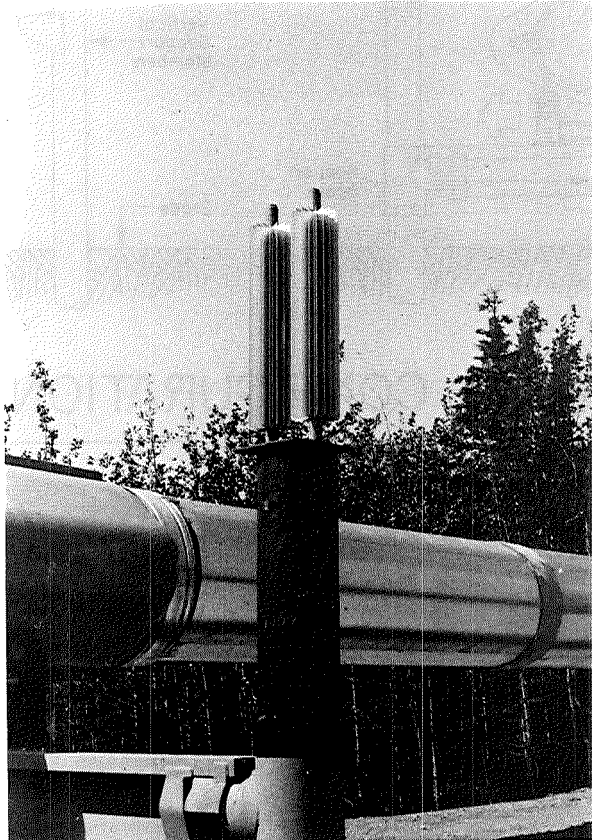
Fig. 6. Above-ground mode showing vertical support members (VSMs) thermal radiators and galvanized covering.

In sections of the route where melting of the permafrost might create soil stability problems, the line has been covered with 10 cm of resin impregnated fiberglass insulation, jacketed with galvanized steel. The insulated pipe is mounted on a cross beam installed between 2 vertical support members (VSMs) which are embedded in the ground at 18.3 m intervals. To prevent thawing around the VSMs, special non-mechanical and self-operating thermal devices have been installed inside the member where required (Fig. 6). These devices consist of metal tubes filled with a refrigerant which evaporates and condenses,

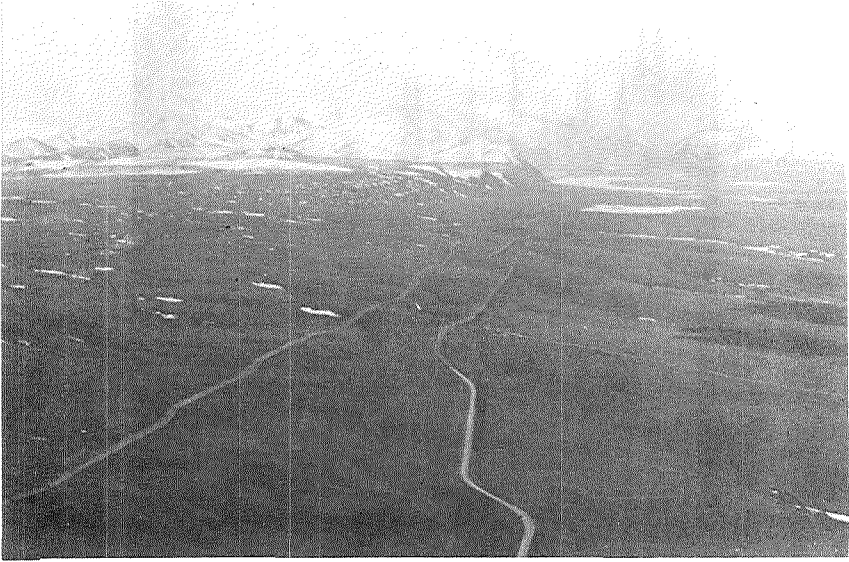
Fig. 7. Zigzag configuration of above-ground selection of pipeline (left) and haul road, Yukon River area.

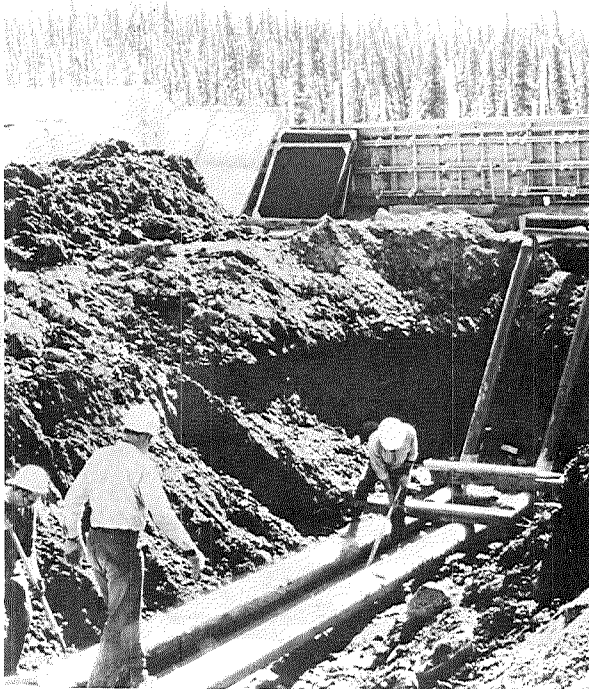
Fig. 8. Installation of brine pipes on refrigerated burial segment of pipeline, Glennallen area.

Three short buried sections of the pipeline, totalling 11 km in length, are insulated with 8 cm of polyurethane foam covered with a fiberglass jacket and continually cooled by special refrigeration pipes placed in the permafrost beneath the line (Fig. 8). This mode of construction is used where the pipe could block the movements of migrating caribou if installed above ground.

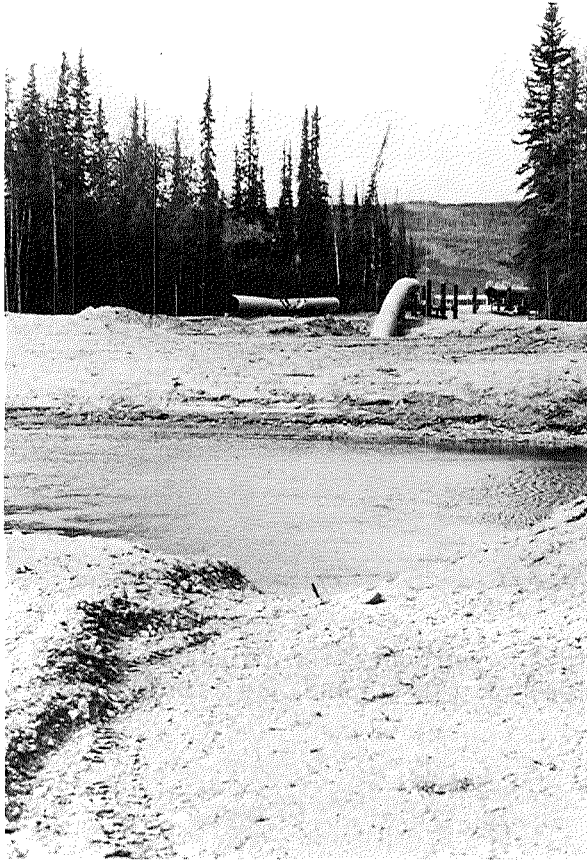
Fig. 9. Descent of pipeline beneath Chatinika River, near Fairbanks

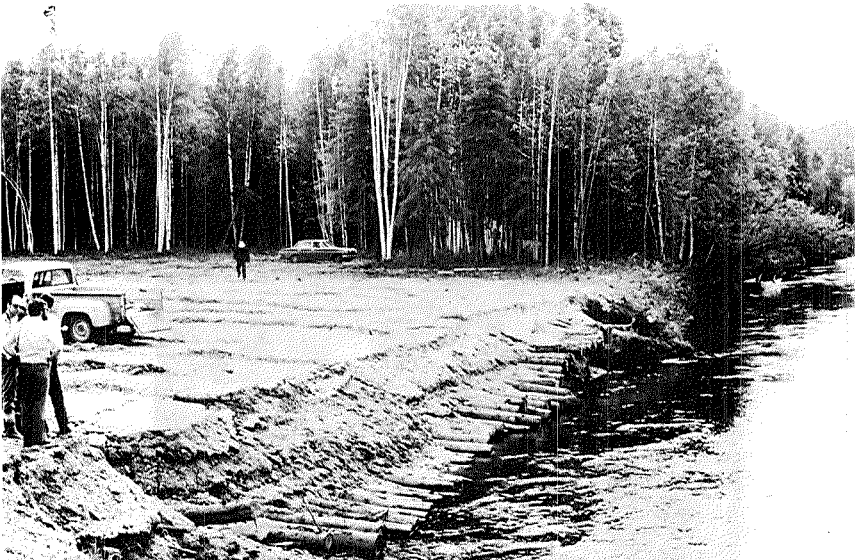
Fig. 10. Chatinika River crossing, near Fairbanks. Note logs used as riprap and erosion of river bank after only four months.

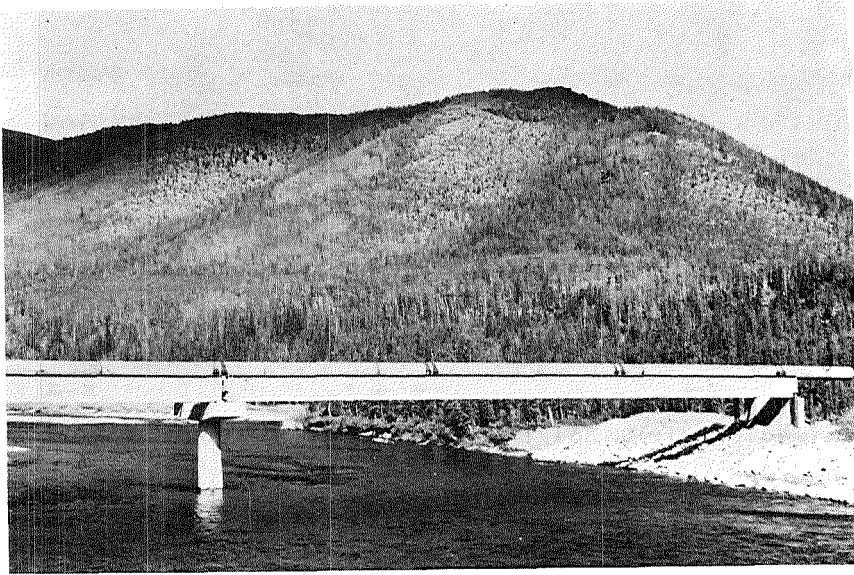
Fig. 11. Bridged crossing of the Koyakuk River, Brooks Range

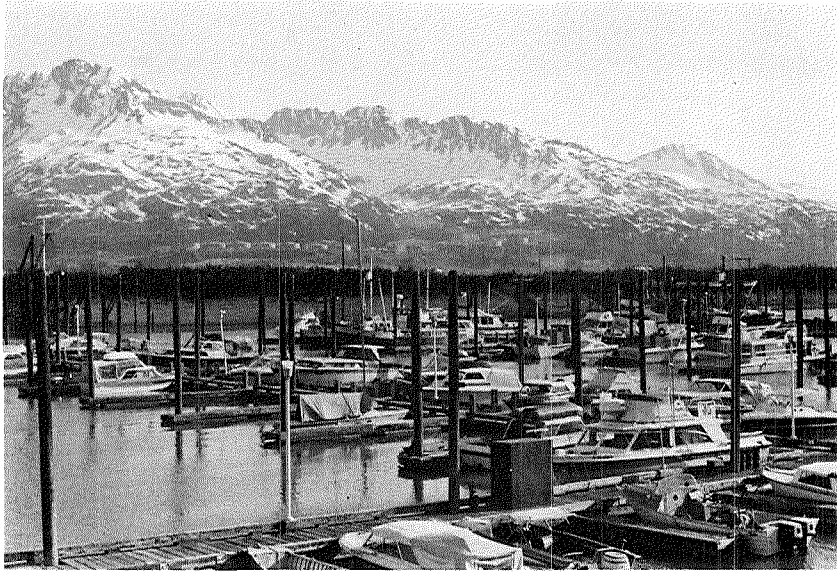
Fig. 12. Valdez Terminal from small boat harbour at Port Valdez.

The southern terminal of the pipeline is situated on the south shore of Valdez Arm, across from Port Valdez. Oil received from Prudhoe Bay is stored in tanks until it can be loaded, by gravity flow, aboard tankers for shipment to outside markets (Figs. 12, 13). The 400 ha terminal site includes storage tanks, docks, tanker loading and ballast water treatment facilities; power plant and vapor control facilities; fire control, oil spill contingency equipment and the pipeline operations centre (Fig. 14). Site elevation ensures that all critical equipment, storage tanks, buildings and other facilities are out of the range of statistically probable seismic waves (tsunamis).

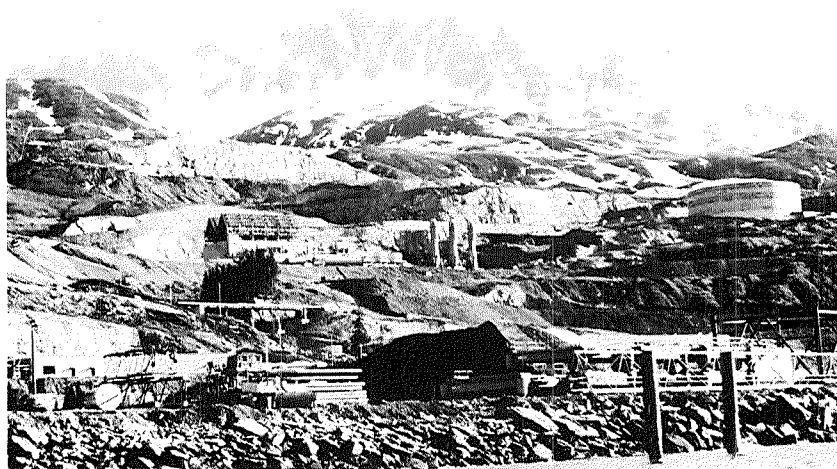
Fig. 13. Construction in progress at Valdez Terminal, June 1976

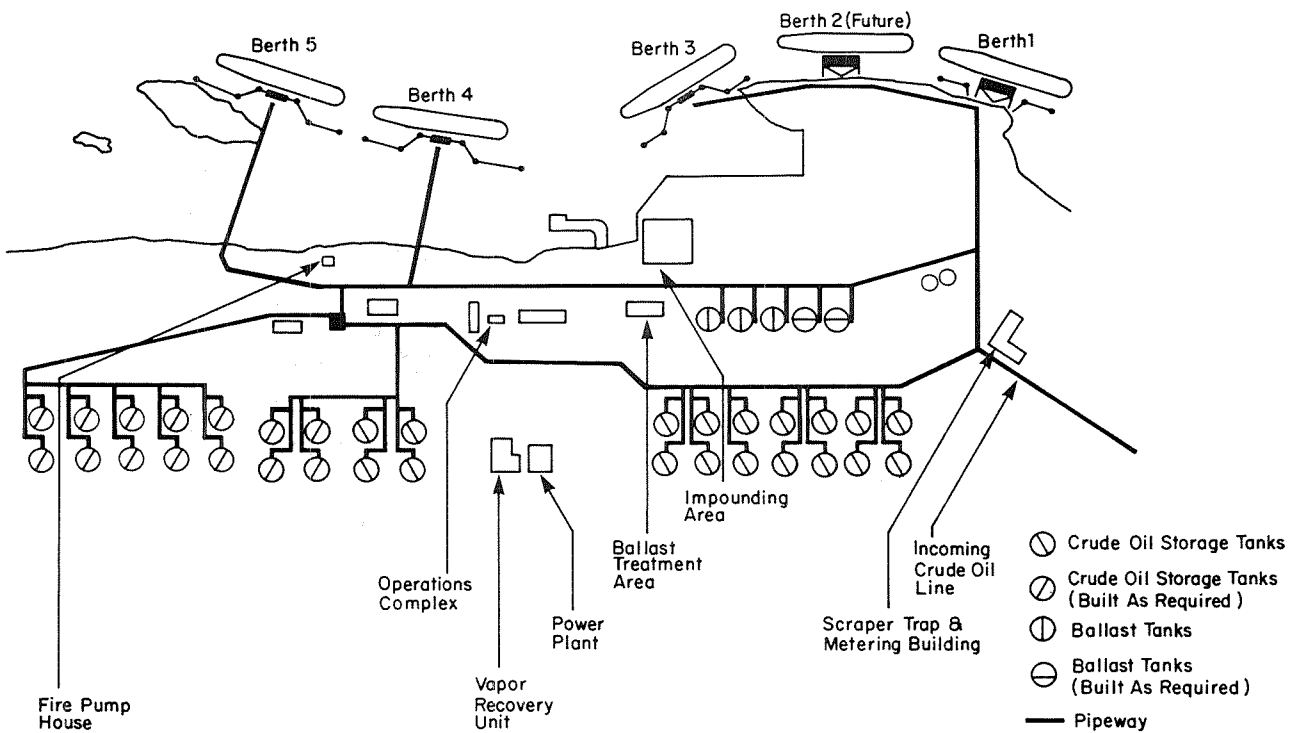
Fig. 14. Schematic of Valdez Terminal at maximum development

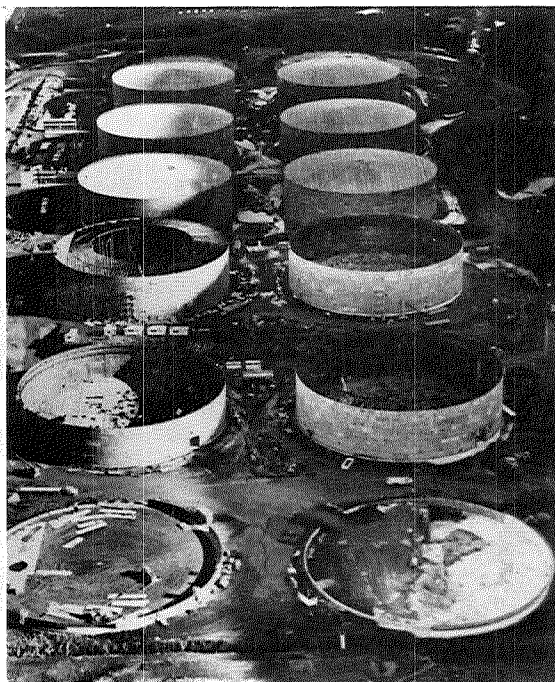
Fig. 15. Fabrication of oil storage tanks, Valdez Terminal. Note size of tanks relative to service vehicles.

Initially, 18 tanks have been erected, with a storage capacity for approximately 8 days flow of oil at an initial delivery rate of 1.2 million barrels per day. As the pipeline approaches its full capacity of 2 million barrels per day, tankage will be increased to 32 units. The storage tanks are 76 m in diameter and 19 m high and are constructed of concrete and welded steel with a cone roof. Each has a storage capacity of 510,000 barrels of oil (Fig. 15). The tanks are sited in pairs within containment dikes with a capacity equal to 110 percent of the total volume

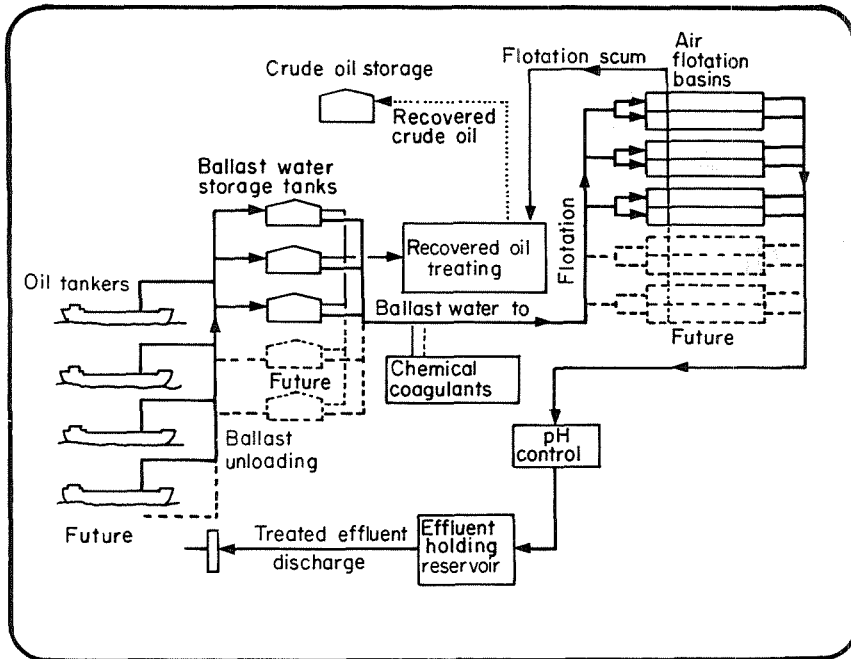
Fig. 16. Schematic of oily ballast water treatment facility at Valdez Terminal.

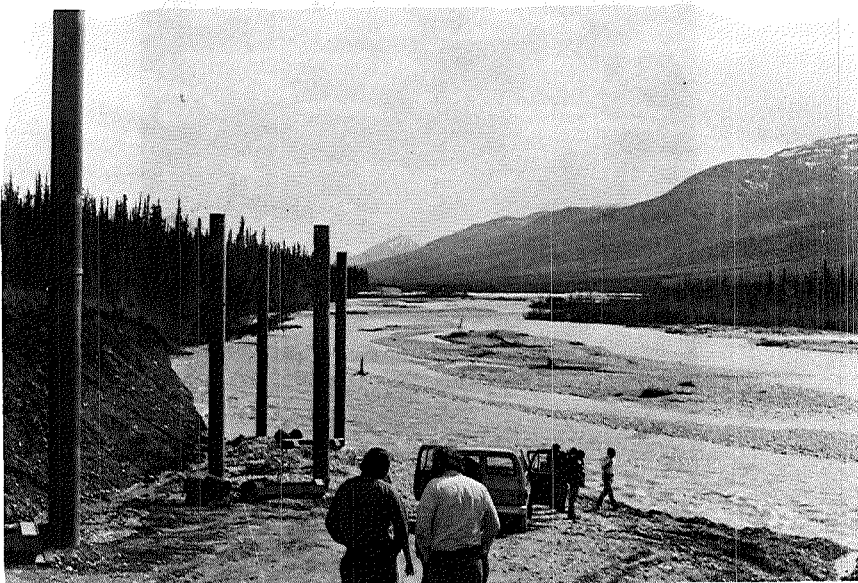
Another alignment problem was observed in this same area. Despite recommendations from JFWAT, Alyeska proposed to construct the pipeline through the middle of one of the major overwintering areas for grayling on the Dietrich River (Fig. 17). At the time of our observation, the work pad had been constructed and vertical-support members were in place to the water's edge, awaiting freeze-up for continuation of the work. In addition, a near vertical face approximately 6 m high has been carved out of the ice-rich river bank to allow construction of the work pad. Some solifluction was already in evidence and many erosional problems were foreseen if no remedial measures were undertaken.

Fig. 17. Vertical-support-members in place to bank of Dietrich River. Pipeline was scheduled to be built through prime grayling overwintering area until JFWAT intervention.

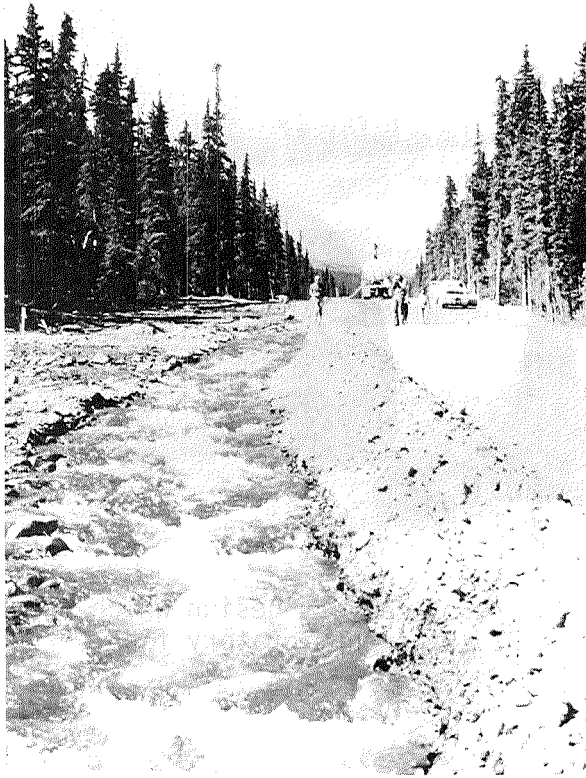
Near Glennallen, we observed the effects of improper alignment and improper drainage control. In this situation, meltwater from a small glacier flowed down the right-of-way of a buried section of the pipeline and deposited silt into an important salmon spawning and nursery area on the Little Tonsina River (Fig. 18).

Fig. 18. Improper alignment of pipeline resulting in flow of glacial meltwater along right-of-way and the deposit of silt in an important salmon and nursery area on the Little Tonsina River.

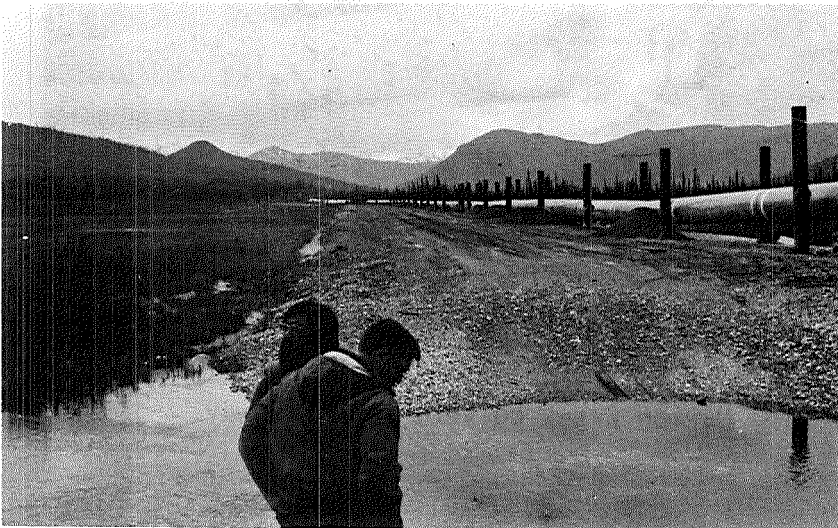
Misapplied southern technology was also evident in the use of low-water crossings (LWC) (Fig. 19). These LWCs were essentially mimics of West Texas type fords, meant to speed construction of the work pad across streams and to allow limited movement of equipment through flowing water without the bother of culvert installation. JFWAT agreed to the construction of a few such crossings on a trial basis but many were built and nearly all failed because of the presence of ice-rich soils underlying thin gravel veneers and also because of heavy traffic loads or high runoff. As a result, streams were silted, fish passage was blocked, equipment got stuck and construction was delayed.

Fig. 19. Low-water-crossing of small grayling stream, Brooks Range area.

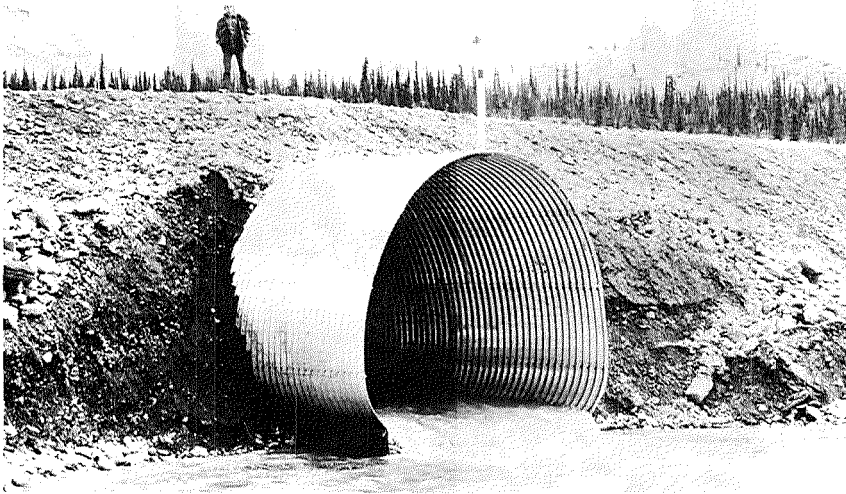
Fig. 20. An improper culvert design which has resulted in a blockage to migratory fish.

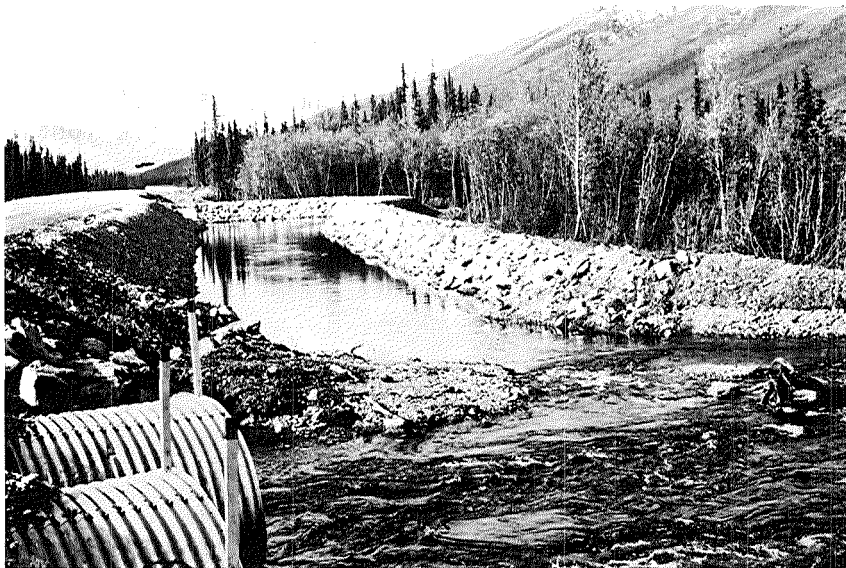
It was quite evident from our inspection that Alyeska's first priority was to build a pipeline and that matters of environmental protection came a distant second, as witnessed by the company's resistance to recommendations from JFWAT for bridges rather than culverts, or large culverts in preference to small ones (Fig. 20). The following serves as a case history. Despite JFWAT's recommendation for a bridge on the haul road across Marion Creek, near Prospect Camp, Alyeska installed a culvert which was under-designed and blocked fish (salmon) migrations. It subsequently washed out. JFWAT recommended replacement of the washed out culvert with a bridge but Alyeska instead installed two culverts. After a near washout and yet another recommendation for a bridge, Alyeska installed three large culverts and constructed a fishway (Fig. 21). Despite an expenditure approaching one million dollars, migratory fish were still denied passage, as the velocity differential between the stream and the fishway was so great that fish could not locate the fishway. Since the completion of the pipeline

Fig. 21. Marion Creek culverts and fishway.

and the decrease in haul road use, Alyeska have installed a permanent bridge permitting unrestricted fish passage. Had this been done during the initial construction of the haul road, as had been recommended by JFWAT, a considerable saving would have been realized, and two years of interrupted fish migration would have been prevented.

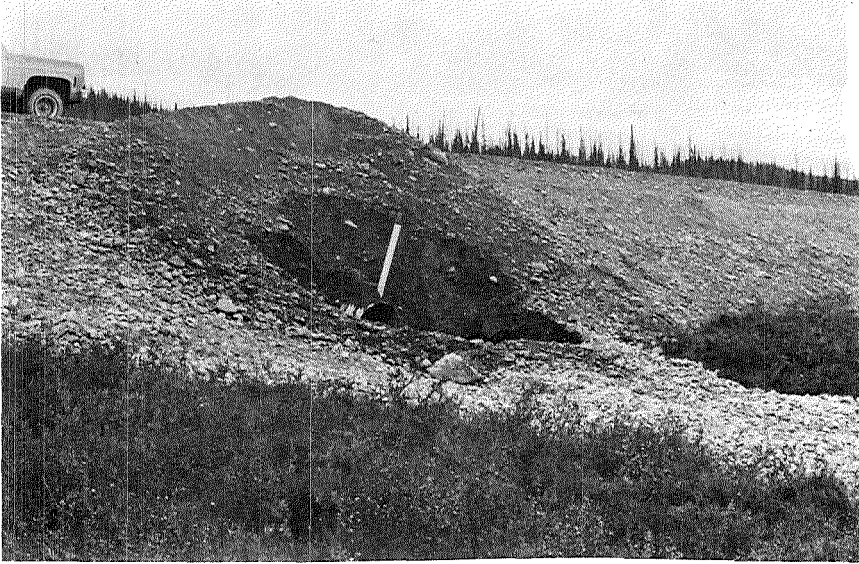
Inadequate drainage control was evident at many locations along the haul road and several near washouts were observed (Fig. 22). Sheet drainage and inadequate culverting to alleviate the situation is a big problem and will require continual surveillance. Inadequate design of the haul road caused many problems. The reason for this inadequacy was probably that design review responsibility for the haul road lay largely outside the purview of either the Alaska Pipeline office, the federal regulatory agency or the state pipeline coordinator's office and construction was well under way by the time JFWAT was mobilized. Had JFWAT been fully operational early in the project, several important changes in route alignment and drainage control might have been implemented. The shortsightedness and concern for the immediate job (construction of the pipeline) by Alyeska is evident in that culverts were designed to accommodate the one-in-five-year flood level only. In contrast, guidelines for highway construction in northern Canada stipulate that culverts should be designed to accommodate the one-in-fifty-year flood level.

Fig. 22. Inadequate side slope drainage will result in failure of haul road.

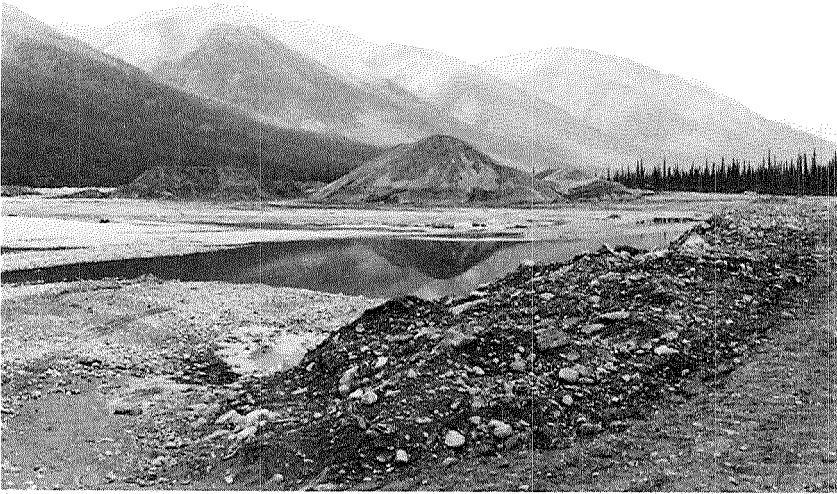
Fig. 23. A typical flood plain materials site, Brooks Range area.

Granular material was obtained from 280 materials sites along the pipeline route. Haul distances of 6.5 km or less were found to be economically efficient during construction and haul distances of 13-16 km or less are planned for ongoing maintenance of the pipeline system. Alluvial deposits in the flood plains of the major river valleys in or near the pipeline alignment have been important sources of gravel for construction. Approximately 50% of the material has come from the flood plain and 50% from upland sites (Fig. 23). In general, despite the number of materials sites, few problems were encountered (Fig. 24, 25). Mining plans had to be submitted to JFWAT and to the Bureau of Land Management (BLM) for approval and all upland sites must be revegetated. An exception to this was the development of an upland site which has resulted in a negative aesthetic impact. Alyeska had requested a permit to open a materials site on the lower slopes of Sukapak Mountain, in the Brooks Range (Fig. 26). An authorization to begin the operation was given by the Alaska Pipeline office before BLM, the official approval agency, had reviewed the plans. BLM rejected the application on the grounds that Sukapak Mountain was one of the most scenic vistas along the pipeline route and should be left in its natural state. However, the rejection occurred after Alyeska had constructed an access road and opened the pit. The road and gravel pit have considerable negative visual impact and it will take quite some time and cost to restore the area to some semblance of its former aesthetic state.

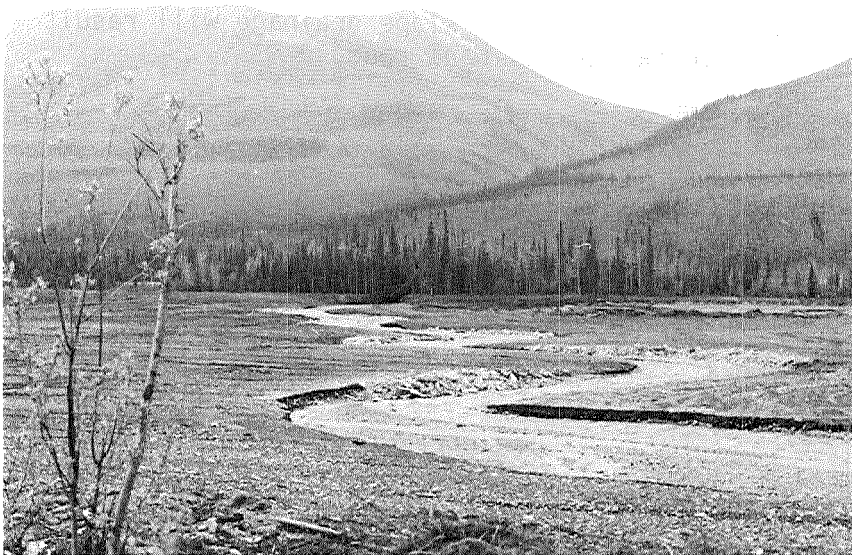
Fig. 24. Rehabilitated materials site, Brooks Range area. Note rechanneled stream and bank stabilization. Area is to be revegetated.

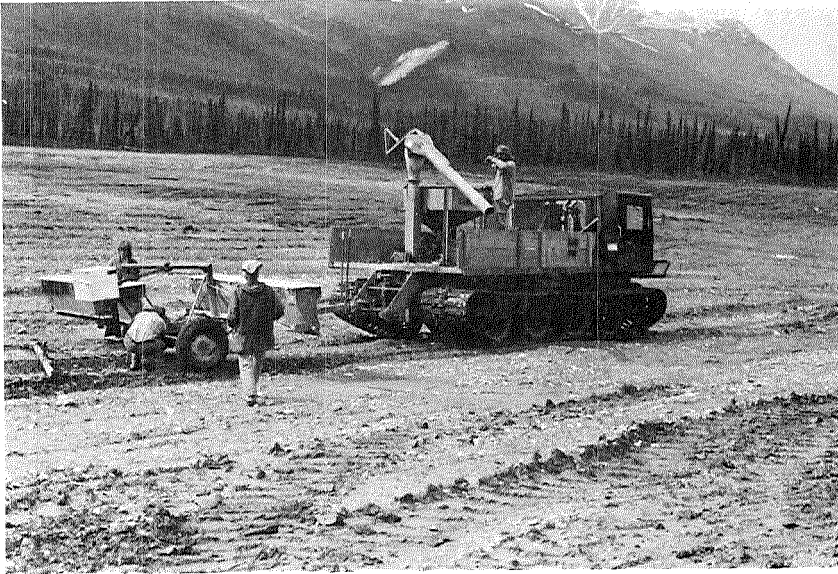
Fig. 25. Reseeding of materials site, Brooks Range area.

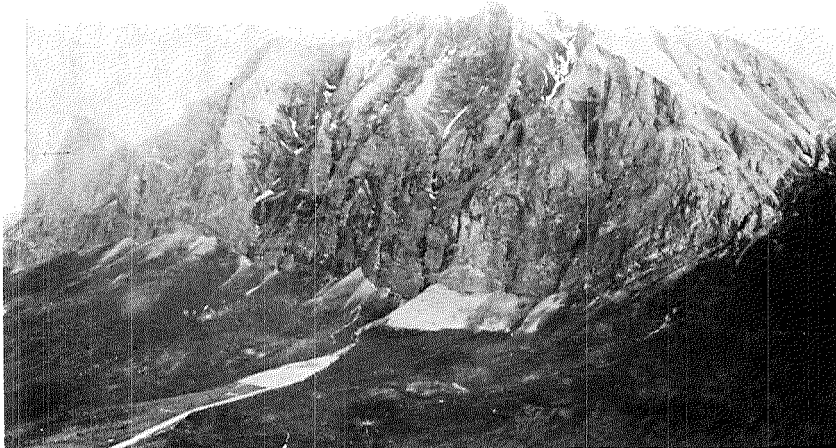
Fig. 26. Materials site on talus slope, Sukapak Mountain, Brooks Range.

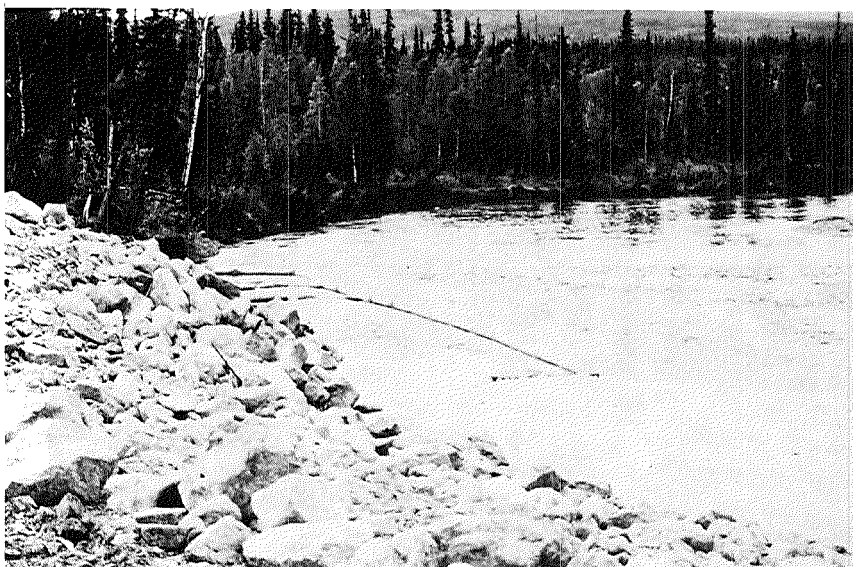
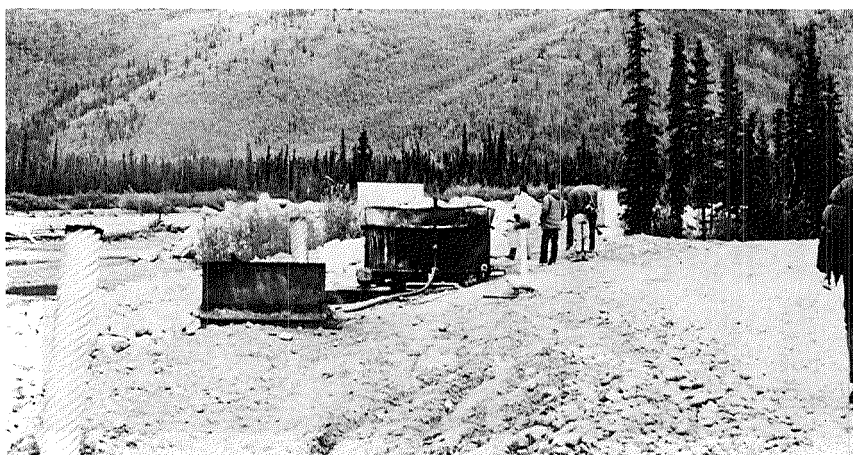
There have been many fuel oil spills during the course of construction. Some of the more severe of these have been at camps constructed prior to the granting of court injunctions in 1969. For example, a spill which occurred at Prospect Camp during the winter of 1975-76 was still being recovered and burned at the time of our inspection. The camp had been constructed on the bank of the Jim River without the 100 m buffer strip stipulated for later camps. During the winter of 1975-76, a fuel oil line buried in the gravel pad ruptured, and some 190,000 L of fuel was spilled. The leak went undetected until spring thaw, when an oil slick appeared on the

river. Booms were placed in the river and the oil was skimmed off and burned (Figs. 27, 28). Seepage from the gravel pad was still continuing in June, 1976.

Fig. 27. Oil spill containment booms in Jim River, Prospect Camp.

Fig. 28. Oil spill skimming and incineration, Prospect Camp
